## FIELD OBSERVATION REPORT

Central Hardin High School, Cecilia, KY

2019111 - CA8

Report No: 63

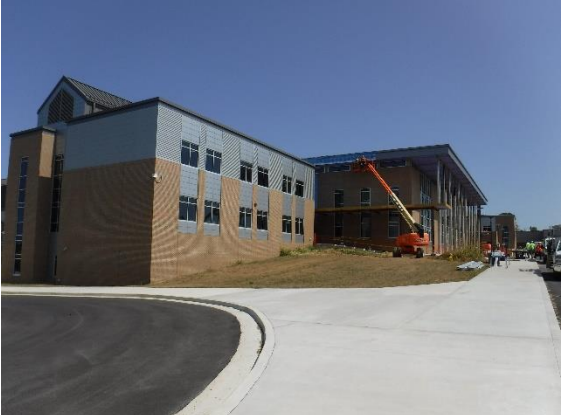
Item No.	Location	Description/Correction	Image	Action
1	Southwest Corner of Addition	The MCM panels and sheet metal coping were being installed. The sheet metal and roofing work for the canopy had not started.

Complete sheet metal work so the building can be fully enclosed and work can be completed by other trades.
2	LMC Exterior	The upper fascia was being covered with MCM panels.

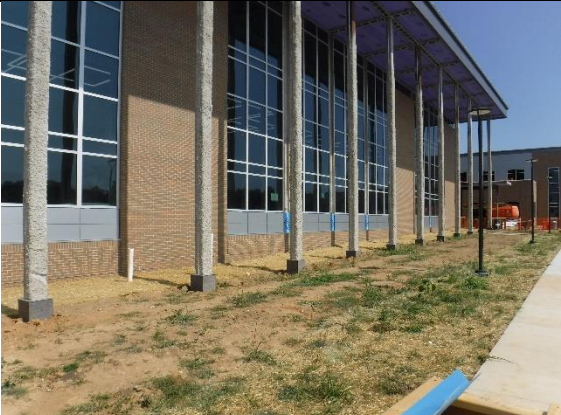
Install roofing and sheet metal on the two entry canopies.
3	LMC Exterior	MCM panels were being installed below the curtainwall windows.

Complete MCM panel installation around the windows.

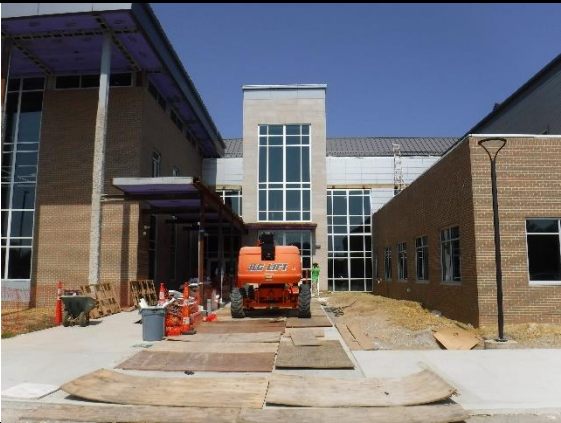
Item No.	Location	Description/Correction	Image	Action
4	Main Entrance	Roofing and sheet metal work and MCM panels need to be installed to finish the main canopy.

Complete sheet metal work for access to the building and admin.
5	LMC Office	The storefront framing was in place but the glass and doors were not installed.

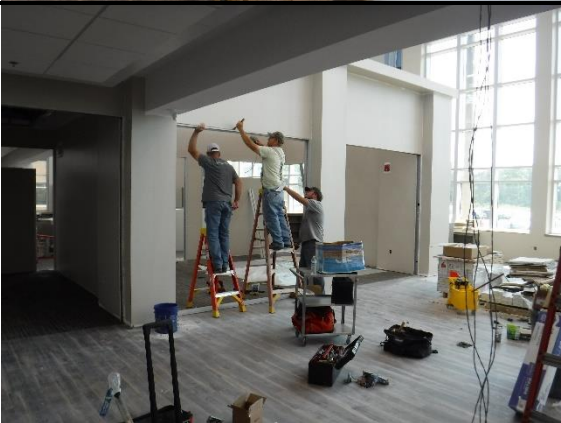
Complete framing, glass and doors to enclose offices.
6	LMC Study Rooms	Storefront framing was being installed.

Complete storefront framing and measure for the glass.

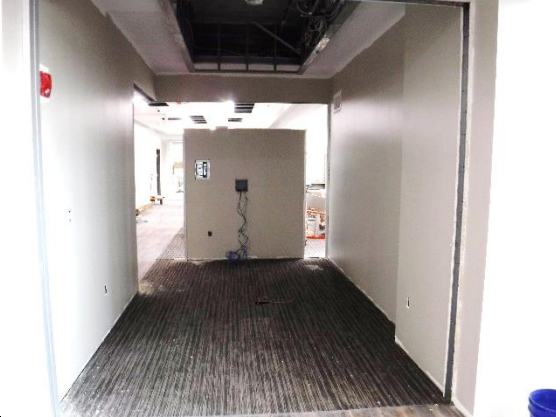
Item No.	Location	Description/Correction	Image	Action
7	LMC Study Room	The rooms were being enclosed.

Complete enclosures of study rooms. Install accessories.
8	LMC Charge Desk	The desk was not installed.

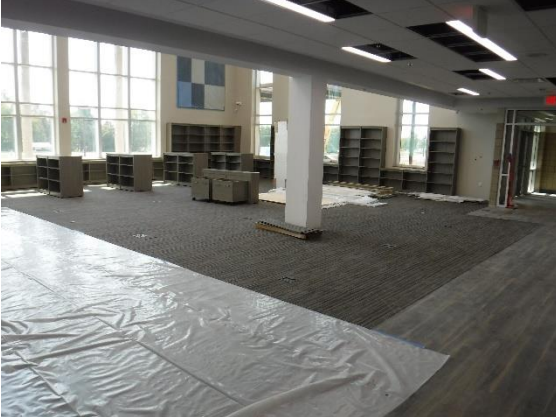
Complete work so desk can be installed.
9	LMC	Book shelving was being installed.

Continue to protect finish materials as shelving is installed.

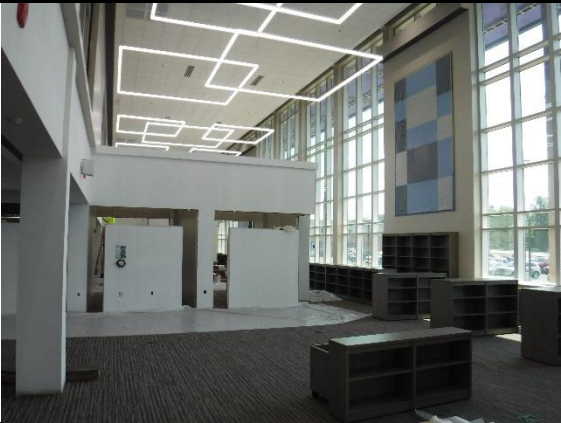
Item No.	Location	Description/Correction	Image	Action
10	LMC	Storefront needs to be installed to enclose the study rooms. The blue paint strip had not been started.

Paint blue stripe as indicated.
11	LMC	Carpet was in place. Floor outlets were being installed.

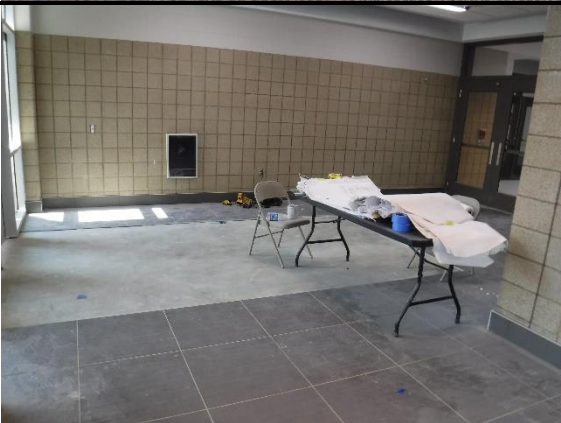
Complete installation of outlets and other electrical devices.
12	Southwest Entry Vestibule	The walk off carpet was not installed.

Complete surrounding areas before installing carpet.

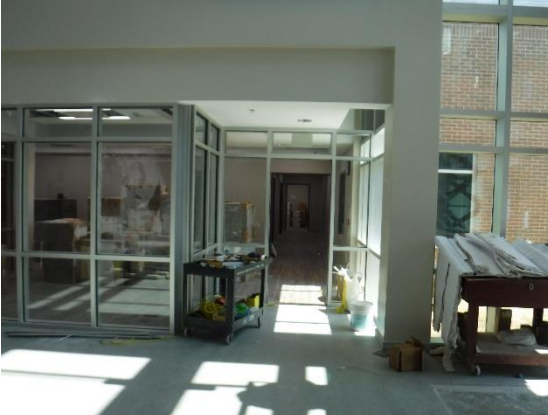
Item No.	Location	Description/Correction	Image	Action
13	Admin Entry	The framing and glass was in place, but the door was not installed.

Install doors and complete storefront.
14	Admin Corridor and Conference Room	The storefront and glass were not complete.

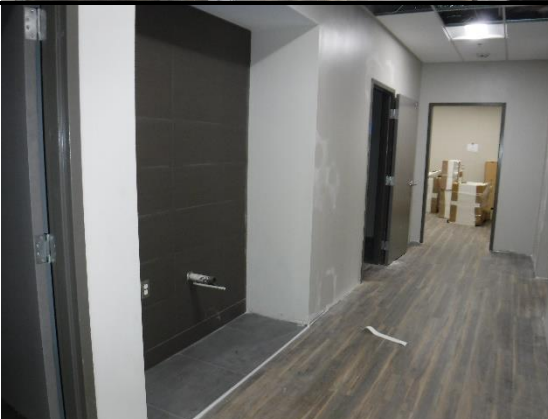
Complete storefront and install glass and doors.
15	Admin Water Fountain Alcove	The fixtures were not installed.

Install EWC.

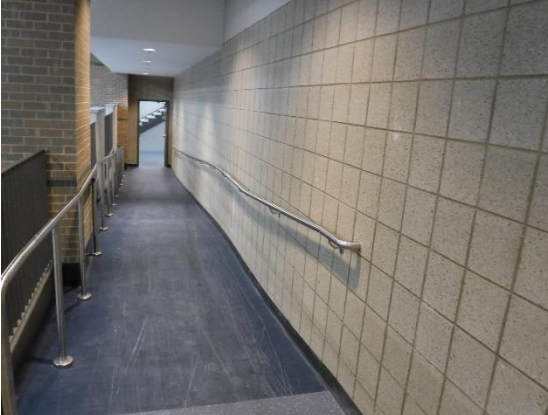
Item No.	Location	Description/Correction	Image	Action
16	Ramp to Café Commons	The ramp is available to make the Café Commons accessible. Several items need correction in this area.

Follow Punch List on Multi-Vista app.
17	Elevator Entrance	The elevator is operational.

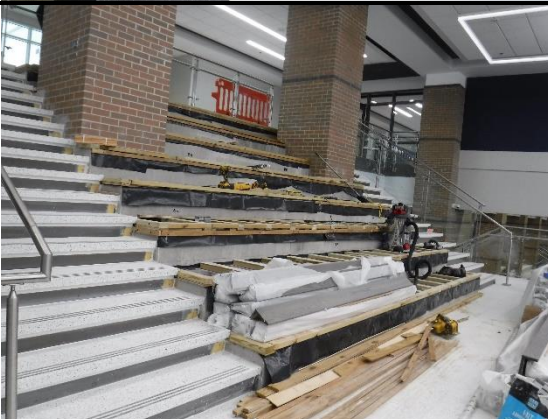
Limit access to necessary uses and access for disabled personnel.
18	Social Stair	Wood blocking was being installed in preparation for installing the wood strip flooring. The strip flooring was at the front of the stair to be acclimated.

Complete installation of wood strip flooring.

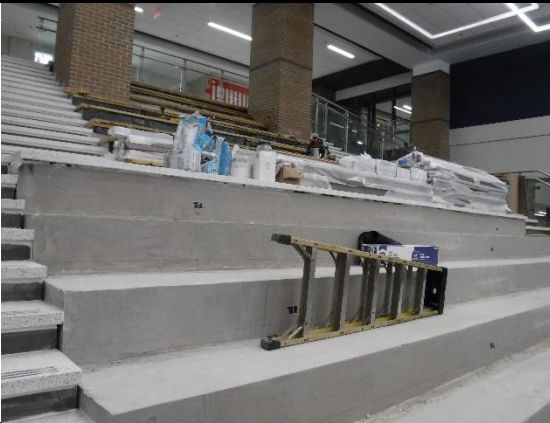
Item No.	Location	Description/Correction	Image	Action
19	Social Stair	Wood blocking was not started on the bottom portion of the stair.

Install flooring.
20	Second Floor at the Entry Foyer (below)	Glass and framing were in, but needs to be caulked and cleaned.

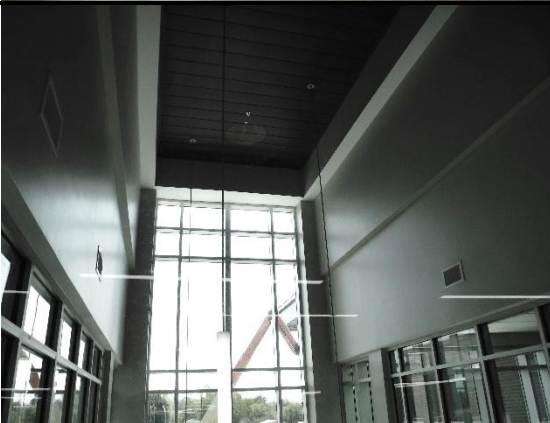
Complete glass and framing work in the area.
21	Entry Foyer	Lighting was not installed.

Complete installation of lighting and security systems.

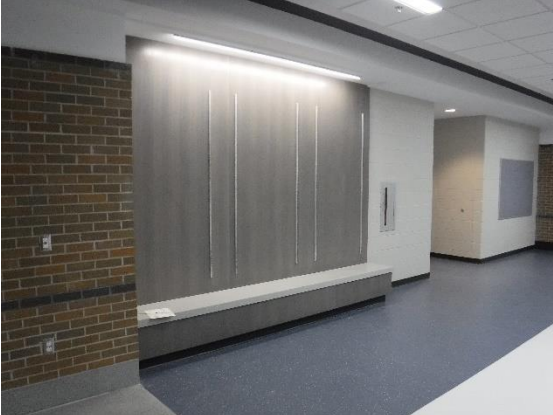
Item No.	Location	Description/Correction	Image	Action
22	Area F Display Case	The glass doors for all the display cases are about 14 weeks out.

Order doors ASAP.
23	Kitchen	Most of the recent corrections list had been addressed.

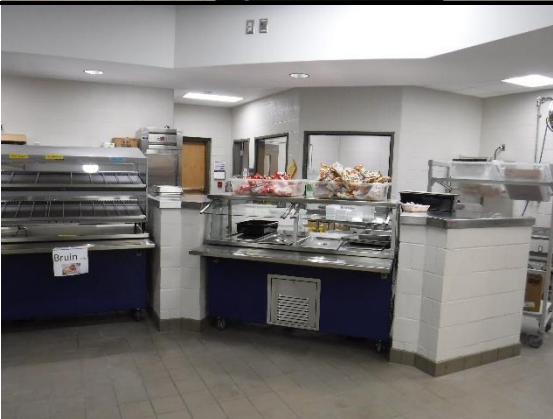
Continue to fix problems as they occur.
24	Kitchen	Stainless steel countertops were installed for displays.

Correct finish on SS tops.

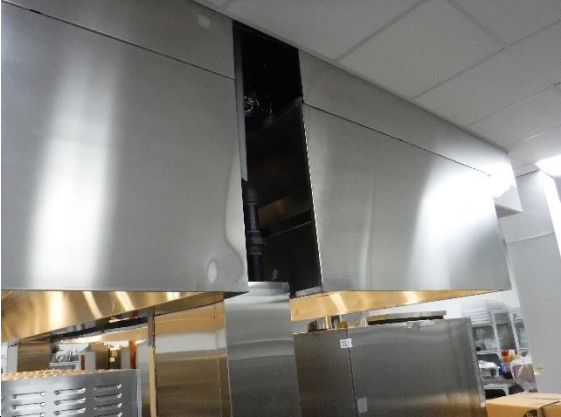
Item No.	Location	Description/Correction	Image	Action
25	Kitchen	There were gaps in the hood.

Complete the installation of SS panels.
26	Kitchen	The tilting skillet was moved back but the grate over the drain was missing.

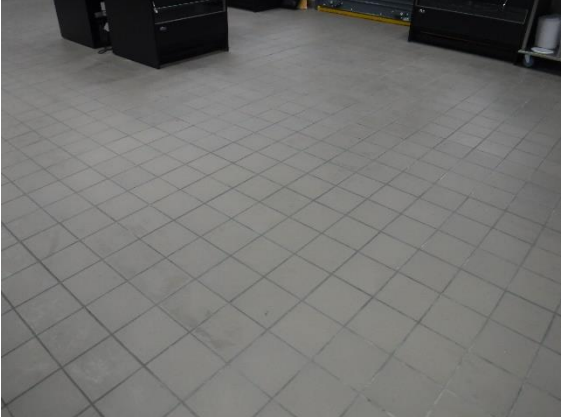
Install the grate.
27	Kitchen	The grout in the quarry tile joints is not uniform.

Repair the grout during fall break.
