## FIELD OBSERVATION REPORT

Central Hardin High School – Phase 2, Cecilia, KY

2019111 - CA8

Date: September 10, 2024

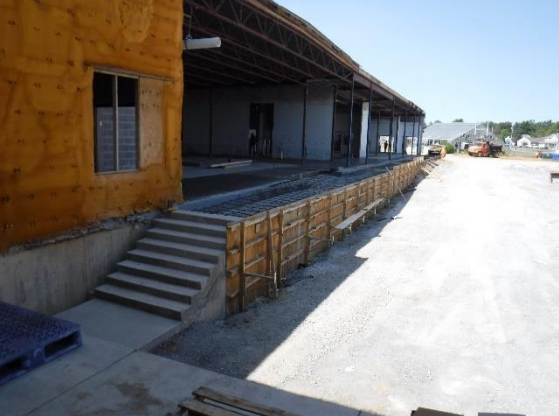
Item No.	Location	Description/Correction	Image	Action
1	East Side of Exterior of Area D	The formwork will be removed soon. When it is removed, the concrete apron in front of the kitchen loading dock can be poured.

Prepare wall for railings.
2	Area 2 A	Additional protection had been applied to the exterior wall.

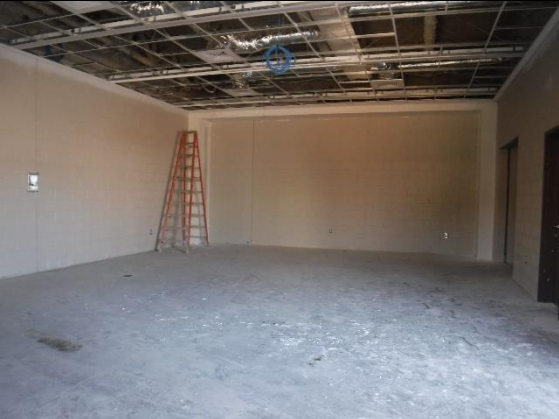
Continue to check for leaks.
3	Phase 1 Area E Vocal Music Room	Finishes were installed but the room is not enclosed.

Enclose the area ASAP.

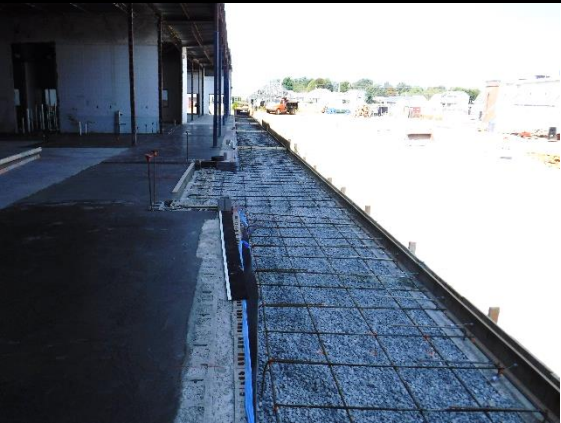
Item No.	Location	Description/Correction	Image	Action
4	Walkway along East Side of Area D	Steel reinforcing bars were installed for the concrete walk.

Provide positive drainage away from building.
5	Gym Lobby Area D	Concrete slab areas were repaired at the new edge of the building.

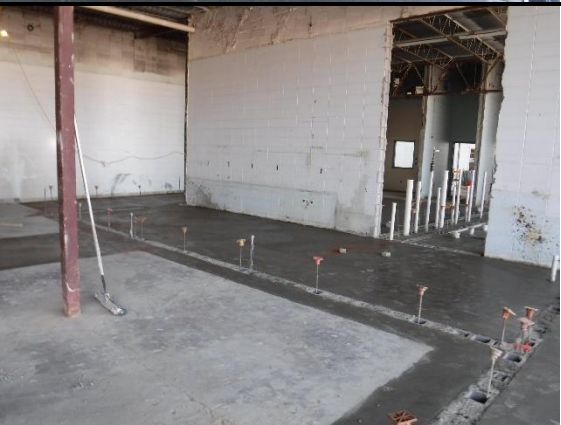
Repair existing slabs as necessary for floor finishes.
6	Concessions Area D	Concrete slab areas were repaired where pipes were installed under slab.

Coordinate work with the concession casework and equipment.

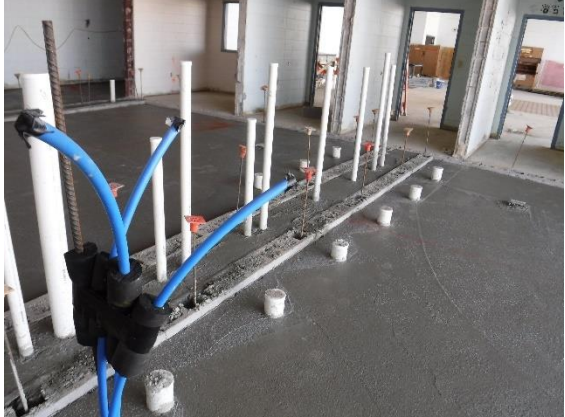
Item No.	Location	Description/Correction	Image	Action
7	Toilets at Gym Lobby Area D	New plumbing extended above the slab.

Protect piping from damage during construction.
8	North-South Corridor at Area D	Concrete slab areas were repaired where pipes were installed under slab.

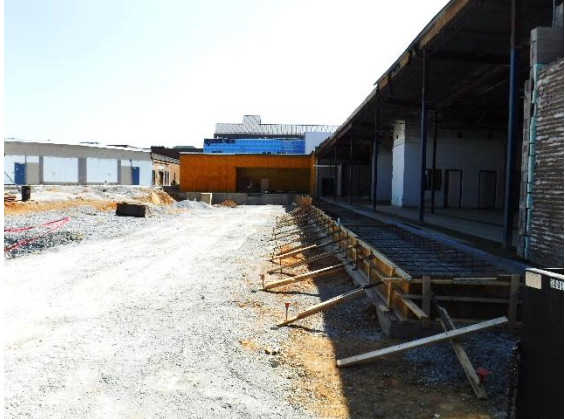
Protect new slabs from damage during construction.
9	Retaining Wall along East Side of Area A  Service Road to the Kitchen Dock	Once the retaining wall forms are removed, the asphalt service road can be paved. This will be done during fall break.

Plan for paving work.

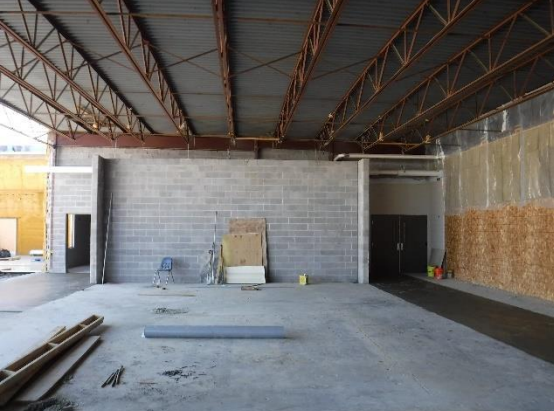
Item No.	Location	Description/Correction	Image	Action
10	Gym Lobby Area D looking South	The walls above the vocal music rooms form a fire and acoustical barrier. They must be extended to the deck.

Provide pricing on the PR.
11	South and West Walls of Band Room in Area D	The existing walls above the original ceiling line do not appear to be suitable to be exposed if the new ceiling is not installed.

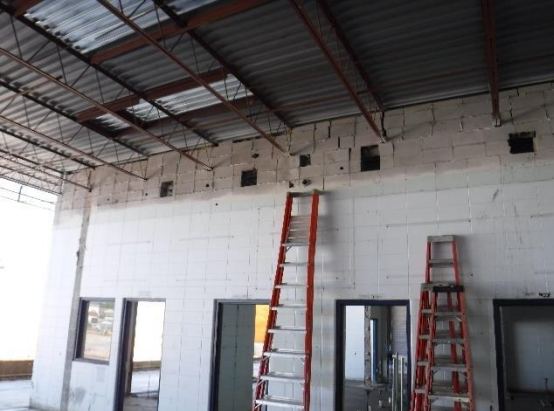
Add remediation work to the proposal.
12	South Wall of Band Room in Area D	The existing south wall is in poor condition to be an exposed wall above the original ceiling line.

Add remediation work to the proposal.

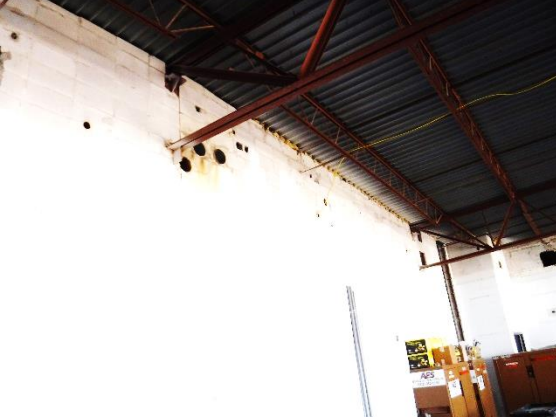
Item No.	Location	Description/Correction	Image	Action
13	West Wall of Area D	A seal is required at the top of the wall.

Refer to the wall details.
14	North Wall of Concessions off Gym Lobby Area D	The remaining portions of the existing wall appear to be in poor condition above the ceiling line.

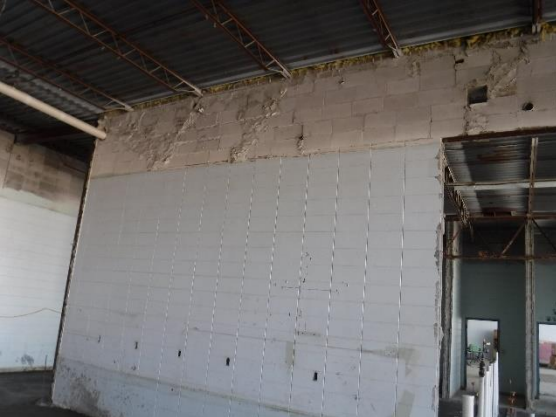
Have the wall inspected by the mason.
15	North Wall of Concessions Area D	The remaining portions of the existing wall appear to be in poor condition above the ceiling line.

Have the wall inspected by the mason.

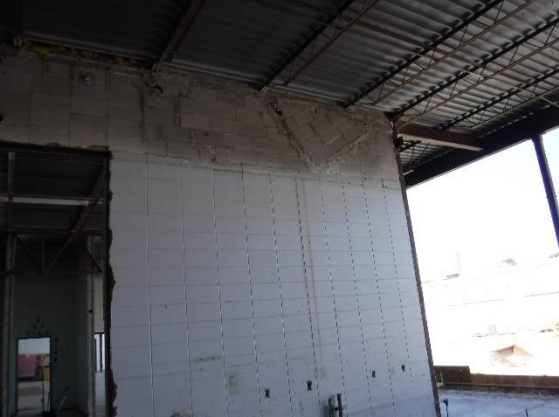
Item No.	Location	Description/Correction	Image	Action
16	South Wall of Concessions Area D	The remaining portions of the existing wall appear to be in poor condition above the ceiling line.

Have the wall inspected by the mason.
17	Existing Walls to Remain in Area J	Some of the existing walls will serve as dividing walls for the renovated area.

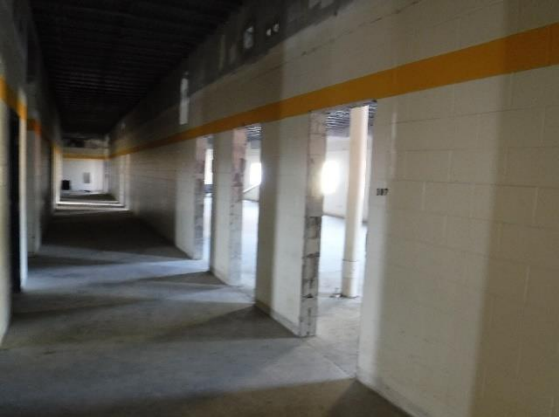
Coordinate new work with existing conditions.
18	Existing Corridor Walls to Remain in Area J	The load bearing corridor walls will remain with modifications for new openings.

Install shoring where required to install new lintels.

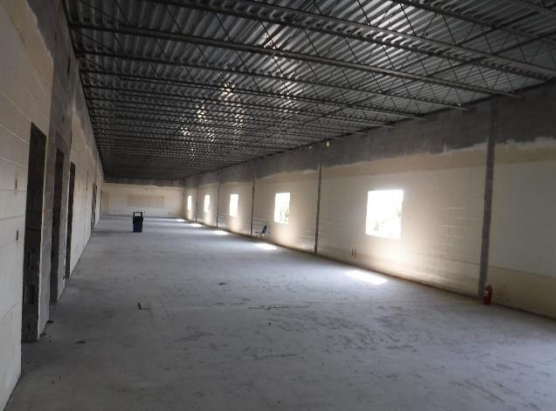
Item No.	Location	Description/Correction	Image	Action
19	Classroom Area on Second Floor of Area J	The area had been stripped for the installation of new walls, finishes, HVAC and lighting.

Start renovation work as soon as possible.
20	First Floor North Corridor of Area J	The floor slab was being cut for new plumbing lines.

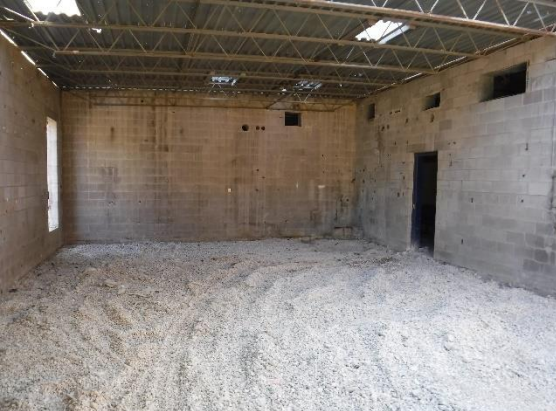
Excavate for pipe trenches.
21	Area J Mechanical Room	The concrete floor slab was removed due to the need to install new under slab piping.

Plan the room layout for the proposed equipment.

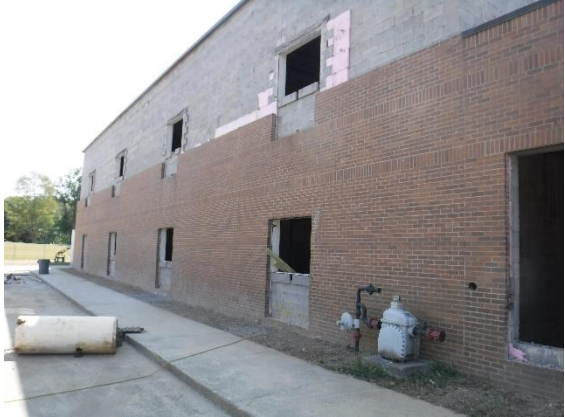
Item No.	Location	Description/Correction	Image	Action
22	Area J East Exterior Wall	The upper portion of the second floor was removed for the new metal panels.

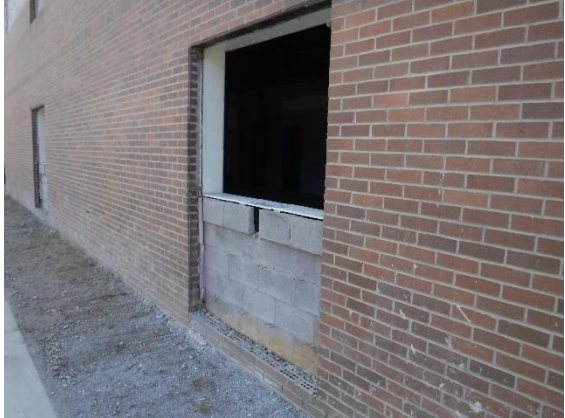
23	Area J Window Opening	New windows will be installed in the existing openings.
