## FIELD OBSERVATION REPORT

Central Hardin High School – Phase 2, Cecilia, KY

2019111 - CA8

Report No: 06

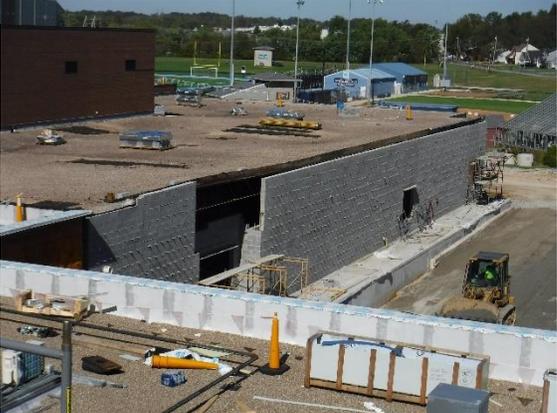
Item No.	Location	Description/Correction	Image	Action
1	East Side of Exterior of Area D	The new CMU backup wall was in place.

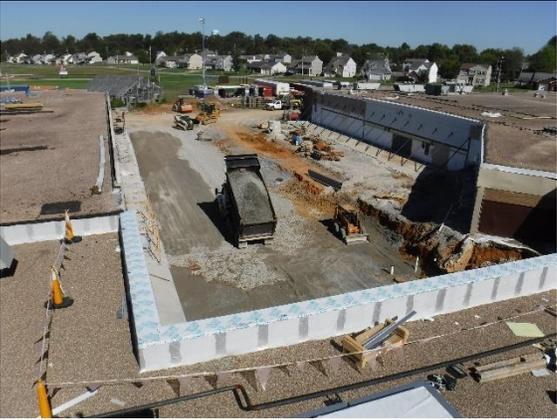
Coordinate the top of the CMU wall with the parapet detail.
2	Area 2 A Original Cafeteria Wall	During the storm on Friday, September, 27 <sup>th</sup> , the cafeteria was flooded. Gill pumped the water out and with the aid of Phase 1 workers created a trench to remove the water.

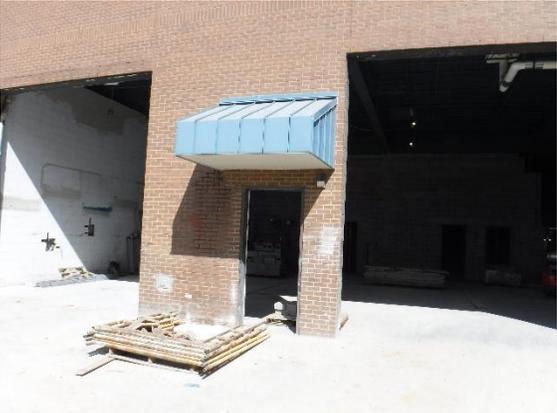
Continue to monitor the exterior wall to prevent water from entering the original building.
3	Phase 1 Site outside the Ag Shop	It appears that a downspout boot for the new canopy at the man door was not installed in Phase 1.

JRA to discuss with Phase 1 contractors.

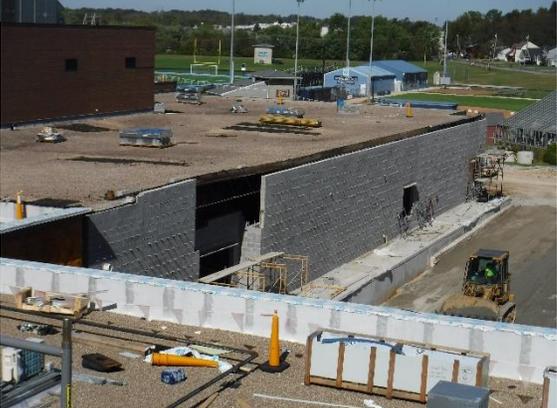
Item No.	Location	Description/Correction	Image	Action
4	Walkway along East Side of Area D	The formwork was stripped off the side of the retaining wall along the walkway.

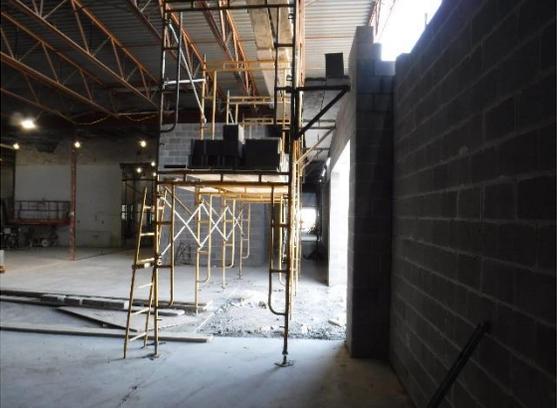
Prepare the retaining wall for exposed appearance.
5	Gym Lobby Area D	To the right of the image is the new CMU backup wall on the East side of Area D.

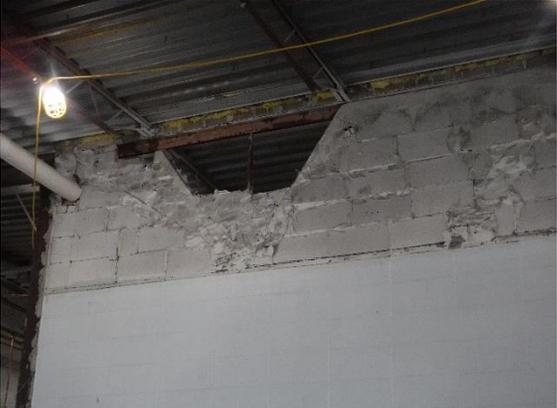
Detail the CMU wall for paint finish.
6	Concessions Area D	The north wall of the area had deteriorated masonry laid in the web of the roof joists. Bailey Masonry had started to remove this material while leaving the CMU wall below the joists.

Remove the rest of the masonry in the girder joist. Examine the top of the wall below the girder for connection to the girder.

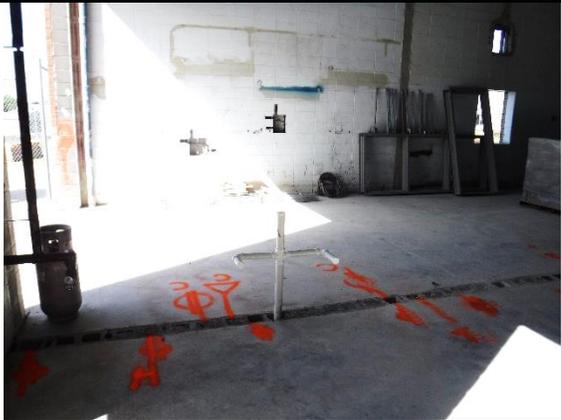
Item No.	Location	Description/Correction	Image	Action
7	Band Room Area D	Under slab utilities were marked on the slabs.

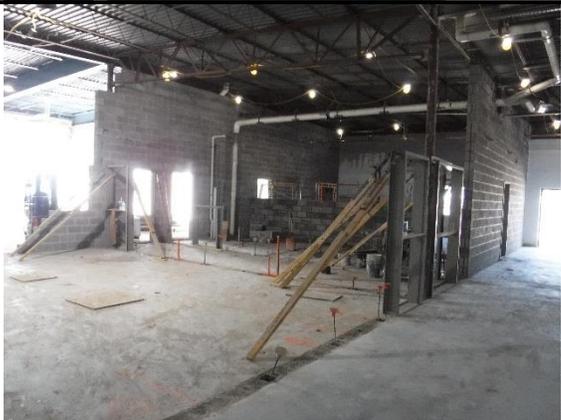
Do not use floor markings that might show through the floor finish.
8	A Shop Area D	Hollow metal frames were braced in place to be laid up in the new CMU walls.

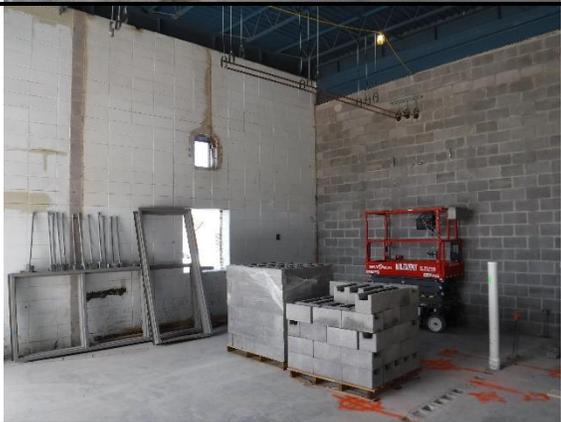
Keep frames plumb and with parallel jambs.
9	Ag Shop Area D	Materials were stockpiled in the space.

Protect stored materials from damage.

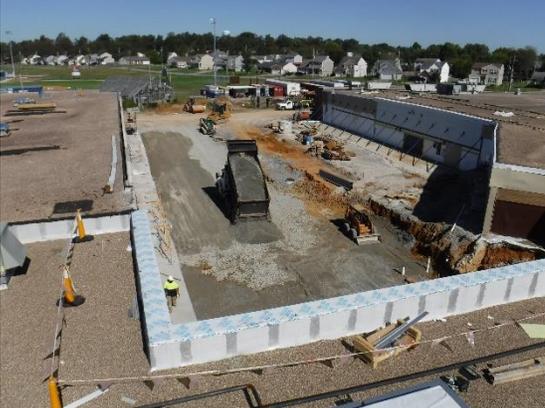
Item No.	Location	Description/Correction	Image	Action
10	Drive to Kitchen Dock	A course of large rock was being laid in preparation for the asphalt paving.

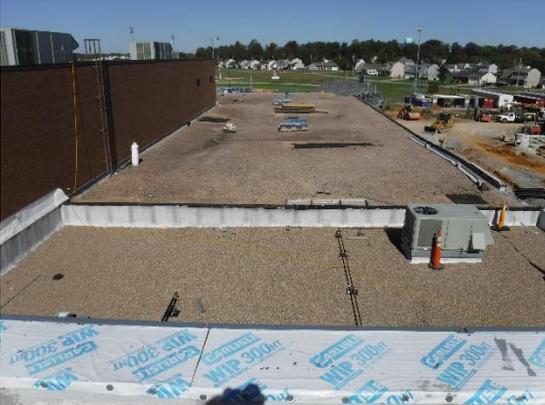
Follow the details and specs for the section through the new driveway.
11	Area D Roof	The existing roof is being studied to determine what can be done to extend the life of the roof.

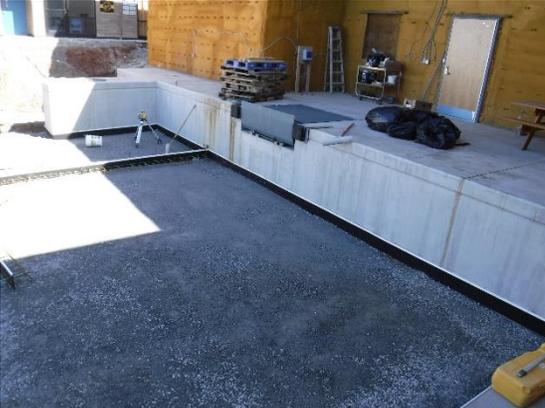
Respond to the PR when it is issued for modification to the scope for the roof.
12	Kitchen Loading Dock Apron	Crushed stone was in place to receive the concrete apron.

Prepare for the concrete pour as detailed.

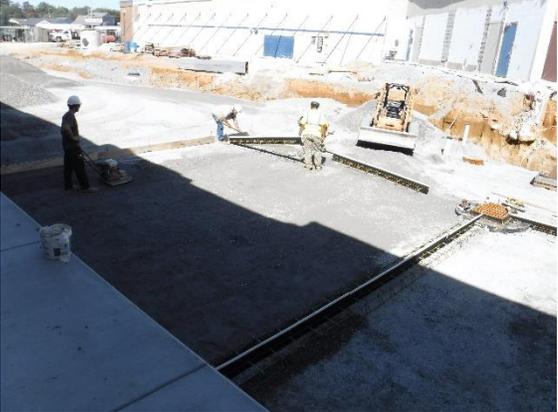
Item No.	Location	Description/Correction	Image	Action
13	Kitchen Loading Dock Apron	Expansion joint material was being installed.

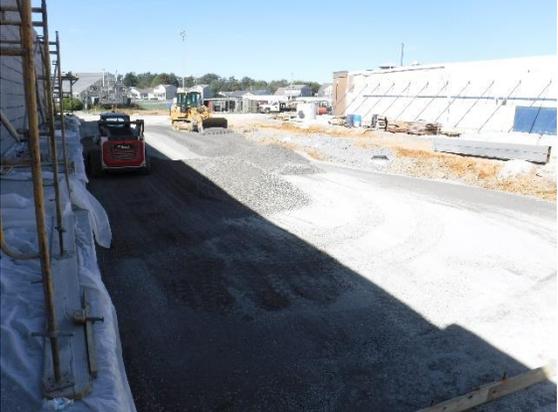
Include pavement sealed joints after the concrete is place.
14	Drive to Kitchen Loading Dock Looking North	Layers of Crushed stone were being placed.

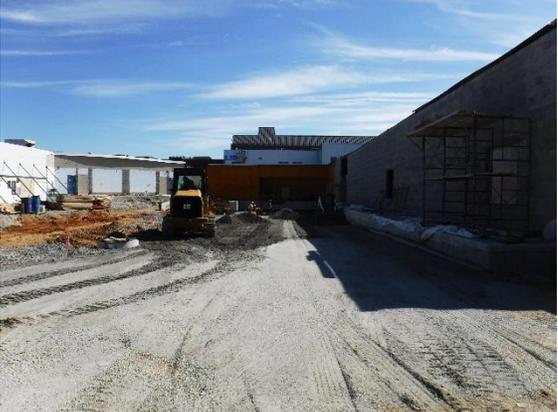
Refer to the SPIN report for compliance with the pavement spec.
15	Drive to Kitchen Loading Dock Looking North	New paving will extend to the existing drive to the north.

Tie into the existing pavement along a straight line.

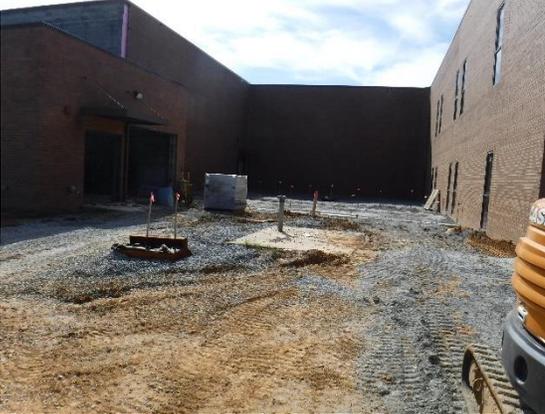
Item No.	Location	Description/Correction	Image	Action
16	Courtyard between Areas J and H	Crushed stone had been placed over the proposed concrete courtyard.

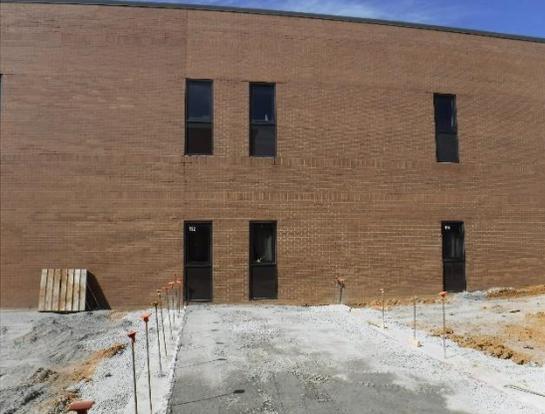
Correct any disturbance in the stone base caused by the installation of the foundations.
17	New connector between Areas H and J looking North at Area H	Foundations were in place for the new exterior walls of the connector.

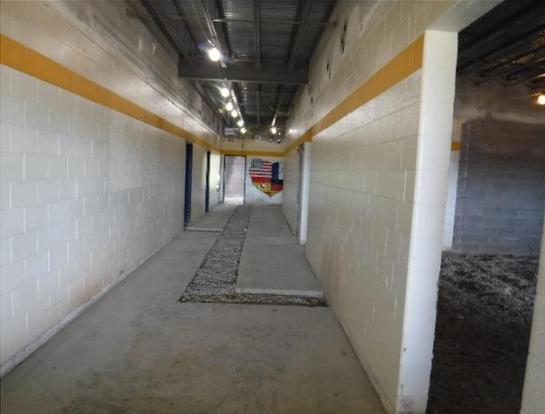
Coordinate the removal of the existing wall at the connector with school activities.
18	Existing Corridor Walls to Remain in Area J	Temporary lighting was installed for the renovation work. The area was clean.

Prepare for temporary shoring to cut new opens in the corridor walls.

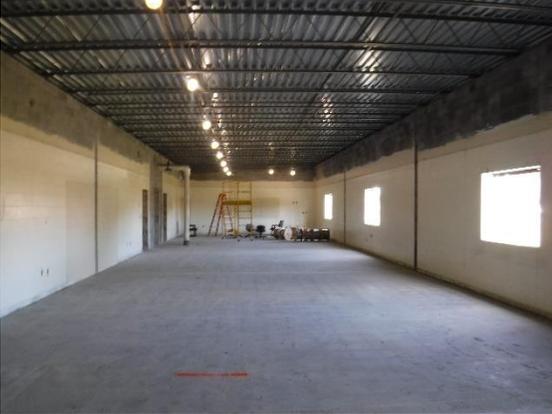
Item No.	Location	Description/Correction	Image	Action
19	Classroom Area on Second Floor of Area J	Temporary lighting was installed for the renovation work. The room area was clean.

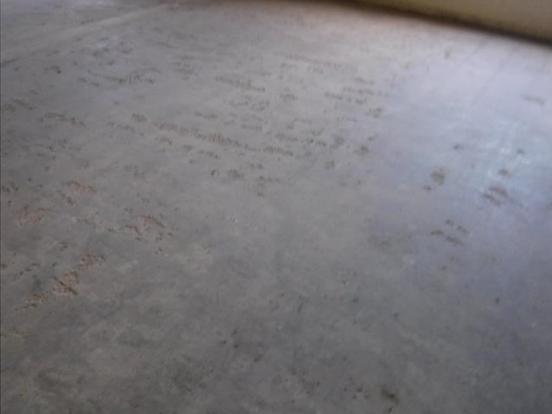
Prepare for temporary shoring to cut new opens in the exterior walls.
20	Second Floor Slab Area J	Apparently, the surface of the concrete was damaged during demolition.

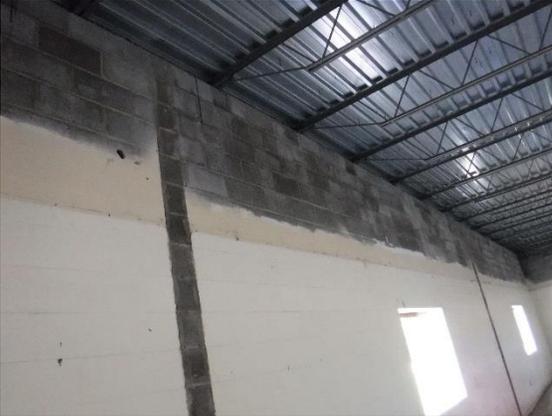
Repair floors before proceeding with finishes.
21	Area J East Exterior Wall	The top of the exterior wall indicates that some moisture entered during the storm. This does not appear to be from roof leaks.

Apply new exterior finishes to protect the exterior wall.

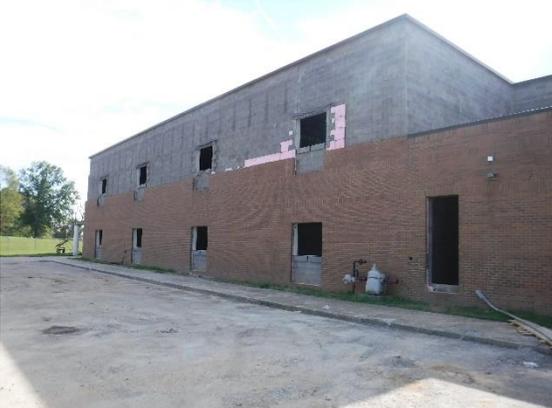
Item No.	Location	Description/Correction	Image	Action
22	Area J East Exterior Wall	The brick was removed from the east elevation that took the rain and wind from the storm.

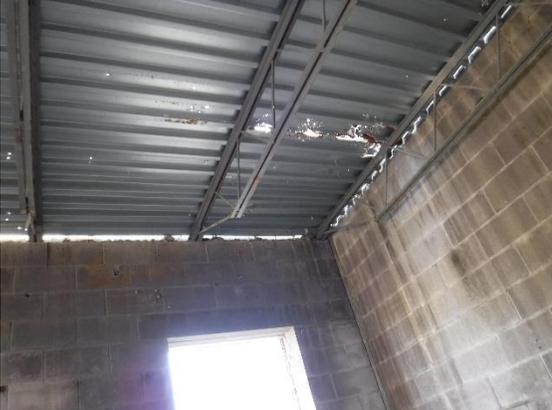
Install exterior finishes as soon as possible.
23	Area J Mechanical Room	The original metal deck had rusted through in places.

Replace the damaged roof deck.
