FIELD OBSERVATION REPORT

New West Middle School – Cecilia, KY

202280 – CA8

Report No: 3

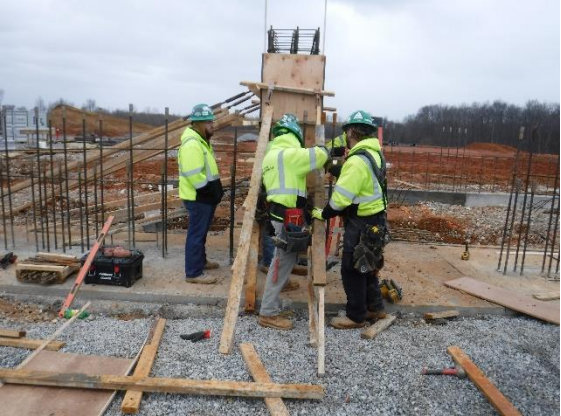
Item No.	Location	Description/Correction	Image	Action
1	Door Portal	Formwork and reinforcing steel bars were being put in place.

Refer to SPIN reports and structural field reports.
2	Door Portal	The form must support a significant amount of concrete during the pour.

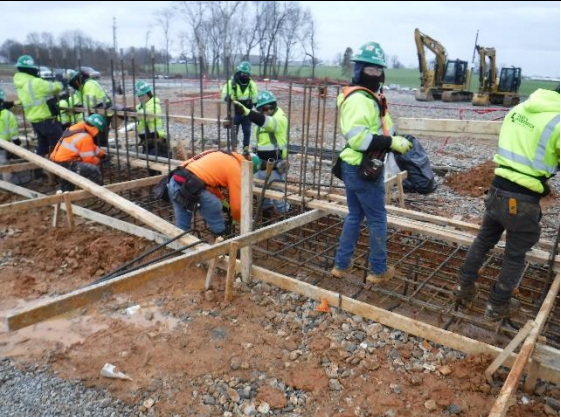
Finish concrete for exposed surfaces.
3	Storm Shelter Footing	Reinforcing steel bars were being placed in the footing.

Refer to the SPIN report and the structural field report.

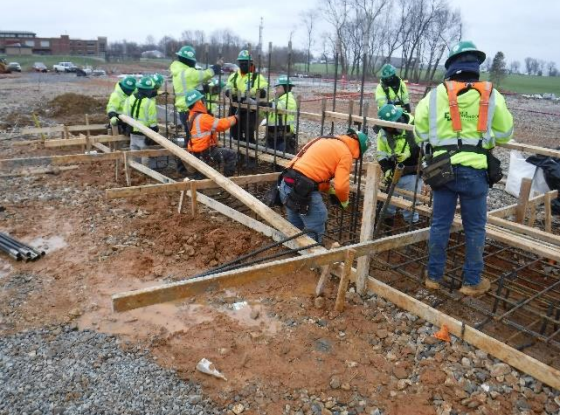
Item No.	Location	Description/Correction	Image	Action
4	Storm Shelter Footing	Reinforcing must be precisely placed in the footings and walls at the storm shelter to meet the structural requirements.

Continue to place reinforcement to meet the requirements.
5	Storm Shelter wall Footing	Dowels must be continuous to the tops of the walls at the storm shelter.

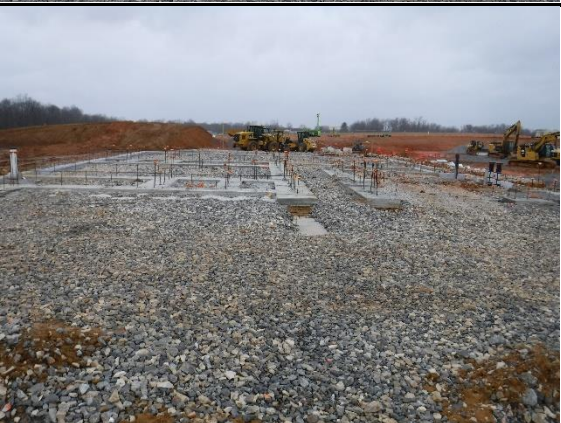
Continue to precisely place dowels and reinforcement in footings and walls.
6	Foundations looking West	Wall footings outside the storm shelter must meet typical structural requirements.

Follow the spec.

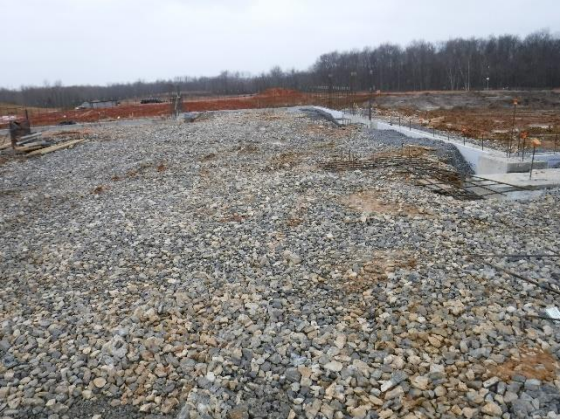
Item No.	Location	Description/ Correction	Image	Action
7	Looking South from inside the Building	Rigid perimeter insulation was placed tight to the stem walls at exterior foundations.

Follow the spec on the placement of perimeter insulation.
8	Corridor beside Storm Shelter	The portal occurs along the expansion joint that runs from north to south in the center of the building.

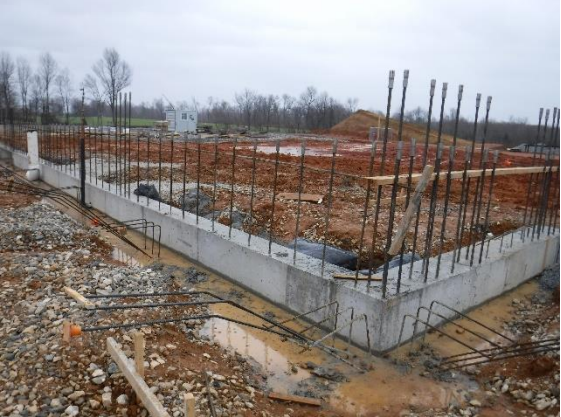
Follow the details for the placement of the portal.
9	Exterior Foundation with Stemwall	Stemwalls occur along the exterior walls of the building due to the depth of the footings.

Follow details for exterior footings.

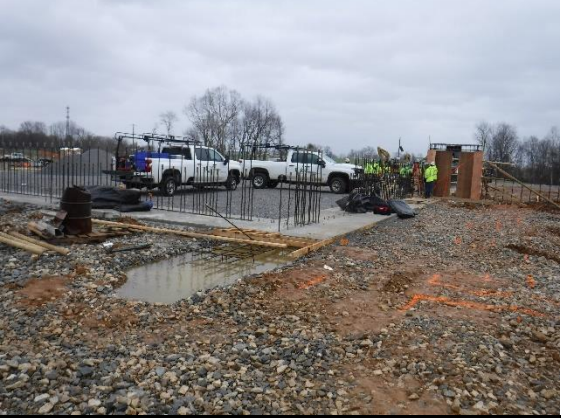
Item No.	Location	Description/ Correction	Image	Action
10	Doorway Portal	Formwork was being constructed for the concrete portal at the double wall for the building expansion joint.

Provide finished surface for exposed portions of the portal.
11	Looking to the Northwest toward Wehr's Trailer from the Building	Excavating equipment was parked due to wet soils.

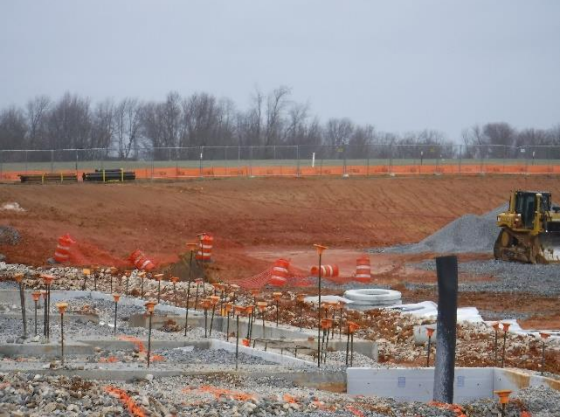
Coordinate soils testing with Solid Ground.
12	Looking to the Geothermal Field from the Building	The geothermal contractor had arrived on site and was preparing to mobilize their equipment to begin drilling wells.

Provide drill logs for wells.

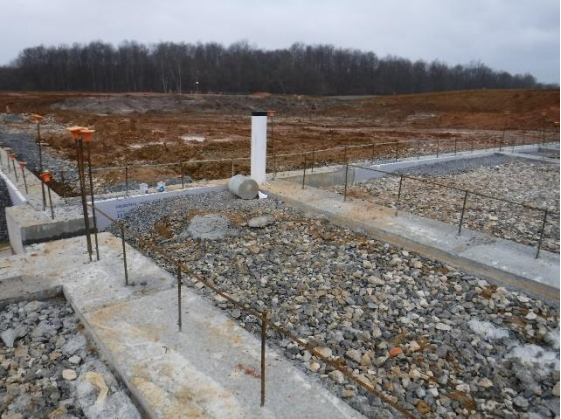
Item No.	Location	Description/ Correction	Image	Action
13	Under Slab Plumbing	Waste piping was installed under slab.

Install waste piping to slope to drains.
14	Area B	Foundations were constructed on the area for the student entrance and classroom wing.

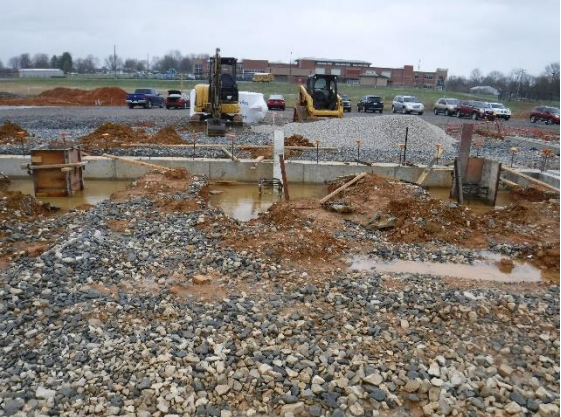
Install foundations per the details.
15	Looking North Area B	Water was ponding in low areas near the foundations.

Remove water to avoid bearing issues for slabs.

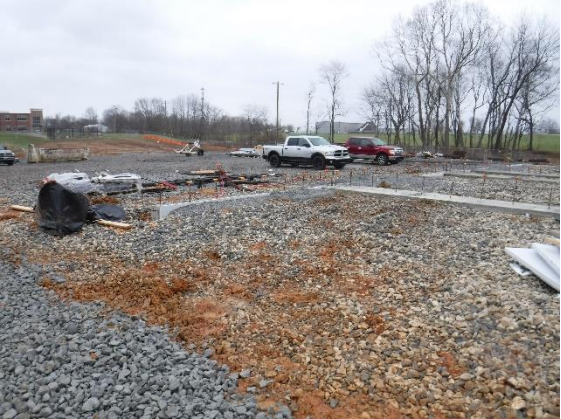
Item No.	Location	Description/Correction	Image	Action
16	Northeast Corner of Building Area B	Foundations were being installed to support masonry walls.

Coordinate masonry work with reinforcement in place.
17	Foundations	Excavations for foundations were being made ahead of the installation of footings.

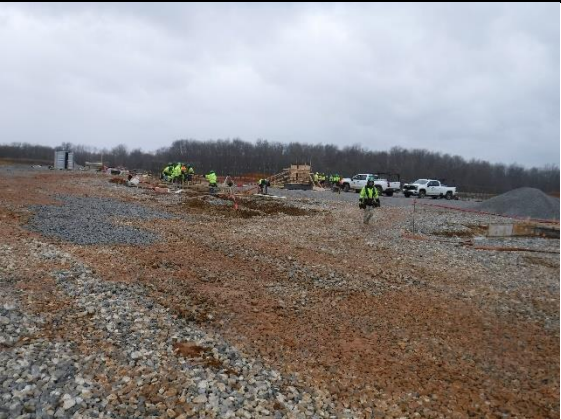
Continue to protect footing bottoms from excess moisture.
18	Looking South Across the Storm Shelter	Work was progressing despite the threatening weather.

Advise all parties when weather conditions will not permit construction activities.

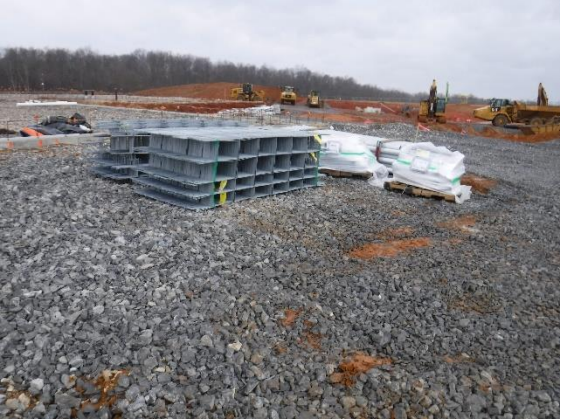
Item No.	Location	Description/Correction	Image	Action
19	Northeast Edge of the Building	Masonry materials had arrived on site so that Baileys Masonry can begin laying concrete block.

Keep stored materials clean.
20	Delivery with Geothermal Piping	This truck has piping that will be inserted in the geothermal wells to carry the water that will serve the hydronic loop throughout the building. The driller also plans to run a hose to the hydrant at Main St. by running it through a culvert at the elementary school entrance.
