## FIELD OBSERVATION REPORT

Central Hardin High School – Phase 2, Cecilia, KY

2019111 - CA8

Report No: 14

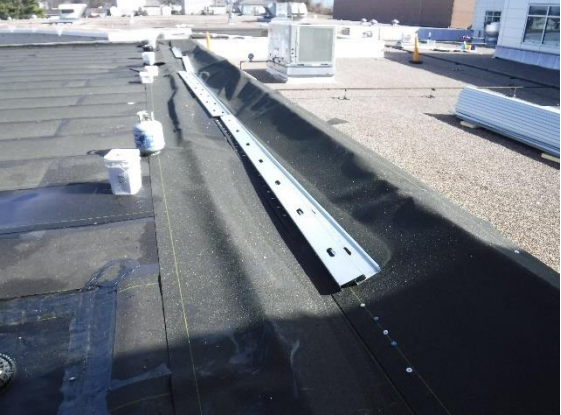
Item No.	Location	Description/Correction	Image	Action
1.	Roof at Expansion Joint Between Phase 1 and Phase 2	Due to the weather, the second wall at the expansion joints had not been constructed. This is required to install the expansion joint coping over the tops of the two walls.

Phase 1 – Complete the wall and the expansion joint. Provide temporary protection until these are complete.
2.	Phase 1 Area E Vocal Music Robe Storage	The temporary cover over the expansion joint was blown open by the wind. This allowed water to enter the building and damage the ceiling in the rooms below the joint. Damage was also caused by the contractor installing a beam over the rooms.

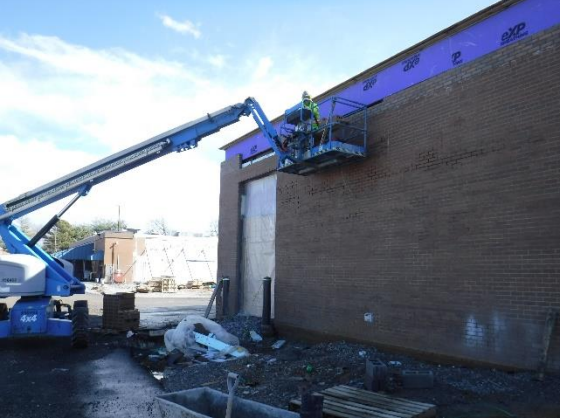
Item No.	Location	Description/Correction	Image	Action
3.	Area D North Elevation	<p>Work was progressing to prepare the parapet for the composite panels.</p> <p>The upper portion of the opening into the band room needs to have a metal panel closure</p>

<p>Coordinate work between the trades to complete the parapets.</p> <p>Install backup construction and composite panels above the overhead door.</p>
4.	East Side of Area D and North Side of Area E.	<p>The parapet was partially covered with spray insulation.</p>

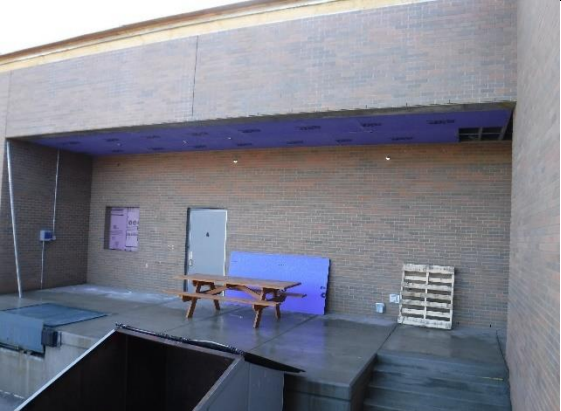
<p>Complete insulation and install the metal panels and coping at the top of the parapet.</p>
5.	Loading Dock	<p>The backing soffit for the metal panel ceiling was mostly in place.</p>

<p>Install the metal panel ceiling after the backing work is complete.</p>

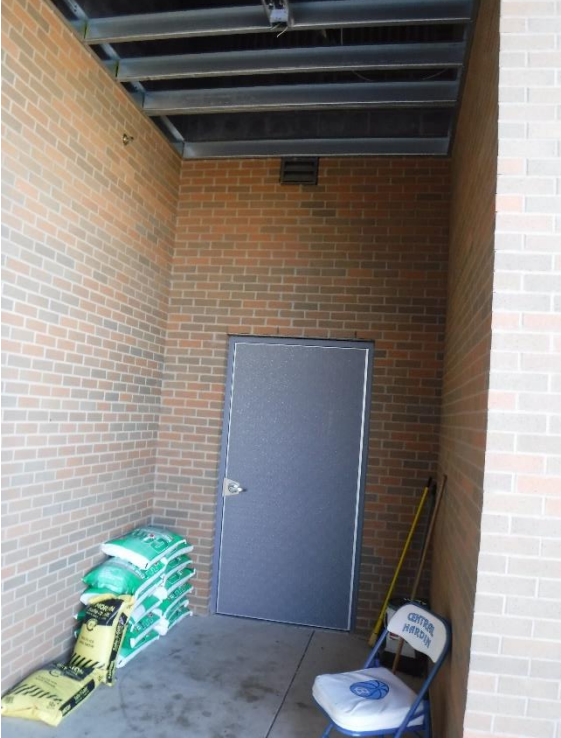
Item No.	Location	Description/Correction	Image	Action
6.	Loading Dock at Custodial Receiving	<p>The soffit cannot be completed until the louver into custodial receiving is lowered below the ceiling. The louver was installed by the Phase 1 mechanical contractor. They will be moving the louver.</p>

<p>Lower the louver and associate ductwork in custodial receiving. Patch the brick wall as required.</p>
7.	Area D Gym Lobby	<p>Wallboard was being hung on the soffits.</p> <p>The temporary barricade was removed. This allows some dust to enter the gym when the doors are opened.</p>

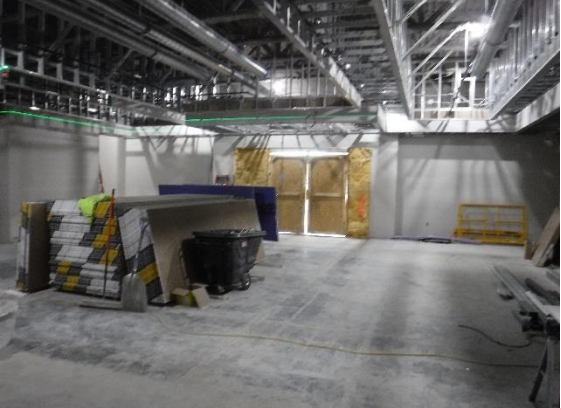
<p>Complete the soffits and install the acoustical ceilings.</p> <p>Keep area by the gym doors as clean as possible.</p>
8.	Area D Gym Lobby	<p>Wallboard soffits did not have control joints installed.</p>

<p>Install control joints before wallboard fascia and soffits are finished and painted.</p>

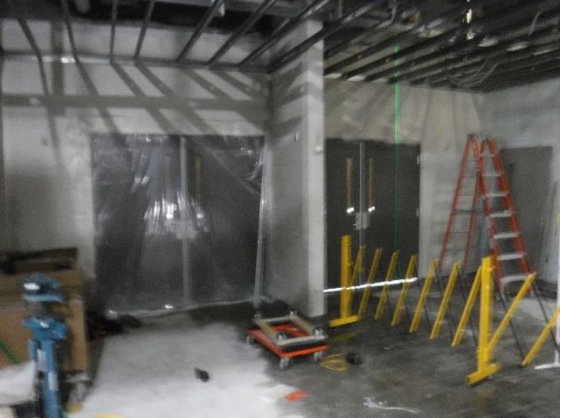
Item No.	Location	Description/Correction	Image	Action
9.	Area D Gym Lobby Doors to Area E at Cafeteria	<p>The doors that are not being used were covered with plastic while the doors that provides access to the gym are not covered.</p> <p>The inactive doors were locked.</p>

Limit construction traffic into Area E.
10.	Area D Ag Shop	The concrete cap over the air compressor room was being finished.

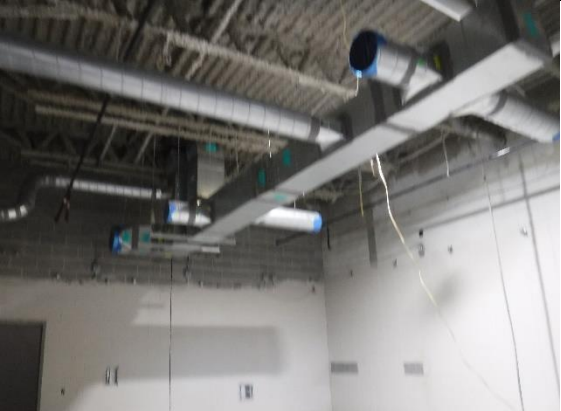
Complete cap.
11.	Area D Ag Classroom	Ductwork was hung and the opening were protected.

Continue to protect duct openings until they are connected.

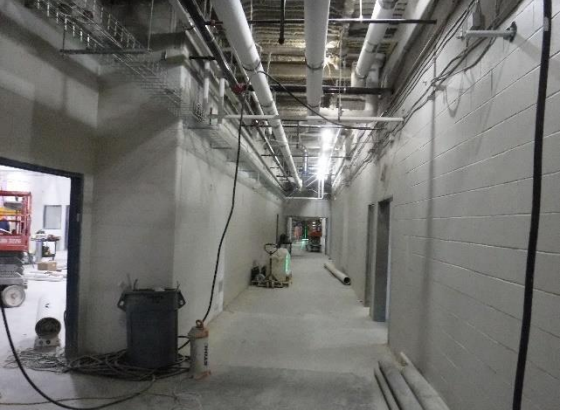
Item No.	Location	Description/Correction	Image	Action
12.	Area D East Corridor	The corridor was approaching the point when ceiling grid and lighting could be hung.

Complete all possible above ceiling work before installing the grid.
13.	Area D Group Toilets	Ceiling grid was being installed.

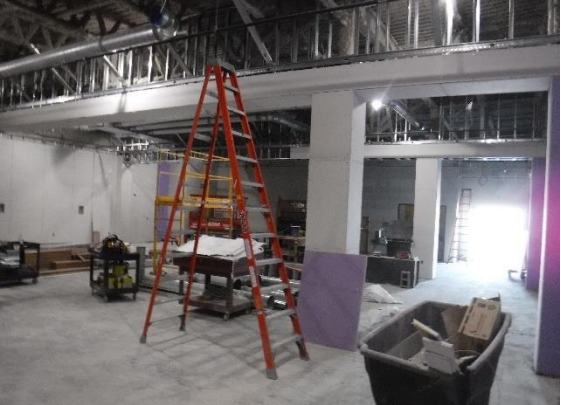
Comply with the grid installation spec.
14.	Area D Band Room	Wallboard had been hung and finished.

Install control joints as required by general note "O" on Sheet G-101.

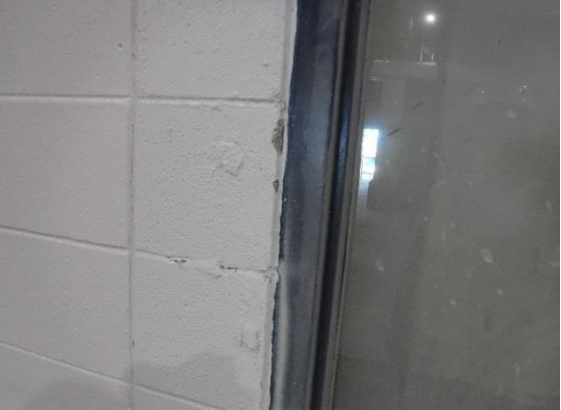
Item No.	Location	Description/Correction	Image	Action
15.	Area D Band Room	Paint was applied over CMU walls that had not been prepped.

Remove existing defects before painting new and existing CMU and wallboard walls.
16.	Area D Roof	The base course of roofing was in place. The roof top units were placed on their curbs but the units were not connected to the gas service.

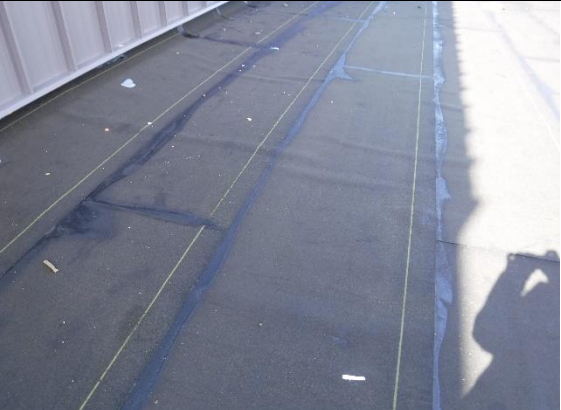
Install the top course of roofing and the gas lines to the roof top units so permanent heat can be available.
17.	Area D Roof	The base course of roofing had several wrinkles and fish mouths.

Repair the base course of roofing before installing the top course.

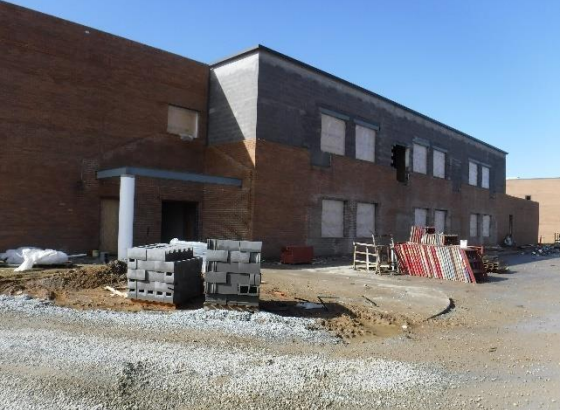
Item No.	Location	Description/Correction	Image	Action
18.	Area J East Elevation	The CMU repairs around the window openings were complete. The window openings were covered with plywood.

Maintain the temporary enclosures so that the area can be heated to install finishes.
19.	Area J South Elevation	The window openings were being prepared for two story high windows.

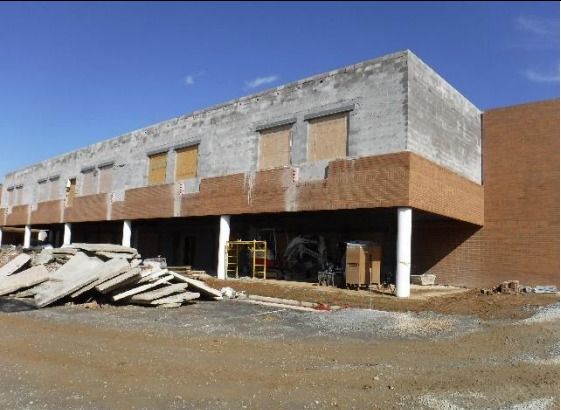
Complete wall repair work as openings can be protected with temporary closures.
20.	Area J West Elevation	The CMU window openings were complete and temporary closures installed.

Measure new window openings and manufacture windows.

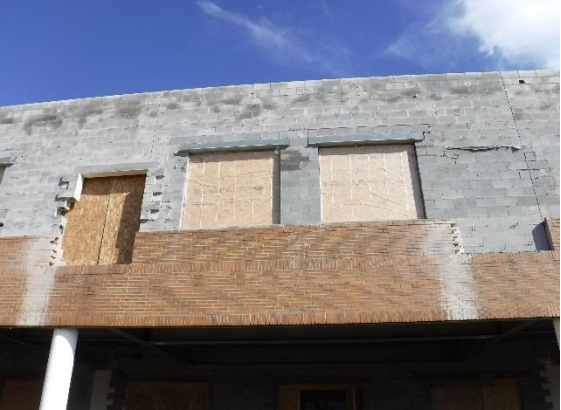
Item No.	Location	Description/Correction	Image	Action
21.	Area J West Elevation	Lintels were not installed. Temporary supports were not in place to install the lintels over the openings.

Install temporary support and install lintels.
22.	Area J West Wall at First Floor	The slab at the west entrance was being prepared for a concrete pour.

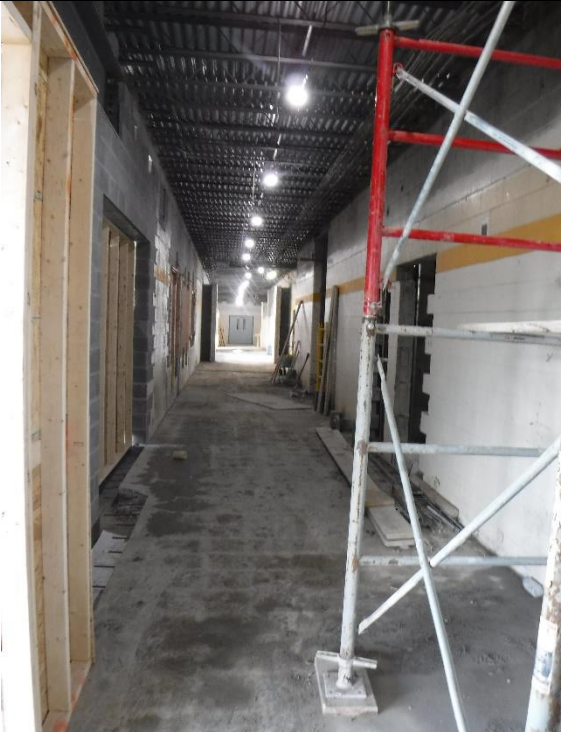
Refer to the SPIN reports for concrete work.
23.	Area J West Corridor	Due to cold weather spray fire resistant material was not applied to the floor joists above the corridor.

Install the SFRM on the joists.

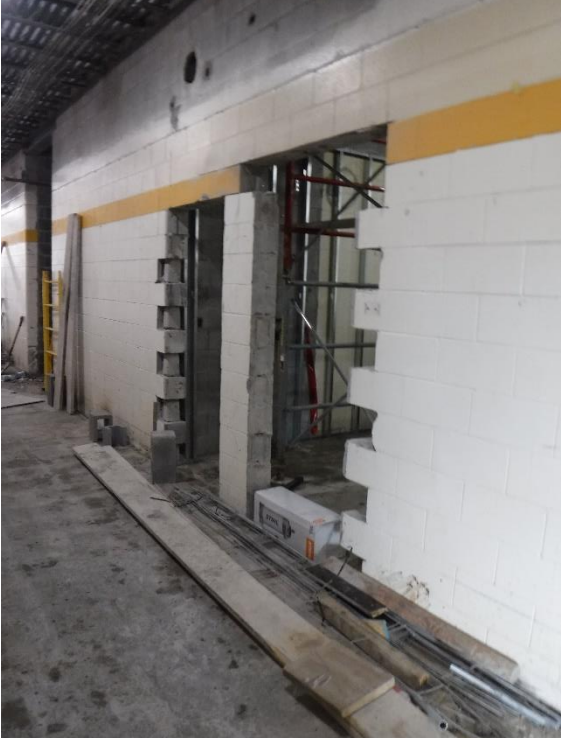
Item No.	Location	Description/Correction	Image	Action
24.	Area J West Corridor	Shoring of the walls was beginning so that the lintels can be installed over new door openings.

Place shoring and install new lintels.
25.	Area J Classroom	The CMU exterior walls were repaired at the new openings. Plywood was installed to enclose the building.

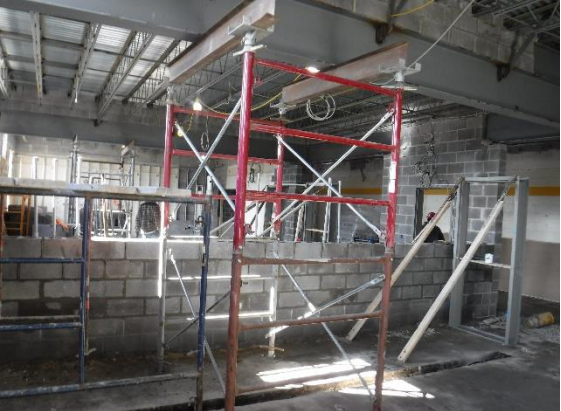
Maintain closures so interior work can proceed.
26.	Area J Classroom	Shoring was in place for the modifications to the structure.

Follow the shoring plan as prepared by the third party engineer.

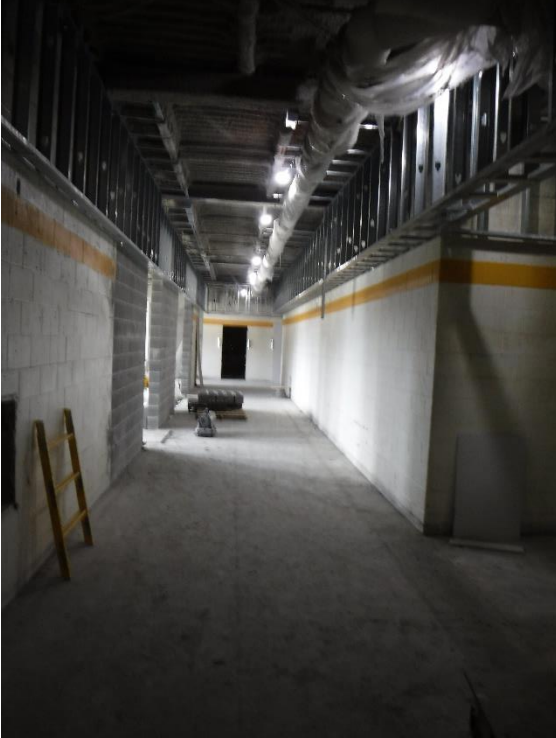
Item No.	Location	Description/Correction	Image	Action
27.	Area J Second Floor Corridor	Metal framing was in place for the new soffits along the corridors.

Install wallboard with control joints at 30' on center.
28.	Area J Second Floor Corridor	New CMU walls were installed.

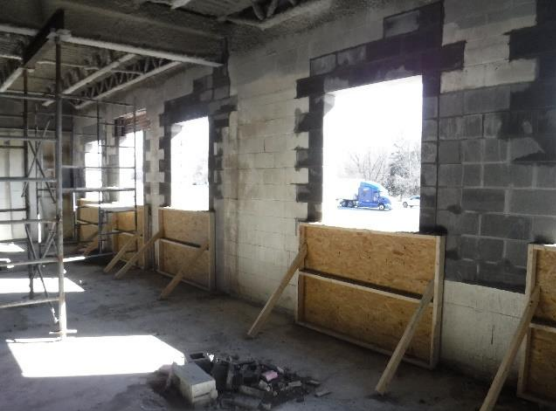
Install wallboard with control joints at 30' on center.
29.	Area J Classroom South Wall	Barricades were in place at the two story high window openings.

Enclose openings for temporary protection.
