## FIELD OBSERVATION REPORT

New West Middle School – Cecilia, KY

202280 - CA8

Report No: 5

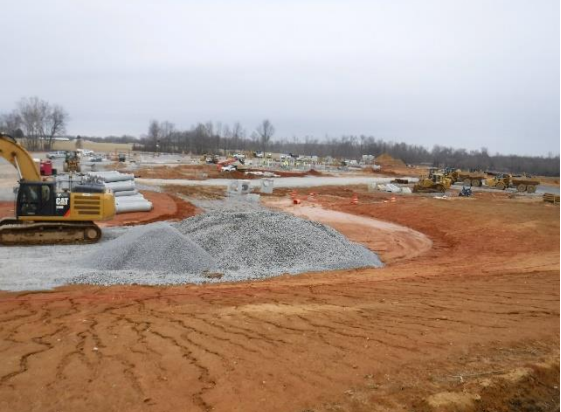
Item No.	Location	Description/Correction	Image	Action
1.	From Hill at West of the Site	Work on the building pad and the site is fully involved with construction and/or stored materials.

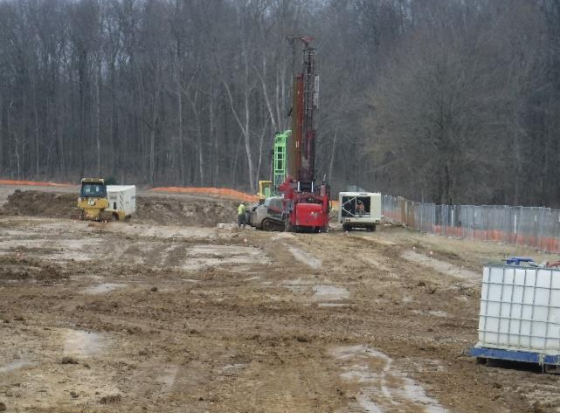
2.	Southwest Corner of the Site at Geothermal Well Field	Kevin said that the drillers continue to make good progress.

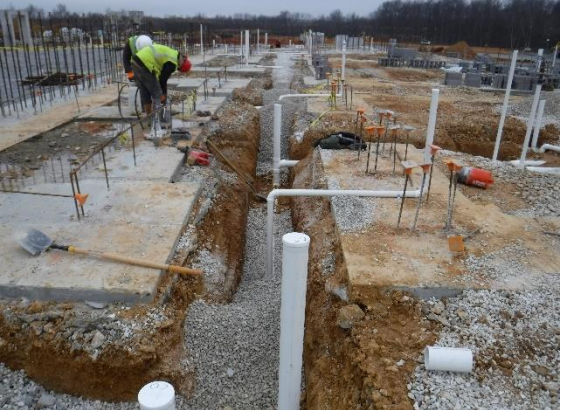
Item No.	Location	Description/Correction	Image	Action
4.	Area C	Sanitary piping was being installed in trenches.

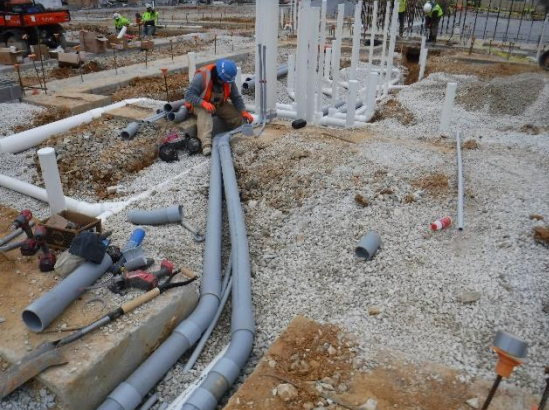
Item No.	Location	Description/ Correction	Image	Action
7.	Area D	Below slab conduits were being installed.

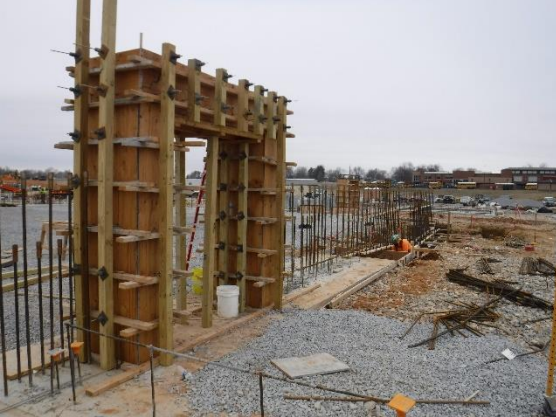
Item No.	Location	Description/ Correction	Image	Action
10.	Fire Rated Door Portal	Another portal was formed to receive concrete.
