## FIELD OBSERVATION REPORT #08

### 2025-02 - New Board Office

■ TO:	Kenton County Board of Education 1055 Eaton Drive Ft. Wright, KY 41017	■ DATE:	2025.02.19
ATTENTION:	Mr. Kevin Pfefferman		
■ FROM:	Mark Perry mperry@embosdesign.com 906 Monmouth Street Newport, KY 41071 V: 859.431.8612 • D: 859.578.6013	■ PROJECT:	New Board Office KCSD BG#24-084
COPIES TO:	Mr. Matt Rigg; Mrs. Carrie Hooten, Mr. Brian Vanover	PROJECT NO.:	22-106

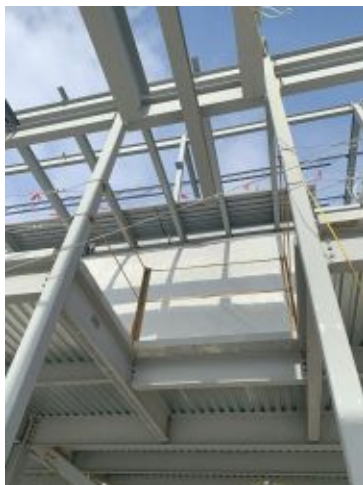
2025.02.04 – Board room operable partition pocket

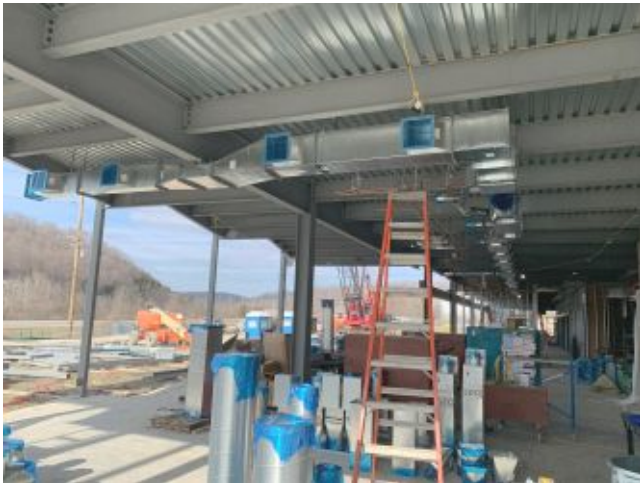
20-28.02: 2025.02.04 – Ductwork installation had progressed on the 1<sup>st</sup> floor, with some sections staged at both the 1<sup>st</sup> and 2<sup>nd</sup> floors.

2025.02.04 – Entry lobby ductwork

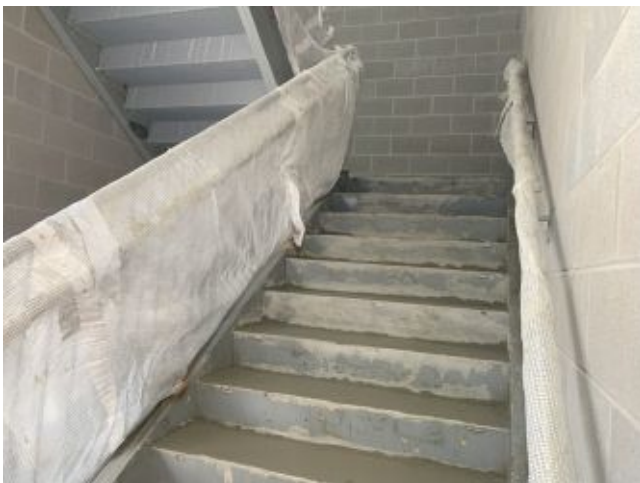
03.01: 2025.02.04 – Stair #2 concrete was poured earlier in the day.

2025.02.04 – Stair #2

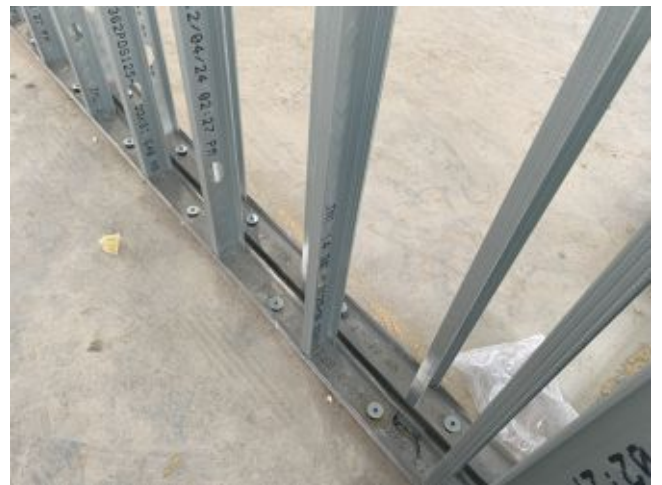
09.02: 2025.02.07 - Proper acoustic isolation was reviewed around the top and bottom of wall framing at Production Studio #223 and at the top of other STC-rated office walls.

2025.02.04 – Double stud wall with acoustic isolation anchors at Production Studio #233

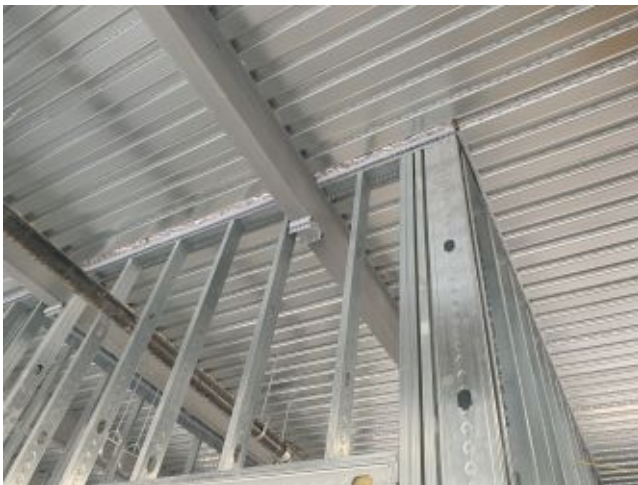
2025.02.07 – Acoustic seals at top of wall

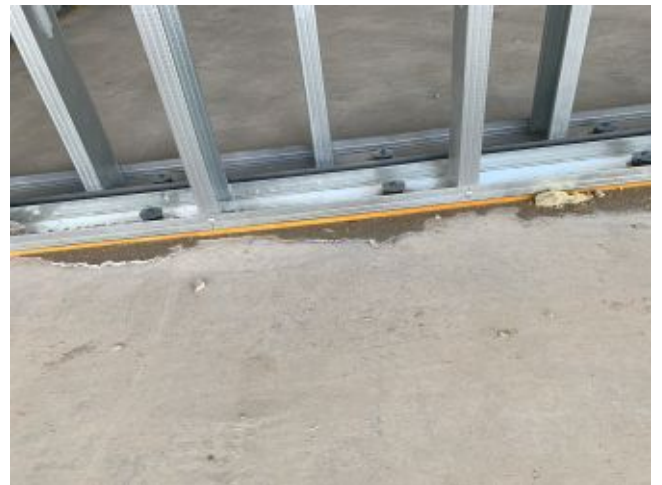
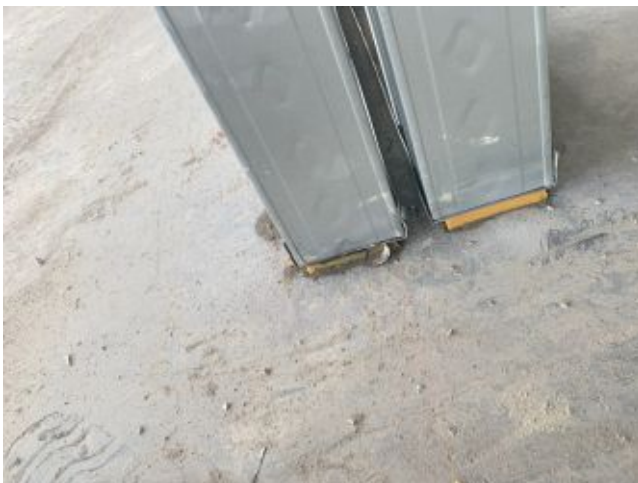
2025.02.07 – Sound isolation board at bottom of Production Studio wall

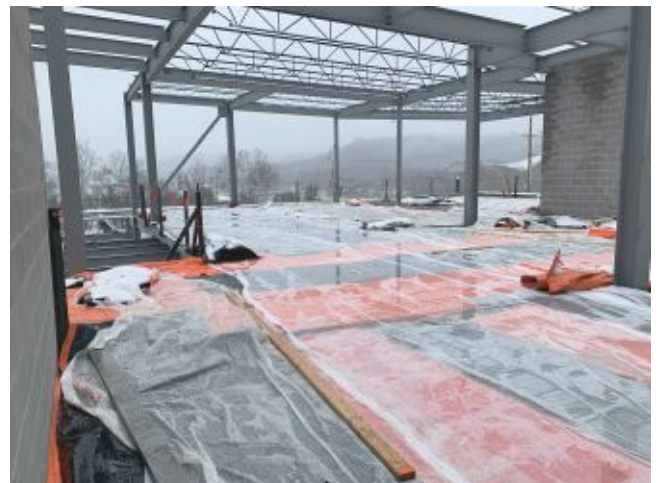
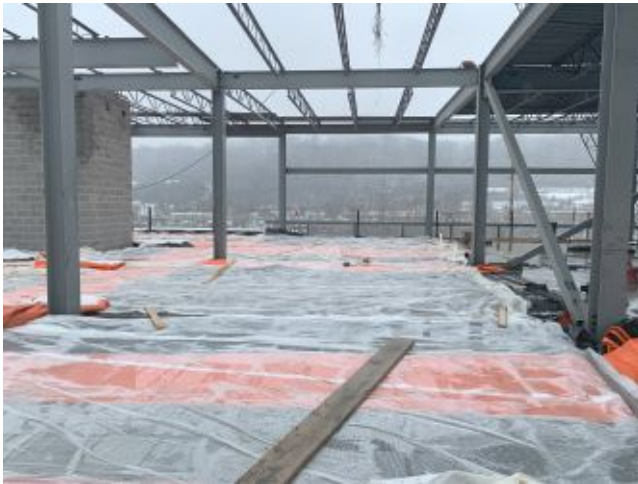
03.03: 2025.02.12 – The 3<sup>rd</sup> floor pour had occurred, and the slab was curing under blankets and plastic.

2025.02.12 – Final 3<sup>rd</sup> floor pour

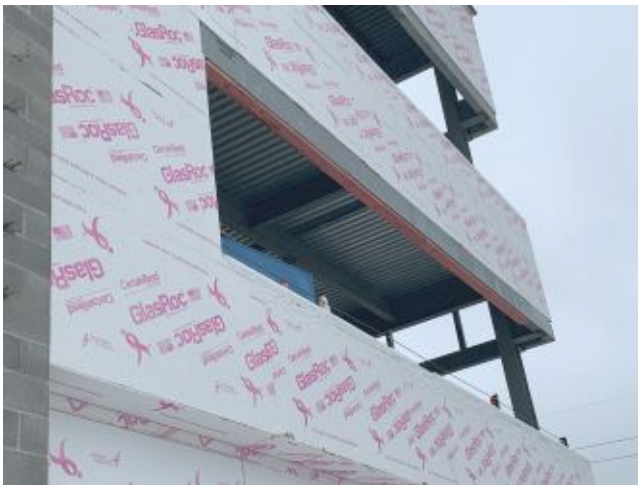
05.04: 2025.02.12 – Emboss visited the site to review issues relative to exterior wall CFMF and HSS girts. Construction tolerances for the HSS girts above the ribbon windows were creating conflicts for CFMF walls and sheathing at the north end of the building, which had been sheathed at the time of visit. The same is anticipated to occur on the other three sides of the building.

2025.02.12 – North wall

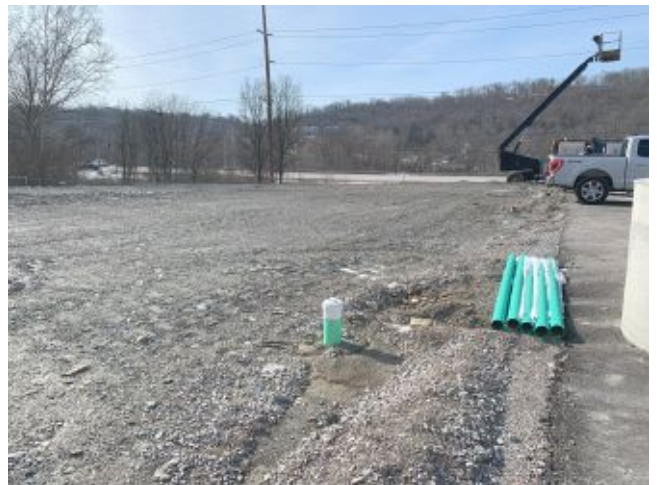
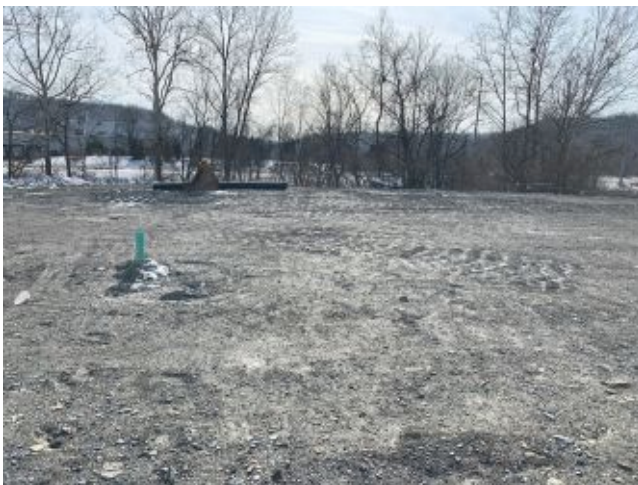
31.01: 2025.02.19 – Additional gravel subbase had been placed south of the asphalted portion of the site.

2025.02.18 – South of parking lot

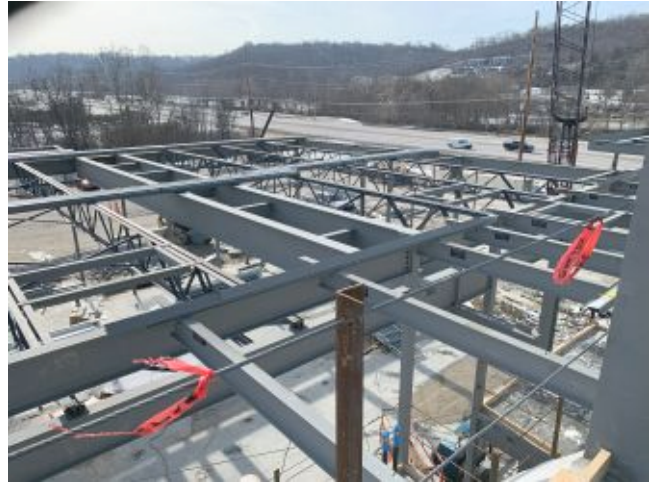
2025.02.18 – Board Room roof framing from above
