## FIELD OBSERVATION REPORT #09

### 2025-03 - New Board Office

■ TO:	Kenton County Board of Education 1055 Eaton Drive Ft. Wright, KY 41017	■ DATE:	2025.03.24
ATTENTION:	Mr. Kevin Pfefferman		
■ FROM:	Mark Perry mperry@embosdesign.com 906 Monmouth Street Newport, KY 41071 V: 859.431.8612 • D: 859.578.6013	■ PROJECT:	New Board Office KCSD BG#24-084
COPIES TO:	Mr. Matt Rigg; Mrs. Carrie Hooten, Mr. Brian Vanover	PROJECT NO.:	22-106

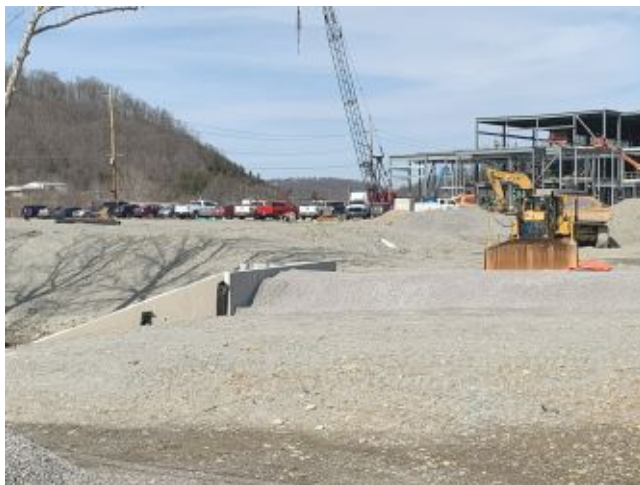
2025.03.04 – Site from southeast

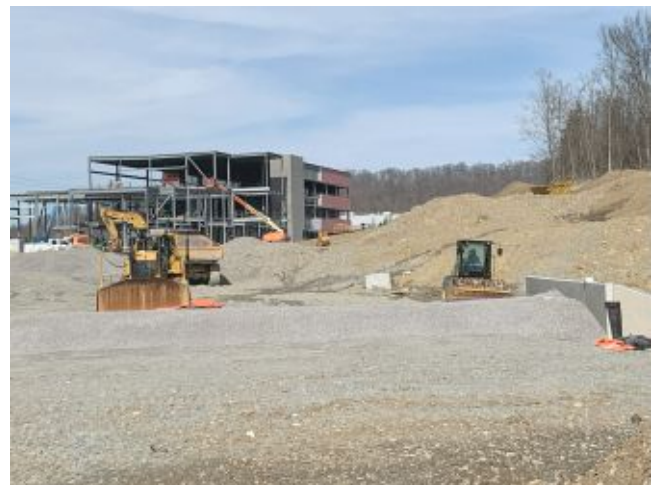
2025.03.04 – Site from southeast

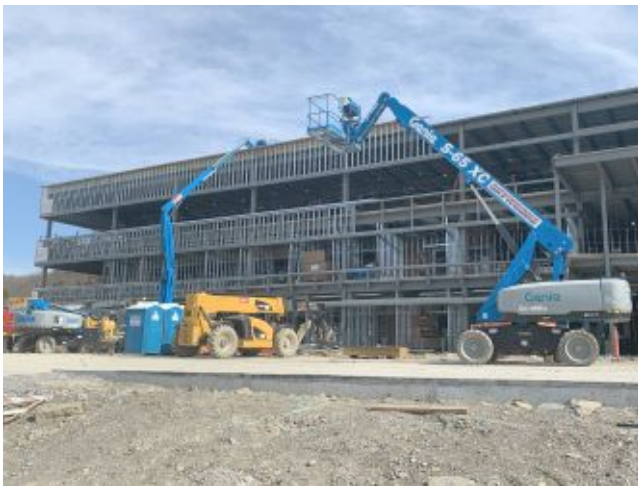
2025.03.04 – Exterior west elevation

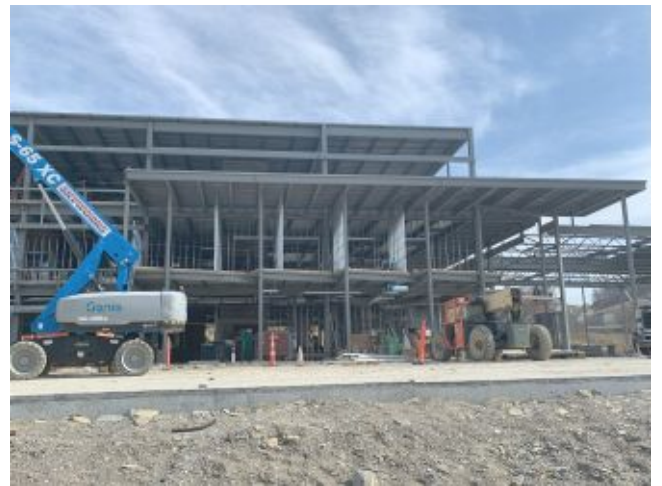
2025.03.04 – Exterior west elevation

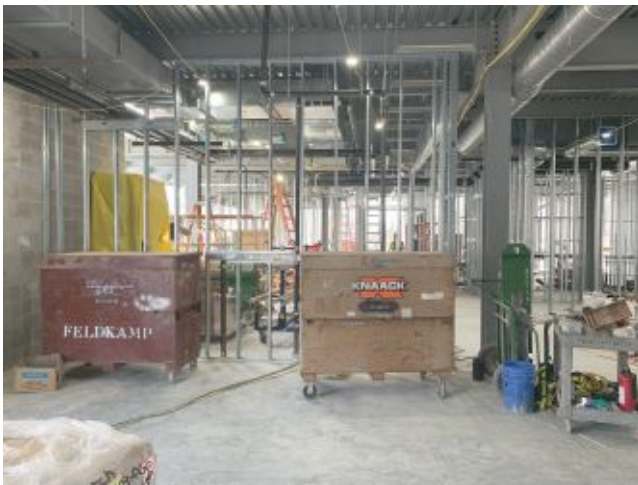
2025.03.04 – Looking south towards Breakroom #165

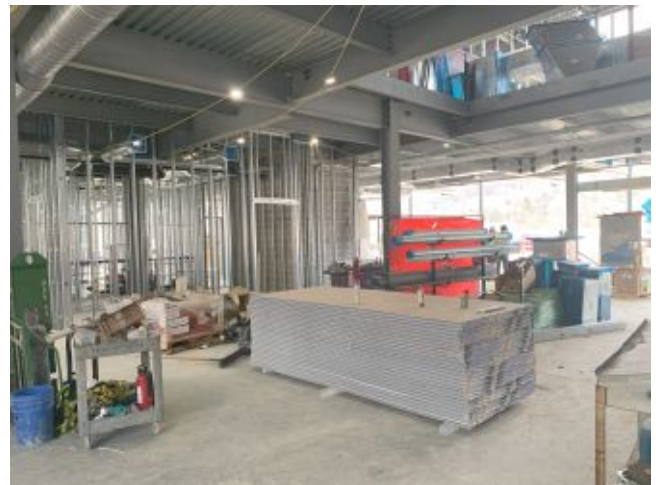
2025.03.04 – Looking southwest towards Work room #122

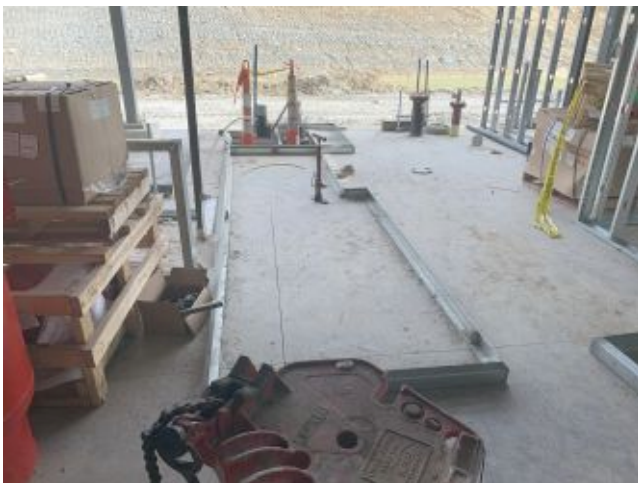
2025.03.04 – Mechanical #119

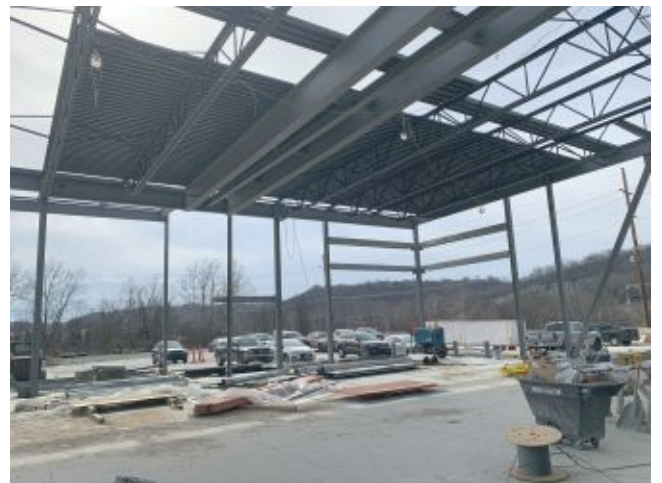
2025.03.04 – Board Room looking southwest

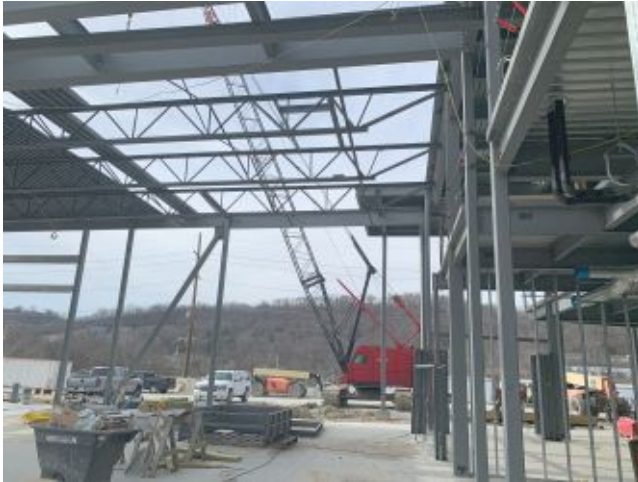
2025.03.04 – Board Room looking west

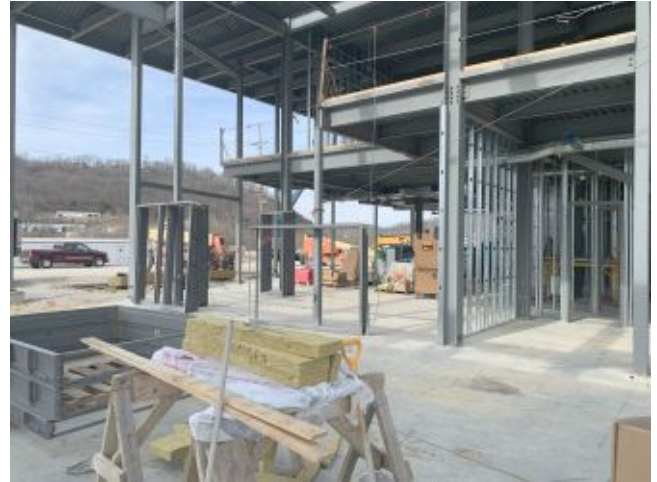
2025.03.04 – Board Room looking towards Entry Lobby

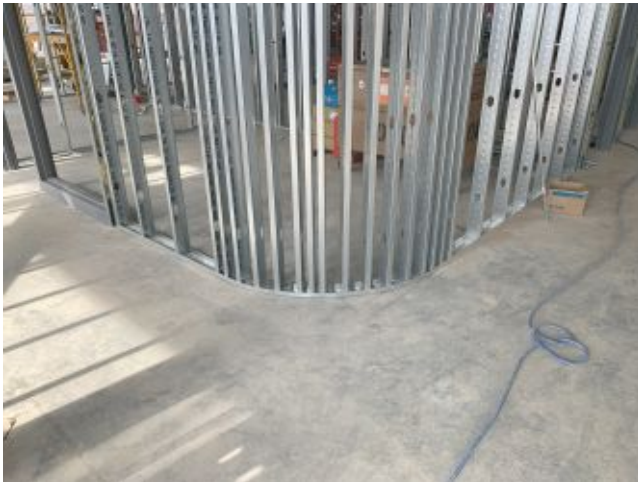
2025.03.04 – Corner of Huddle Room #115

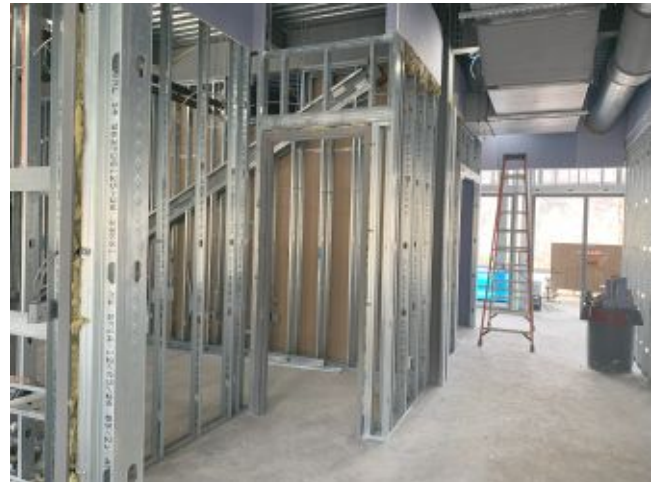
2025.03.04 – Looking southwest towards Women #246

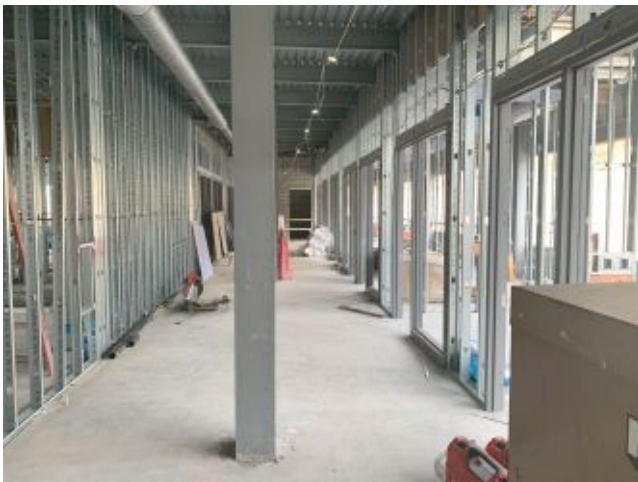
2025.03.04 – Second floor, east corridor

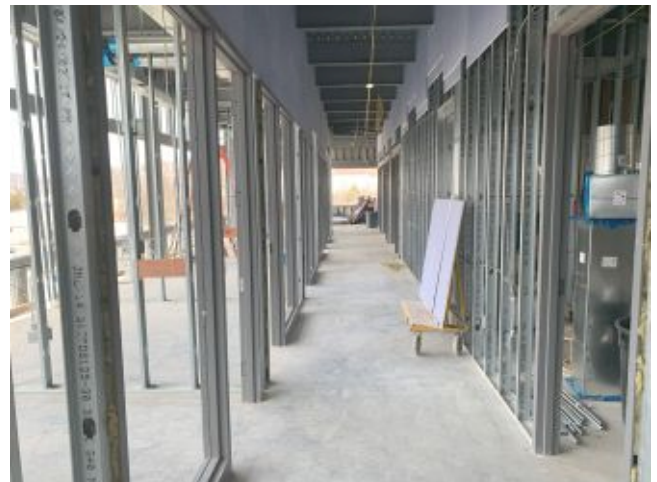
2025.03.04 – Second floor, west corridor, looking north

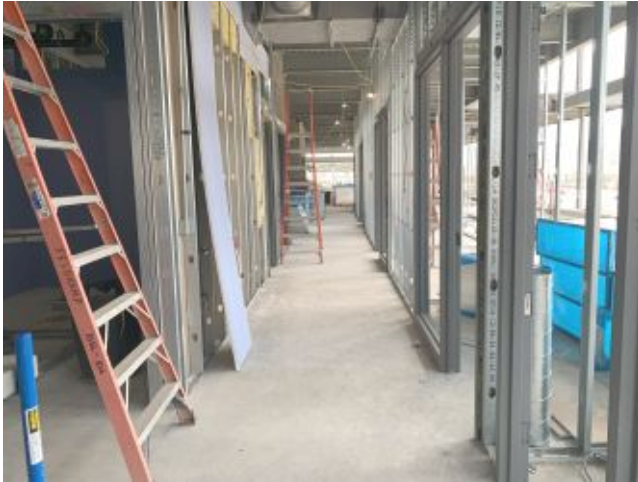
2025.03.04 – Second floor, west corridor, looking south

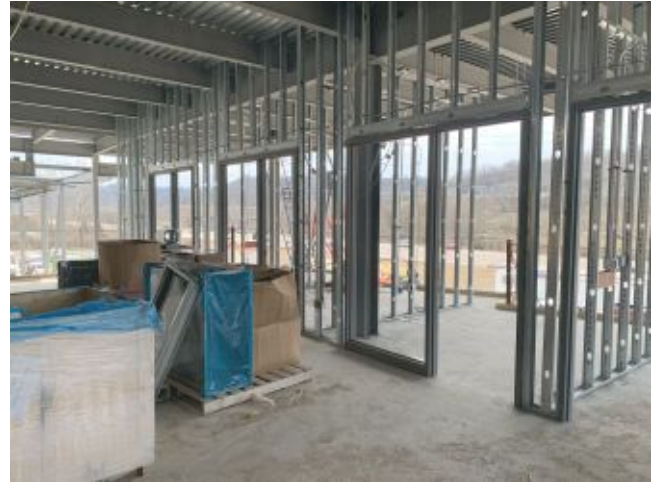
2025.03.04 – Offices #204-#206

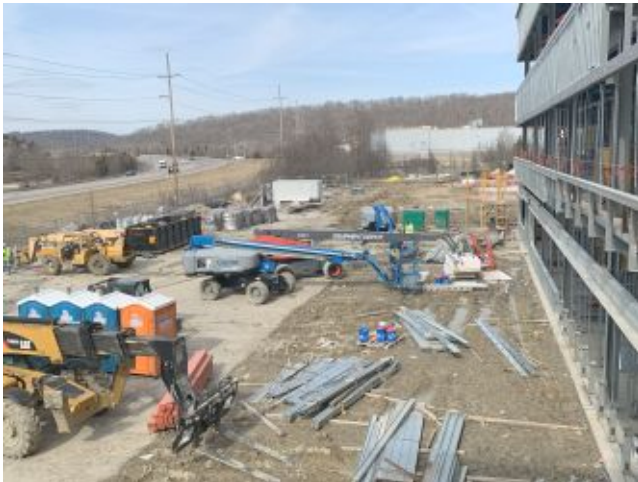
2025.03.04 – Site from Conference #202

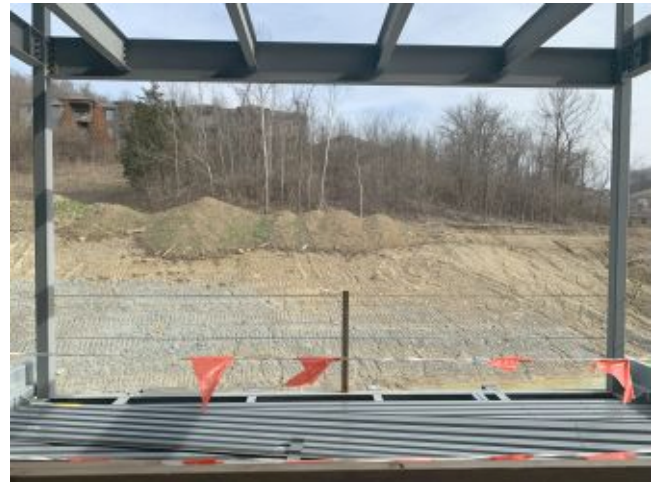
2025.03.04 – Looking out towards Outdoor Patio #252

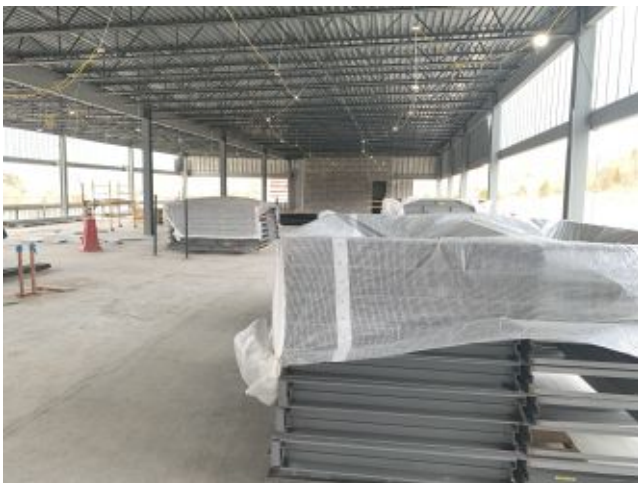
2025.03.04 – Third floor looking north

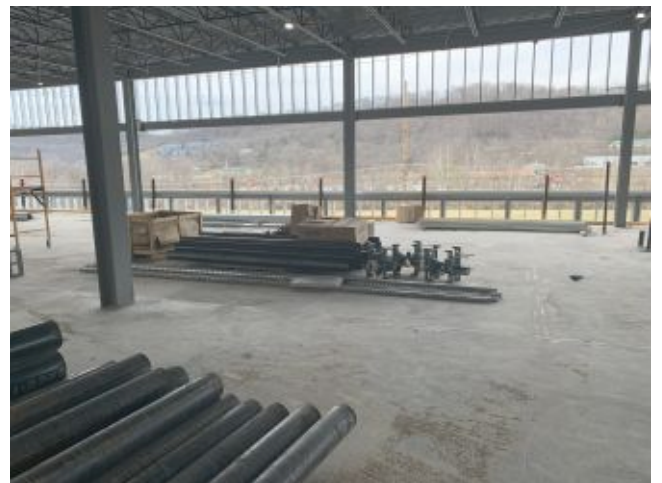
2025.03.04 – Third floor looking west

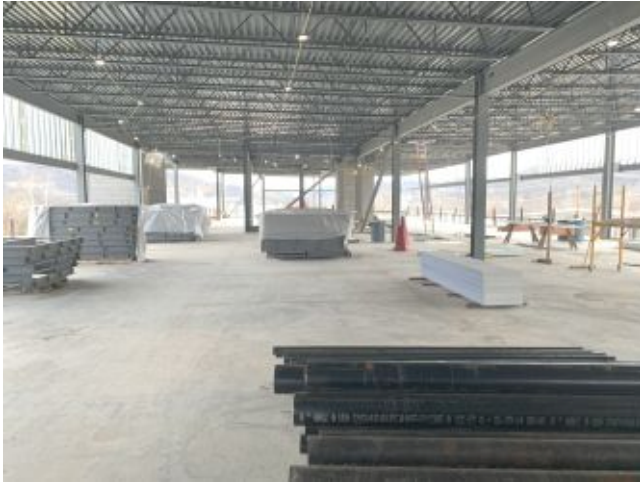
2025.03.04 – Third floor looking south

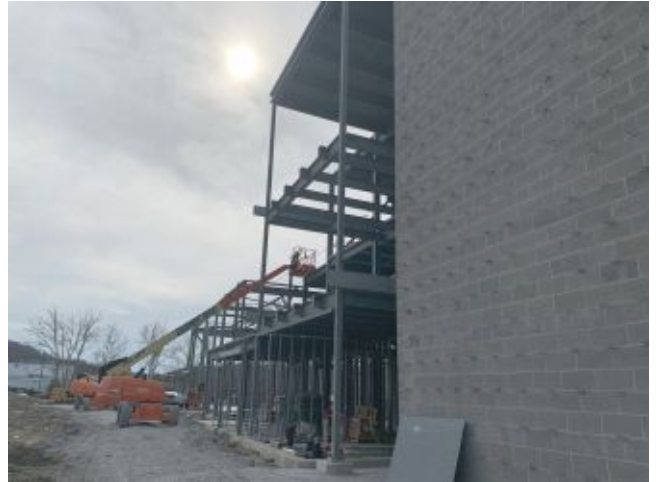
2025.03.04 – Exterior east elevation

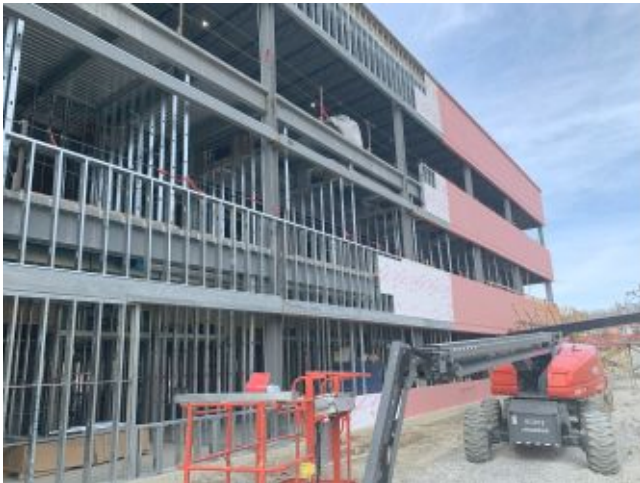
2025.03.04 – Exterior east elevation

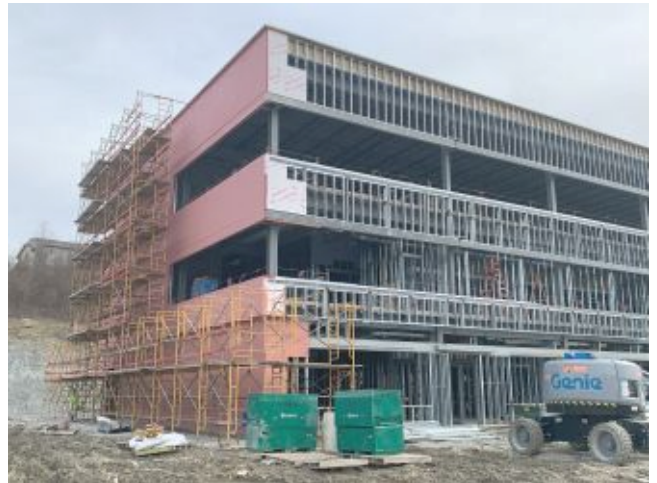
2025.03.04 – Exterior north elevation

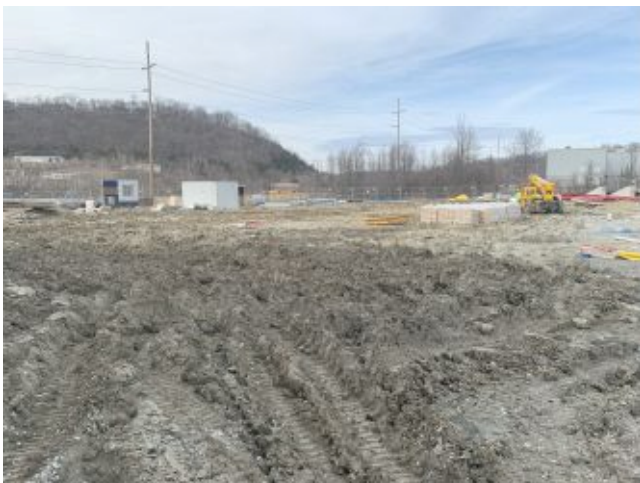
2025.03.04 – North parking lot area

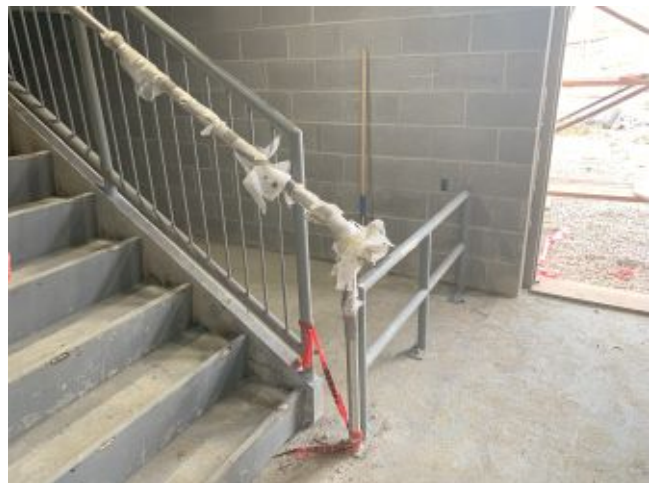
05.02: 2025.03.04 – Stair #1 steel had been installed and inspected. Ready for concrete pour. Roof deck had been installed over area B and a portion of the board room roof deck had been installed.

2025.03.04 – Stair #1

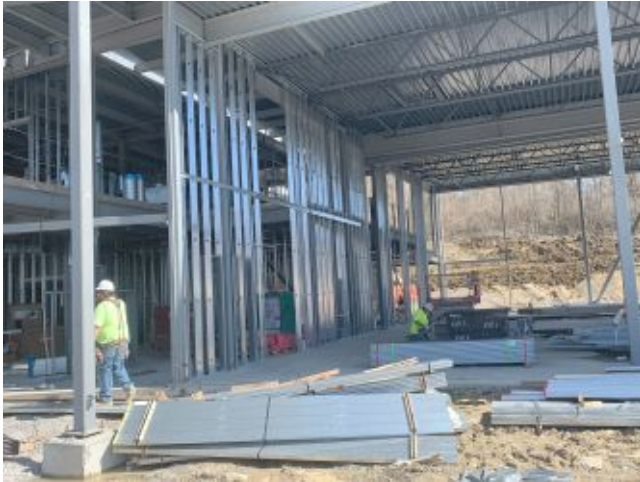
09.01: 2025.03.18 – Interior CFMF was in progress at the north wall of the board room and had begun at the third floor.

2025.03.18 – North wall of Board Room from outside

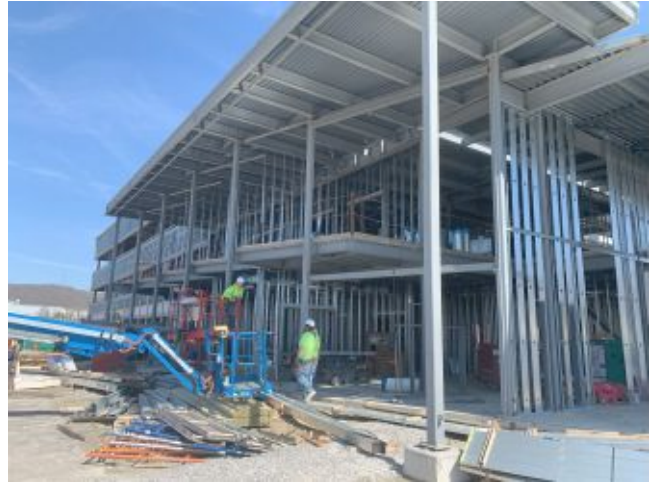
2025.03.18 – Entry and sawtooth

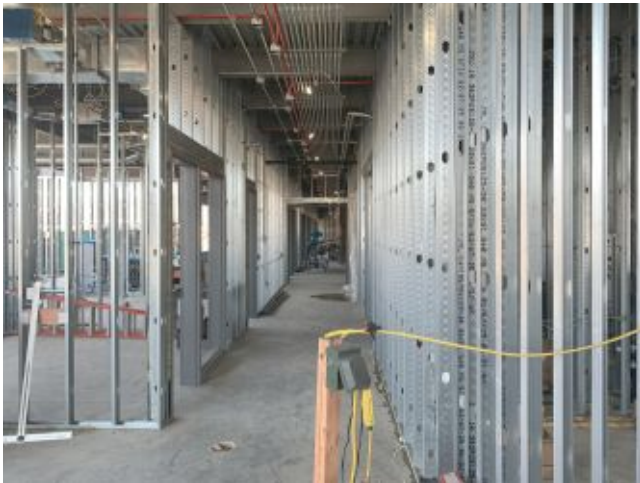
2025.03.18 – Corridor #100B

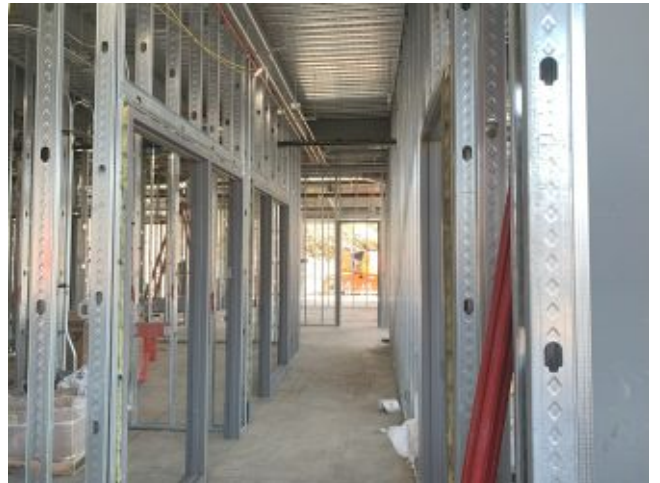
2025.03.18 – Looking towards Safety Office #116

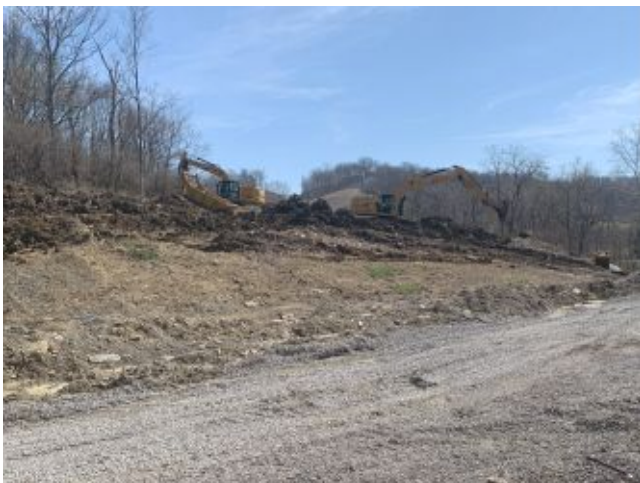
31.01: 2025.03.18 – The earthwork contractor was spreading materials along the southeast edge of the site to dry.

2025.03.18 – Drying grading materials

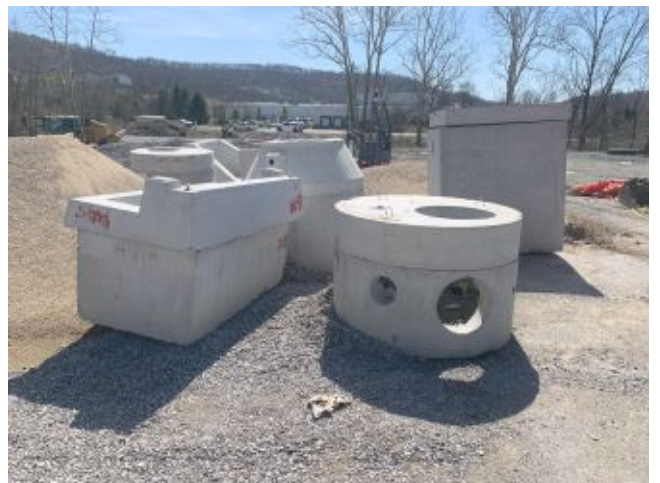
32.01: 2025.03.18 – Remaining storm structures were staged on-site for installation.

2025.03.18 – Storm structures

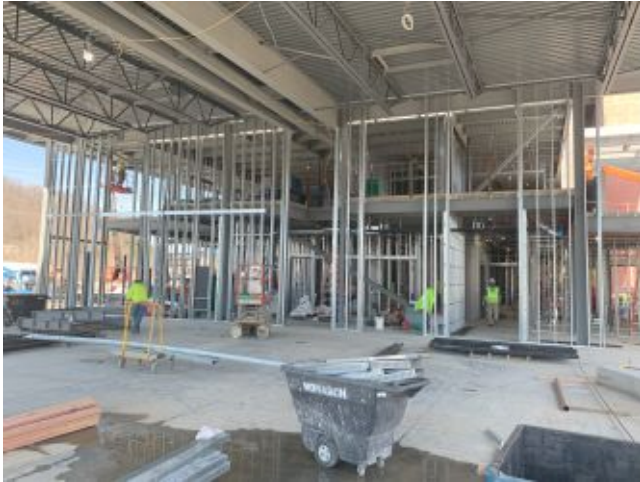
2025.03.18 – Board Room looking north

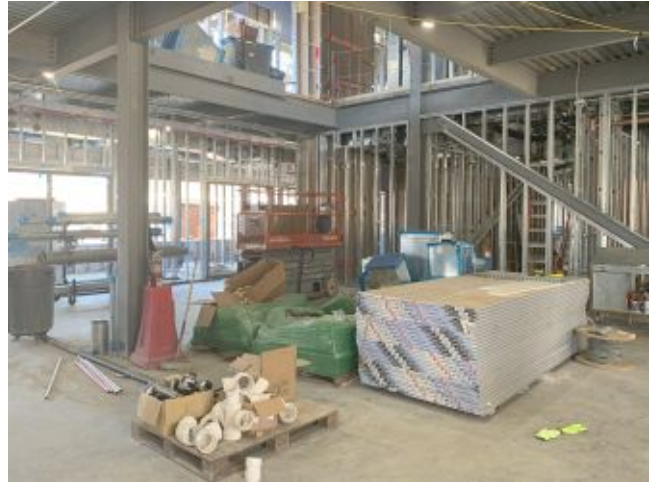
2025.03.18 – Monumental stair area

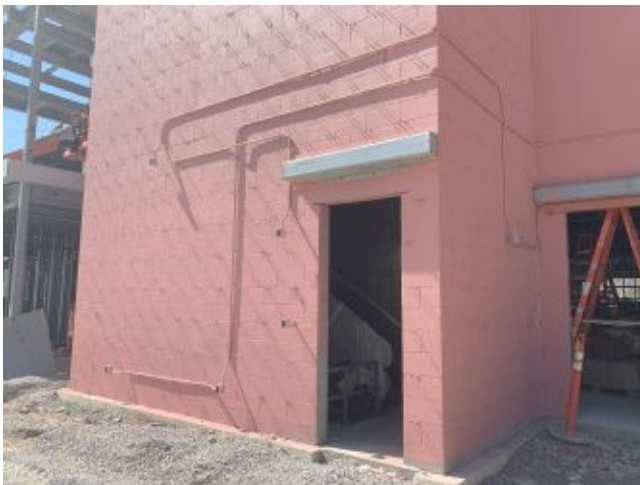
2025.03.18 – Exterior east elevation

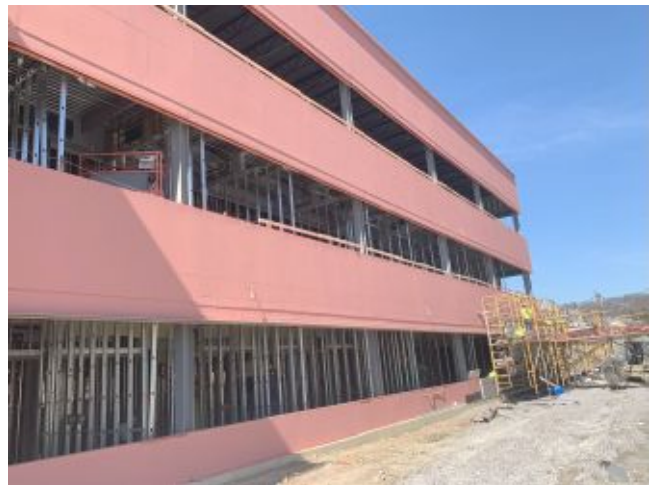
2025.03.18 – Exterior east elevation

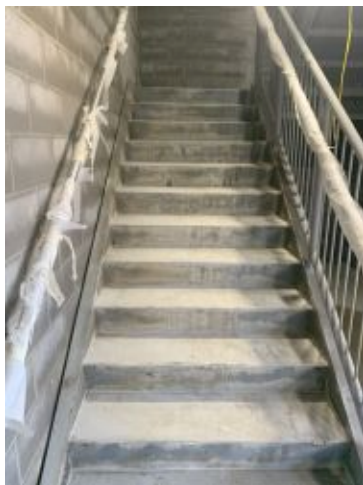
03.01: 2025.03.18 – Stair #1 had been poured and was available for use.

2025.03.18 – Stair #1

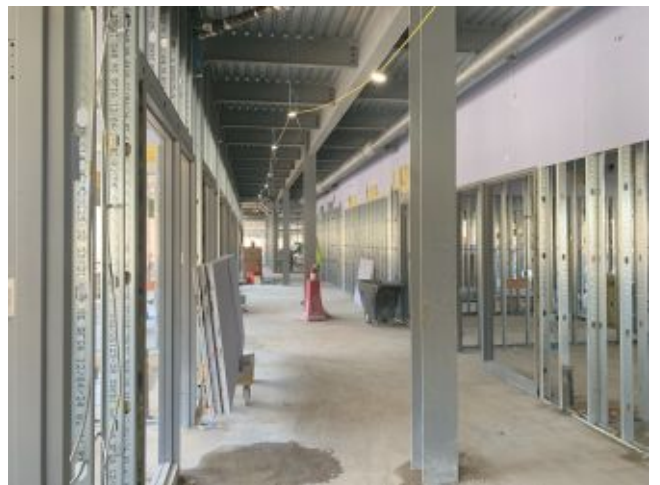
2025.03.18 – Second floor east corridor

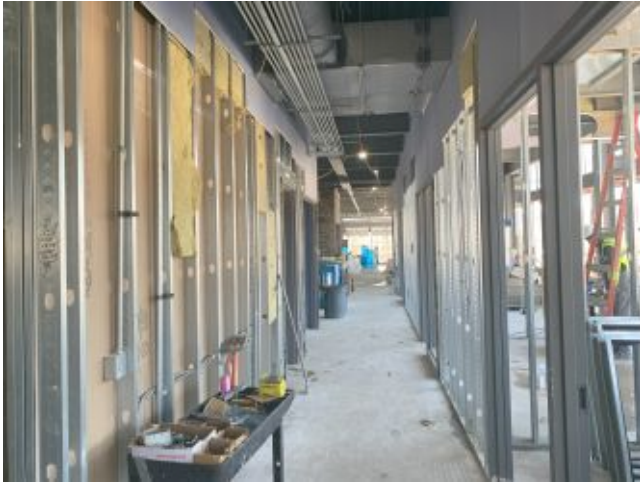
2025.03.18 – Second floor west corridor

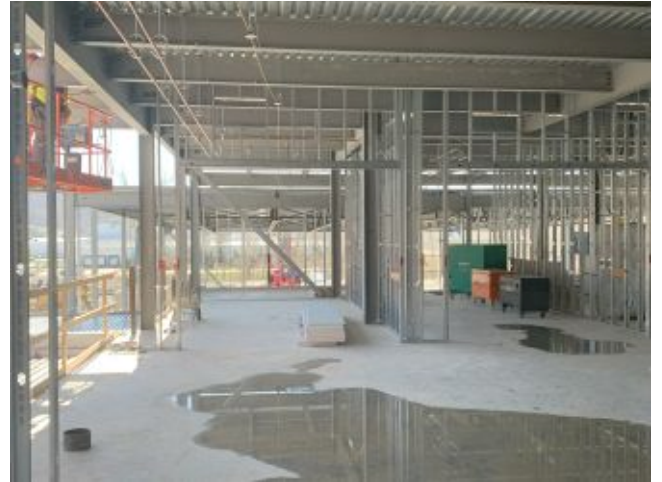
2025.03.18 – Second floor looking towards Break #210

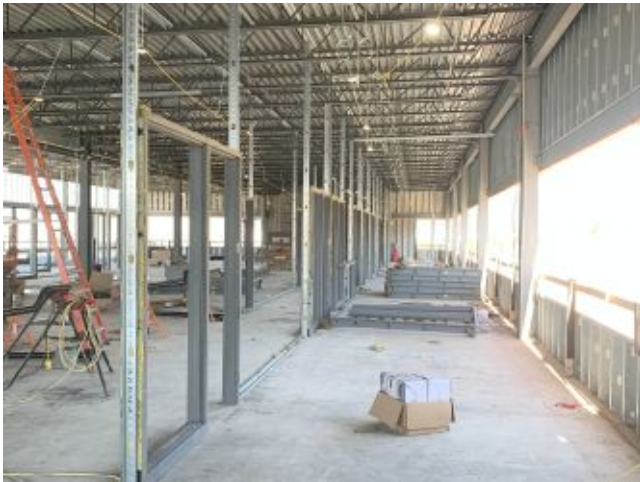
2025.03.18 – Third floor looking north

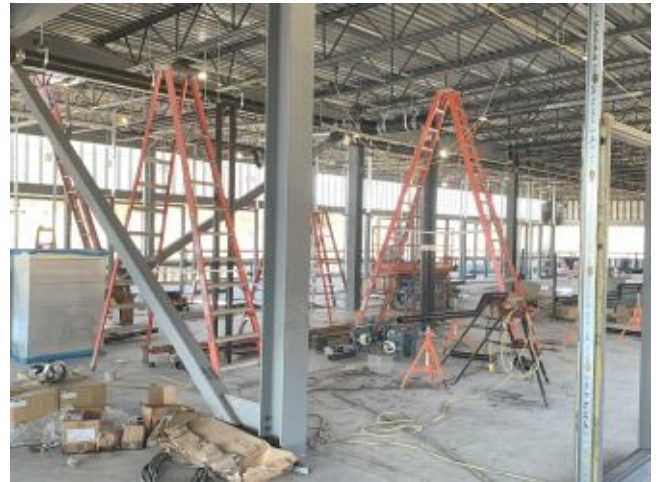
2025.03.18 – Third floor looking northwest

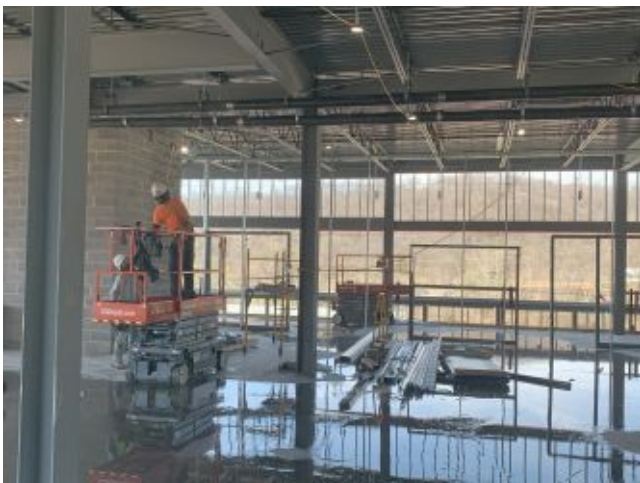
2025.03.18 – Third floor looking east

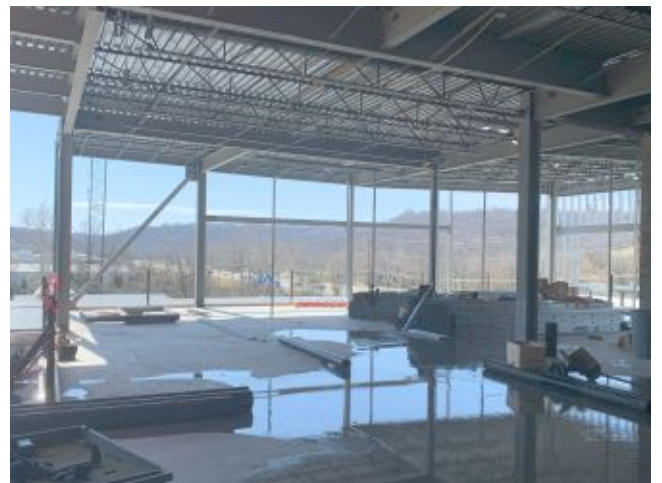
2025.03.18 – Third floor looking south

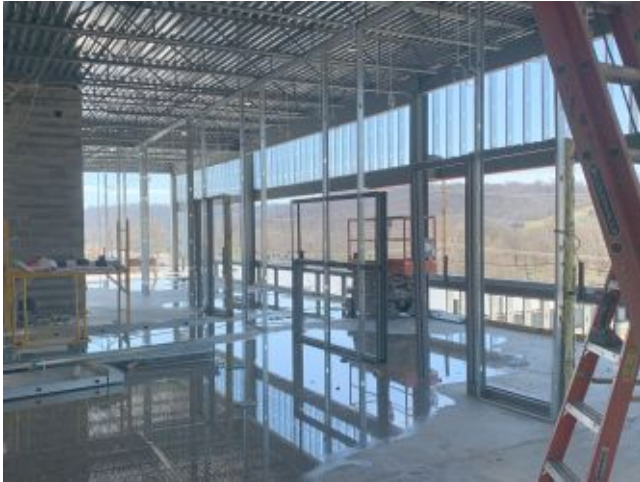
2025.03.18 – Third floor looking southwest

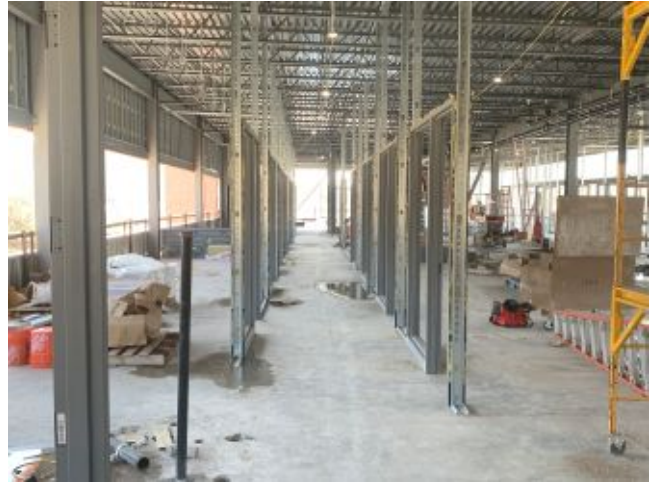
2025.03.18 – Third floor, west corridor, looking north

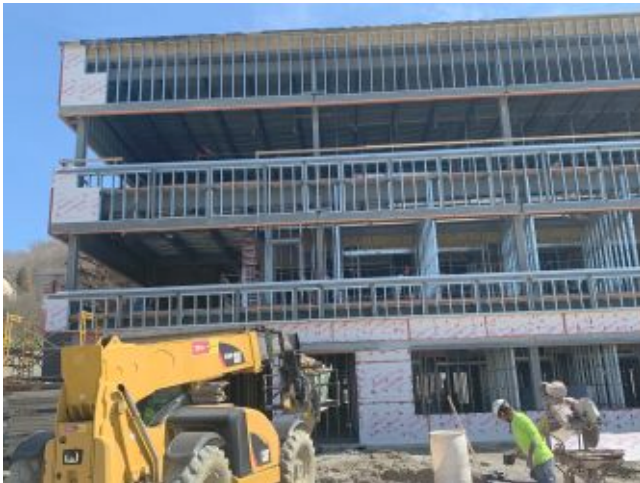
2025.03.18 – Exterior west elevation

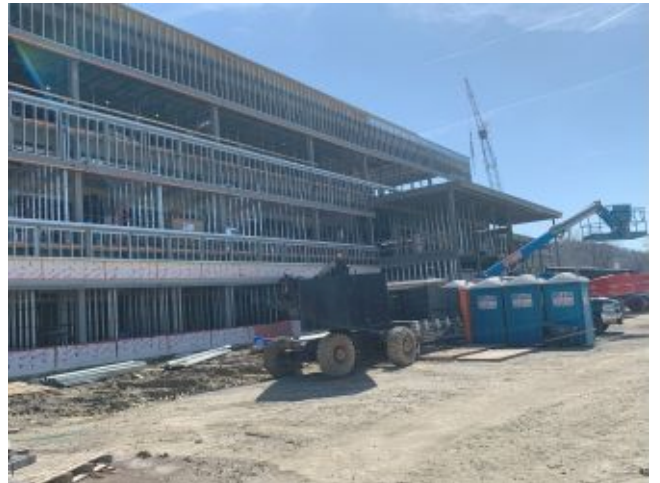
2025.03.18 – Exterior west elevation
