FIELD OBSERVATION REPORT

Food Service Building, 202276 -CA8

Date: 4/8/2025 Time: 1:00 PM

Report No: 3

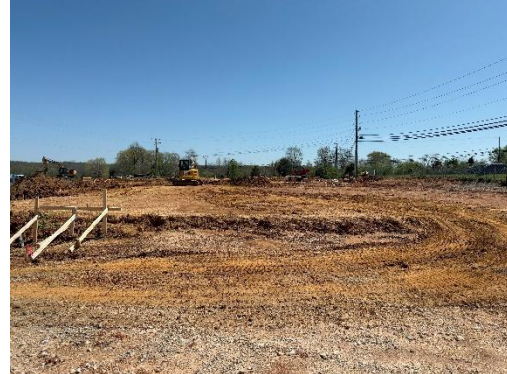
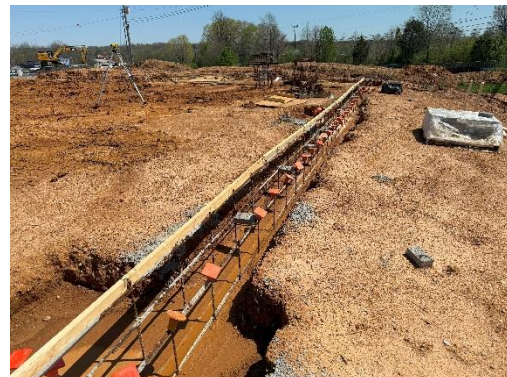
- a) The site had recovered well from the recent flooding rains to the point that excavations and earth moving were proceeding normally.
- b) Excavating and earth moving was ongoing.
- c) Preparing areas for the next footing pour.
- d) Preparing steel reinforcing for footings.

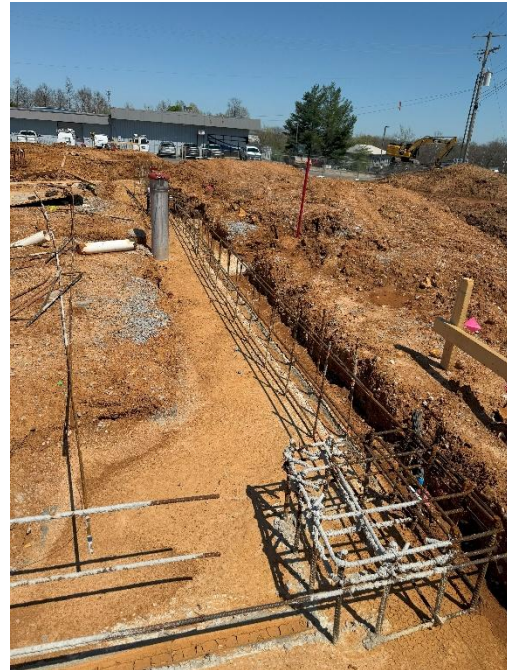
- c) The footing on the southeast corner drops significantly to bear on suitable soils. The reinforcement that was in place reflects that. The footing bottoms appeared to be firm.

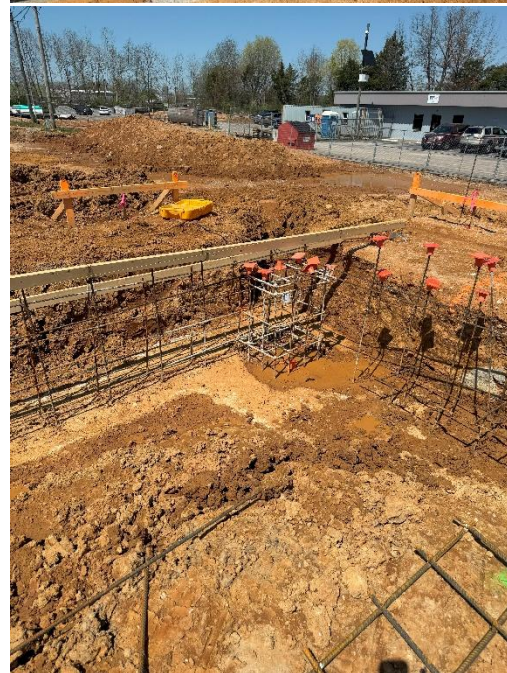
- d) Steel reinforcement was in place at the northeast corner.

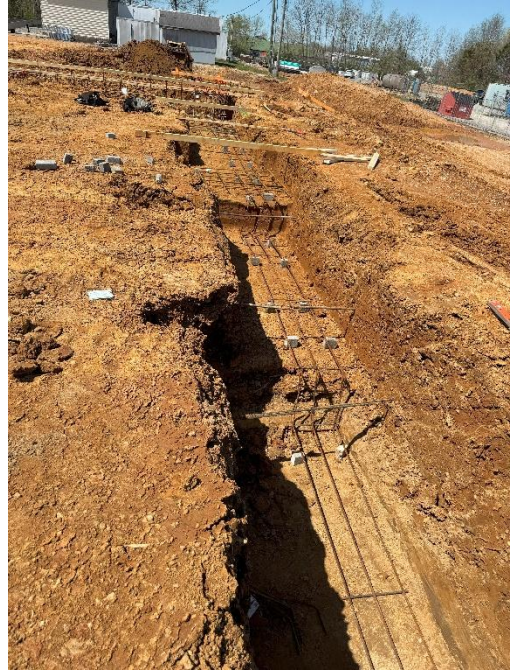
- e) The footing steps to the southeast. Steel reinforcing was placed on concrete block risers.

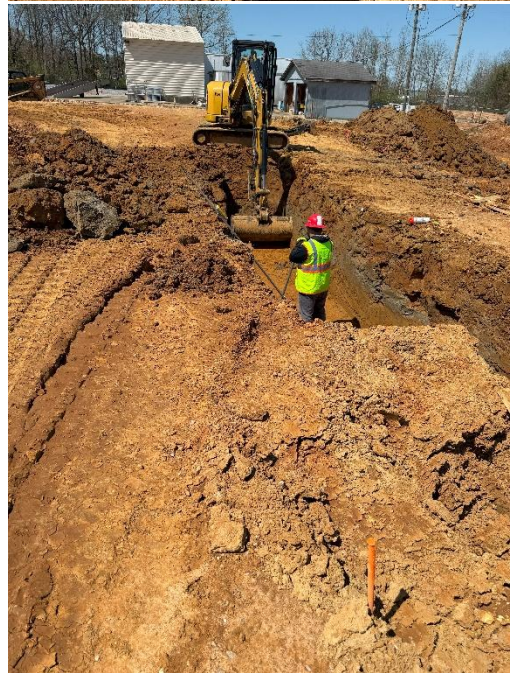
- f) Soils were being removed to reach plan bottoms.

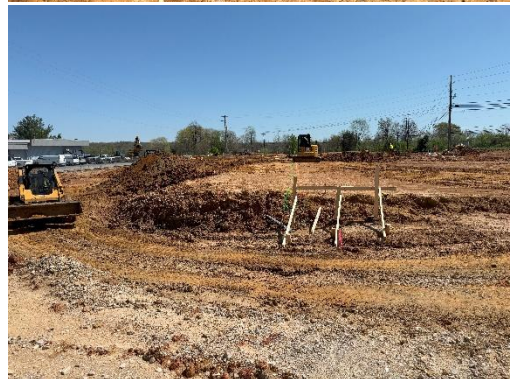
- g) Once soils were excavated, it was removed to the area in front of the facilities building for loading onto dump trucks.

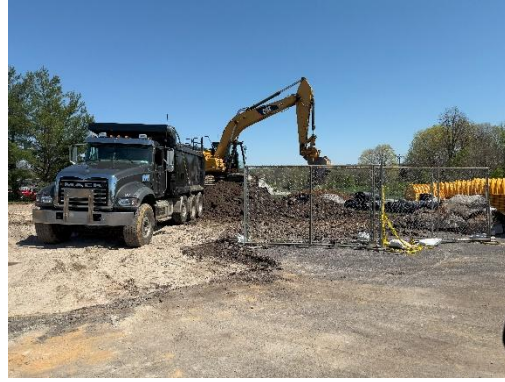
- h) The excess soils were being loading into dump trucks for disposal off site.
