FIELD OBSERVATION REPORT

West Hardin Middle School, 202280 -CA8

Date: 4/8/2025 Time: 11:00 AM

Report No: 7

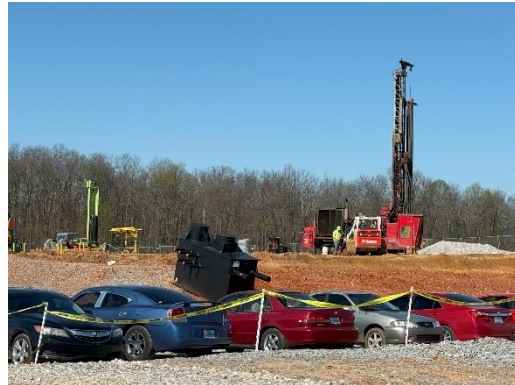
- a) Geothermal well drilling and associated work was ongoing.

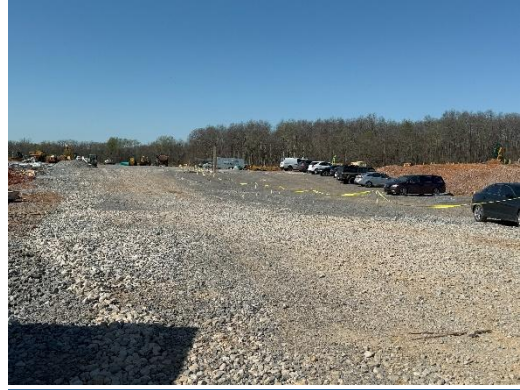
- b) Crushed rock was placed in the parking lot area.

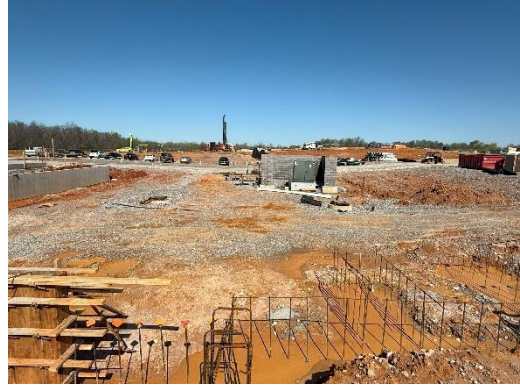
- c) The loading dock area was dry.
The dock wall was being formed.

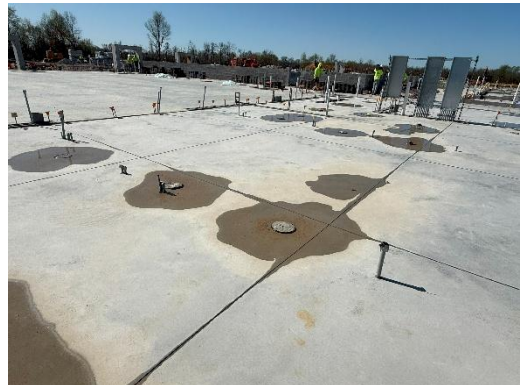
- d) The concrete slabs were mostly dry. Water remained from the rains at the floor drains in the kitchen.

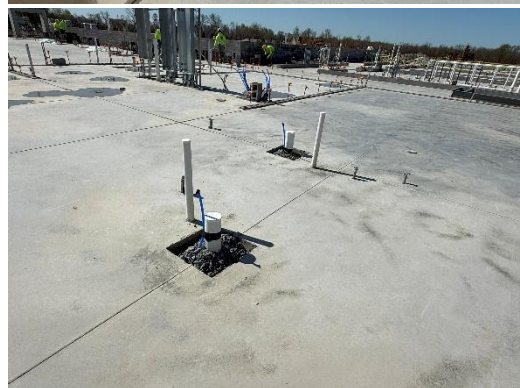
- e) PEX piping for trap primers was visible in the kitchen.

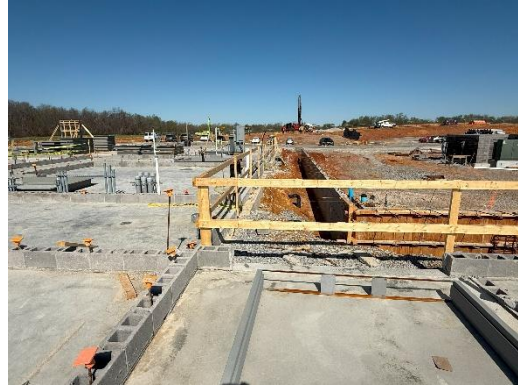
- f) The retaining wall for the walk beside the dock area was formed.

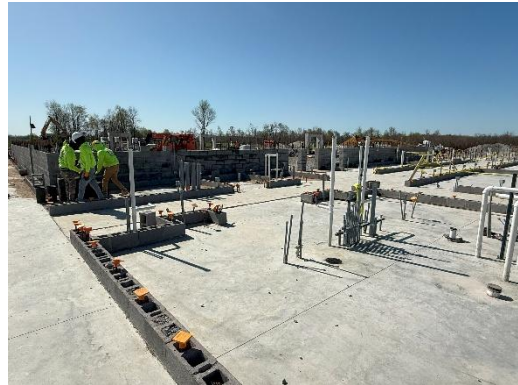
- g) Interior CMU walls around the gym/storm shelter were laid to four to six courses.

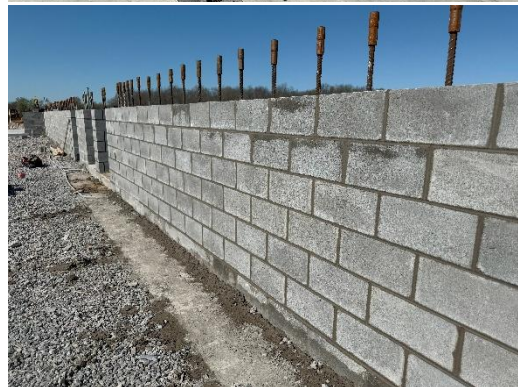
- h) The CMUs around the gym have arrived on site 1/8" taller than normal. This was reported to be within tolerance but will show with smaller mortar joints. The half blocks at corners are the standard height of 7-5/8" and will vary slightly from the rest of the course. Overall coursing must remain at 8" to work with standard door frames and other items built into the masonry walls.

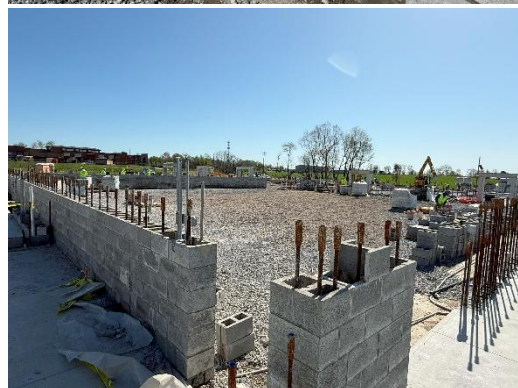
- i) Icon has raised a concern that some of the vertical reinforcing bars are not being grouted into place at 3/4" clear from the inner face of the block cells. It was reported that Wehr and Baileys have taken corrective actions to correct this.

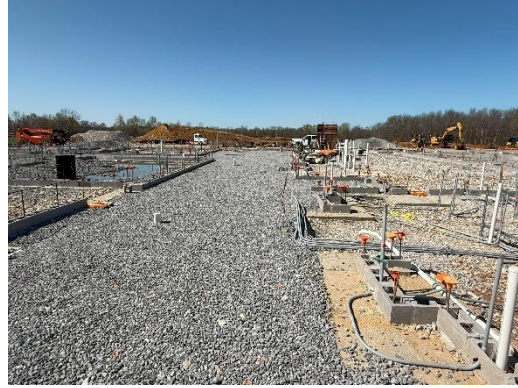
- j) Foundations along the main corridor extend to the front entry.

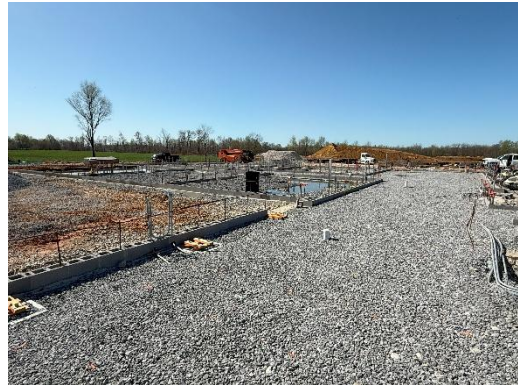
- k) Foundations for the classroom wings were in place.

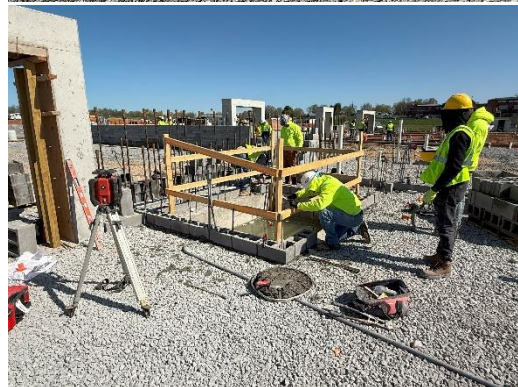
- l) CMUs were being laid around the elevator shaft.

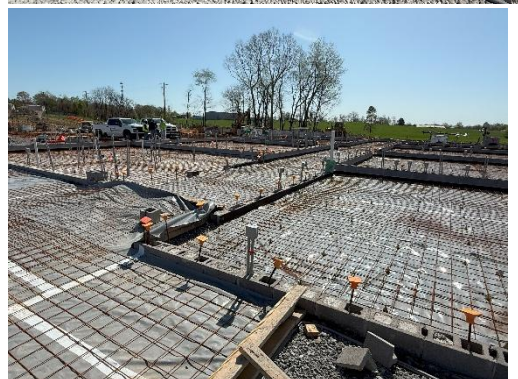
- m) Slab areas in the classroom wings were being prepared with reinforcing fabric over vapor barrier materials. The vapor barrier materials appeared to be sealed at the edges and around penetrations.

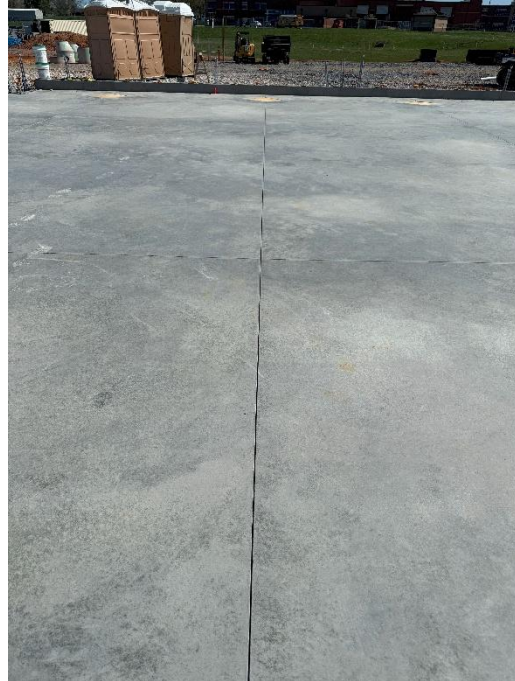
- n) Concrete slab crack control joints appeared to be properly cut into the slabs.
