FIELD OBSERVATION REPORT #10

2025-04 - New Board Office

■ TO:	Kenton County Board of Education 1055 Eaton Drive Ft. Wright, KY 41017	■ DATE:	2025.04.23
ATTENTION:	Mr. Kevin Pfefferman		
■ FROM:	Mark Perry mperry@embossdesign.com 906 Monmouth Street Newport, KY 41071 V: 859.431.8612 • D: 859.578.6013	■ PROJECT:	New Board Office KCSD BG#24-084
COPIES TO:	Mr. Matt Rigg; Mrs. Carrie Hooten, Mr. Brian Vanover	PROJECT NO.:	22-106

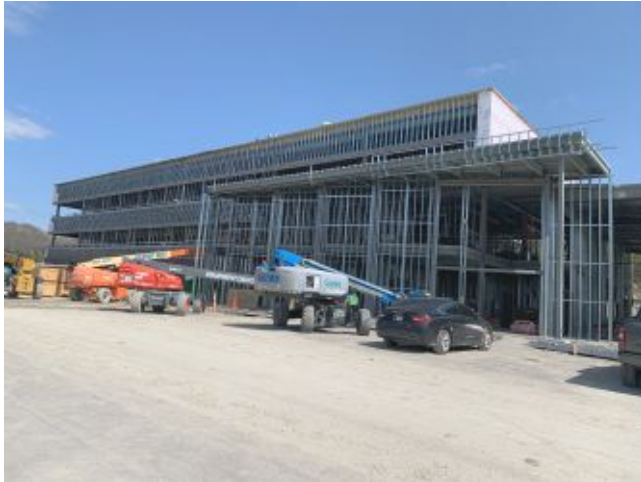
2025.04.01 – Exterior from west

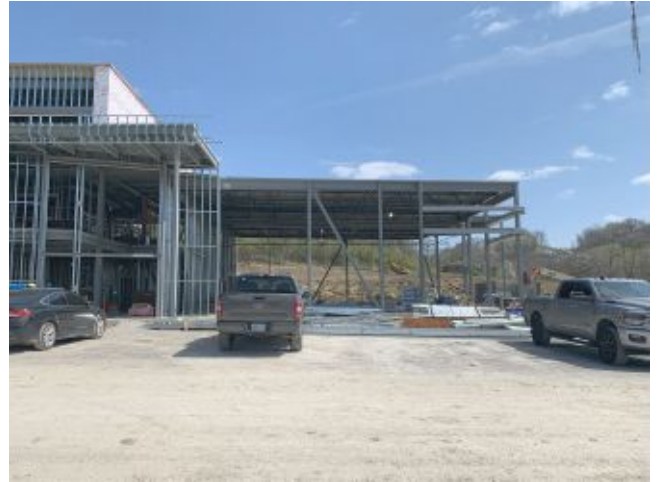
2025.04.01 – Exterior from west

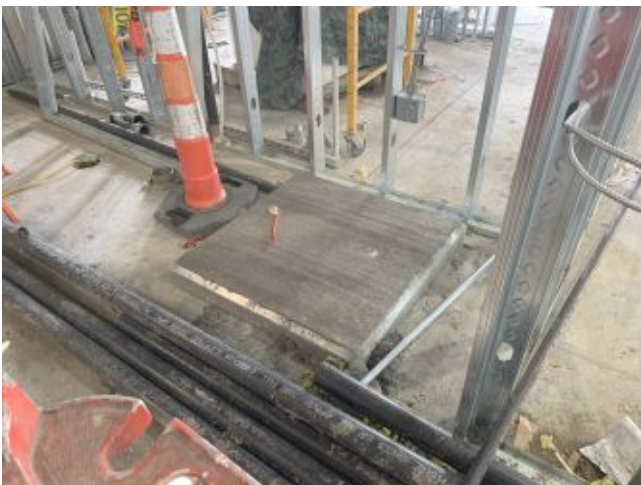
2025.04.01 – Housekeeping pad in MEP #119

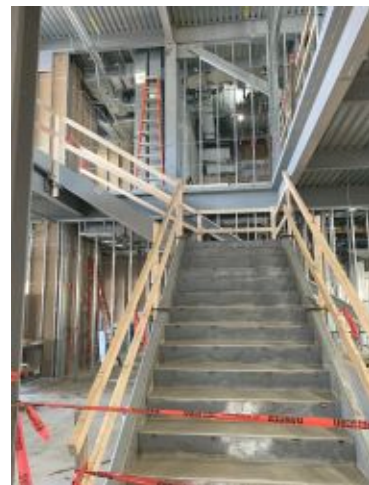
2025.04.01 – Monumental stair

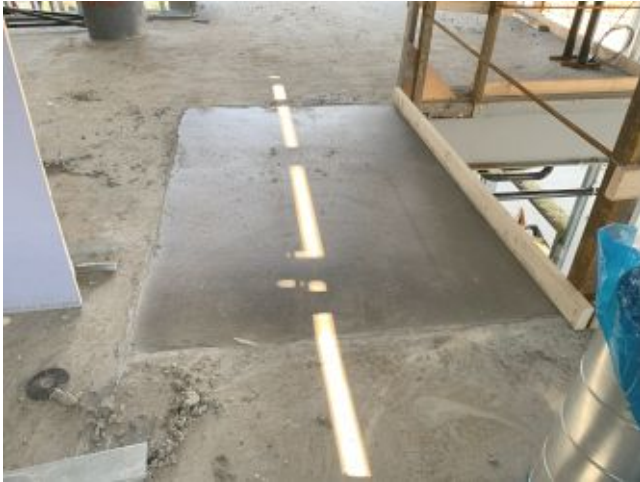
03.01: 2025.04.01 – The monumental stair had been poured as had the small area of the second floor north of the operable partition pocket.
03.02: 2025.04.01 – Numerous housekeeping pads had been poured.

2025.04.01 – Slab pour north of operable partition pocket

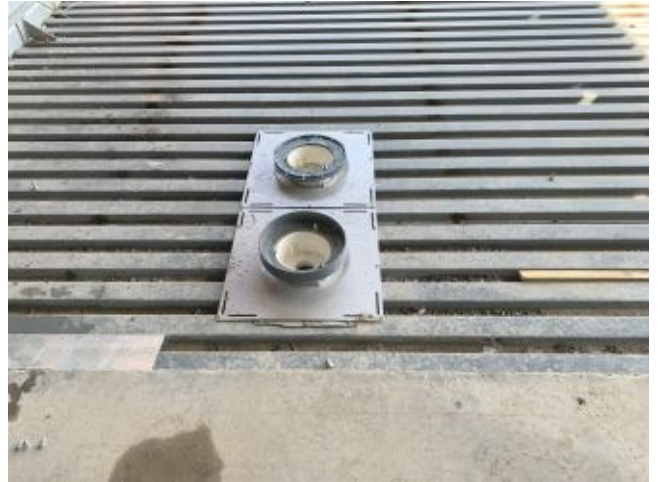
20-28.01: 2025.04.01 – Roof drains had been set at the roof patios.

2025.04.01 – Roof drains at second floor patio

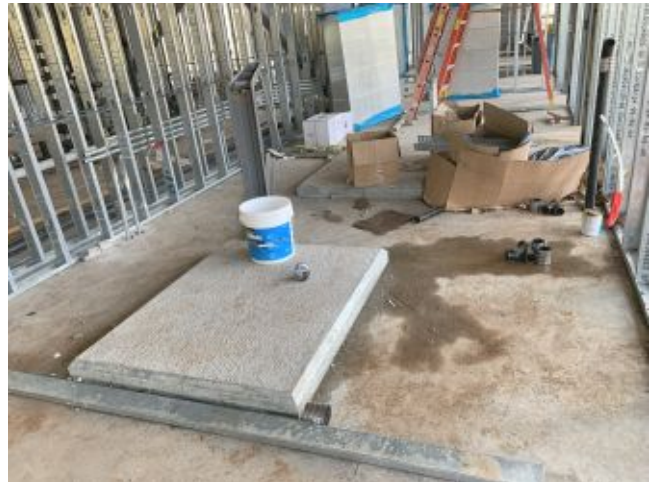
2025.04.01 – Housekeeping pad in Mech #354

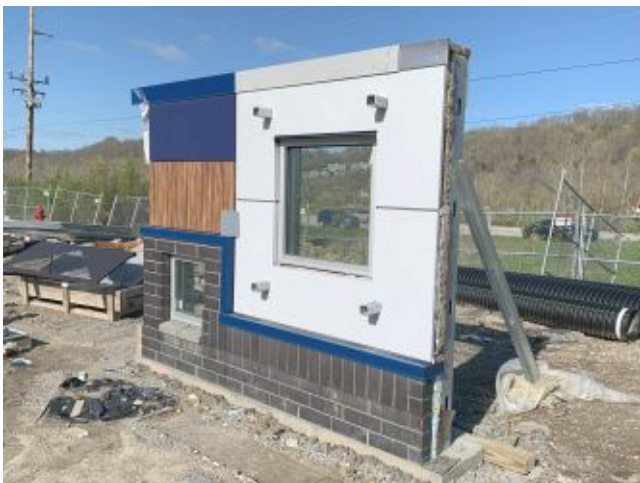
01.01: 2025.04.08 – The mockup panel was reviewed in advance of geothermal well field borings beginning.
01.02: 2025.04.23 – A total of five of the budgeted twenty inclement weather days beyond the normally anticipated weather days had been claimed and granted as of this date.

2025.04.08 – Mock-up panel

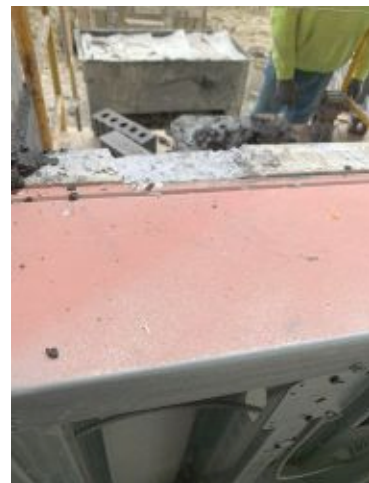
07.02: 2025.04.09 – A meeting was conducted on-site to review insulation challenges and thermal bridging concerns. Several air barrier installation issues were identified and discussed.

2025.04.09 – Missing liquid flashing at a first floor sill

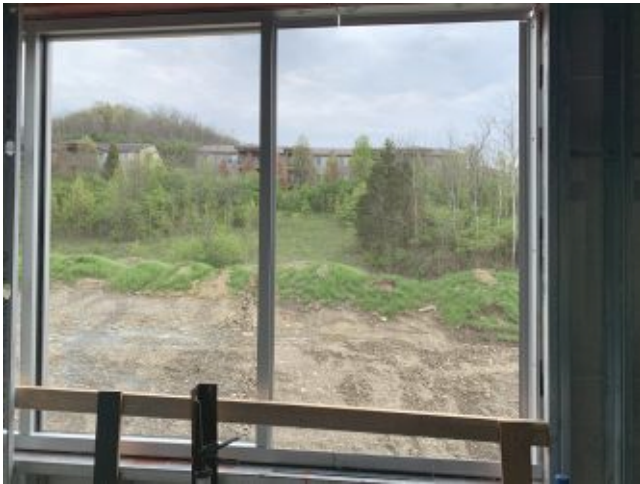
2025.04.09 – Window installation Huddle #356

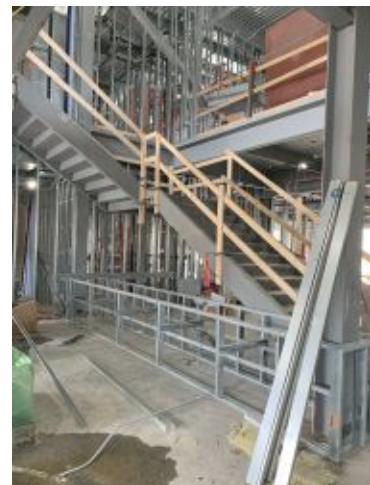
09.02: 2025.04.09 – The planter walls at the monumental stair had been rough framed.

2025.04.09 – Monumental stair

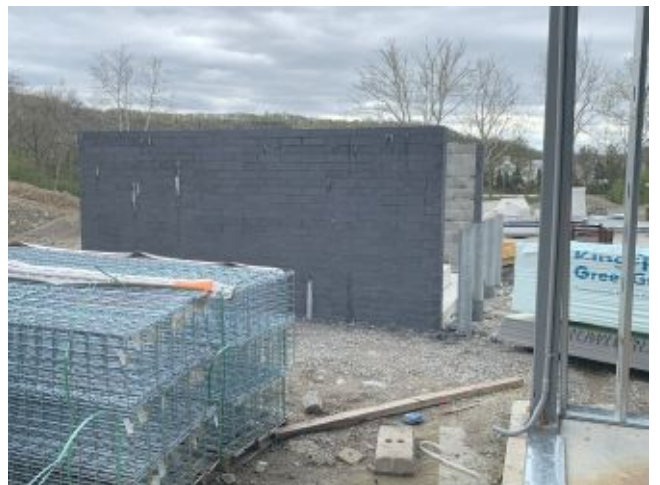
2025.04.15 – Generator screen wall

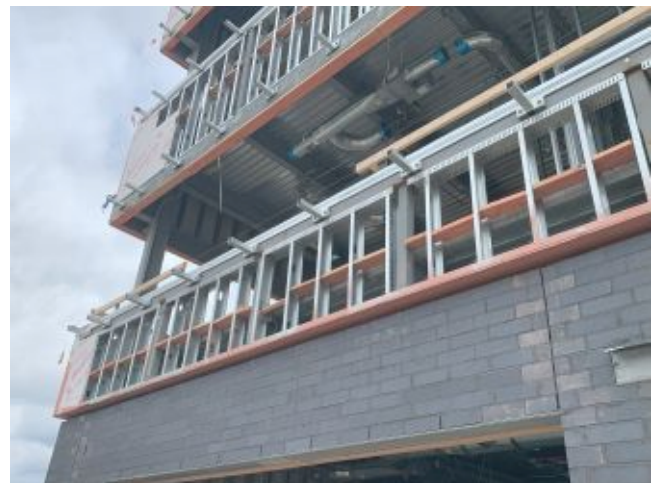
10.01: 2025.04.15 – Outriggers for the exterior grilles and screens had been installed at most west elevation locations.

2025.04.15 – Outriggers on west wall

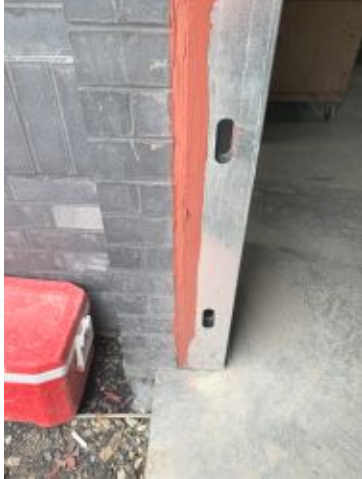
07.04: 2025.04.15 – Air barrier had been applied to the west wall of the board room. Several deficiencies previously identified had been corrected.

2025.04.15 – Air barrier repair at opening #121

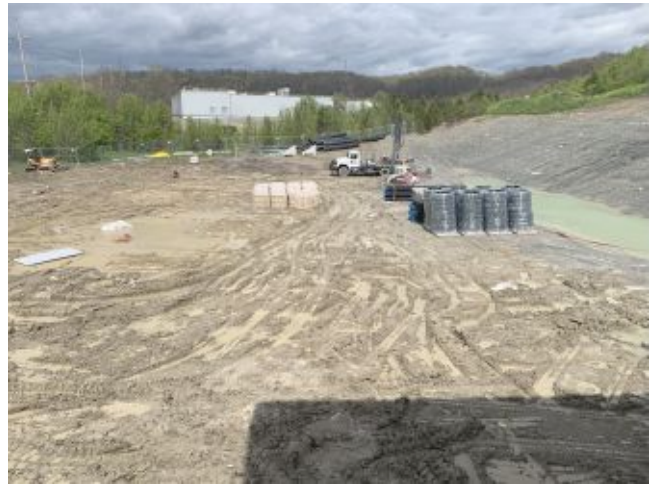
20-28.08: 2025.04.15 – The geothermal drilling rig was active at the northeast corner of the site.

2025.04.15 – Northeast corner of site

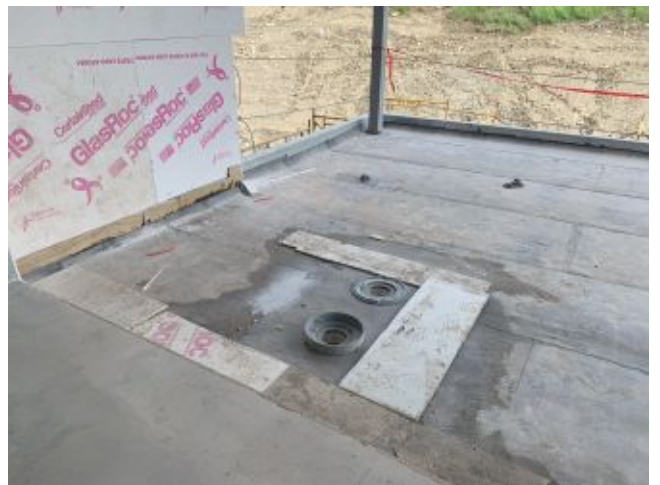
07.06: 2025.04.15 – Roofers were active at both patios and the adjacent low roof on the second floor.

2025.04.15 – Second floor patio

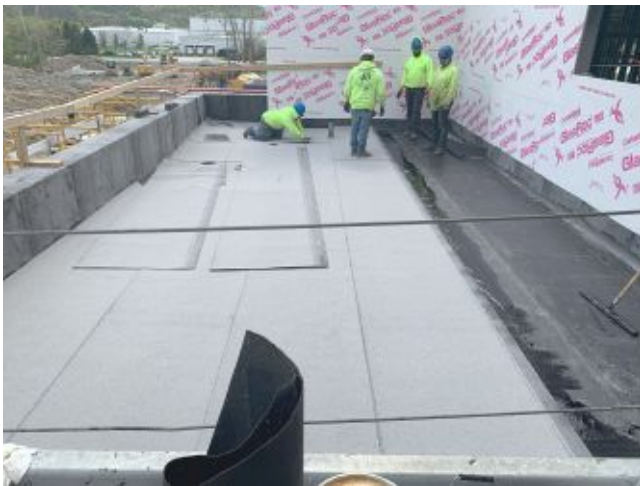
2025.04.15 – Roof adjacent to second floor patio
