FIELD OBSERVATION REPORT

Central Hardin High School – Phase 2, 2019111 -CA8

Date: 5/7/2025 Time: 11:00 AM

Report No: 21

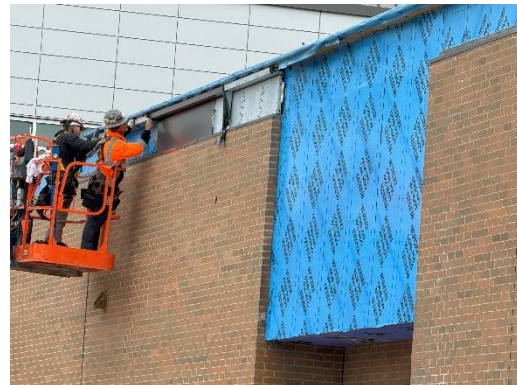
- a) Metal Panels were being installed at the parapet for Area D.

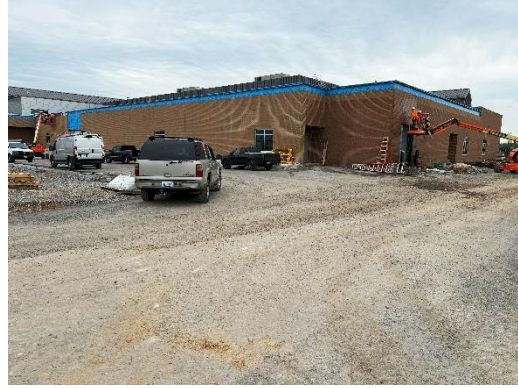
- b) New brick was being cleaned at Area D.

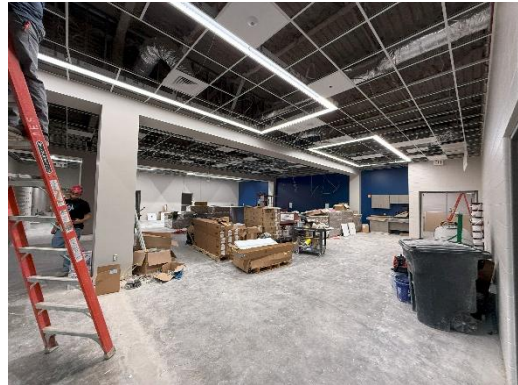
- c) Light fixtures were being installed in the Band Room.

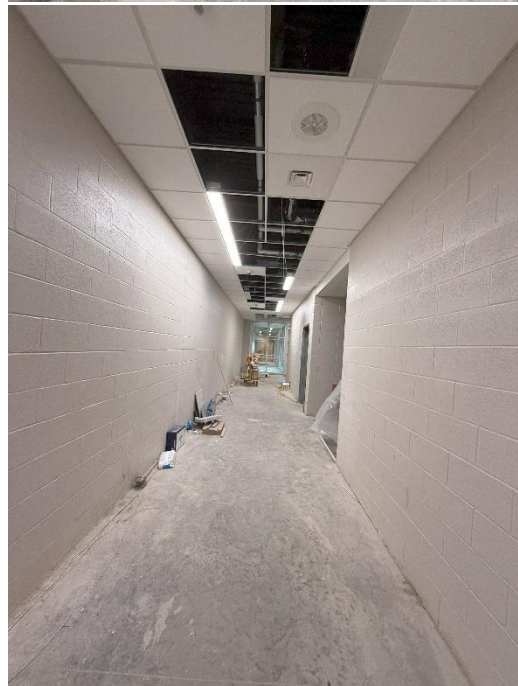
- d) Ceiling tiles were being installed in the corridors of Area D.

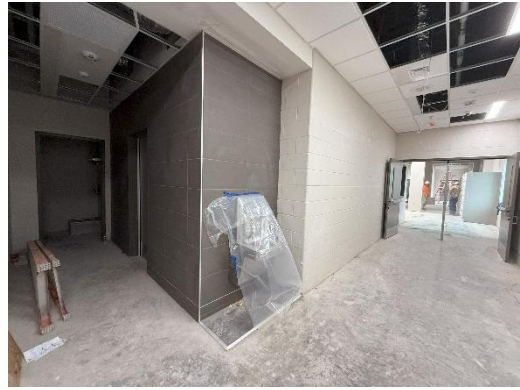
- e) The electric water coolers were being installed in Area D.

Ceramic tiles were installed on the walls.

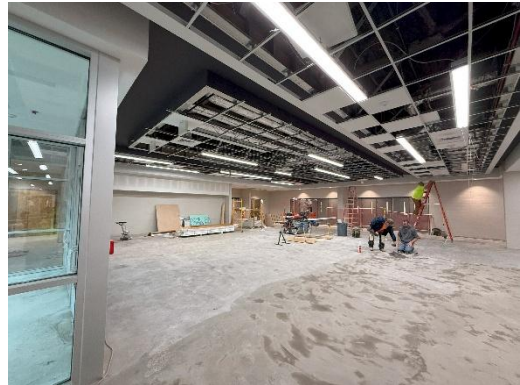
- f) Floor prep was ongoing in the Gathering Space in Area D.

Light fixtures were installed in the ceilings.

Axiom trim was being installed at the edges of the ceilings.

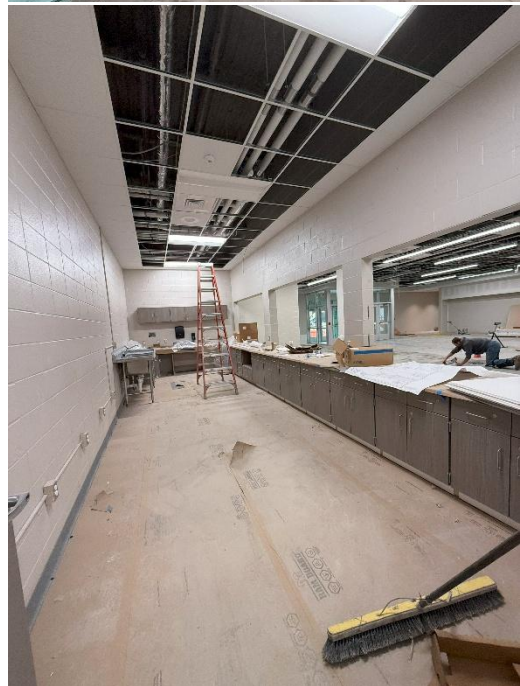
- g) Ceiling tiles were being installed in Concessions. Plumbing and electrical work was completed.

Protection board was placed over the epoxy flooring.

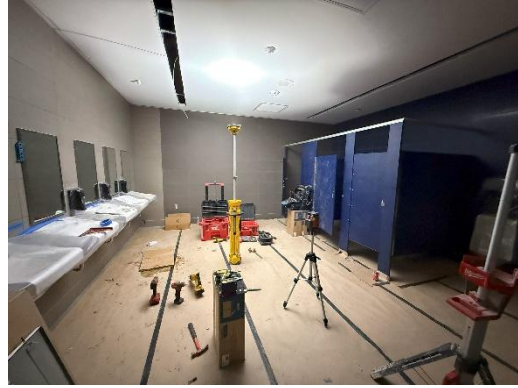
- h) Lavatories and toilet partitions were installed in the toilets. Light fixtures were due to be shipped to the site.

The ceramic tile flooring was covered with protection board.

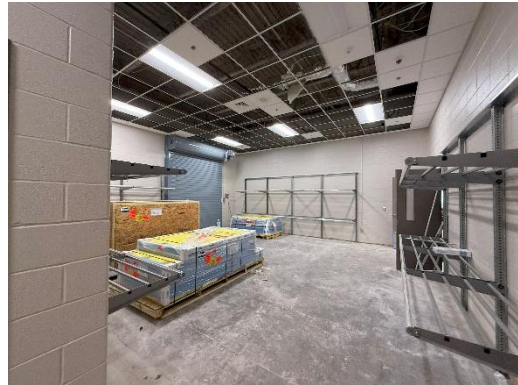
- i) Ceilings were progressing in the rooms in Area D.

The steel shelving was installed in Band Storage.

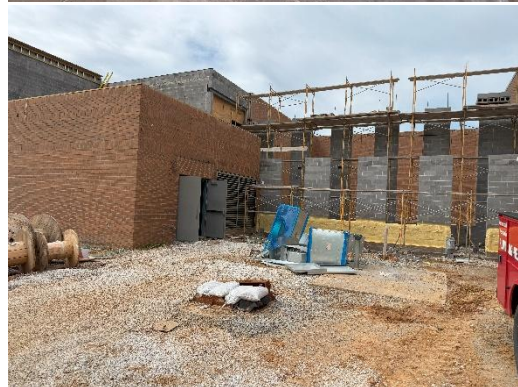
- j) Spray insulation was being applied to exterior CMU walls.

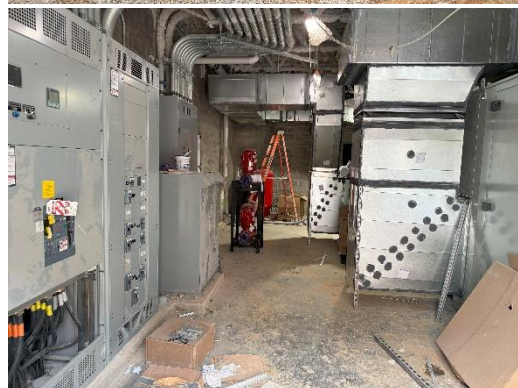
- k) Rough-ins for electrical and mechanical devices in the Area J mechanical room were nearing completion.

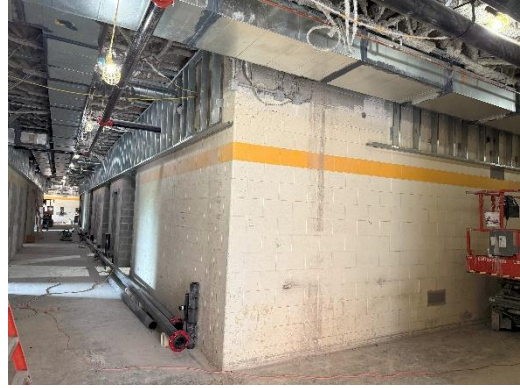
- l) Hydronic piping and ductwork were being installed above ceiling in Area J on the first floor.

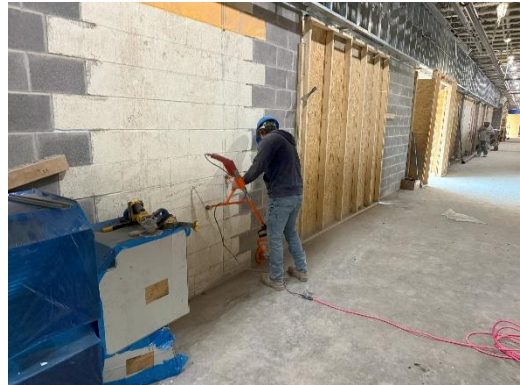
- m) CMU walls were being prepped in the corridors of Area J to receive vinyl base.

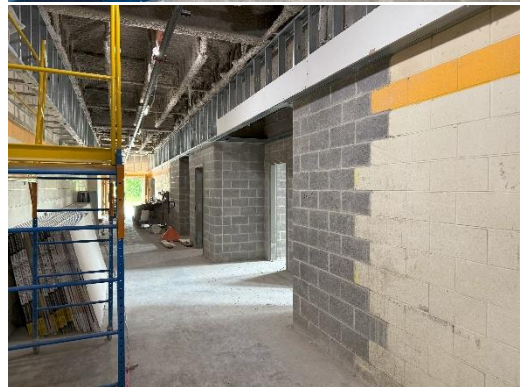
- n) Wallboard soffits were being installed along the corridors in Area J.

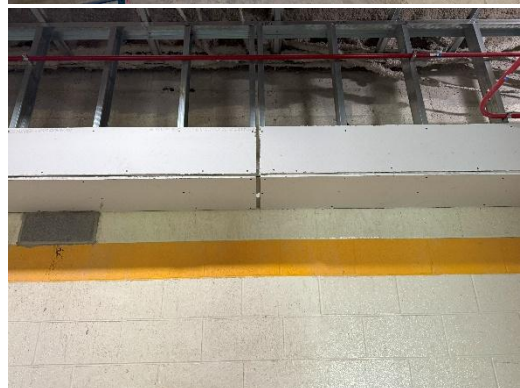
- o) Metal framing and wallboard were properly installed to receive control joints in the soffits in Area J.

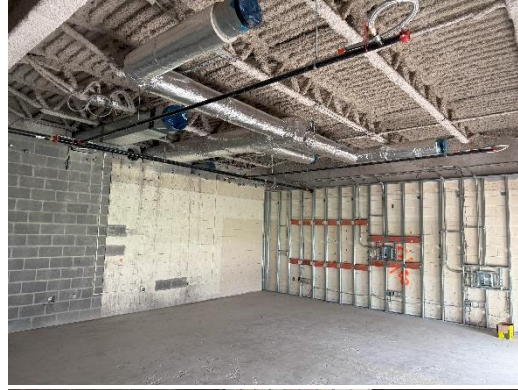
- p) Where ductwork was installed the open ends were covered with plastic to keep dust out of the HVAC system.

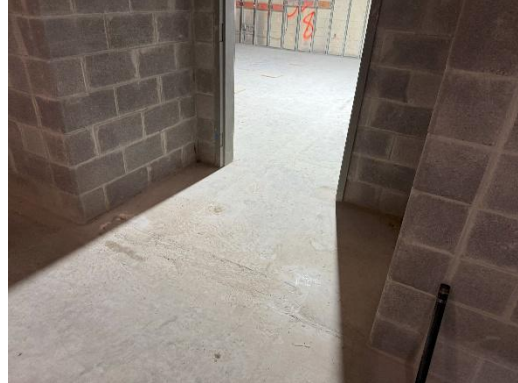
- q) Floor slabs at new door openings on the second floor were filled with concrete. Floor prep will be required, but these areas appear to be properly prepared to receive floor finish.

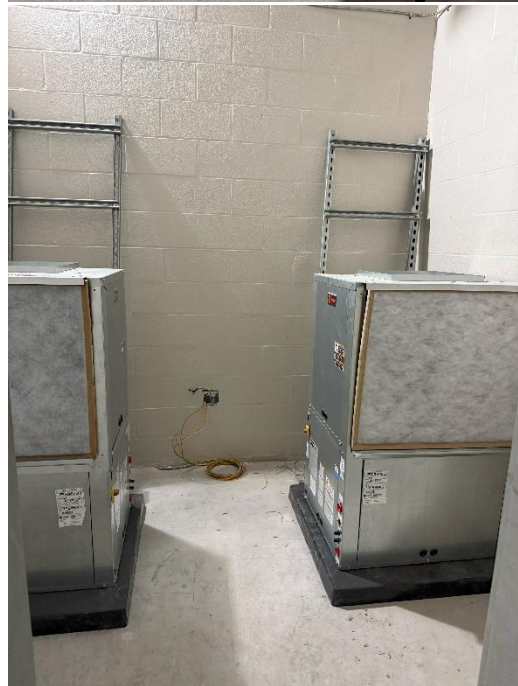
- r) Heat pumps and piping racks were being placed in the mechanical closets.
