FIELD OBSERVATION REPORT

West Hardin Middle School, 202280 -CA8

Date: 5/7/2025 Time: 12:30 PM

Report No: 10

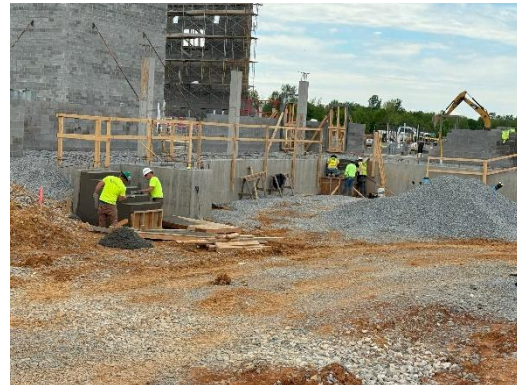
- a) The concrete steps at the loading dock area were poured and the forms were removed. The concrete was being rubbed for the exposed finish.

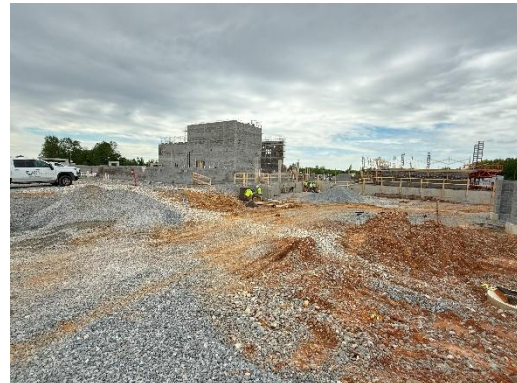
- b) CMUs were being laid for the Gym/Storm Shelter. The walls appear to be nearing roof joist bearing elevations.

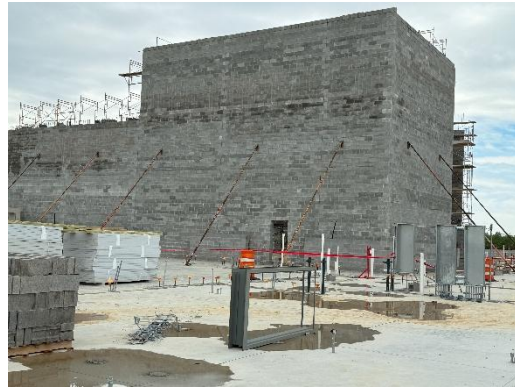
- c) The masons had added temporary bracing to support the walls while they are exposed to the elements and do not have all structural components in place to brace the walls.

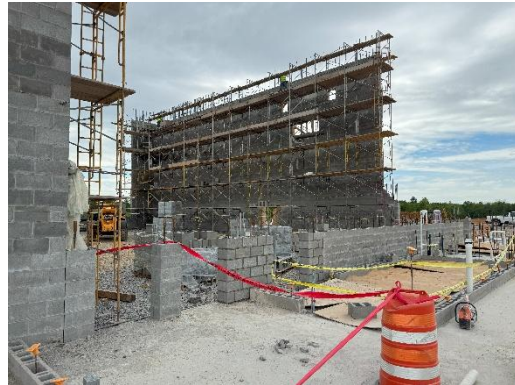
- d) The lower wall appeared to be rebuilt after the inspection determined that the placement of the vertical reinforcement was not properly located in the cells of the CMUs.

The other walls have been inspected and appeared to be properly reinforced.

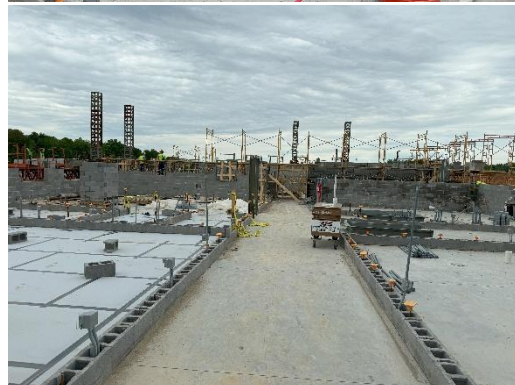
- e) The one-story western area was being built starting in the Band Room.

Floor slabs that will be polished were covered with Skudo protection board.

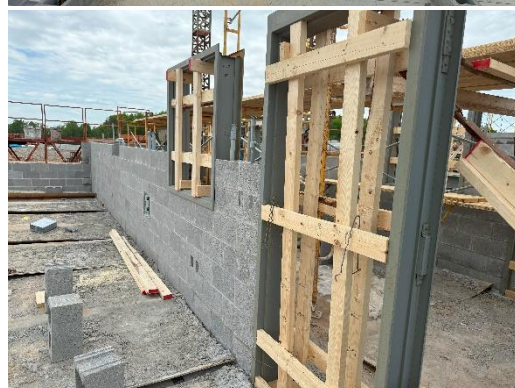
- f) Door frames were extensively braced to prevent racking and bowing.

Door frames are susceptible to damage from the trades driving through the openings on lifts.

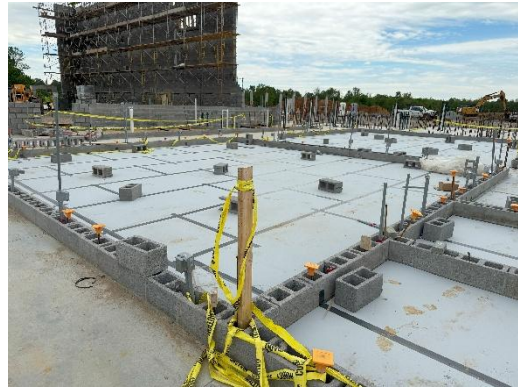
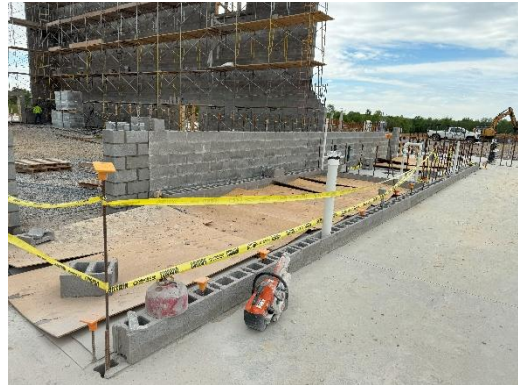
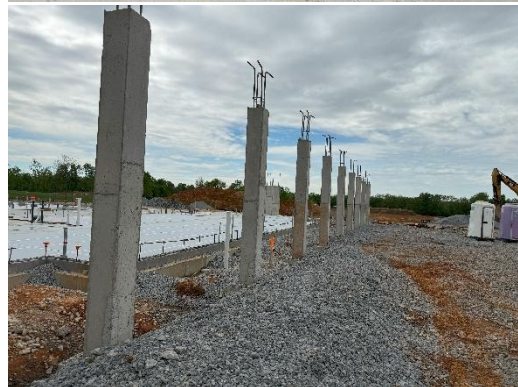
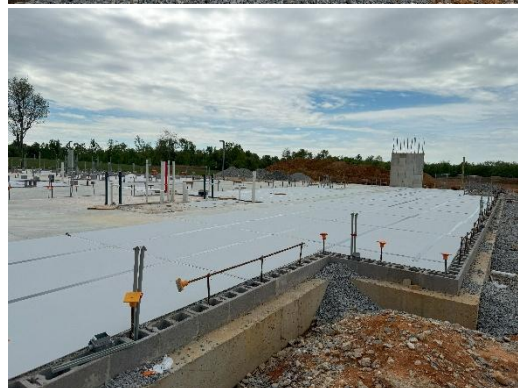
- g) The Skudo system was being held in place with CMUs placed on top of the board.
- h) Another method of protecting the Skudo system was to cover it with plywood. In this case, the plywood was significantly warped.
- i) The concrete columns outside of the administrative area had been poured.
- j) The concrete slab for the administrative area was in place.

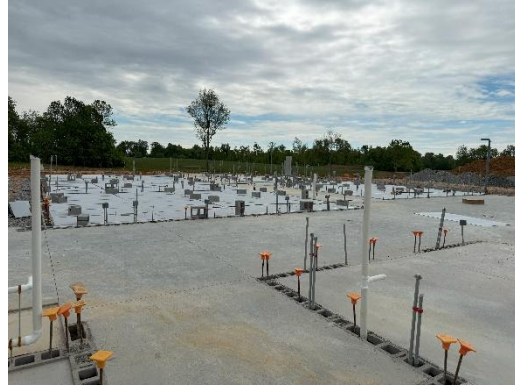
- k) Most of the slabs in the classroom areas will be polished and were covered with Skudo board.

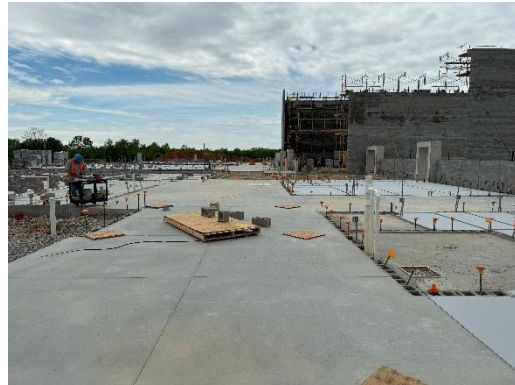
- l) The central north-south corridor will have resilient tiles covering it. Skudo board is not required in this area.

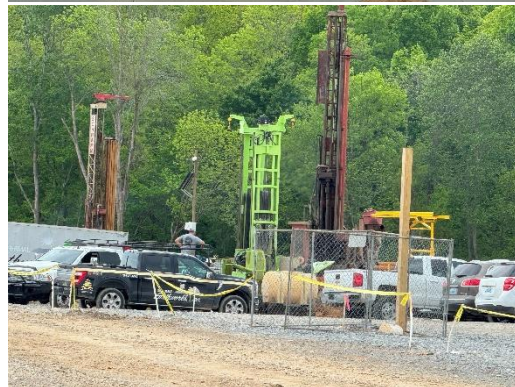
- m) Drilling for the geothermal well field continues. Piping is placed in the wells and wells are back filled. Due to the conditions of the underlying soils and rock, casings were being installed in the wells.
