FIELD OBSERVATION REPORT #11

2025-05 - New Board Office

■ TO:	Kenton County Board of Education 1055 Eaton Drive Ft. Wright, KY 41017	■ DATE:	2025.05.20
ATTENTION:	Mr. Kevin Pfefferman		
■ FROM:	Mark Perry mperry@embosssdesign.com 906 Monmouth Street Newport, KY 41071 V: 859.431.8612 • D: 859.578.6013	■ PROJECT:	New Board Office KCSD BG#24-084
COPIES TO:	Mr. Matt Rigg; Mrs. Carrie Hooten, Mr. Brian Vanover	PROJECT NO.:	22-106

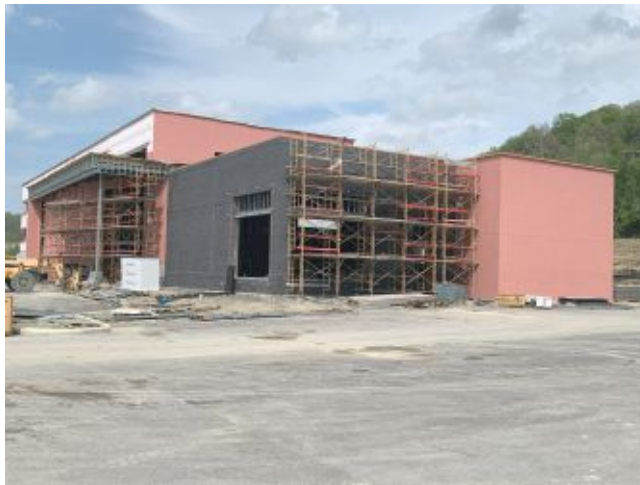
2025.04.29 – Exterior from southwest

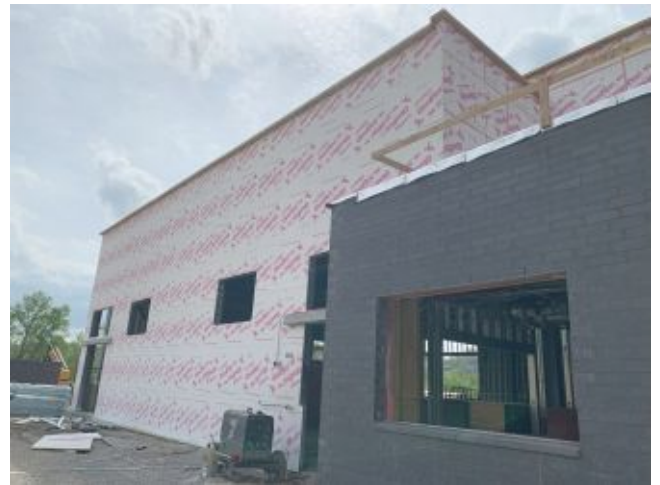
2025.04.29 – Exterior of board room from east

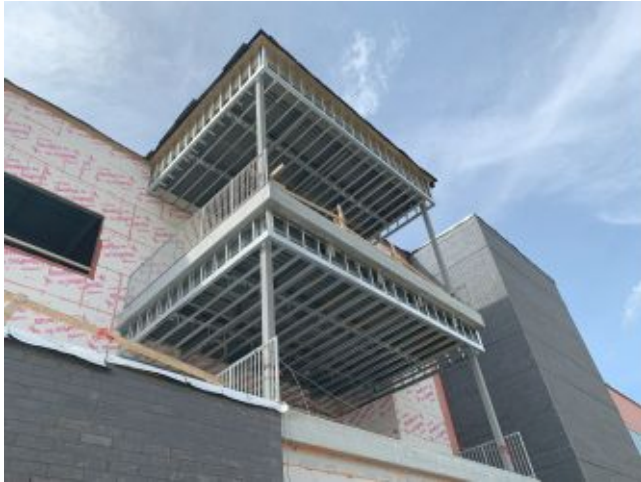
2025.04.29 – Exterior patios at second and third floors

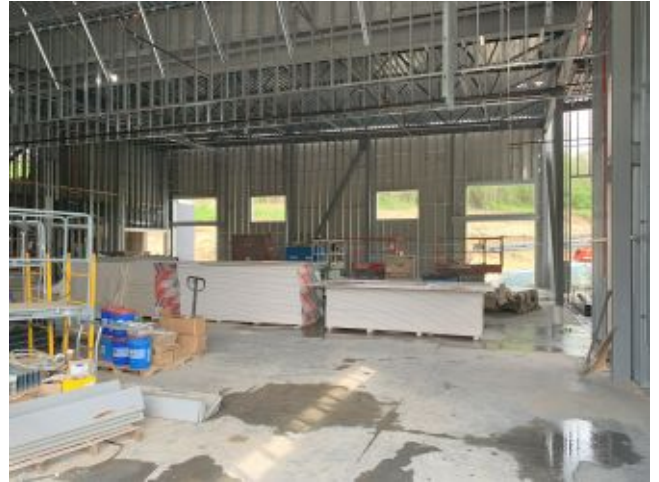
2025.04.29 – Board room looking east

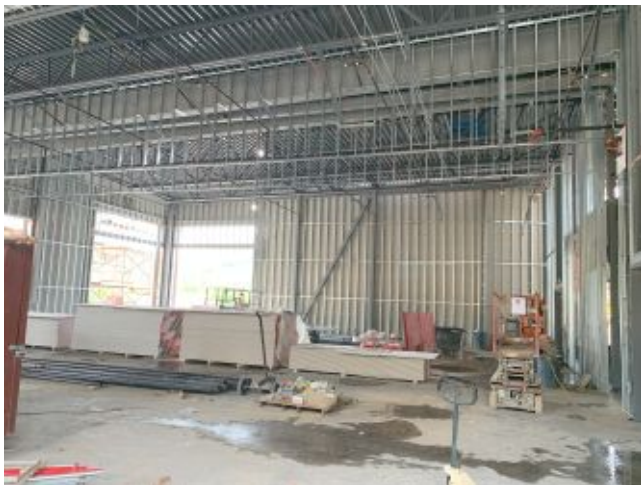
2025.04.29 – Board room looking west

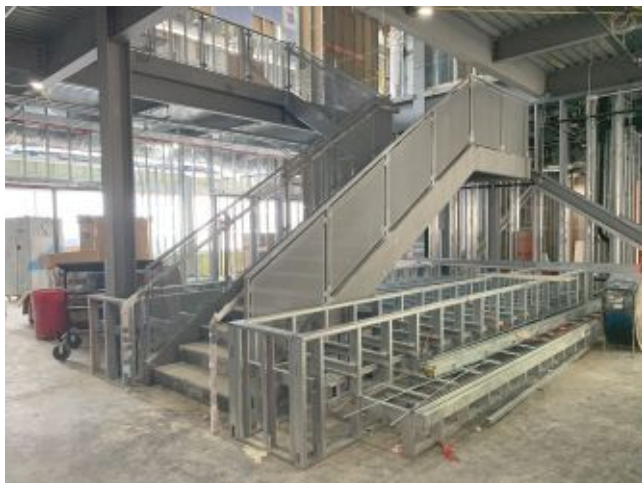
05.02: 2025.04.29 – The decorative railing at the open stair had been installed. Several issues were discussed. Guardrails had been installed at exterior patios except where omitted for material deliveries.

2025.04.29 – Monumental stair

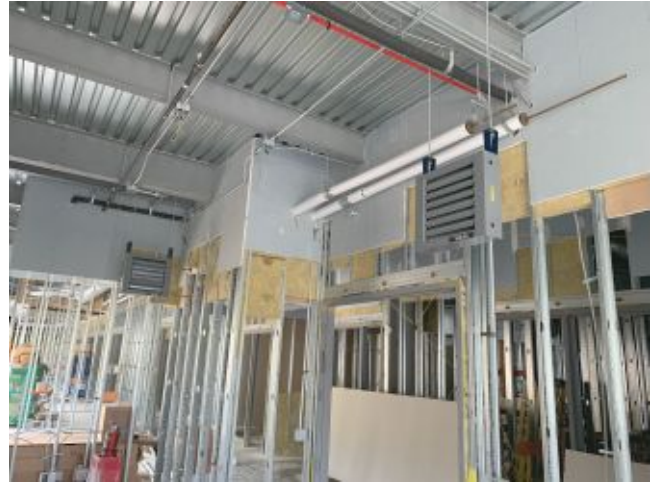
20-28.02: 2025.04.29 – Unit heaters had been installed in Receiving #150.

2025.04.29 – Receiving #150

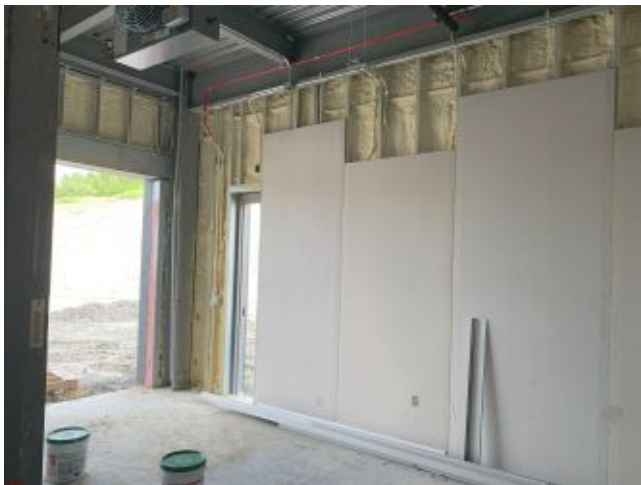
2025.04.29 – Receiving #150

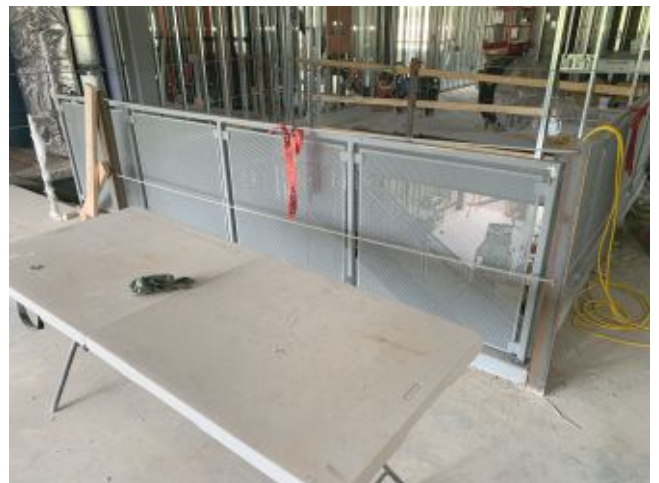
2025.04.29 – Monumental stair – second floor guardrail

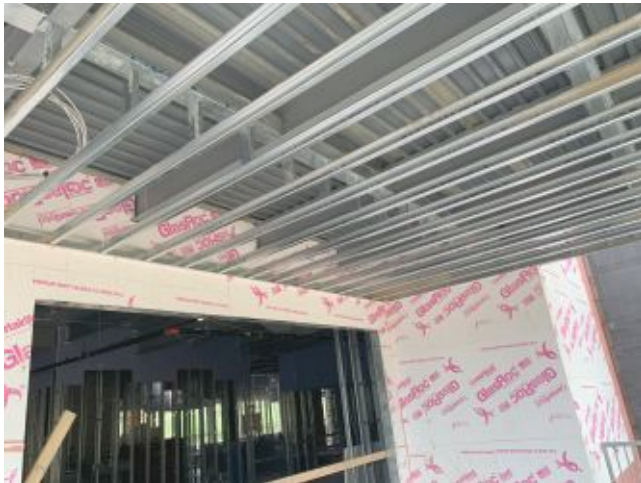
2025.04.29 – Patio #252

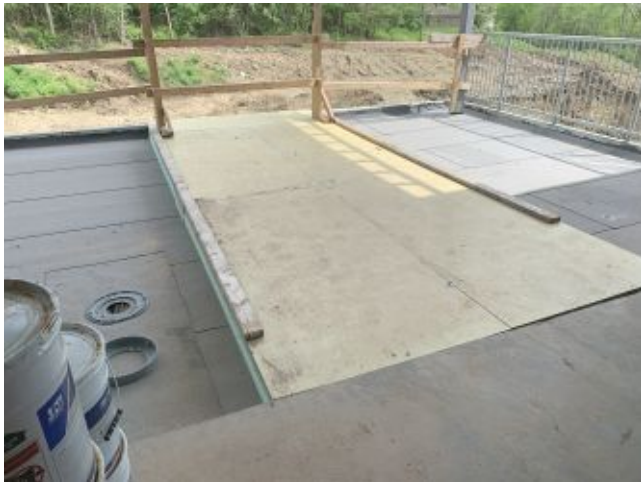
2025.04.29 – Patio #358

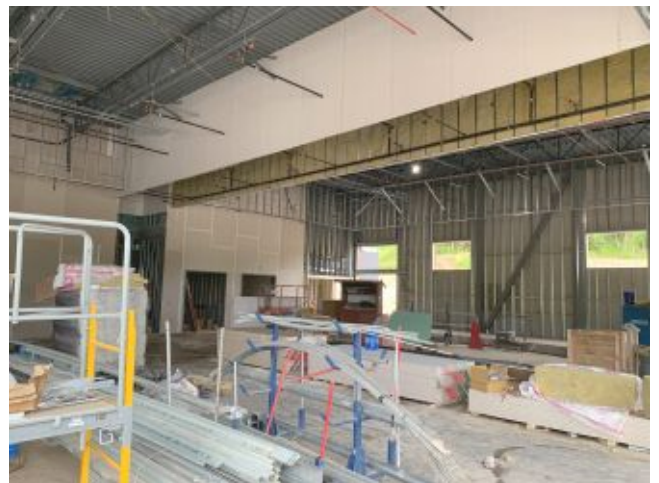
09.02: 2025.05.13 – Interior gypsum board was being hung in the board room and had progressed at the first floor. The GC was advised to keep an eye on water intrusion resulting in water damage as the envelope was not weather tight.

2025.05.13 – Board room looking northeast

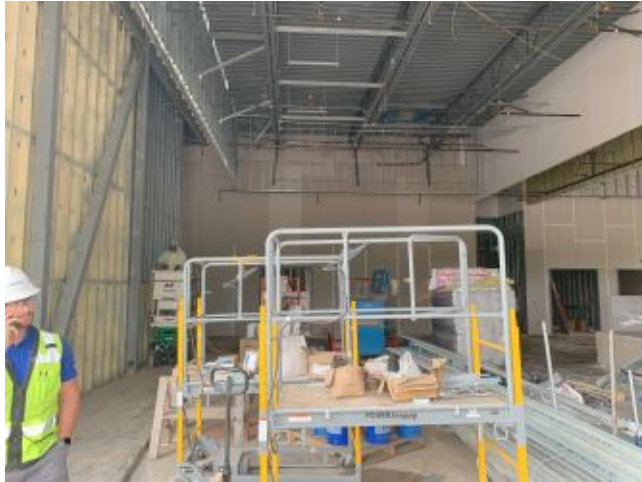
2025.05.13 – Board room looking north

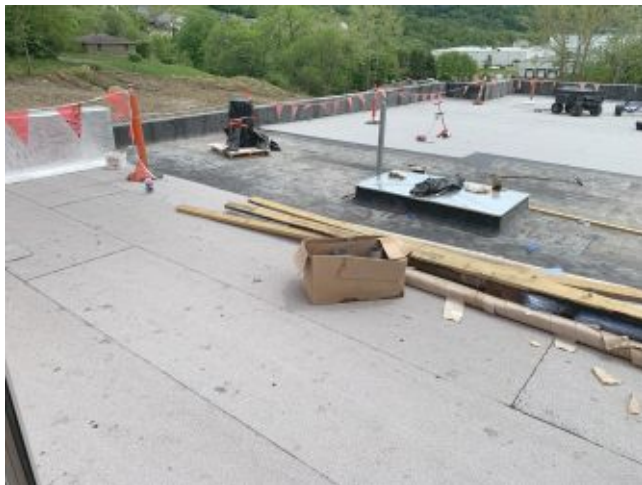
07.03: 2025.05.13 – Air barrier installation was complete except Area A (east).

2025.05.13 – Roof over Area A

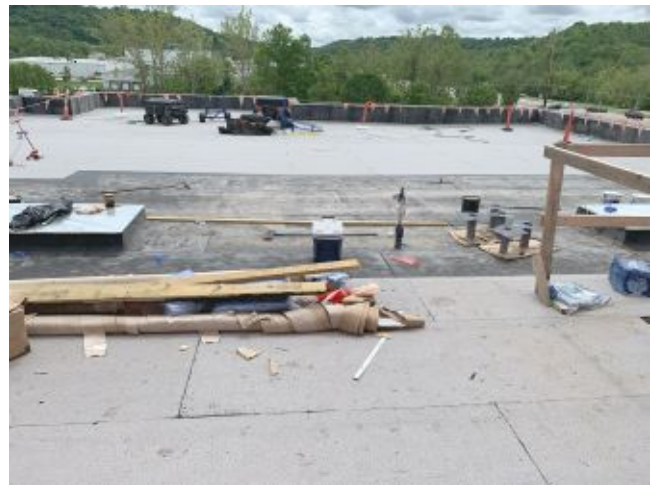
2025.05.13 – Roof over Area A

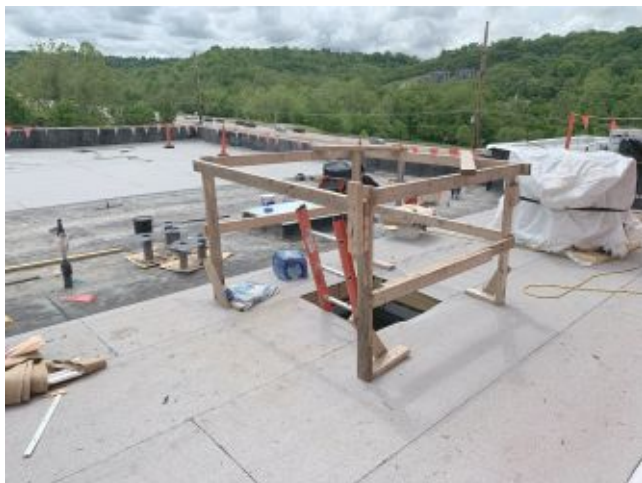
2025.05.13 – Roof over Area A
