MOLD SCREENING AND PROTOCOL REPORT

Anchorage Public School 11400 Ridge Rd, Louisville, KY 40223 Project # 25-0284-32

Survey Date: May 27, 2025

Report Date: June 4, 2025

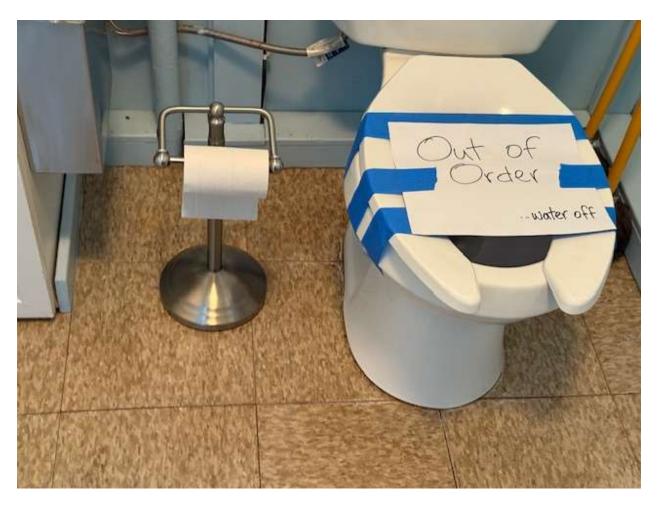
- It was reported that the toilet had water leaks in Room 201 and was discovered in May 2025.
- The area around the toilet has evidence of water damage. Staining was present on baseboards and floor tiles were losing adhesion to the subfloor.

The area from which the leak originated. Some water staining is present around the toilet and around edges of the floor tiles.

Crawlspace and Room 201 – Remove affected flooring (floor tile, etc.) and affected drywall and wood, inspect the subfloor or structural integrity – Replace if needed. Remove standing water from crawlspace. Disinfect the areas. Non-porous surfaces can be cleaned.

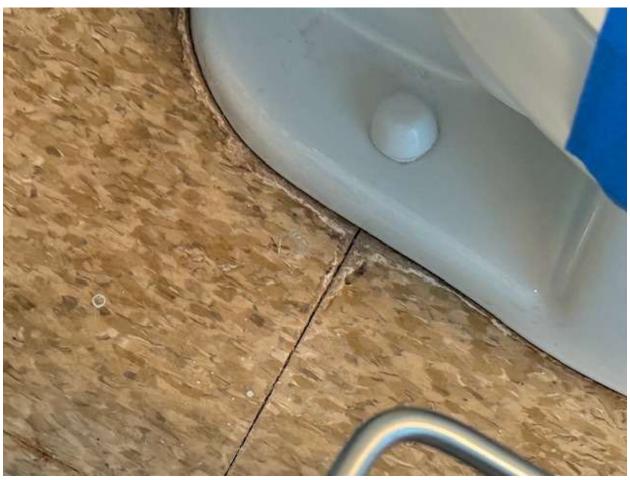
Water staining around the toilet.

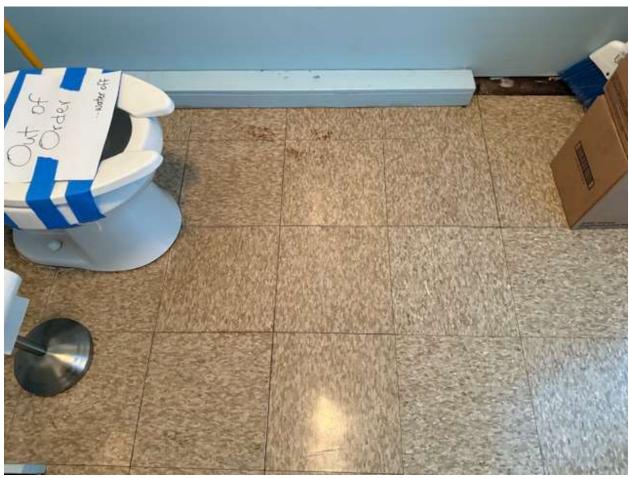
The affected area.

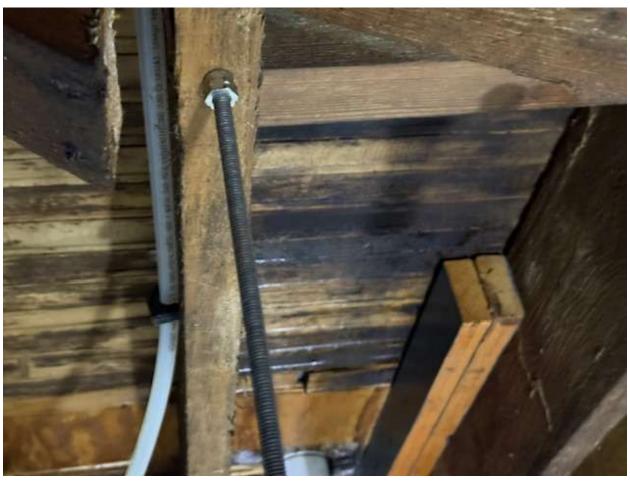
- The subfloor had some flexing and instability indicating a prolonged water leak.
- The underside of the subfloor was discolored when viewed from the crawlspace. Mold growth was observed from the crawlspace. Pooling water was present above the vapor barrier under the water leak.

Underside of the subfloor of the affected area. Water staining and mold growth are present.

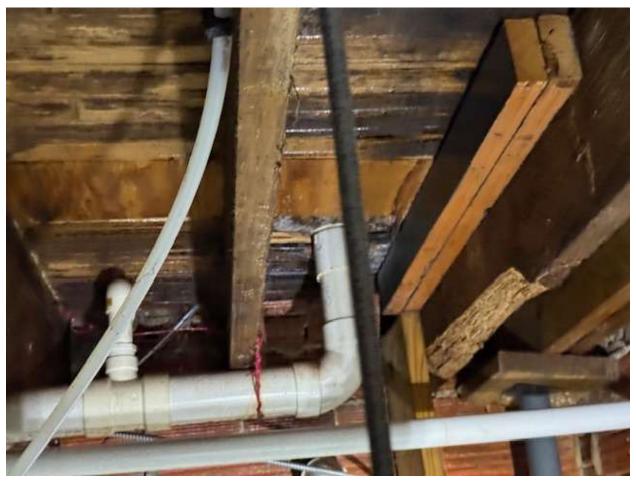
Underside of the subfloor. Water staining and mold growth are present.

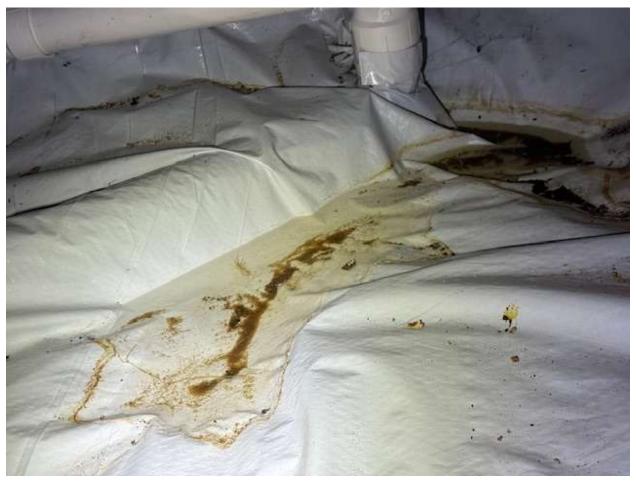
Standing water in the crawlspace under the affected area.

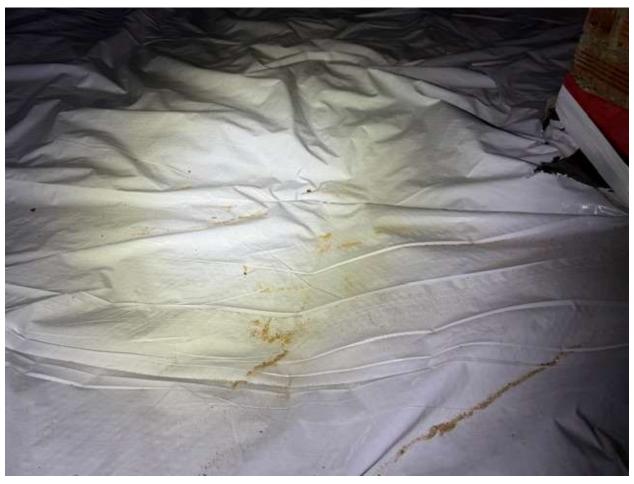
- In the middle of the crawlspace, there was pooling water under the vapor barrier. The slope of the soils under the vapor barrier do not allow for water coming from the known water leak to reach where the water under the vapor barrier is located by ground movement. There could be a second source of moisture in the crawlspace. An inspection during heavy rain is recommended to see if water is coming in from heavy rain or if there is an internal leak. No moisture on walls or joists was detected other than the area of the known leak at the time of inspection. It is possible the water from the known leak flowed along the above subfloor floor and was deposited in the middle of the crawlspace. It is recommended to fix the known leak of the toilet, remove any water in the crawlspace, occasionally inspect the crawlspace for additional water, determine if the known leak of the toilet is the source of the water in the center of the crawlspace, if the water returns after the remediation of the known leak.

Area of standing water under the vapor barrier. Near center most brick column. From the entrance to the crawlspace move to the back of the crawlspace 15ft, facing the rear wall move to the left 5 feet standing water is present there under the vapor barrier.
