Inspection Report

Powell County Schools Powell County Middle School 770 W College Ave Stanton, KY 40380

Site Overview

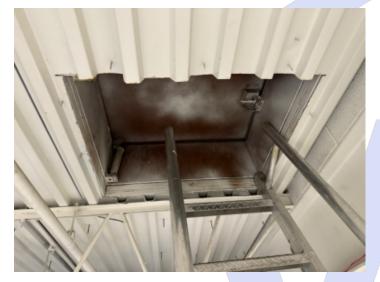
Metal Deck

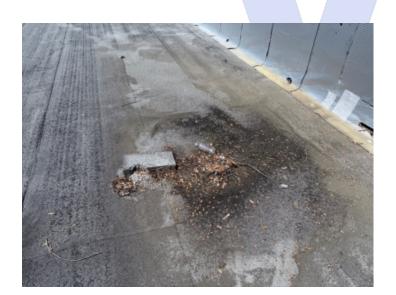
Existing Drain Clogged

The clogging of this drain could lead to leaks and unnecessary water buildup. This could lead to weight over burden on the structure.

We cleaned the drain while we were on site. However, we recommend putting a maintenance program together that will address the drains.

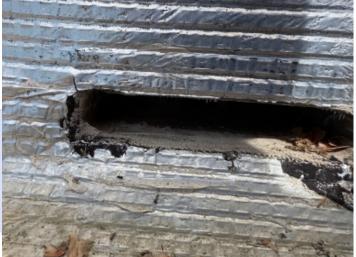
Small Overflow Scuppers

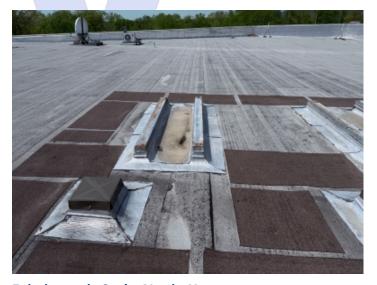
Existing unit Curbs Not in Use

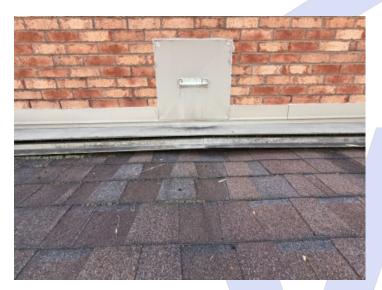
Scupper & Ventilated Headwall Flashing

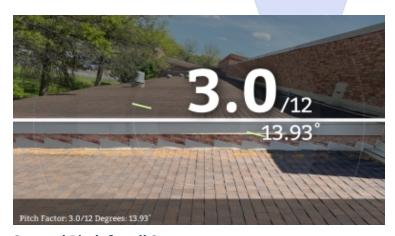
Stanard Pitch for all Structures

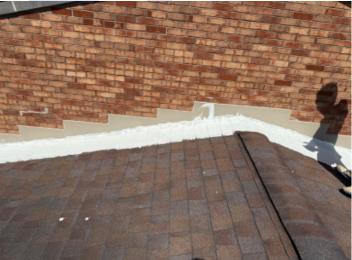
Improper Repairs

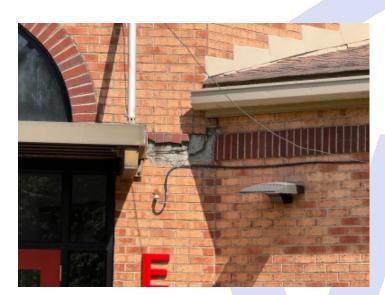
Masonry Cracking
