Inspection Report

Powell County Schools
Powell County High School
700 W College Ave
Stanton, KY 40380

Site Overview

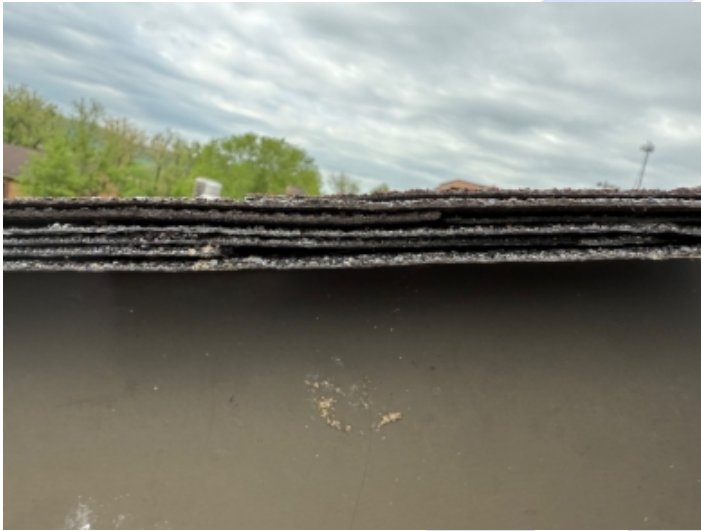
Multiple Layers of Shingle on Existing Structure

The current roof system has two layers of shingle on it. We recommend a full tear off of the existing roof and a replacement with either standing seam or shingles.

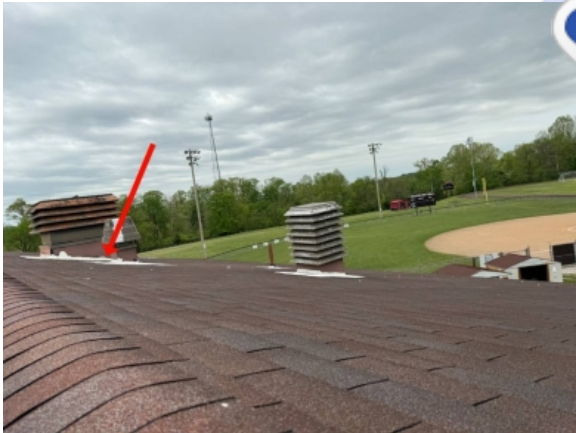
1

Improper Shingle Repairs

The current coating repairs around the penetrations will fail in time.

Replace roof.

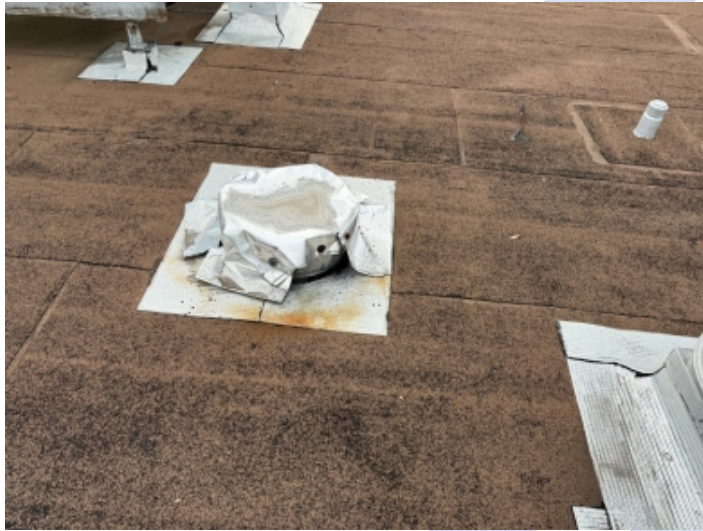
Improper Flashing

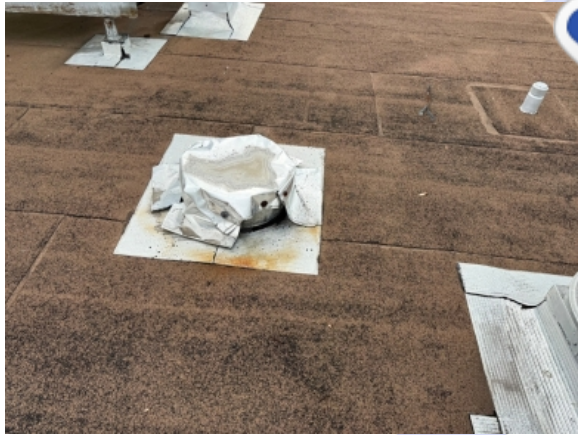
1

Improper Flashing (Emergency)

This flashing is not sealed properly and is not using appropriate materials.

During roof project remove this penetration flashing and patch deck.

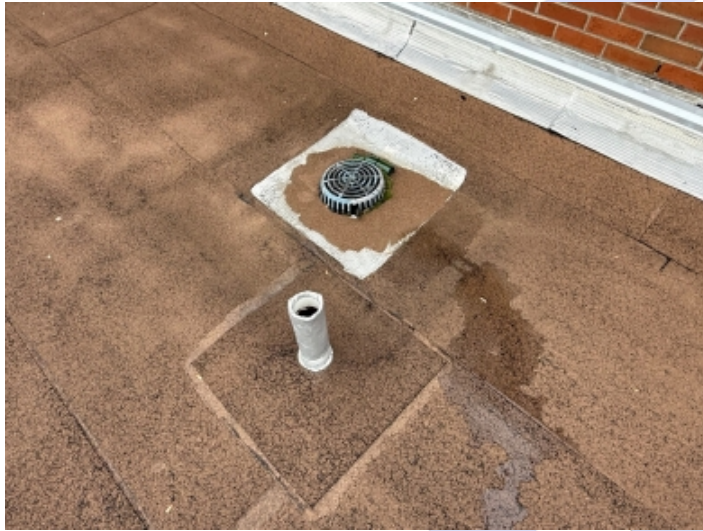
Debris & Granules in Drain Area

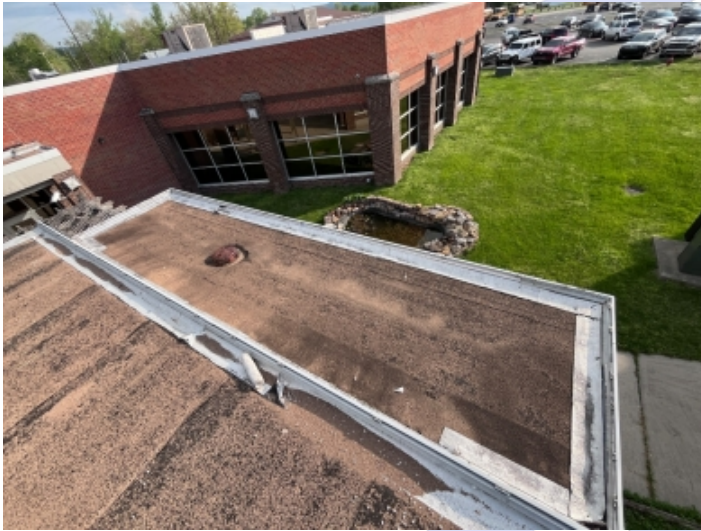
Small Roof Adjacent to this Section

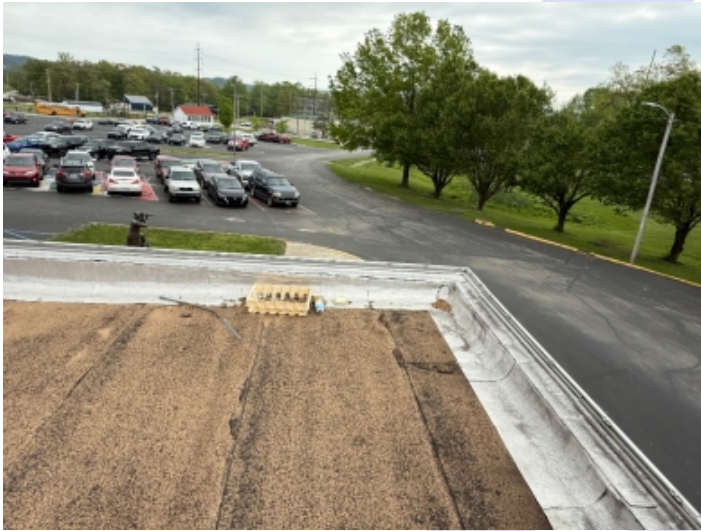
Debris on Roof

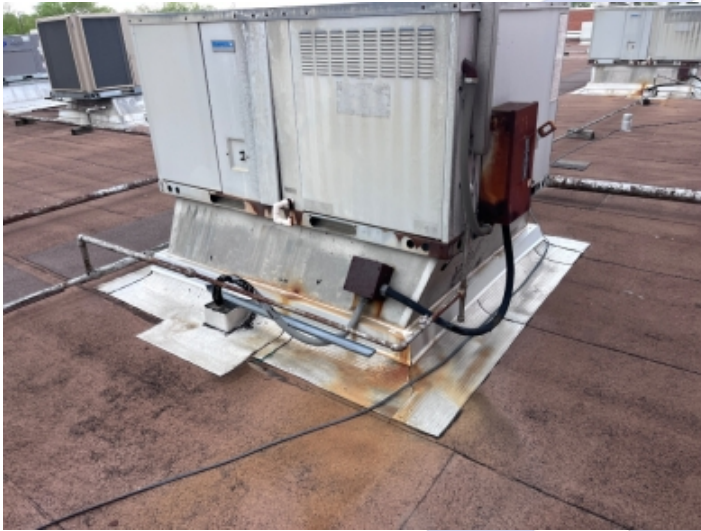
Existing Unit Curb Condition

Most of the units on this section are mounted on curbs that need to be addressed by an HVAC contractor. Some of curbs could be contributing to existing leaks.

This roofing area has a significant amount of rooftop mounted equipment. We recommend that the rooftop equipment at this location be inspected and sealed by a qualified HVAC contractor in conjunction with the roof replacement. Otherwise, this roofing area is a suitable candidate for an overlay and did not show signs of significant moisture infiltration.

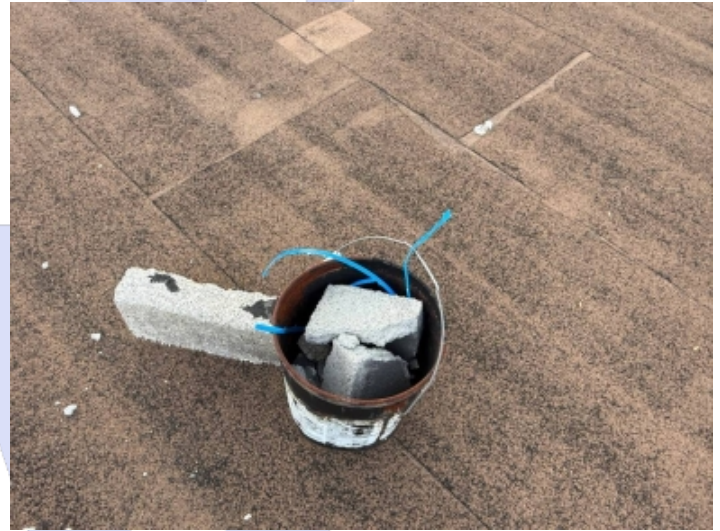
Debris on Roof

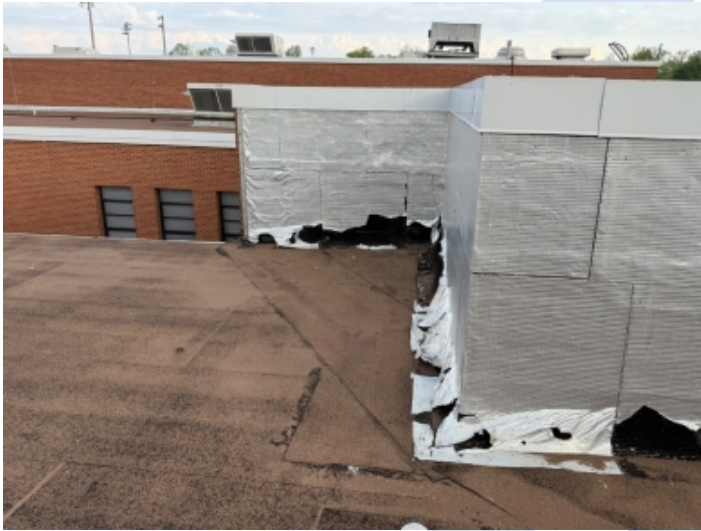
Wall Flashing Degradation
