## FIELD OBSERVATION REPORT

Food Service Building, 202276 -CA8

Date: 6/12/2025 Time: 5:30 PM

Report No: 9

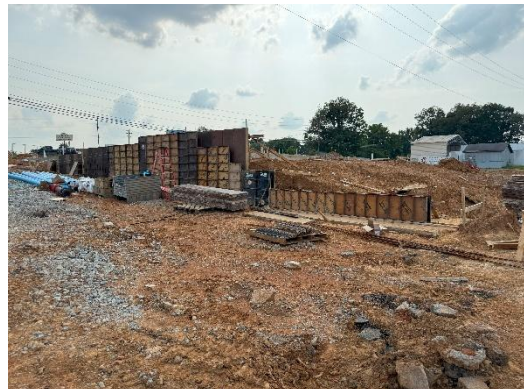
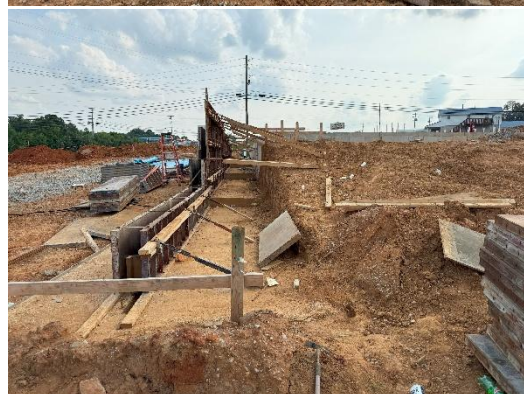
- a) With the preceding dry days, the earth had dried allowing excavations and concrete pours to proceed. Much of the work thus far has been done in the mud slowing the work and making tasks more difficult.
- b) Forms for the retaining wall at the front parking lot were in place.

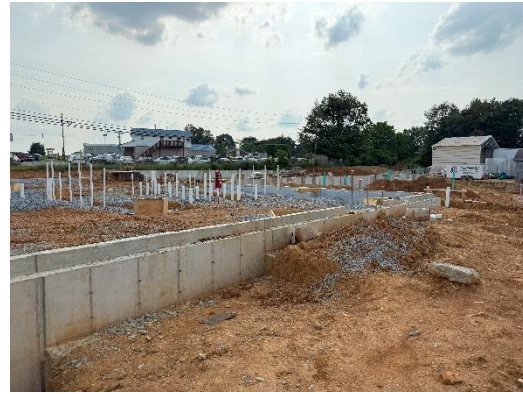
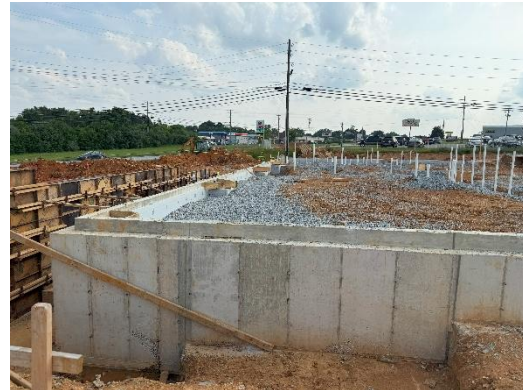
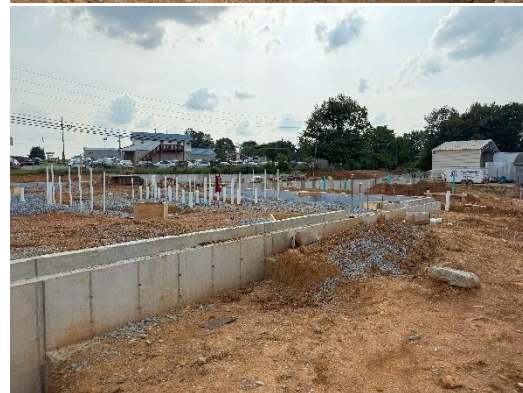
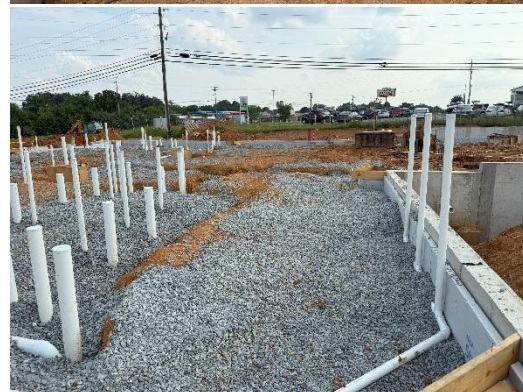
- c) Forms had been removed from the foundation walls around the office area.

- d) Crushed stone was used to back-fill along the interior of the foundation walls.

- e) It appeared that most of the under-slab plumbing piping was in place in the office area.

- f) Rigid perimeter insulation was installed against the foundation walls and the area back filled with crushed stone.

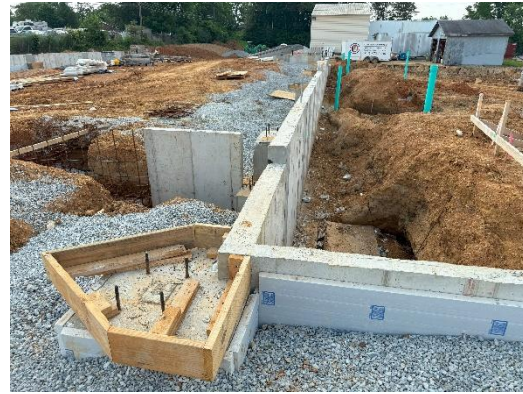
- g) Leave outs for steel column base plates were formed. The loading dock foundation wall was poured and the forms removed.

The foundation wall at the north side of the warehouse was not in place to allow access for equipment to reach the rest of the building.

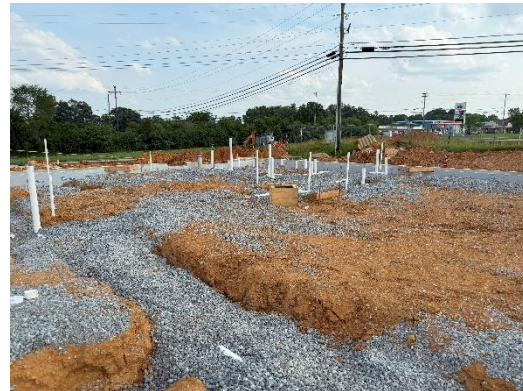
- h) Underslab utilities were installed and back filled with stone.

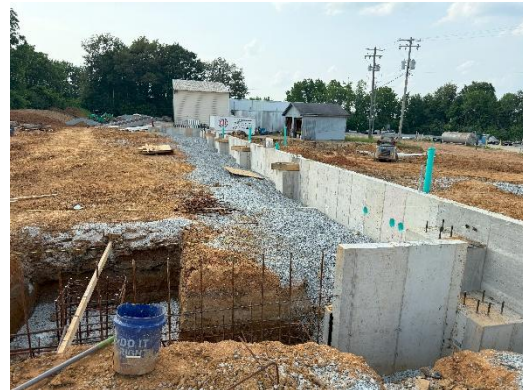
- i) Due to the depth of the footings at the loading dock wall, a considerable amount of fill is required.

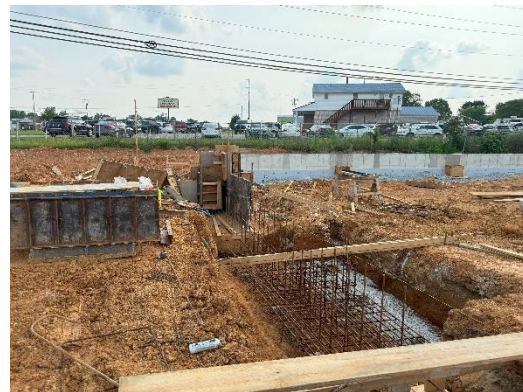
- j) The foundation between the office area and the warehouse was being prepared with the steel reinforcing being placed. Construction of this foundation was delayed until the rest of the under-slab work was in place to allow construction equipment access to the office area.

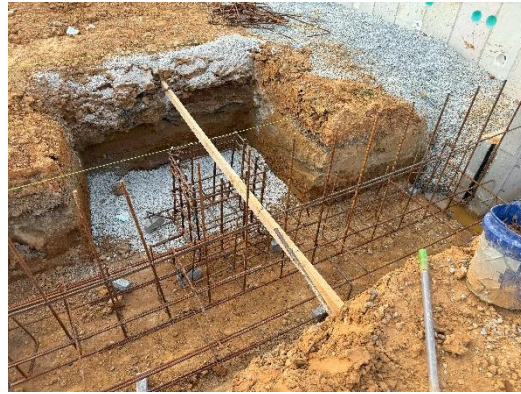
- k) Steel reinforcement was in place for the foundation supporting the columns in the warehouse.

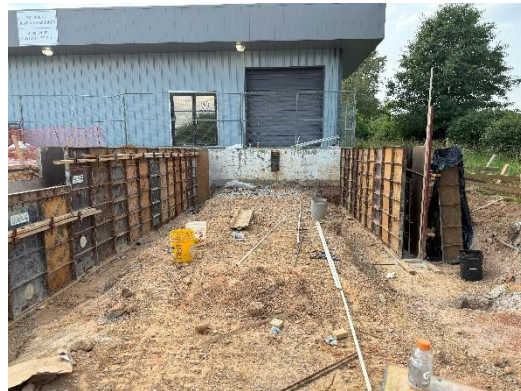
- l) Forms were in place for the retaining walls at the maintenance building loading dock. The soils around the footings and wall appeared to be stable.
