FIELD OBSERVATION REPORT

West Hardin Middle School, 202280 -CA8

Date: 6/12/2025 Time: 4:30 PM

Report No: 13

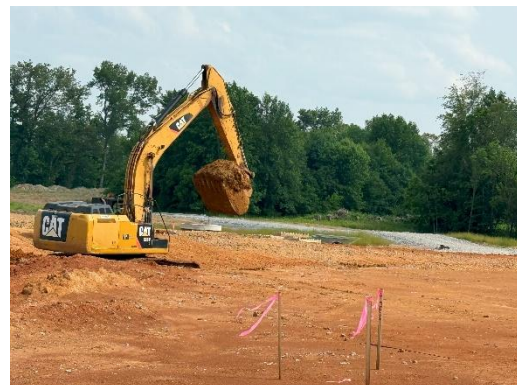
- a) Grading was underway in the football field area.

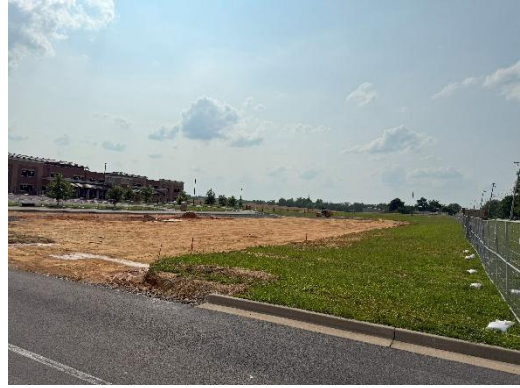
- b) Grading has been done for the new parking lot in front of Cecilia Valley Elementary School.

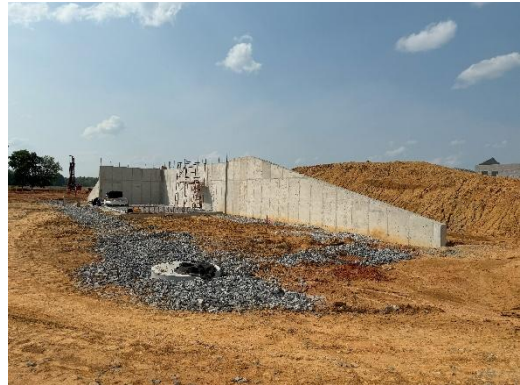
- c) The retaining wall and foundation for the concession building had been poured.

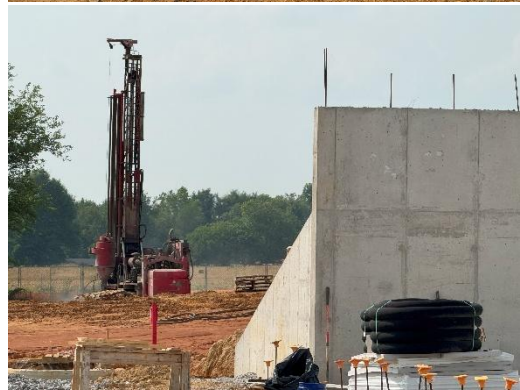
- d) The geothermal contractor was drilling geothermal wells.

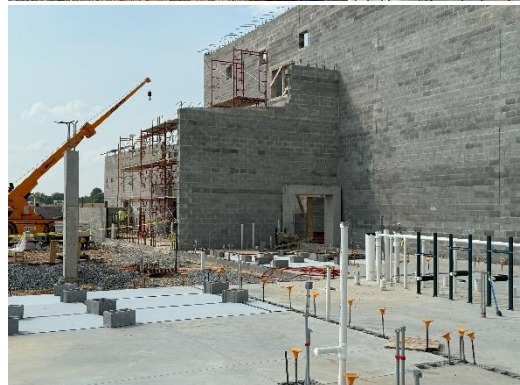
- e) The CMU walls at the west side of Area D were topped out.

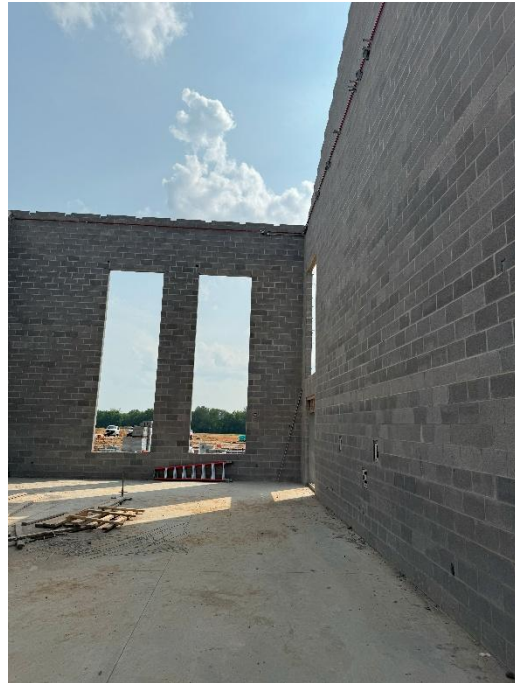
- f) The CMU walls around the Band Room were topped out. This large room has a high ceiling thus the need for the taller walls.

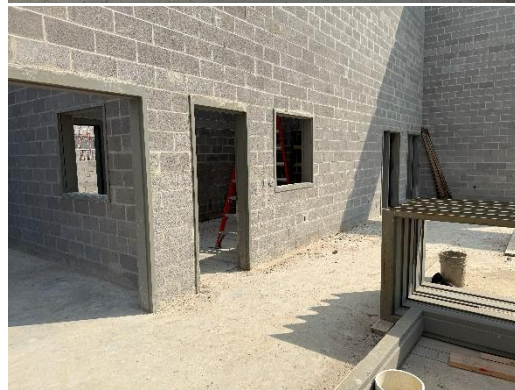
- g) Interior walls for rooms off the Band Room, including the practice rooms and office were laid, and the door and window frames were installed.

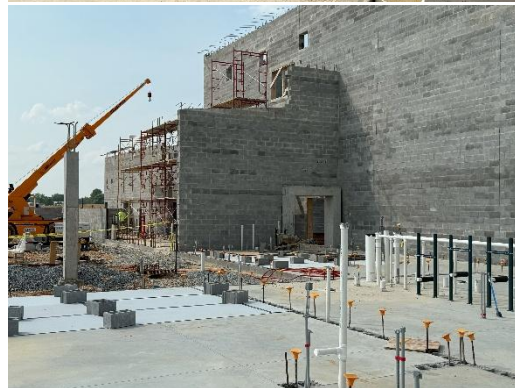
- h) Area D was being extended around the higher Gym walls.

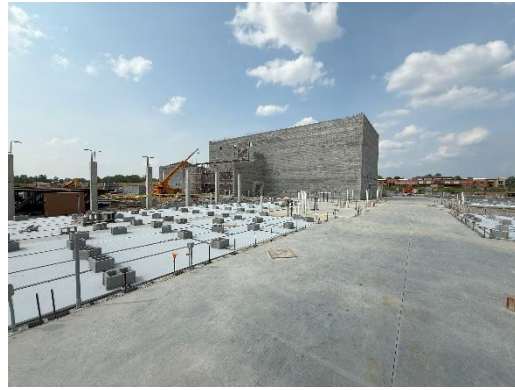
- i) Looking from the south side of the building at the entrance lobby and administrative area to Area D, the Gym walls are topped out. The blockwork is confined to the Gym and Area D currently.

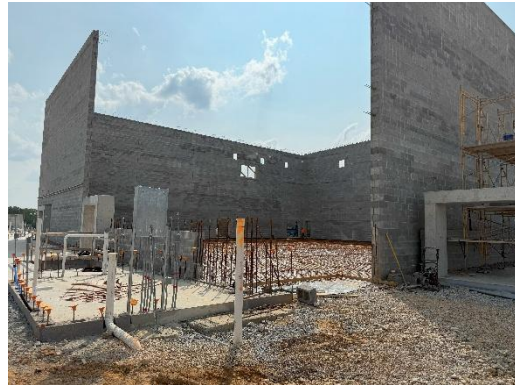
- j) The northeast corner of the Gym has been left open so that materials can be delivered into the Gym area.

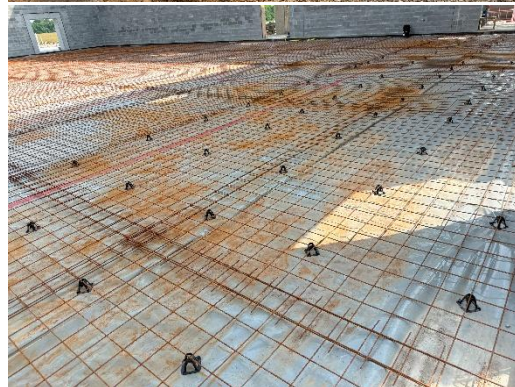
- k) Preparations had begun to prepare for the pouring of concrete for the subfloor for the wood gym floor. Welded wire mesh and the plastic vapor barrier were in place. Some of the supporting chairs were in place to hold the welded wire mesh in the center of the concrete slab where it is required to be to reduce the cracking of the slab.

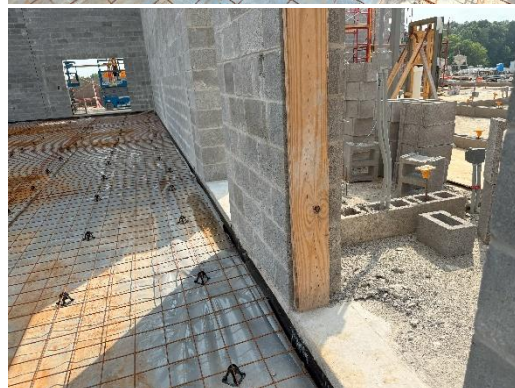
- l) Before the concrete is poured the vapor barrier is required to be taped to the block walls. This reduces moisture rising into the wood gym flooring system.

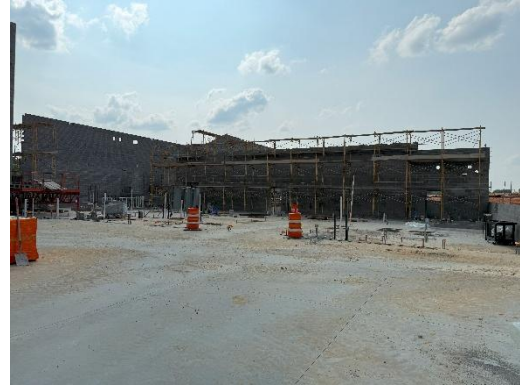
- m) Over the cafeteria area, the peaked end wall of Area D was above the other walls.

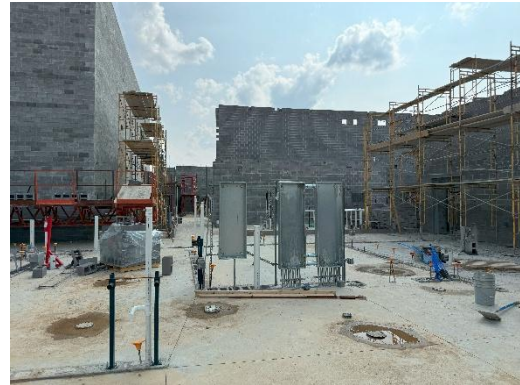
- n) In the kitchen area, above slab plumbing and electrical rough-ins were visible.

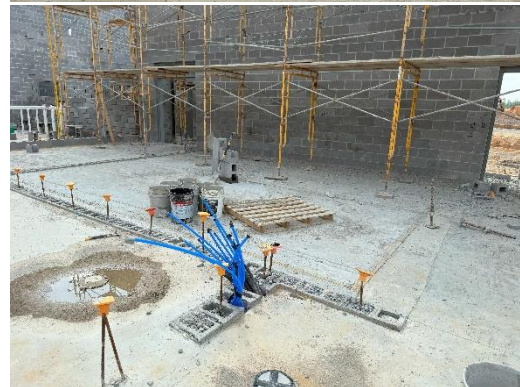
- o) It appeared that the insulated concrete slab was poured to form the base for the walk-in cooler and freezer off the Kitchen.

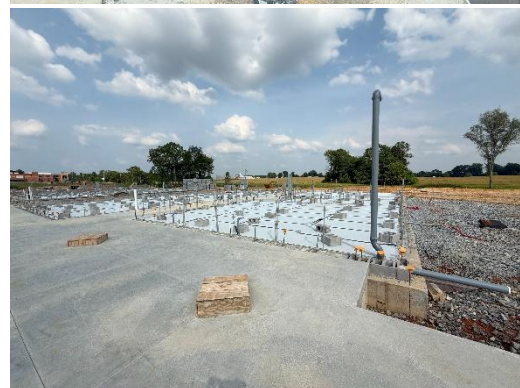
- p) Concrete slabs scheduled to be polished in the classroom areas were covered with protective Skudo board. The areas of the building where block walls were not being laid were being kept clean of mud and debris.

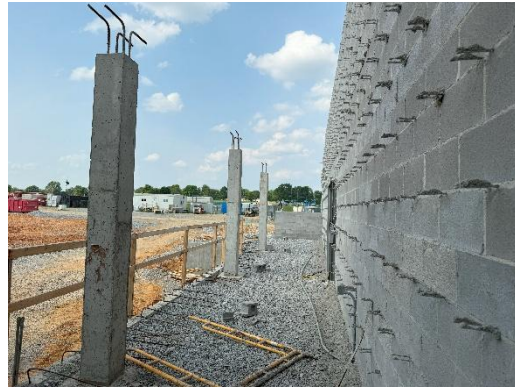
- q) The concrete columns on the loading dock at the Kitchen were poured. These will support the roof over the loading dock.
