FIELD OBSERVATION REPORT #12

2025-06 - New Board Office

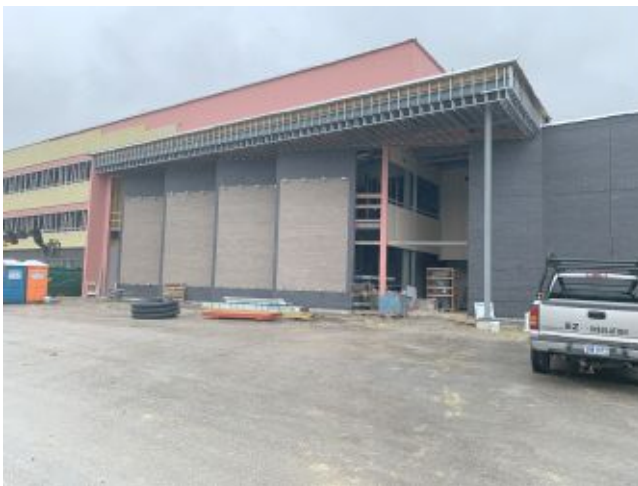
2025.05.27 – Exterior from southwest

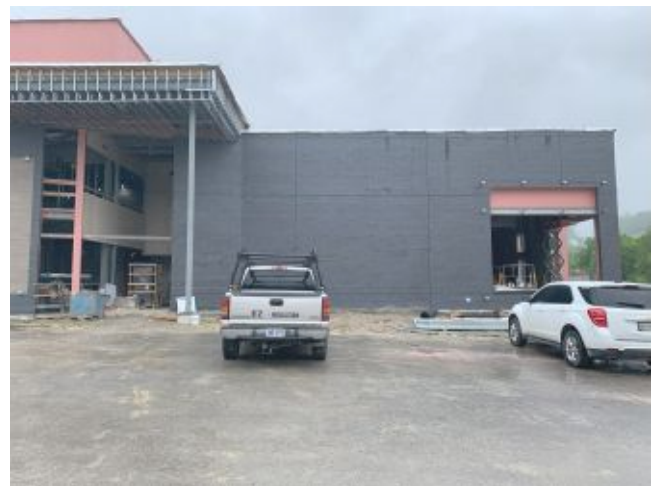
2025.05.27 – Exterior from southwest

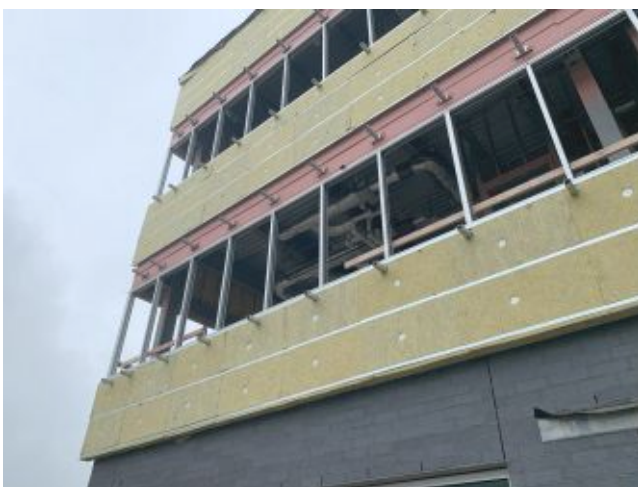
2025.05.27 – West elevation, north end

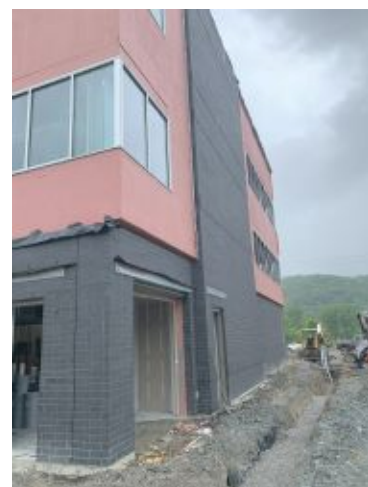
2025.05.27 – North elevation from northeast

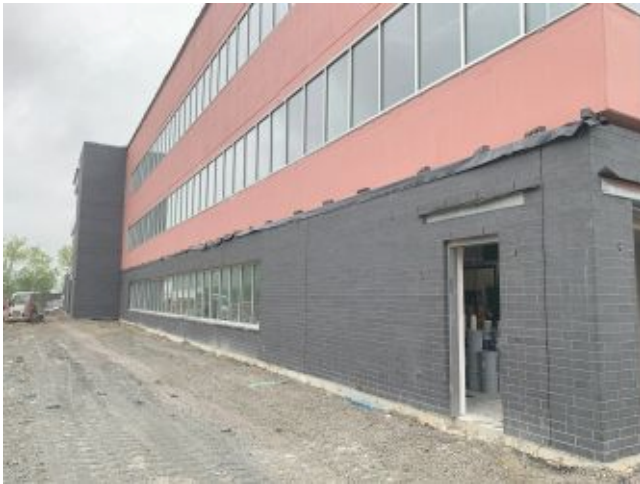
2025.05.27 – East elevation from northeast

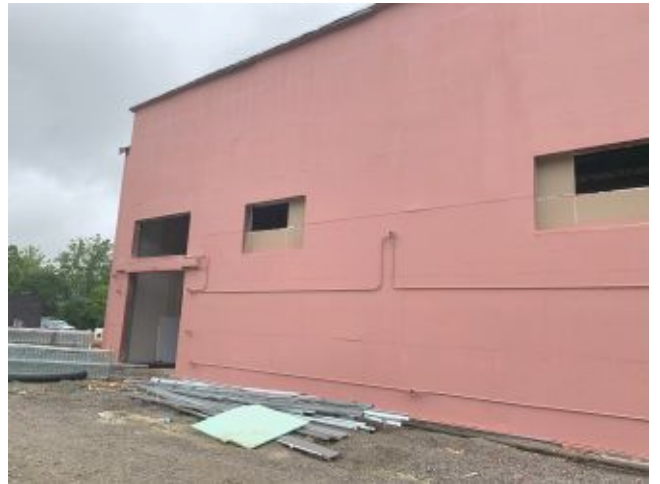
2025.05.27 – East elevation, south end

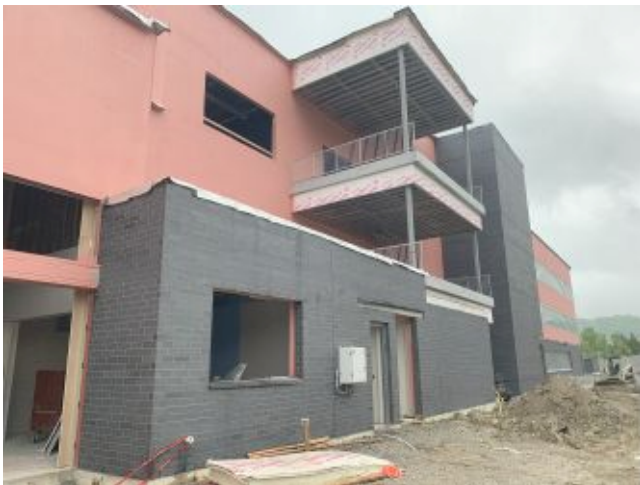
2025.05.27 – East elevation, south end

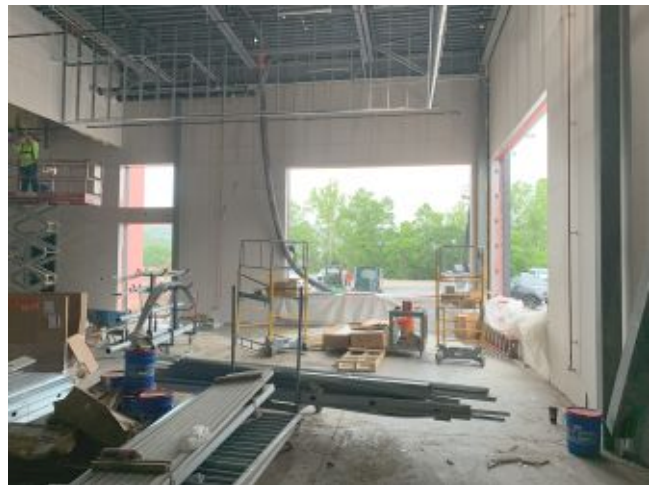
2025.05.27 – Southwest corner of board room

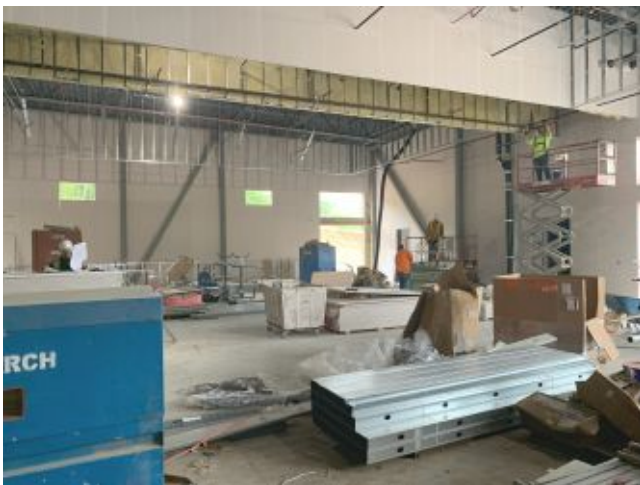
2025.05.27 – Southeast corner of board room

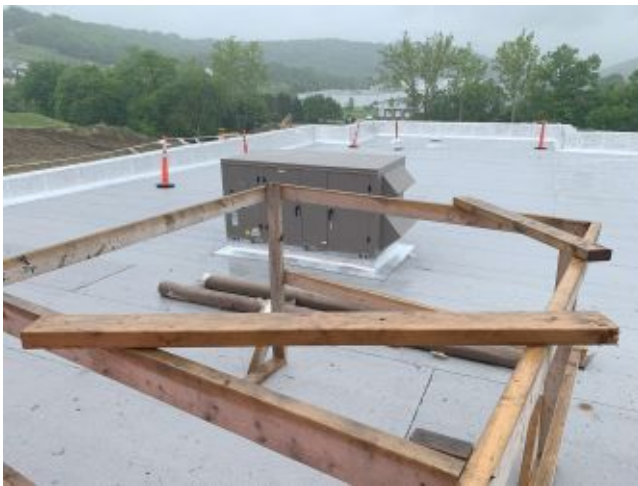
2025.05.27 – Roof over board room

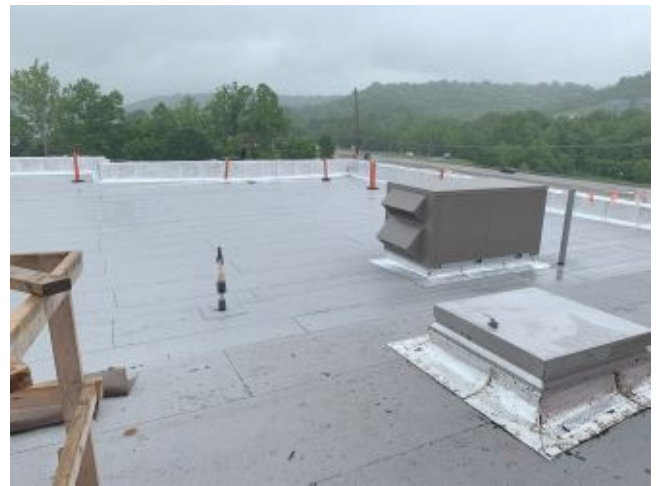
2025.05.27 – Roof over board room

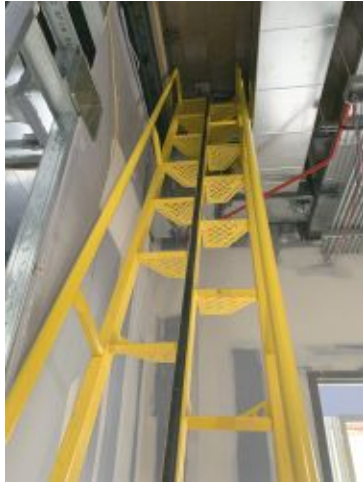
05.01: 2025.06.10 – Alternating tread ladder to roof from third floor had been installed.

2025.06.10 – Third floor roof ladder
