## FIELD OBSERVATION REPORT

Central Hardin High School – Phase 2, 2019111 -CA8

Date: 6/16/2025 Time: 9:30 AM

Report No: 24

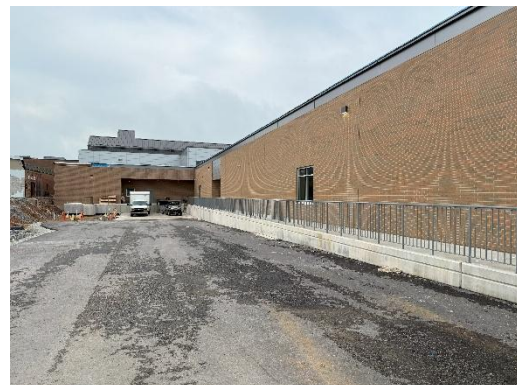
- a) We agreed that the exterior of Area D was not ready for a punch list inspection.

The metal copings at the parapet for Area E and D needs to be installed.

The steel railing along the walkway needs to be painted.

Sitework needs to be addressed.

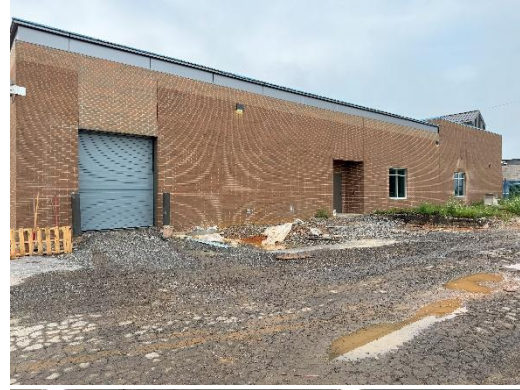
- b) The north elevation for Area D appeared to be mostly complete but needs some cleanup.
- The site in the area needs to be completed.

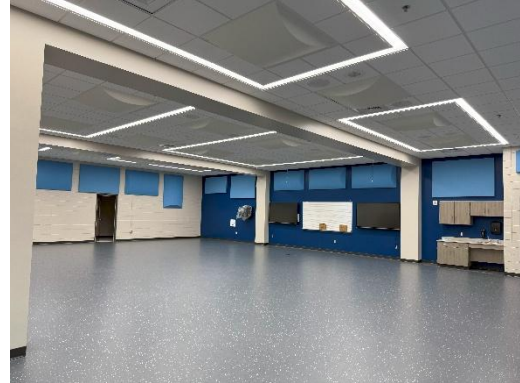
- c) The Band Room appeared to be mostly complete.
- The block walls, especially the existing ones, require detailing and repainting in several areas.

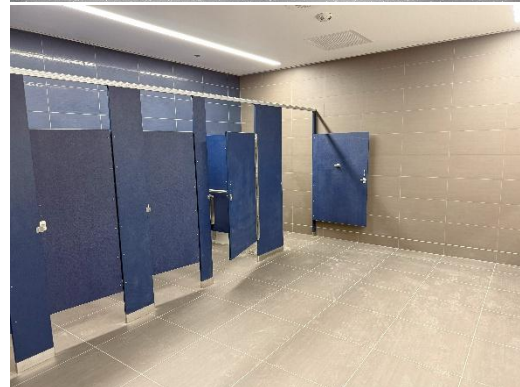
- d) The floor and wall tile installation has left a haze from the grout on most of the surfaces in the toilets. We agreed that this needs to be cleaned off all materials before the area can be punched. This also includes the tile at the electric water coolers in the corridors.

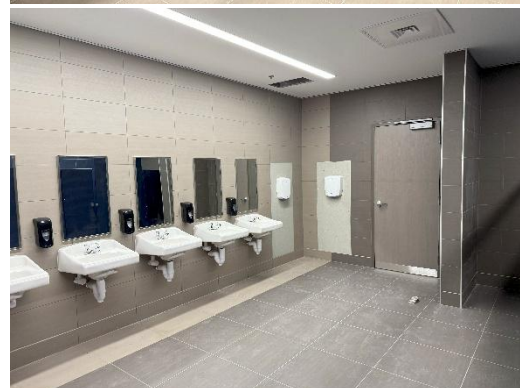
- e) The ceilings, lighting, plumbing fixtures and accessories were mostly complete. STW Engineers will inspect the HVAC, plumbing and electrical items.

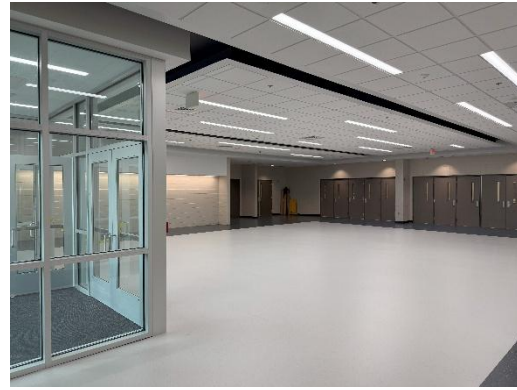
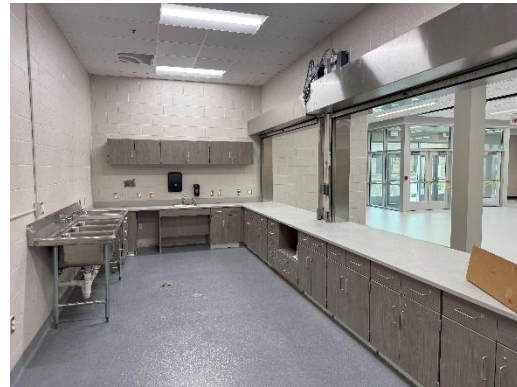
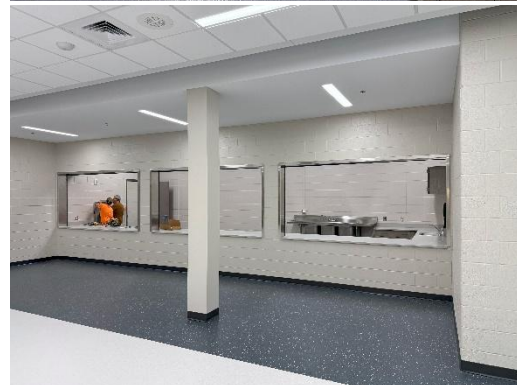
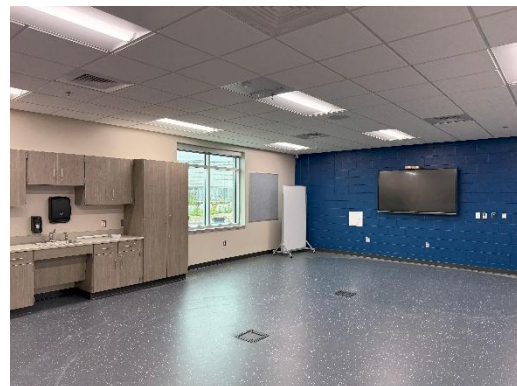
- i) The classrooms in the Ag area are nearing completion. Several of the walls had defects that need correction and repainting.

The floor, walls, ceilings, cabinets and accessories are installed.

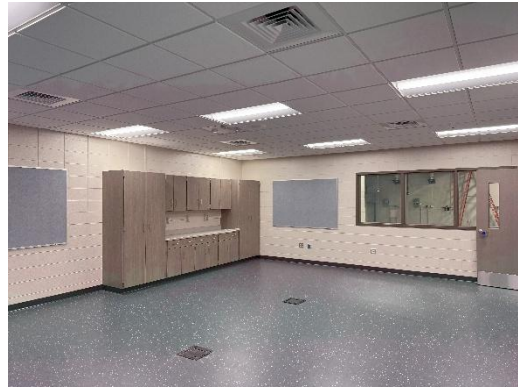
- j) The cabinets need a final cleaning.

Interior windows need to be cleaned.

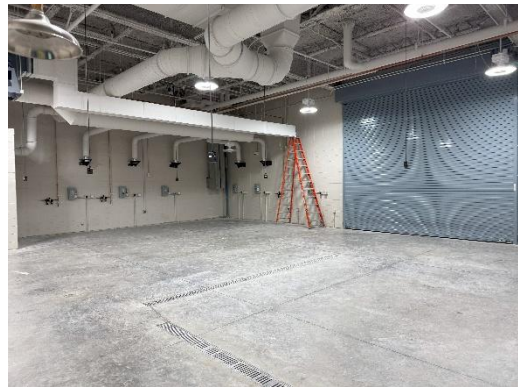
- k) The ceilings, casework, and floors were installed in the Ag Classrooms. The floors need to be sealed. A stain will be added to the floor sealer to make the floor uniform in appearance.

Jamey asked for the overhead doors to be checked to ensure that there were no air/water leaks around the edges.

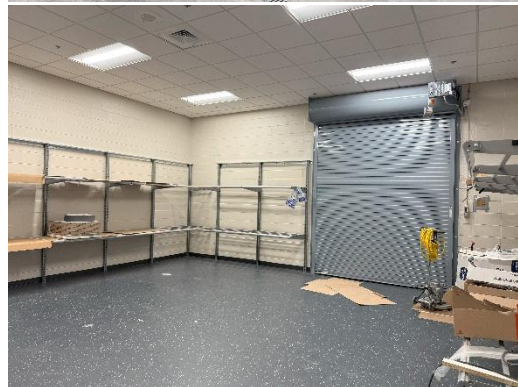
- l) The floor condition under the overhead door needs to be addressed. The rubber floor tile needs to be covered with an aluminum threshold under the door.

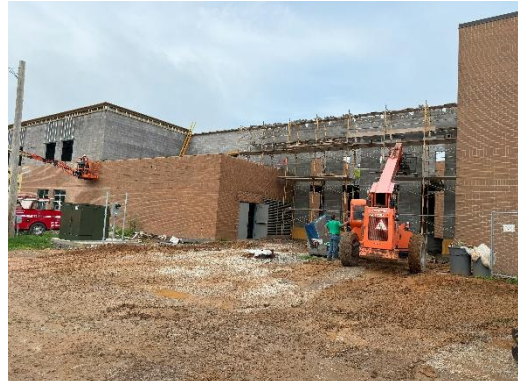
- m) The exterior walls for the connector between Areas J and H were being completed.

Once the walls are in place, the roof structure and roofing can be installed.

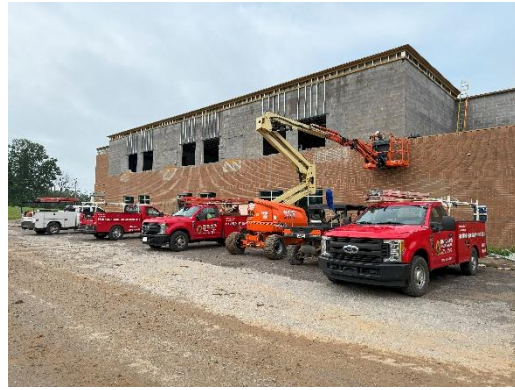
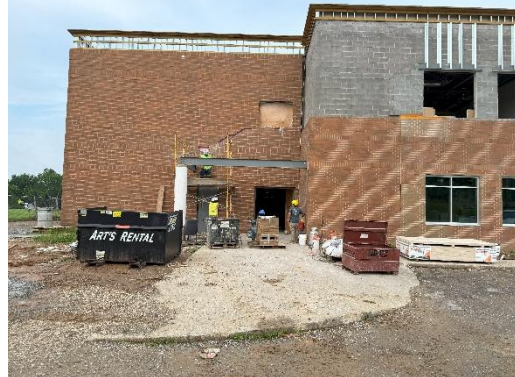
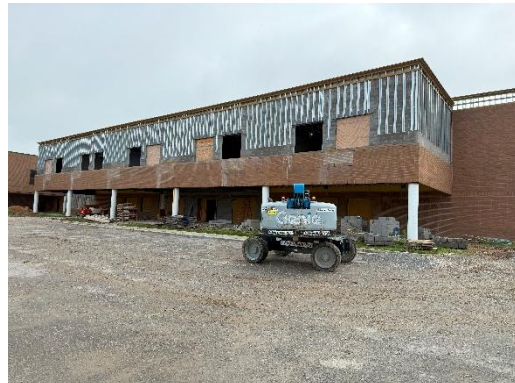
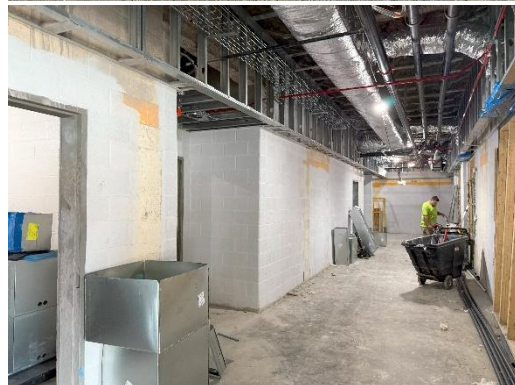
- n) Work was beginning to install the metal panela over the second floor of Area J.
- o) The brick was being replaced where the flashing for the canopy over the exit doors was removed.
- p) John asked JRA to make arrangements for a firm specializing in brick staining to visit the site to determine what can be done to match the original and new brick including the scope and costs.
- q) The area above the corridor ceiling has been filled with piping, ductwork and conduits. The fireproofing contractor needs to return to touchup structural members where the fireproofing materials were damaged as the items were hung.

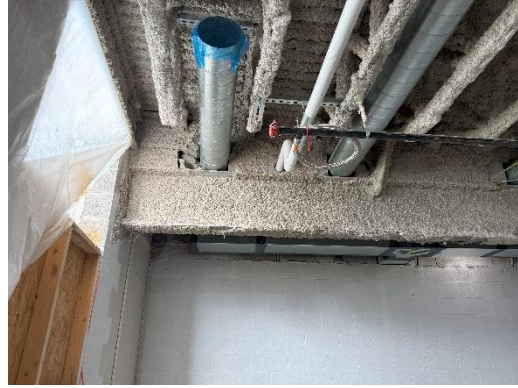
- r) Repair work is required at the duct openings in the load bearing block wall between the steel beam and floor above.

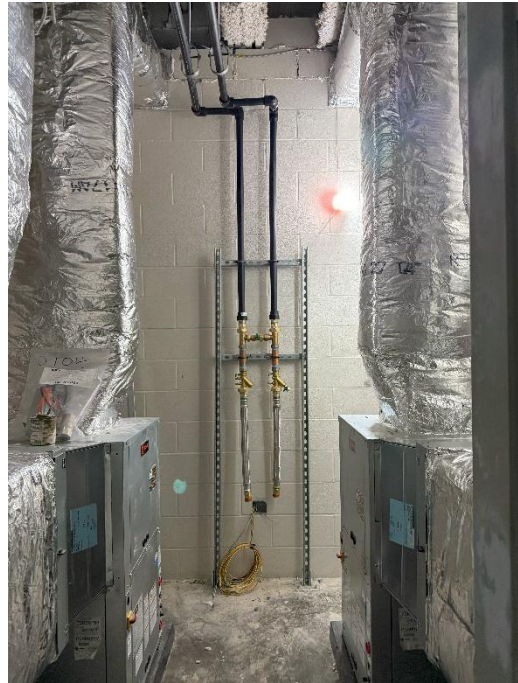
- s) The geothermal heatpumps were being connected to ductwork and insulated. These are in the new closets between the classrooms.

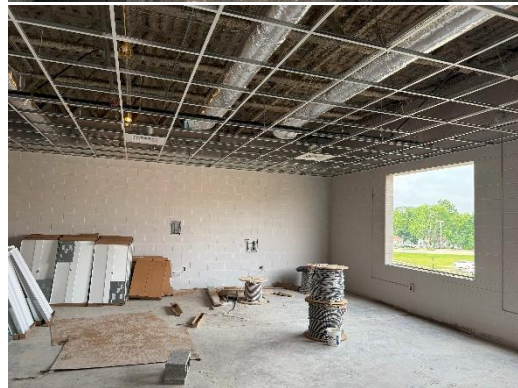
- t) Ceiling grids were being installed in the classrooms in Area J.

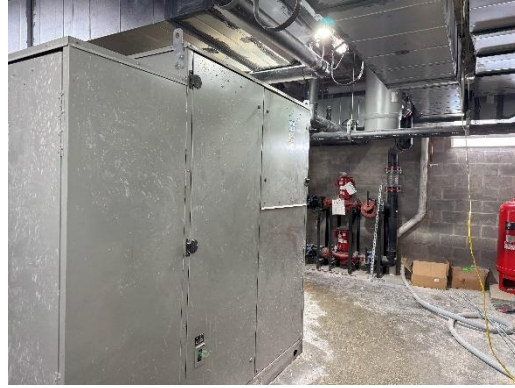
- u) The mechanical and electrical equipment in mechanical room for Area J was being connected to the systems in the rest of the area.
