FIELD OBSERVATION REPORT #13

2025-07 - New Board Office

■ TO:	Kenton County Board of Education 1055 Eaton Drive Ft. Wright, KY 41017	■ DATE:	2025.07.23
ATTENTION:	Mr. Kevin Pfefferman		
■ FROM:	Mark Perry mperry@embosdesign.com 906 Monmouth Street Newport, KY 41071 V: 859.431.8612 • D: 859.578.6013	■ PROJECT:	New Board Office KCSD BG#24-084
COPIES TO:	Mr. Matt Rigg; Mrs. Carrie Hooten, Mr. Brian Vanover	PROJECT NO.:	22-106

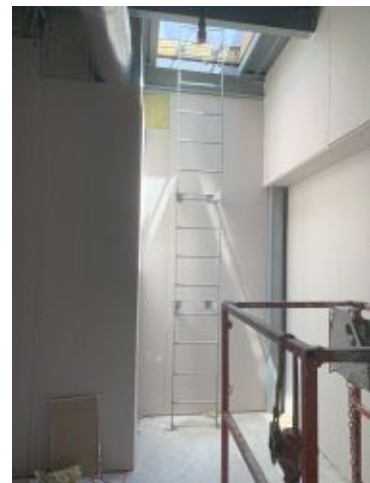
05.01: 2025.06.24 – Ladder from second floor to board room roof had been installed.

2025.06.24 – Access to board room roof

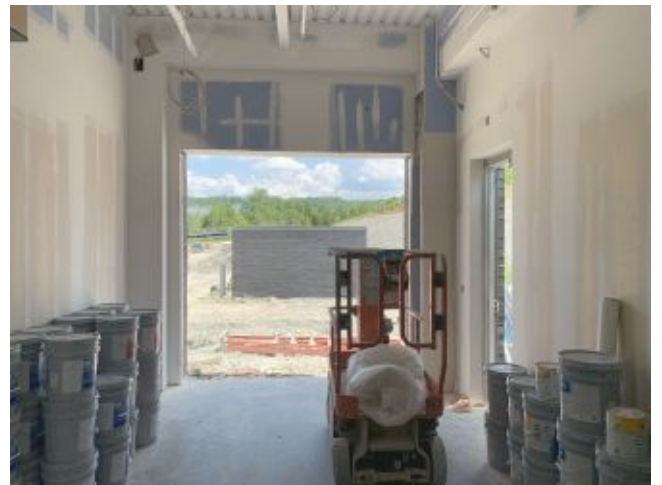
08.02: 2025.07.11 – An issue with the coiling door at Receiving #150 was reviewed with Monarch.

2025.07.11 – Receiving #150

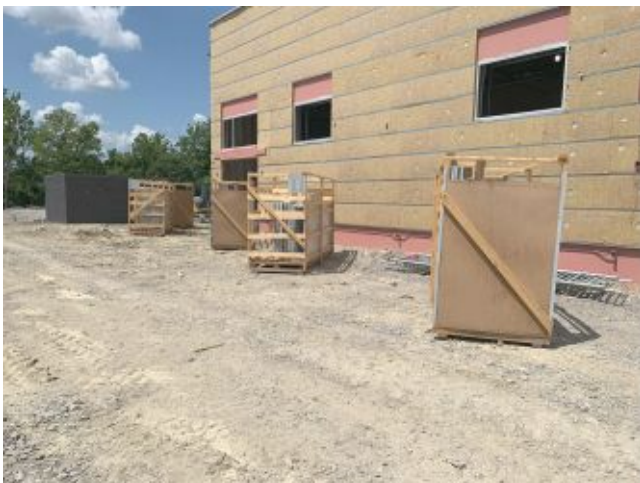
07.03: 2025.07.11 – The first of four anticipated deliveries of composite metal panels had been delivered to the site.

2025.07.11 – Composite metal panel crates

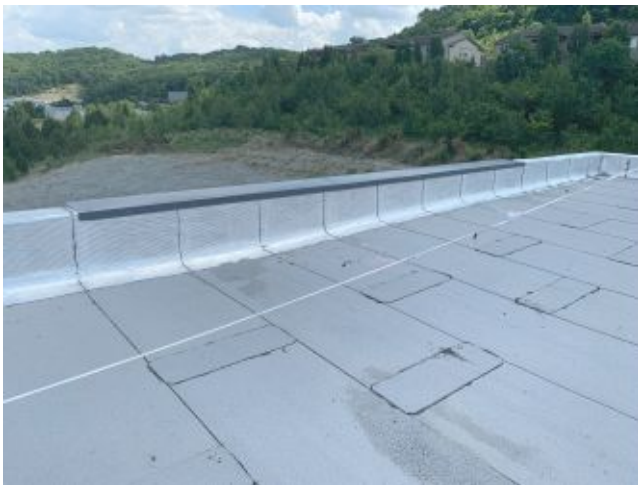
07.04: 2025.07.11 – Metal coping had been installed where brick terminates at copings.

2025.07.11 – Coping at north wall

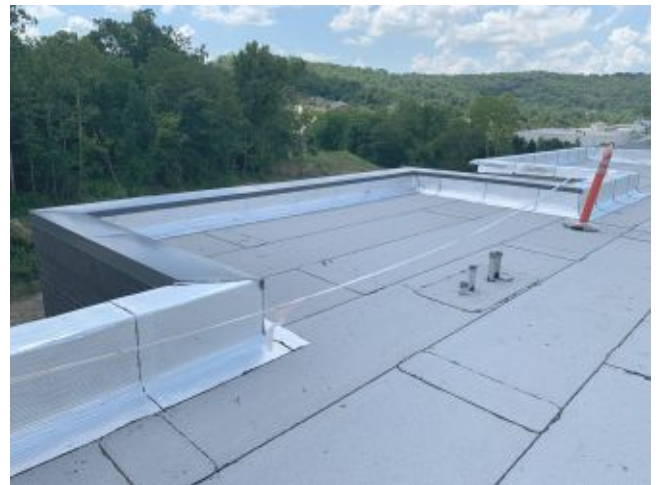
2025.07.11 – Coping at Stair #2

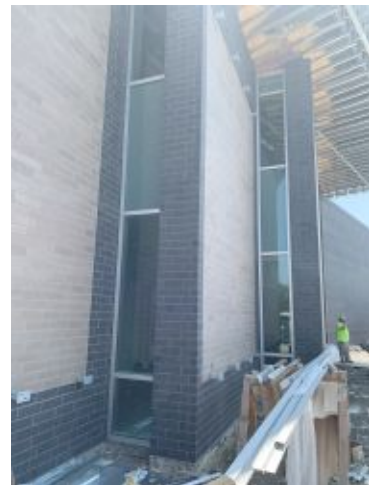
08.04: 2025.07.22 – Glass had been installed at the saw-tooth, entry, and portions of the board room.

2025.07.22 – Glass at the sawtooth

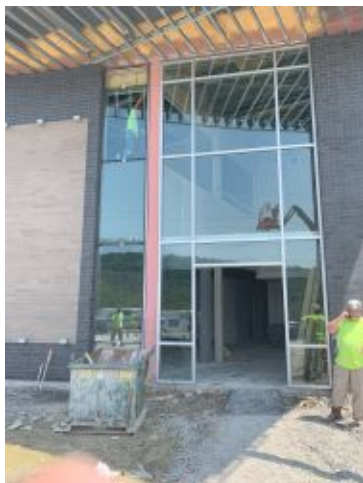
2025.07.22 – Glass at the entry

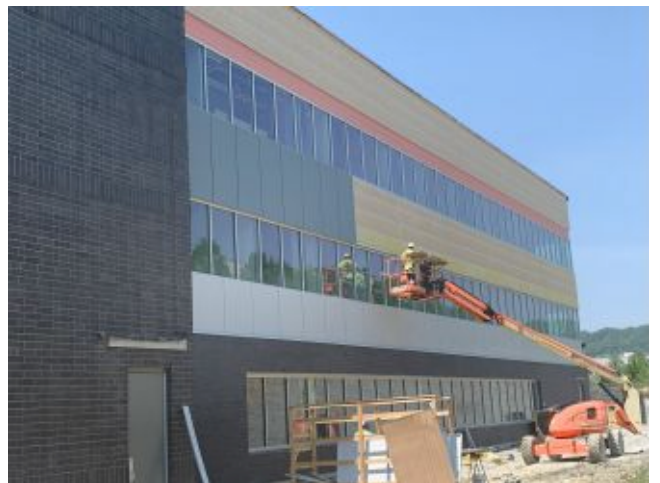
07.05: 2025.07.22 – Composite metal panel installation was active at the east elevation, north of stair #2.

2025.07.22 – East elevation metal panels

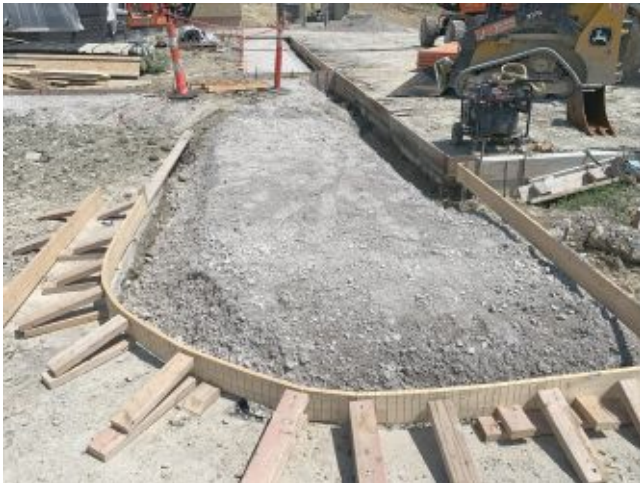
32.01: 2025.07.22 – A portion of sidewalk south of the board room had been poured and formwork for an upcoming pour wrapped the southwest corner and turned north towards the building entrance.

2025.07.22 – Curb forms at southwest corner of building

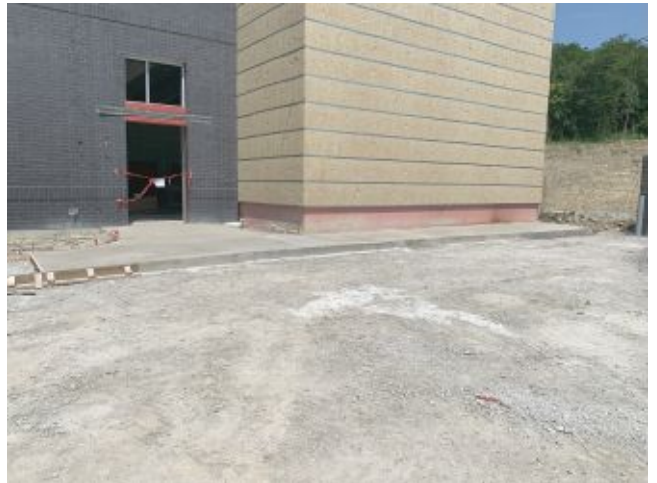
2025.07.22 – Sidewalk south of board room
