FIELD OBSERVATION REPORT

Central Hardin High School – Phase 2, 2019111 -CA8

Report No: 28

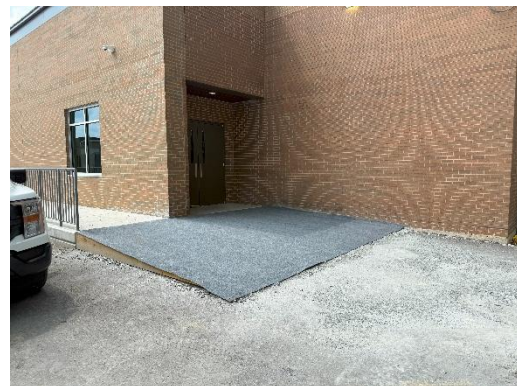
- a) Because the sitework is not completed in the area, the building inspector required that a temporary ramp be constructed at the exits from Area D. This was in place and was approved by the inspector.

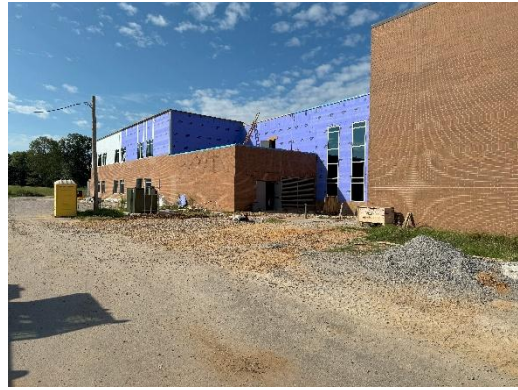
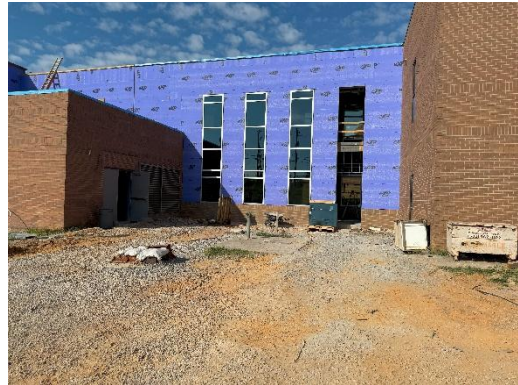
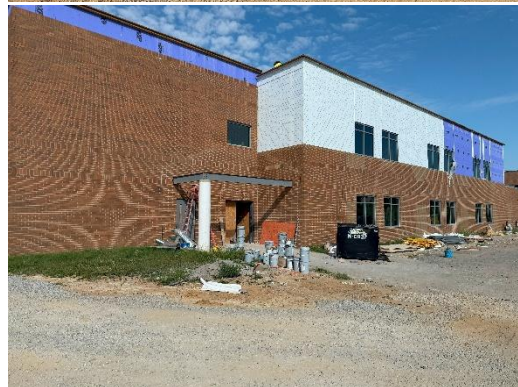
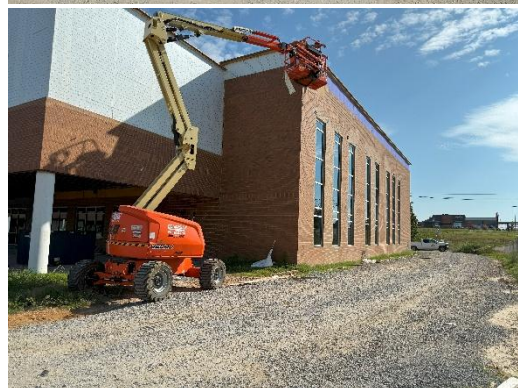
- b) Area J was being prepared to receive the sheet metal panels matching those on the second floor of Phase 1.
- c) The connector to Area H was being prepared for the sheet metal panels. The curtainwall windows were mostly installed.
- d) Two different colors of air barrier were in place due to availability of the original material.
- e) The air barrier was being completed on the south elevation.

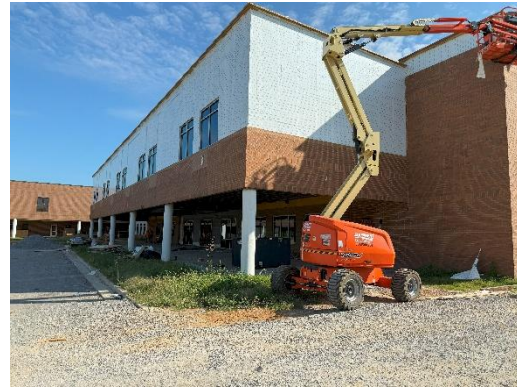
- f) The second floor was ready for the sheet metal panels.

Pricing for the repairs to the support angle at the overhang has not been finalized.

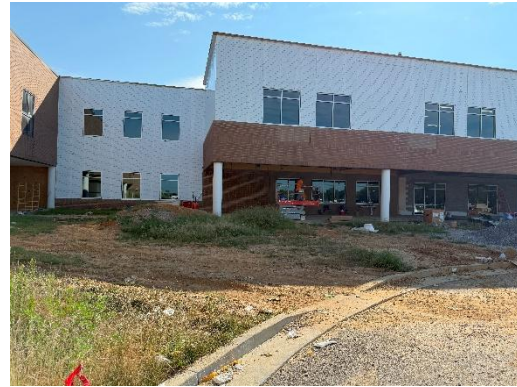
- g) The original connector to Area H was prepared to receive metal panels.

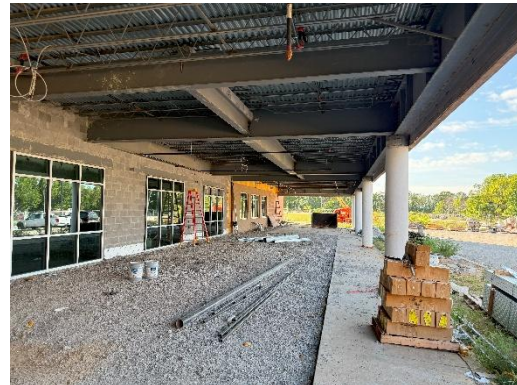
- h) Installation of the fire suppression system under the overhang was underway.

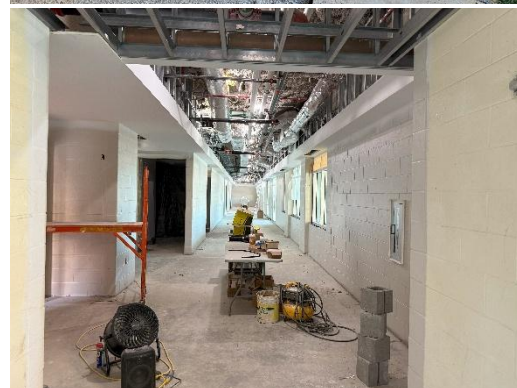
- i) Ceiling work was being completed above ceiling in the first-floor corridors. An above ceiling punch list will be conducted next week.

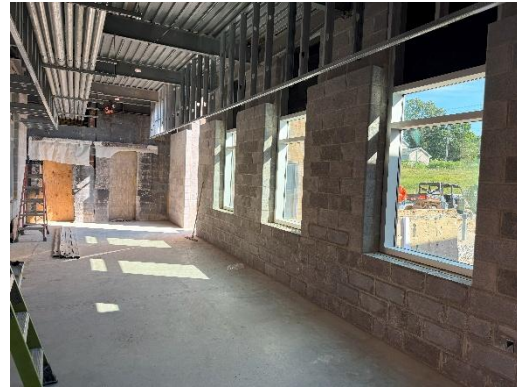
- j) Soffit framing was being installed in the connector to Area H.

The slab on the second floor was polished for comparison with work in Phase 1. It appeared to be consistent with the sheen and quality in Phase 1. Gill reported that Shelee said that they need to match the work in Phase 1.

- a) Review the polished concrete sample for approval.

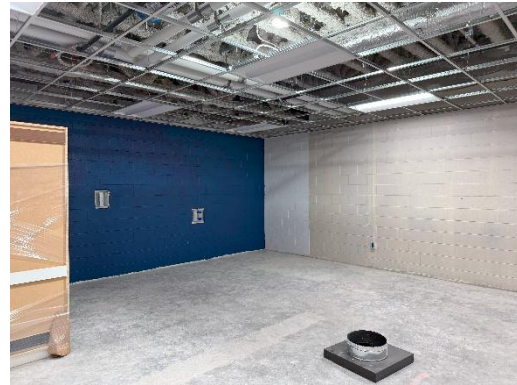
- k) Rooms are more complete on the second-floor including ceilings, utilities, painting and floor prep work.

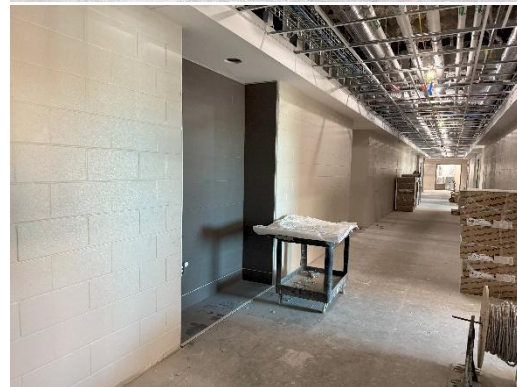
- l) Tile was installed in the water cooler alcoves.

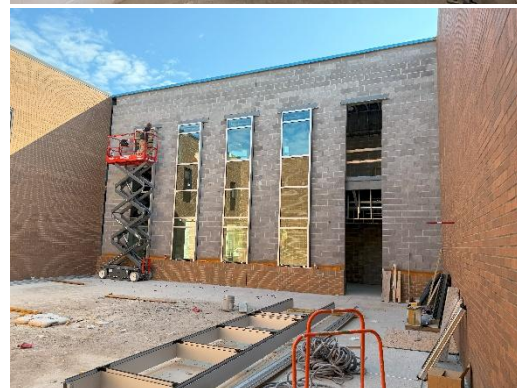
- m) The curtain wall windows were being installed on the courtyard side of the connector.

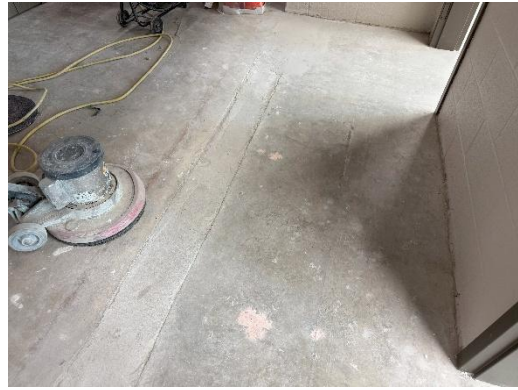
- n) Floor prep was underway on the second floor.

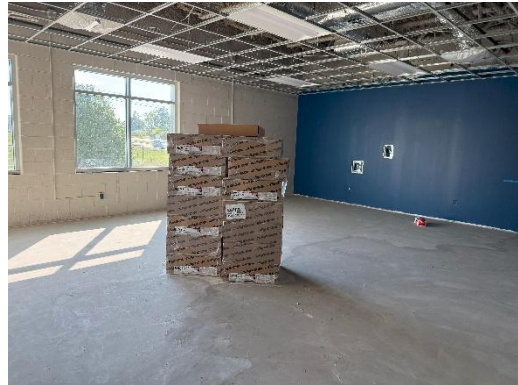
- o) Several classrooms had been prepped for floor finish. With HVAC system startup this week, finishes can be installed.

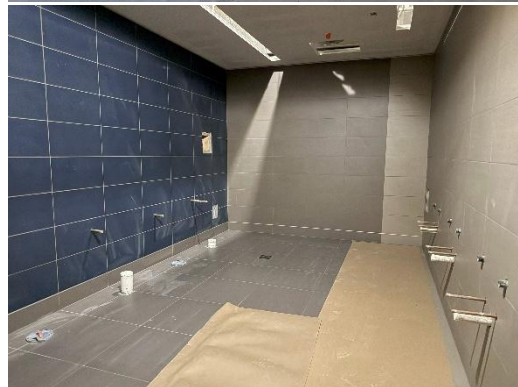
- p) Tile walls and floors were in place in toilets. The floors were protected.

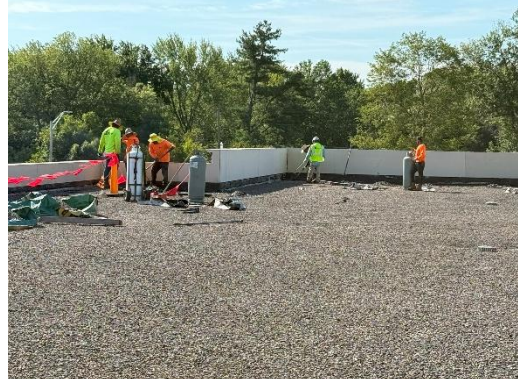
- q) The existing roof was being tied into the new parapets for the roof around Area J.

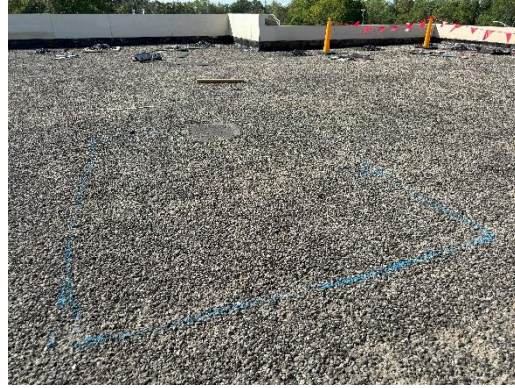
- r) The damaged roof area identified in the infrared scan was identified with a blue outline. There is another damaged area near to this location. Both will be replaced.
