FIELD OBSERVATION REPORT

Food Service Building, 202276 -CA8

Date: 8/19/2025 Time: 11:30 AM

Report No: 14

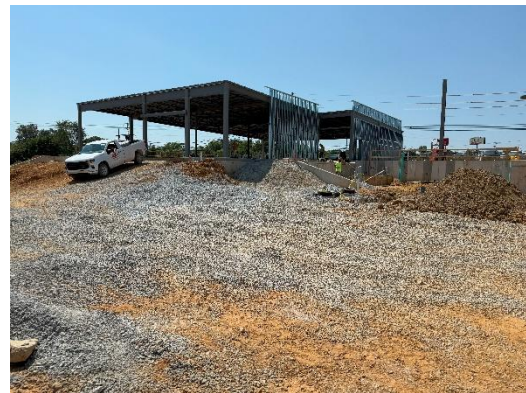
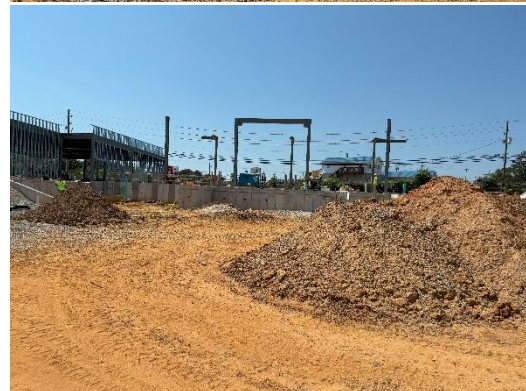
- a) The structural metal roof deck was on the office area. Light gauge curtainwall framing was being placed on the north side of the office area.
- b) Caleb reported that they are nearing the point that excess earth will be removed so that the building is easier to access from the east side.

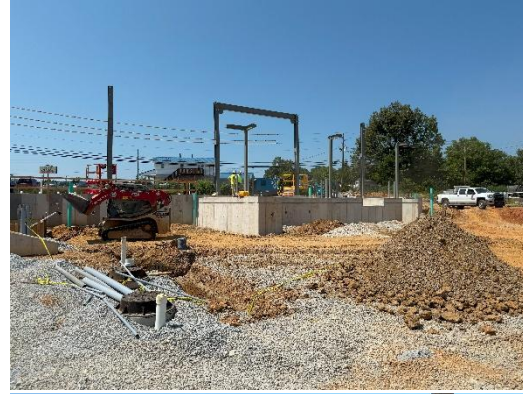
- c) Structural steel columns were being erected for the warehouse area.

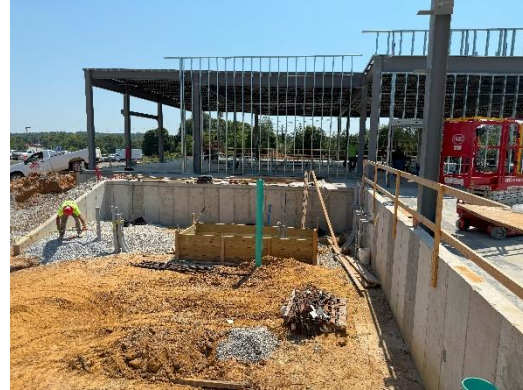
- d) The concrete crew was preparing the area for the transformer and generator.

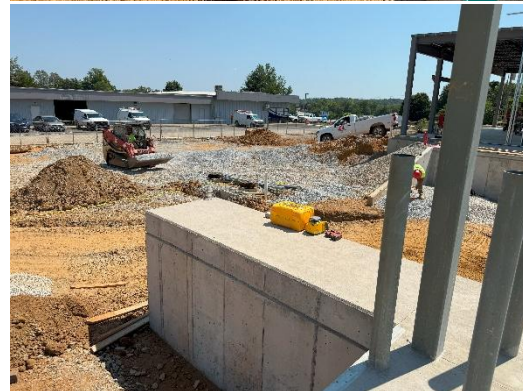
- e) The peninsula for the loading dock was in place.

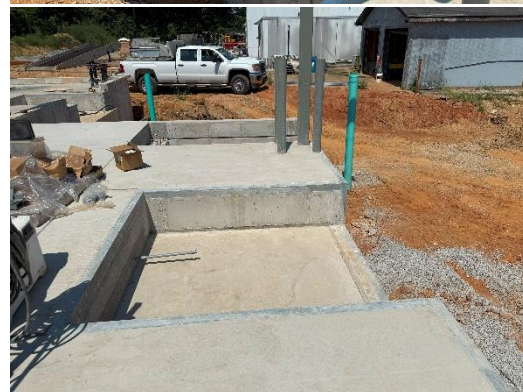
- f) The pit for the dock leveler on the loading dock appeared to be ready for the leveler. A conduit was extended into the pit for the leveler motor.

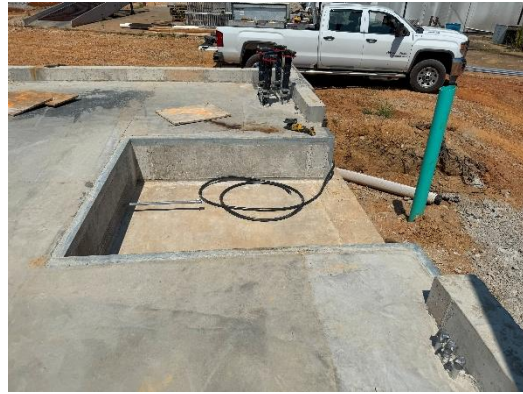
- g) The pit for the dock leveler into the warehouse appeared to be ready for the leveler. A conduit was extended into the pit for the leveler motor.

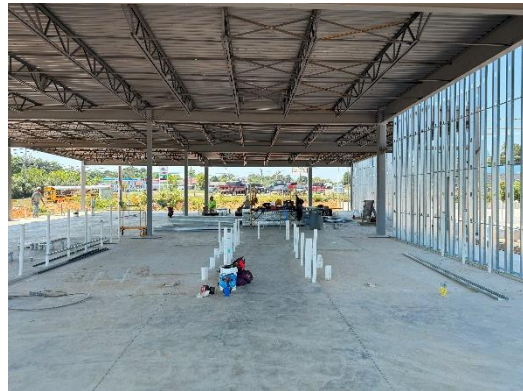
- h) Framers were laying out the partitions on the office slab.

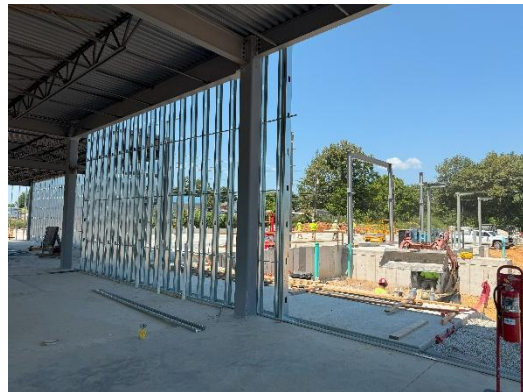
- i) Light gauge structural exterior wall framing was extended past the east wall of the warehouse.

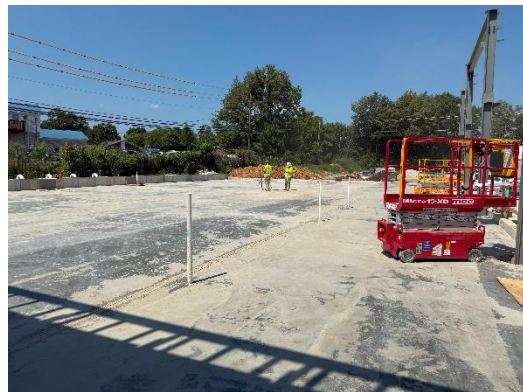
- j) The corridor in front of the freezer was bordered with the pressure treated wood blocking that will be under the front wall of the freezer.

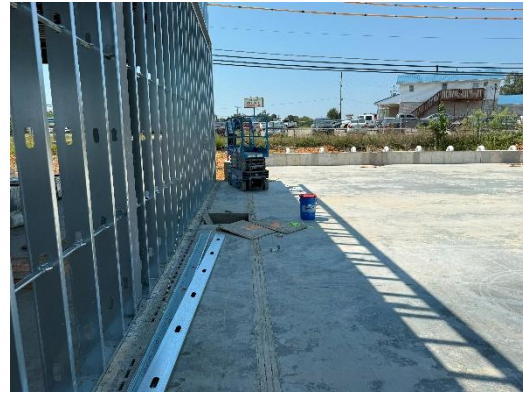
- k) The pressure treated wood blocking that will be under the freezer walls was visible at the tops of the slab along the south side of the freezer. Once the stud framing and office wall is complete, masons will lay concrete block to separate the office area from the warehouse.

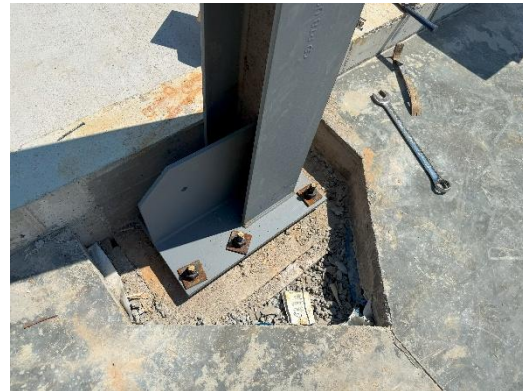
- l) Steel columns were being installed in slab block outs in the warehouse area.

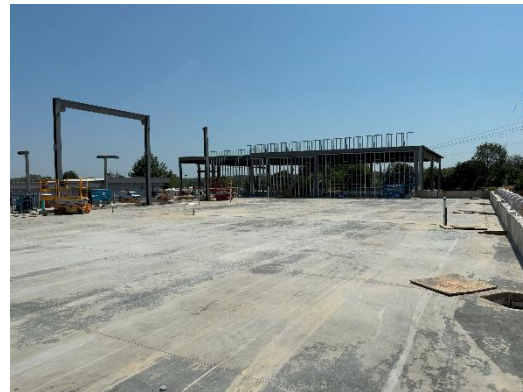
- m) Looking south from the warehouse slab toward the freezer slab and then the office area.

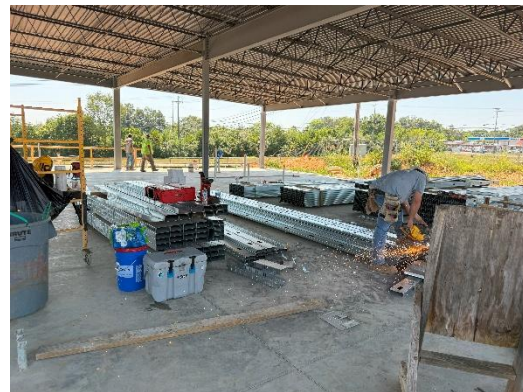
- n) Light gauge steel framing was stockpiled on the office slab.
