## FIELD OBSERVATION REPORT

West Hardin Middle School, 202280 -CA8

Date: 8/12/2025 Time: 11:30 AM

Report No: 17

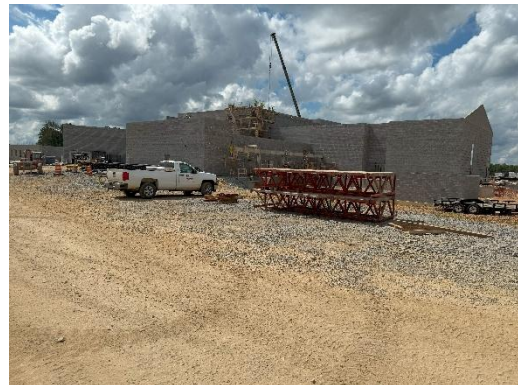
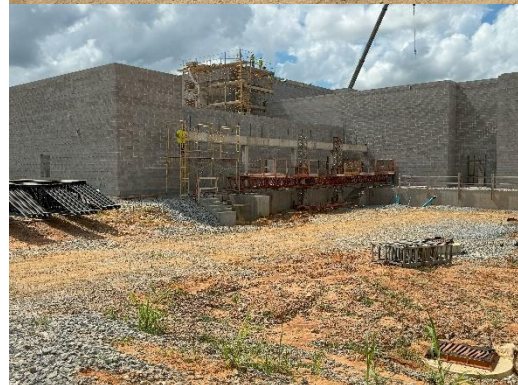
- a) From the northwest of the site, the concrete block walls enclose the kitchen, music rooms, and mechanical room with the gym in the background.
- b) Scaffolding was being erected to lay the block backup wall for the overhang at the kitchen loading dock.

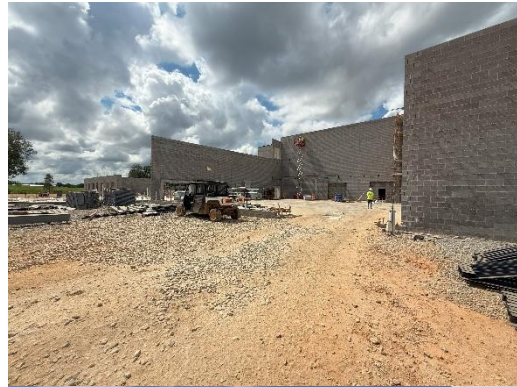
- c) Block work was being completed on south end of the east cafeteria wall.

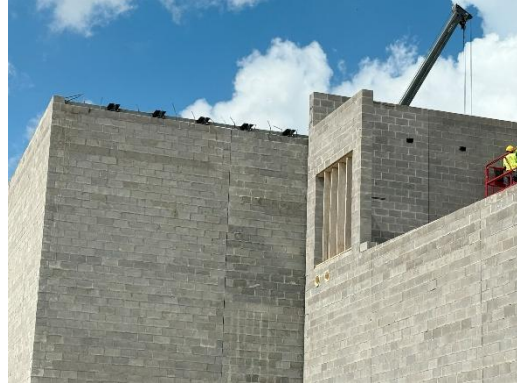
- d) At the east side of the cafeteria above the corridor, there is an opening in the fire rated wall separating Area B from Area C.

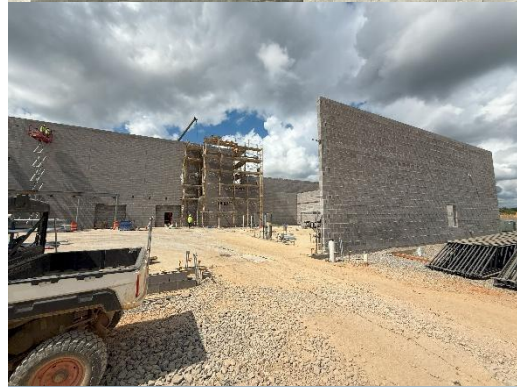
- e) The cafeteria exterior wall was still open for access to the interior of the building. Jeremy said that the masons will work their way out of Area D and complete Area C at the exterior of the cafeteria.

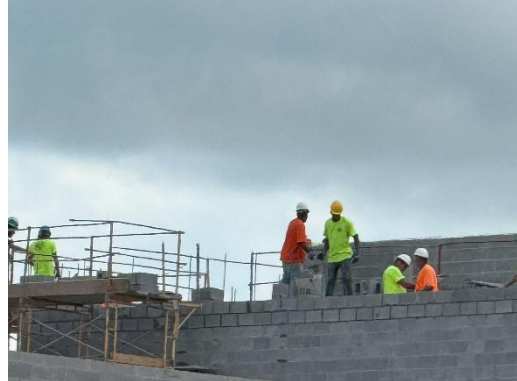
- f) Masons were laying concrete blocks at the tops of the walls in Area D. These walls form the structure for the mechanical platform spaces.

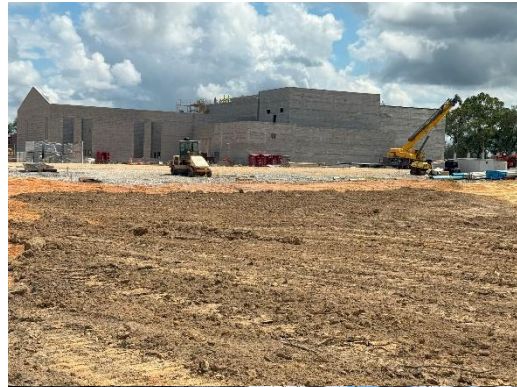
- g) From the southwest corner of the building, Area D block work was mostly complete.

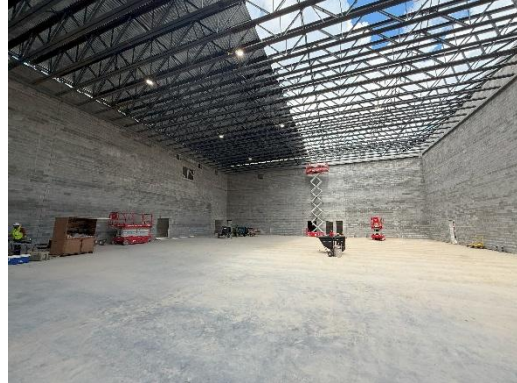
- h) Metal roof deck was being installed over the roof joists over the gym. Due to the requirements for the storm shelter the joists are extra heavy and the deck will support a concrete slab to support the roofing materials.

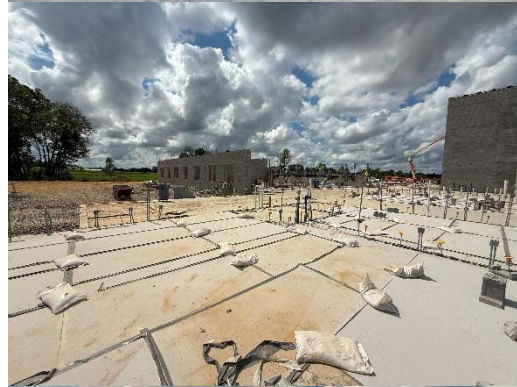
- i) Electrical and plumbing rough ins were in place to be laid in the concrete block walls for the middle and southern wings of classrooms.

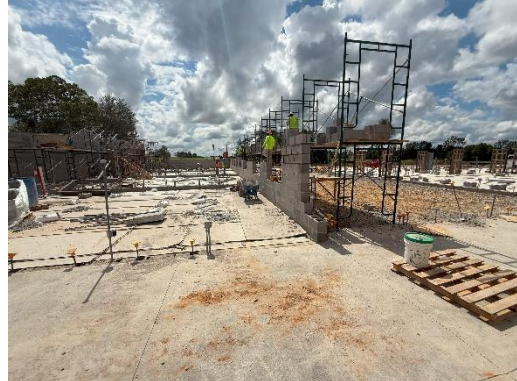
- j) Concrete block walls were being laid on the first floor of the north classroom wing. It is critical that electrical and plumbing piping and devices be laid in the walls in the correct locations to properly serve the equipment to be used in the classrooms.

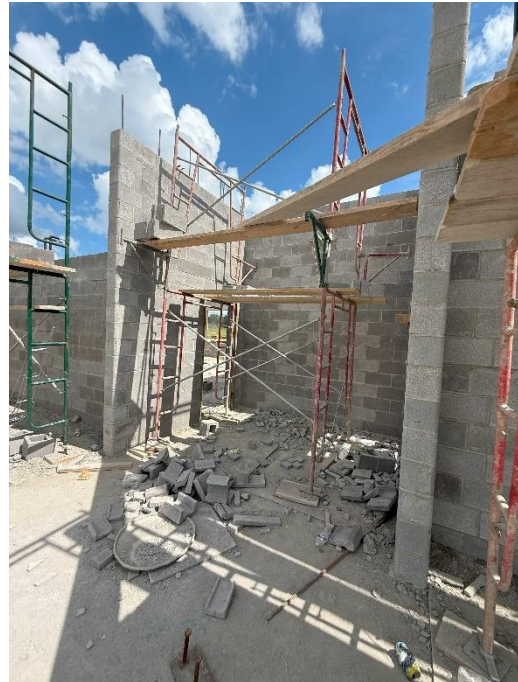
- k) The concrete block in the north classroom wing on the first floor forms the recessed entrances to the classrooms.

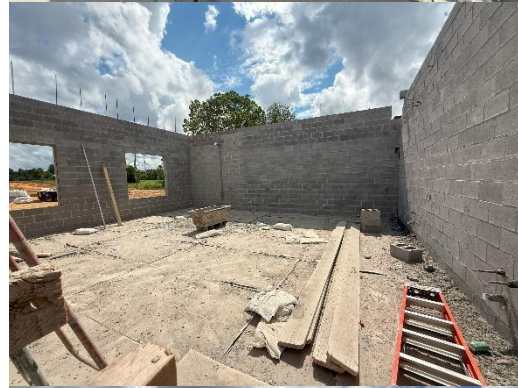
- l) First-floor classrooms were being constructed in the north classroom wing. Precast concrete floor panels are on order and will soon be installed on the tops of these walls so the second-floor concrete block can be laid.

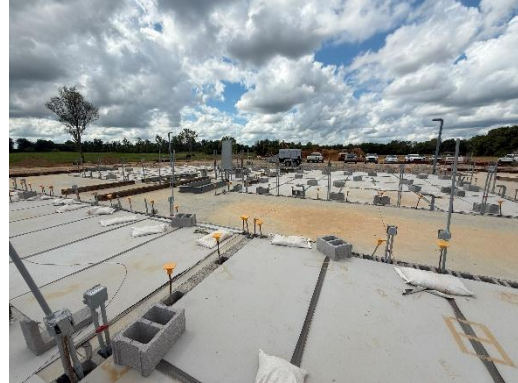
- m) Plumbing and electrical piping and boxes were in place for the concrete block walls in the classroom wings.

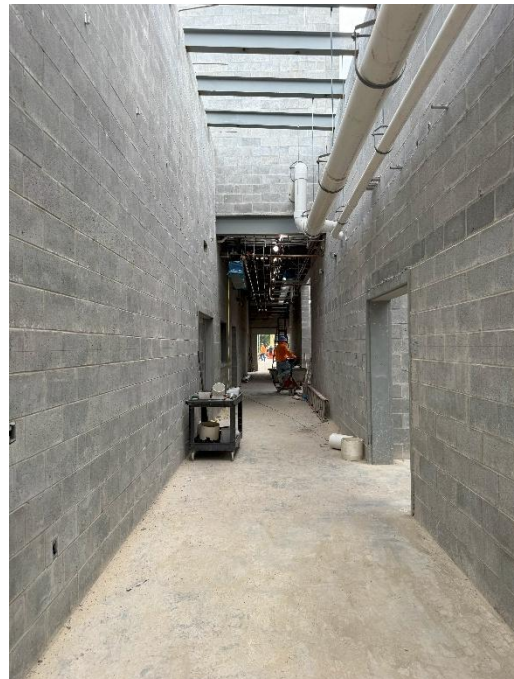
- n) The corridor by the mechanical room and music rooms were being completed. The mechanical platform will run above the corridor. The steel beams will support the platform.

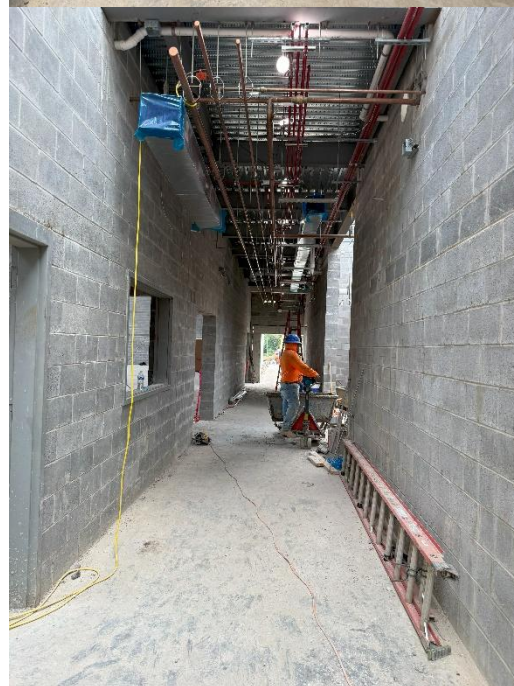
- o) The corridor in the storm shelter has been mocked up with the utilities that will be above the ceiling. The mechanical platform above that is supported by steel floor deck.

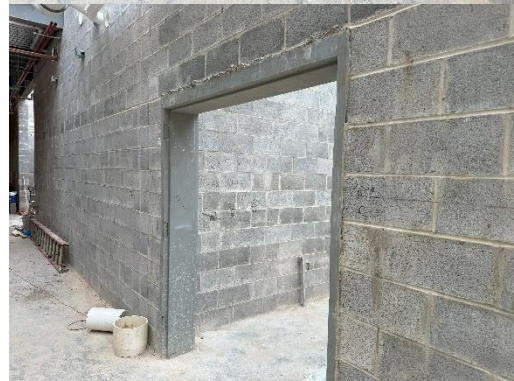
- p) As areas of concrete block have been laid, the hollow metal door frames have been cleaned so they are ready for paint when the building is enclosed. Mortar needs to be cleaned off the frames including above the heads for a smooth substrate for the paint finish.

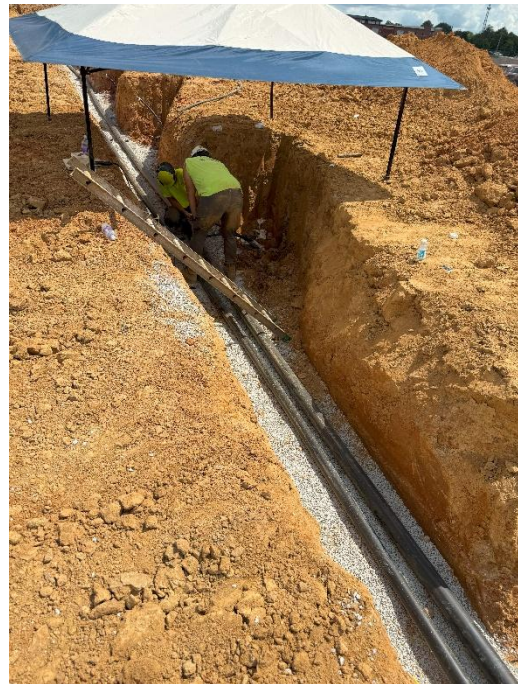
- q) The geothermal well piping was being fused together.

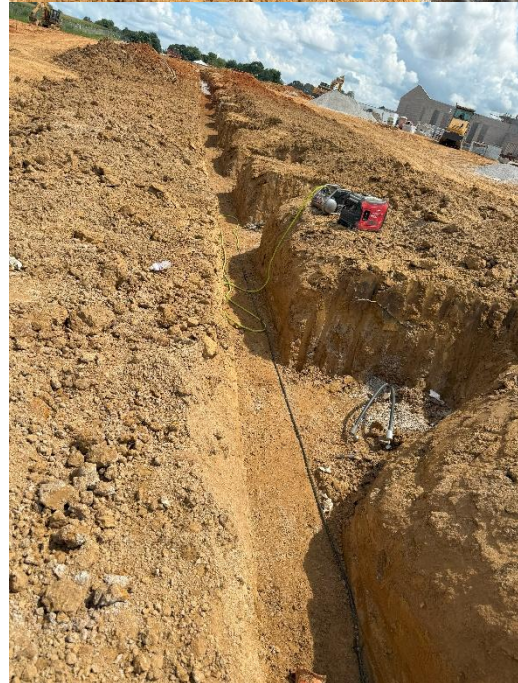
- r) Trenches for the geothermal piping were excavated beside the well heads.
