FIELD OBSERVATION REPORT #14

2025-08 - New Board Office

■ TO:	Kenton County Board of Education 1055 Eaton Drive Ft. Wright, KY 41017	■ DATE:	2025.08.25
ATTENTION:	Mr. Mike Blau		
■ FROM:	Mark Perry mperry@embosssdesign.com 906 Monmouth Street Newport, KY 41071 V: 859.431.8612 • D: 859.578.6013	■ PROJECT:	New Board Office KCSD BG#24-084
COPIES TO:	Mr. Matt Rigg; Mrs. Carrie Hooten, Mr. Brian Vanover	PROJECT NO.:	22-106

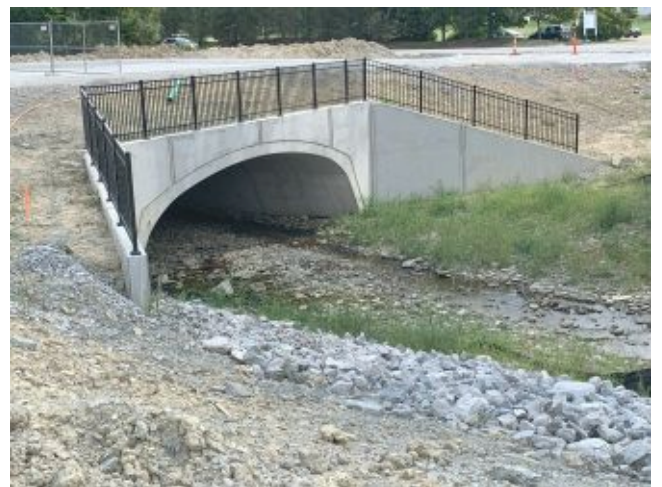
32.03: 2025.08.05 – Aluminum fence railing had been installed on the bridge.

2025.08.05 – Bridge railing

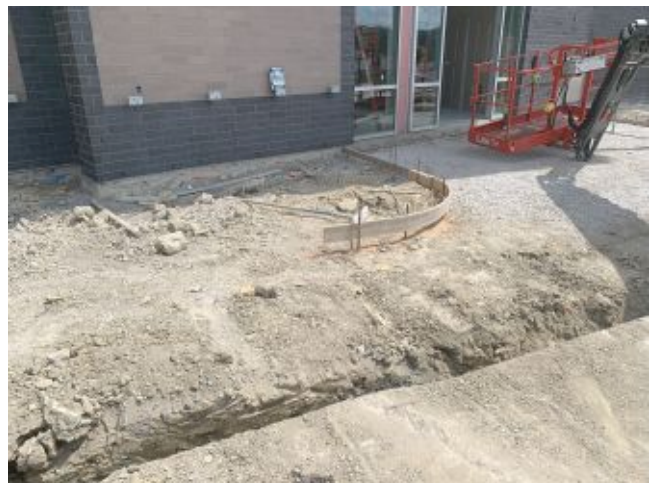
32.01: 2025.08.05 – Sidewalk installation was nearing the main entrance. Form installation had started at the entrance. Curbs between the building and Tuscanview Drive were complete.

2025.08.05 – Form work at entry

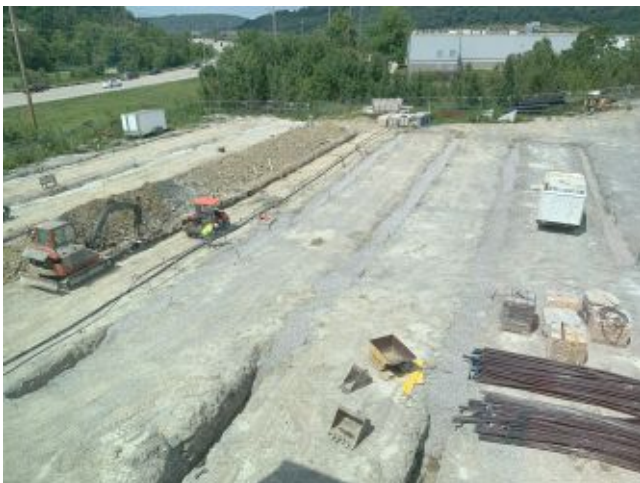
20-28.01: 2025.08.05 – The geothermal subcontractor was working on the final laterals in the well field.

2025.08.05 – Geothermal well field

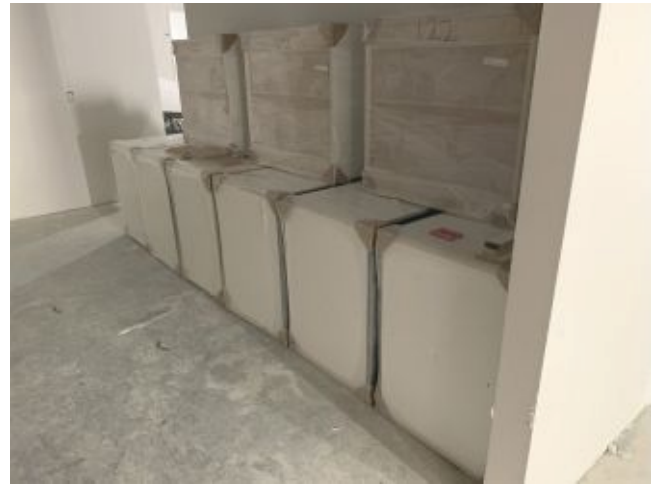
06.02: 2025.08.05 – First floor cabinets had been delivered. Installation had begun, but most were stored/staged.

2025.08.05 – Casework in Work #122

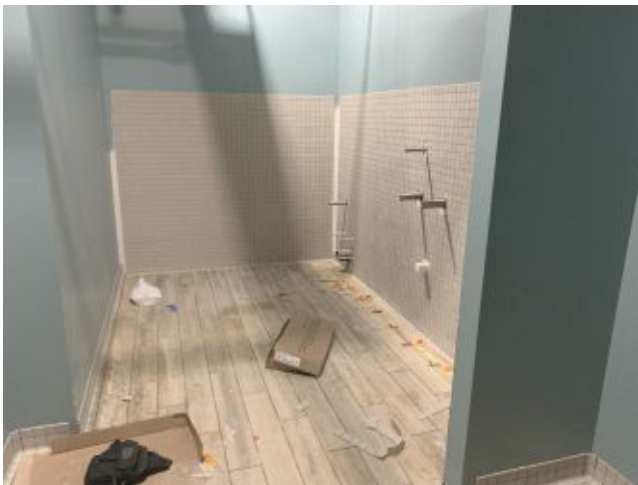
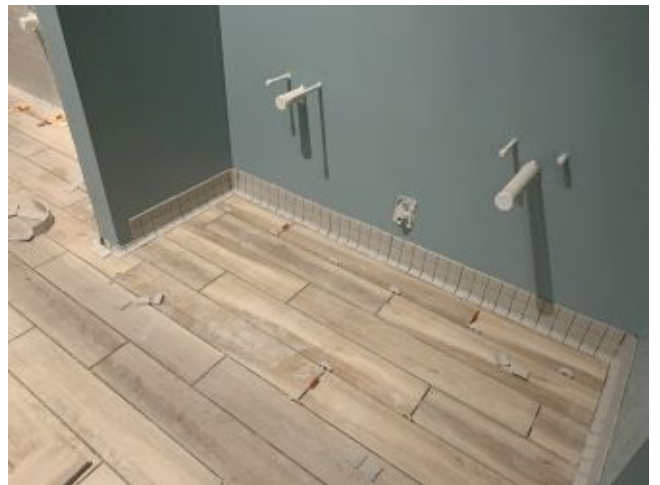
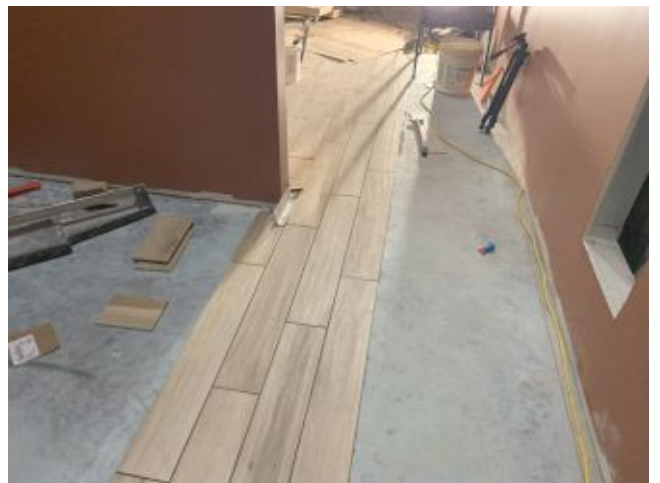
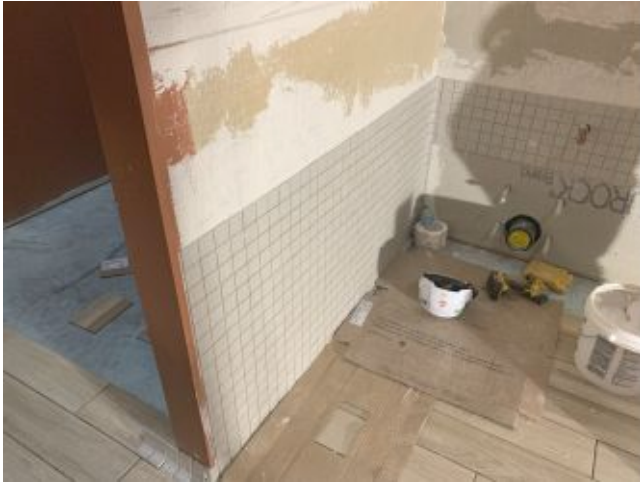
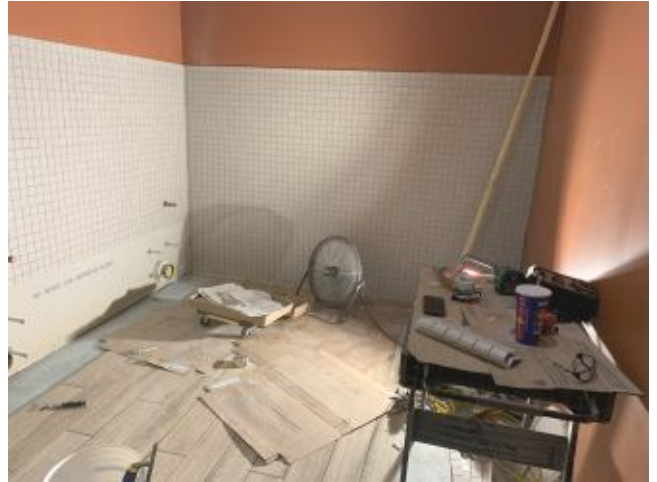
09.04: 2025.08.19 – Ceramic tile installation was active at first floor group restrooms. Issues were reviewed and discussed with the installer and GC.

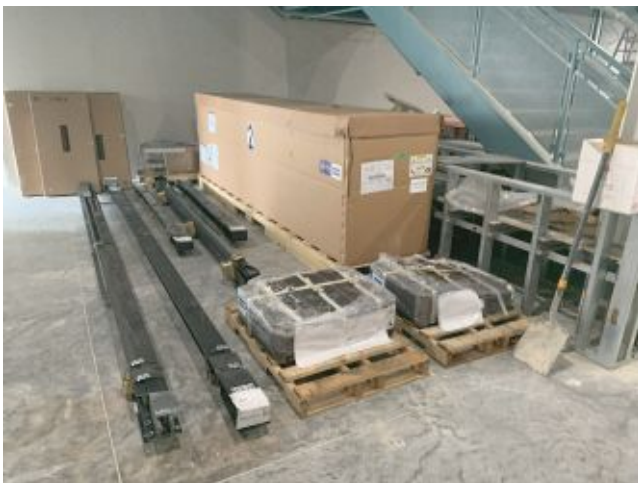
14.01: 2025.08.19 – Elevator had been delivered.

2025.08.19 – Elevator components

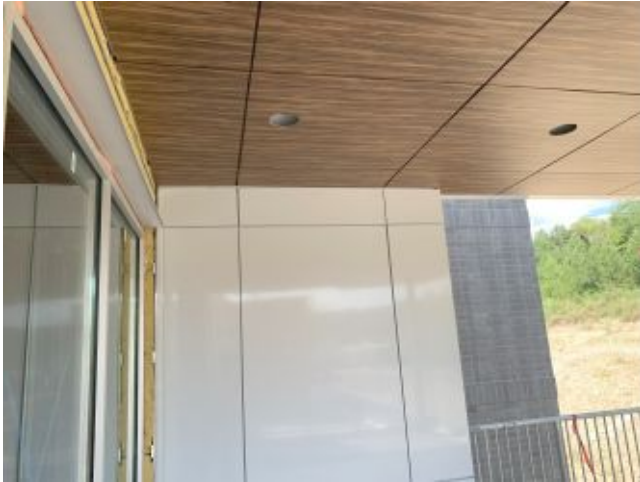
07.02: 2025.08.19 – A third shipment of composite metal wall panels had been delivered. Wood look panels had been partly installed at the second floor patio.

2025.08.19 – Second floor patio
