## FIELD OBSERVATION REPORT #03

### 2025-08 - R.C. Hinsdale-Phase 2

■ TO:	Kenton County Board of Education 1055 Eaton Drive Ft. Wright, KY 41017	■ DATE:	2025.08.25
ATTENTION:	Mr. Mike Blau		
■ FROM:	Jim Kaiser jkaiser@embosdesign.com 906 Monmouth Street Newport, KY 41071 V: 859.431.8612 • D: 859.578.6013	■ PROJECT:	R.C. Hinsdale Elementary Phase 2 Addition & Renovation BG#21-142
COPIES TO:	Mr. Matt Rigg; Mrs. Carrie Hooten	PROJECT NO.:	24-046

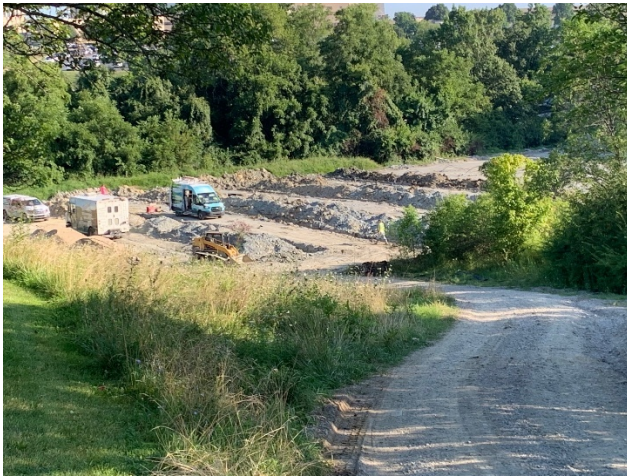
20-28.01: Work continues on installation of piping from geothermal well field to school.

2025.08.13 – Geothermal well field.

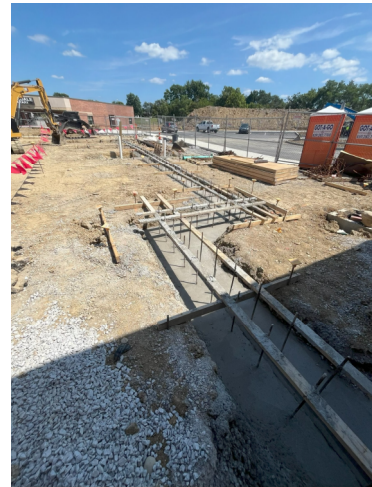
03.01: Installation of footings for new addition have begun

2025.08.13 – New addition footings

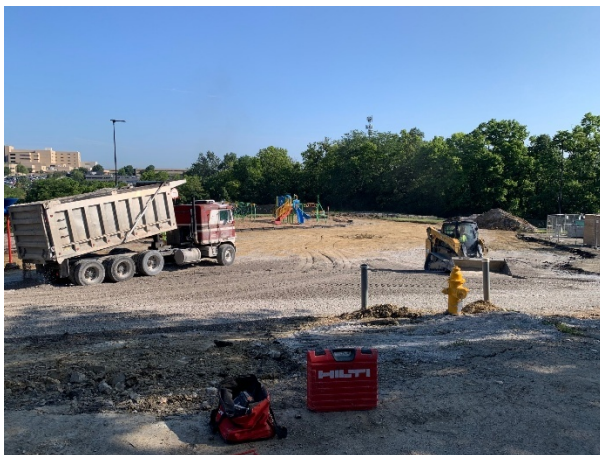
*32.01: Paving and poor soil at rear paved area/playground has been removed and new stone base installed to prep for new asphalt paving*

2025.08.13 – Rear playground stone base

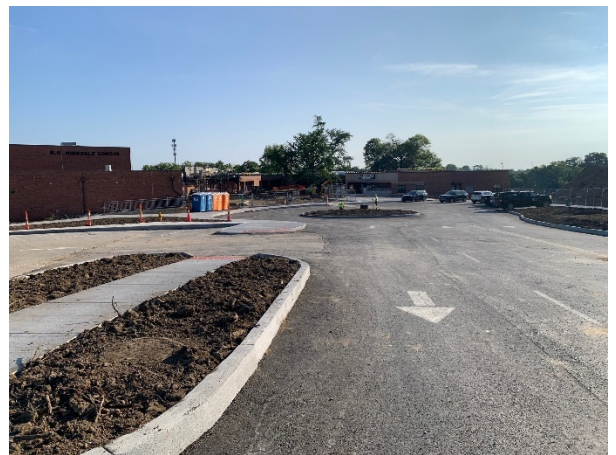
2025.08.13 – Completed new bus loop

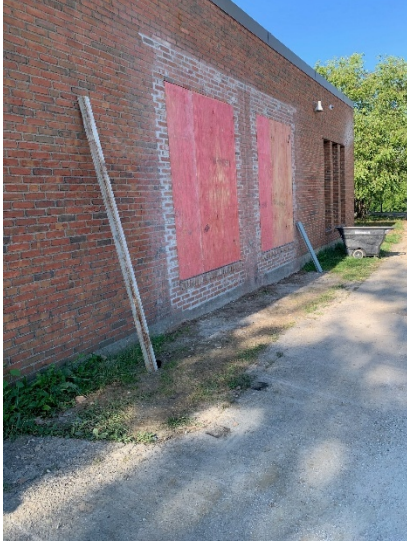
04.01: New window openings in phase 1 classrooms are complete and temporarily infilled with metal stud and sheathing until new windows arrive

2025.08.13 – New classroom window openings-exterior view

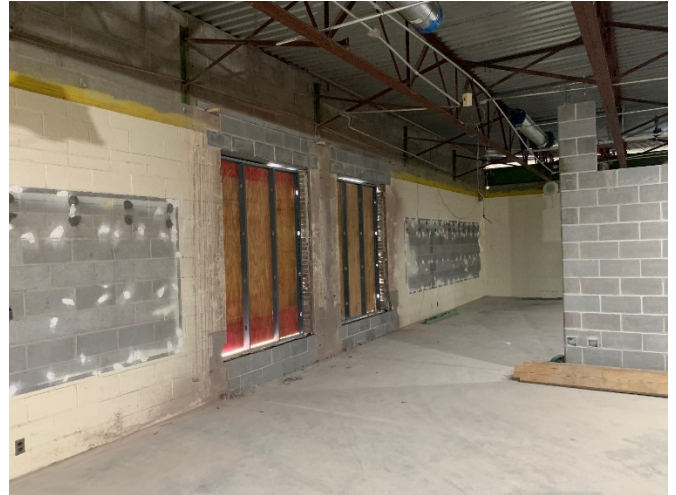
2025.08.13 – New classroom window openings – interior view

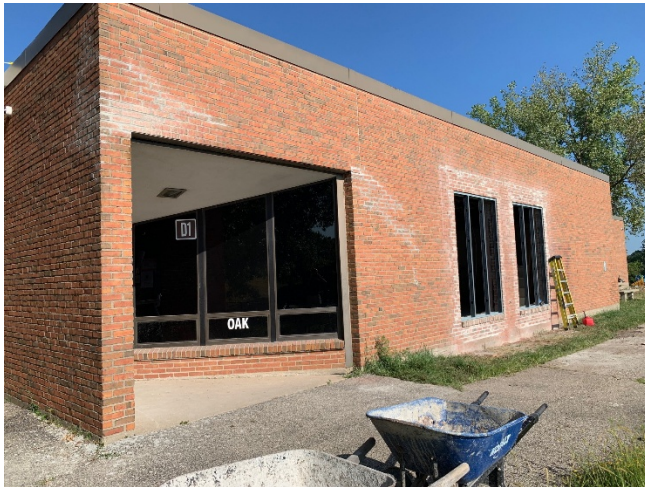
04.02: Tuckpointing and brick repair of existing brick veneer is nearly complete in the Phase 1 area

2025.87.13 – Brick tuckpointing/repair

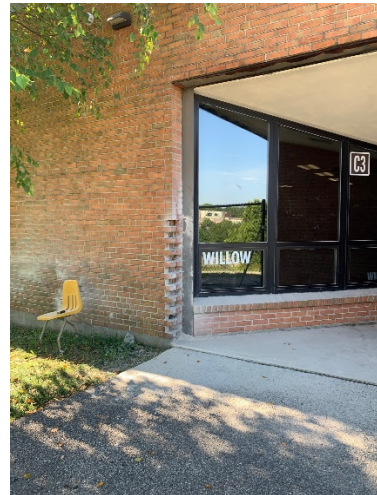
2025.08.13 – Brick tuckpointing/repair

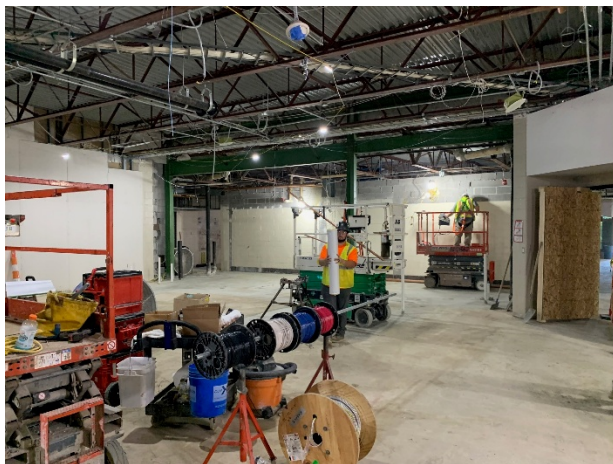
20-28.07: Under slab plumbing rough-in for new bathrooms in the Phase 1 area has been completed and slab repoured.

2025.08.13 – Bathroom underslab plumbing roughin

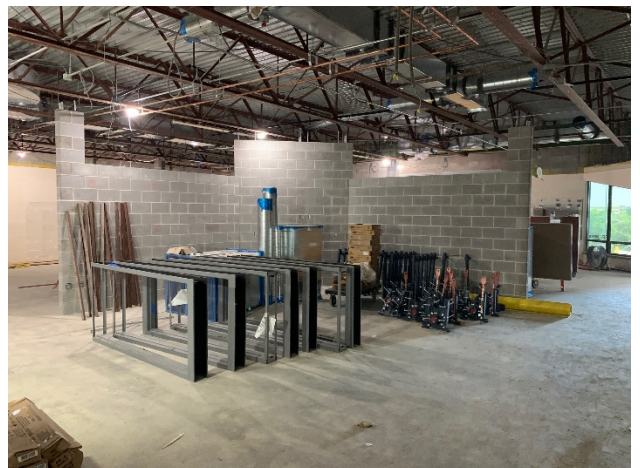
20-28.05: Duct installation in phase 1 area is 95% complete

2025.08.13 – Typical pod classroom with dividing wall and duct installation
