FIELD OBSERVATION REPORT

West Hardin Middle School, 202280 -CA8

Date: 9/16/2025 Time: 11:30 AM

Report No: 20

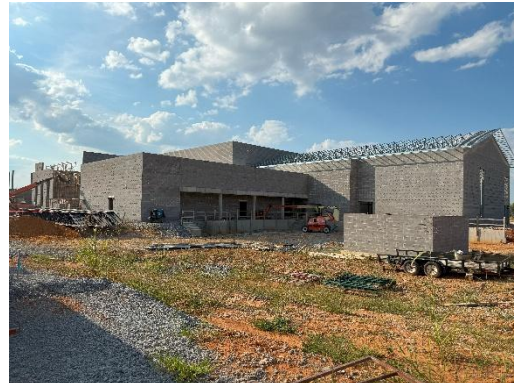
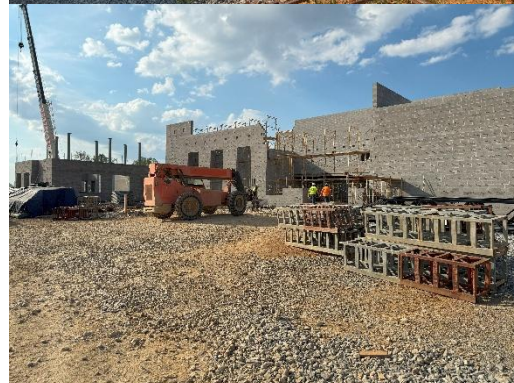
- b) Block was being laid at the exterior wall of the cafeteria on the north side of the building.

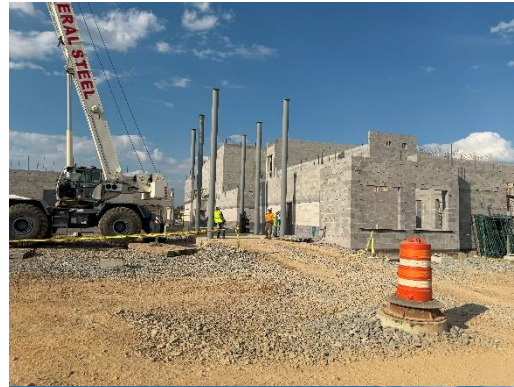
- c) Steel columns were being installed at the entrance to the north end of the main corridor. These will be exposed and tied into steel beams supporting the second floor and roof in that area of the building.

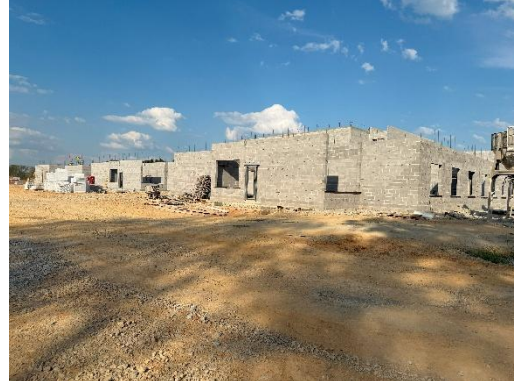
- d) All three of the classroom wings were surrounded with blockwork. The first two areas will soon be covered with precast concrete-floor planks for the second floor. The third area will be right behind the first two.

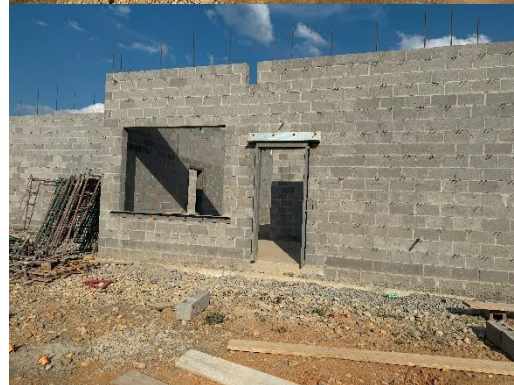
- e) Galvanized steel support angles were being secured to the block walls to support brick.

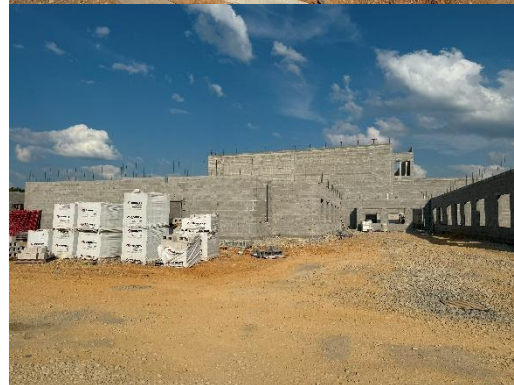
- f) From the south end of the building the storm shelter area including the gym and dressing areas was up to the roof level.

The roof area of the gym was completely covered with a reinforced concrete slab to put a cap on the storm shelter.

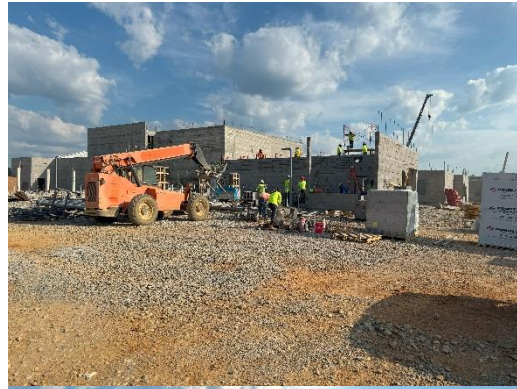
- g) The southernmost classroom wing was being laid up with concrete block.

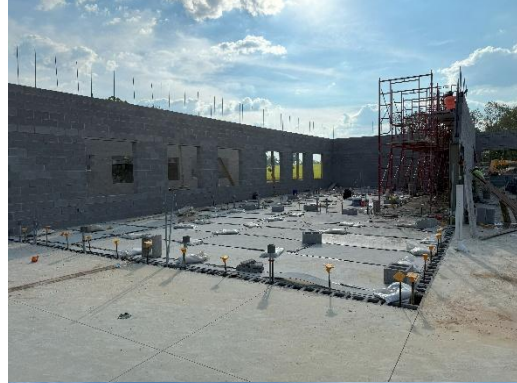
- h) The exterior of the classroom wing was laid first. Soon, this wing will have internal walls like the other two.

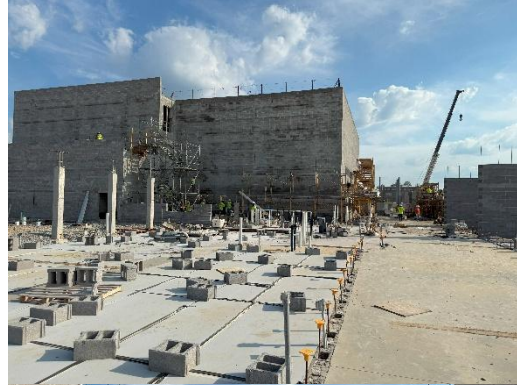
- i) The last area to be enclosed will be the administrative area on the first floor. The library will be above administration.

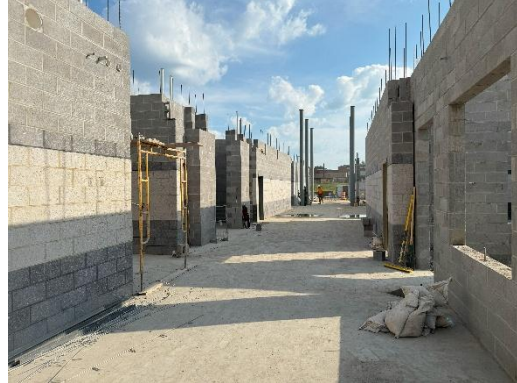
- j) The main corridor was lined with ground faced concrete block which has integral colors. These walls have the 16" long block without the center score. The walls generally looked uniform in appearance.

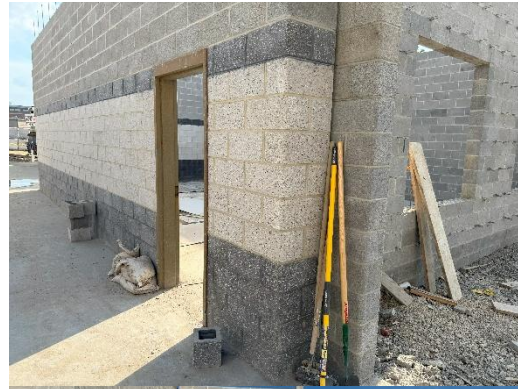
- k) The ground faced concrete blocks stop at the top of the metal door frames. The walls will be painted above that. The outside corners have a bullnose radius.

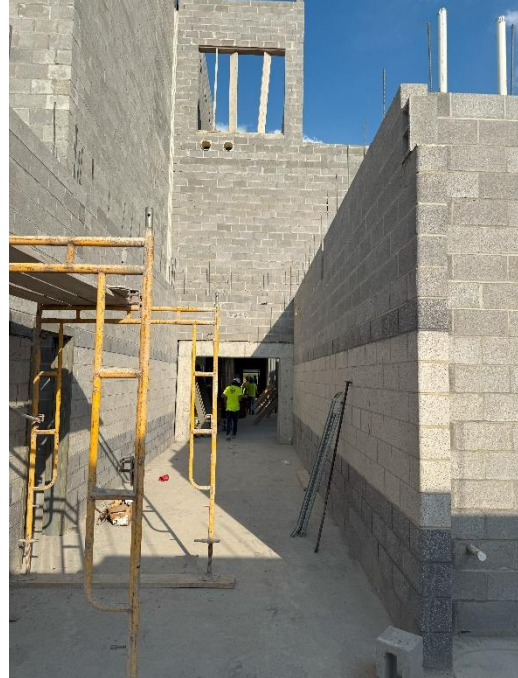
- l) The corridor back to the cafeteria and Area D rooms was taking shape.

The opening at the top of the wall was through a fire rated wall on the mechanical platform level.

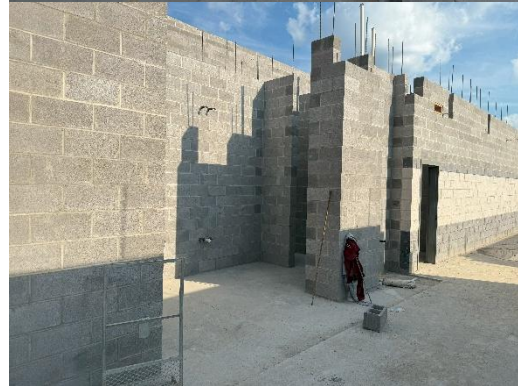
- m) The entrance to the student toilets was defined by the block work. The interior floor and walls of the toilets will be covered with ceramic tile.

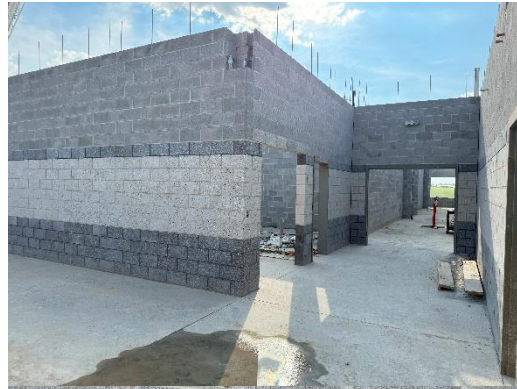
n) The northern classroom wing appeared to be ready for the precast concrete floor planks.

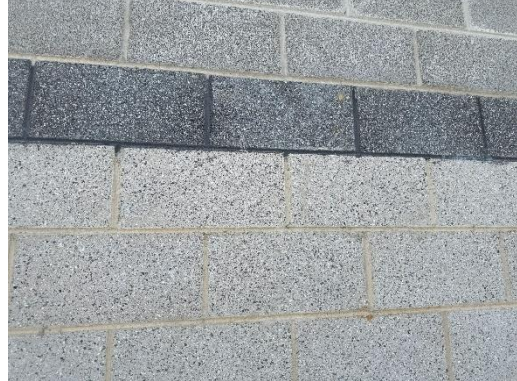
o) The darker ground faced block had a darker mortar. Some of this mortar had bled down to the lighter mortar. This will need to be repaired.

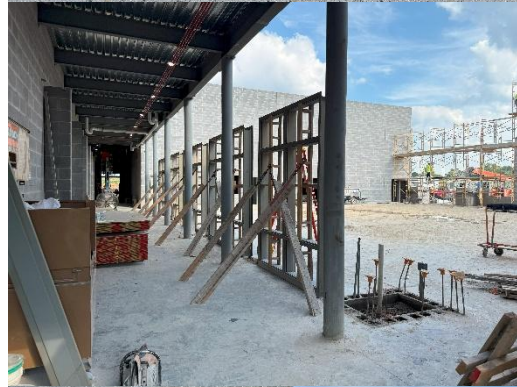
p) Along the corridor outside the cafeteria, steel columns and hollow metal window frames were in place.

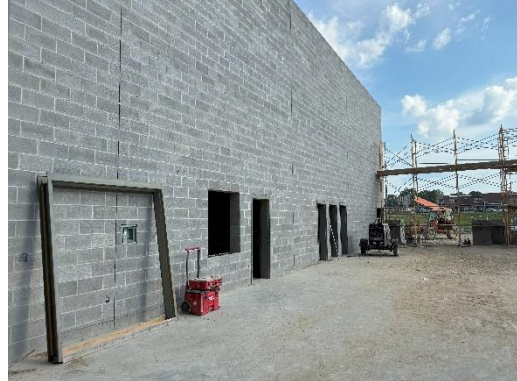
q) The block wall forming the entrance to the kitchen was in place. Doors will lead to the serving lines and the window opening is for the dish return.

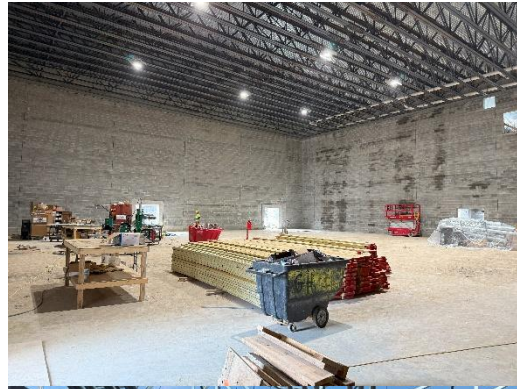
- r) The gym roof area is now covered with the concrete slab. This will effectively dry in the space, although the roofing system will need to be in place to completely keep water out.

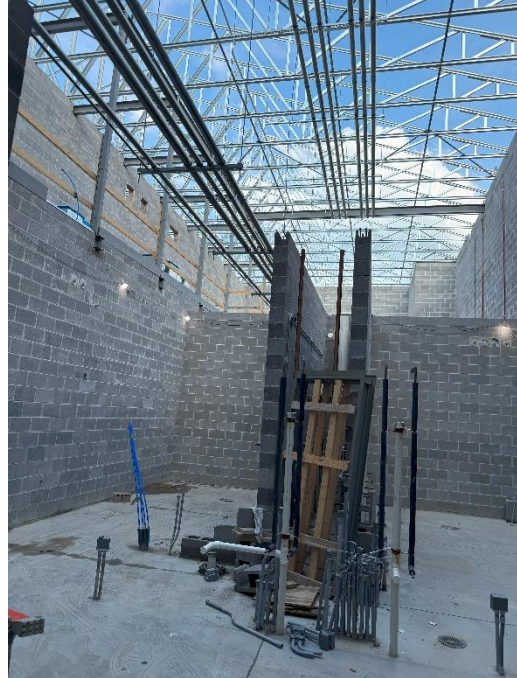
- s) Over the student toilet group in Area D, light gauge metal trusses were installed to support the roof.

Refer to the field report from Shane Kurtz concerning the trusses.

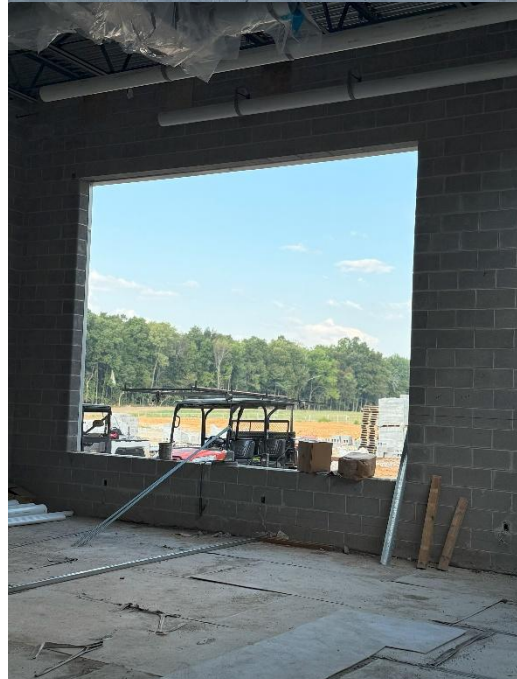
- t) The window opening for the art room appears to have an excellent view.

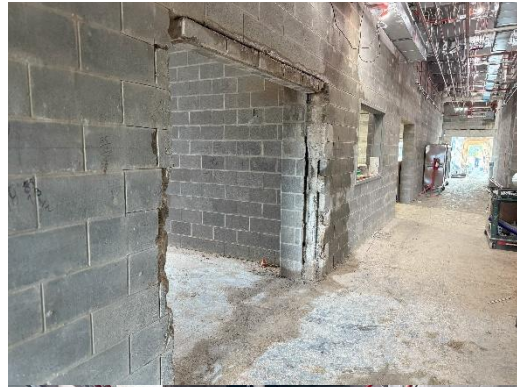
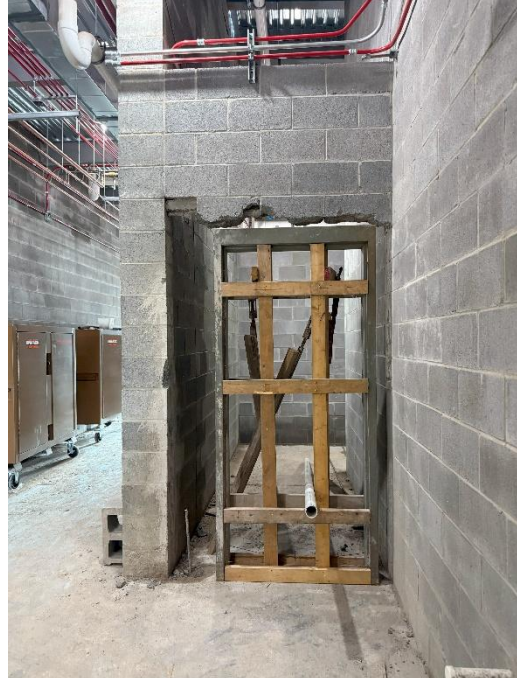
- u) Corrections to this opening and another at the Area D corridor were underway. Steel reinforcing. Jamb blocks and the lintel need to be installed according to the structural drawings. When repaired, the walls must match the surrounding block spacing and texture.

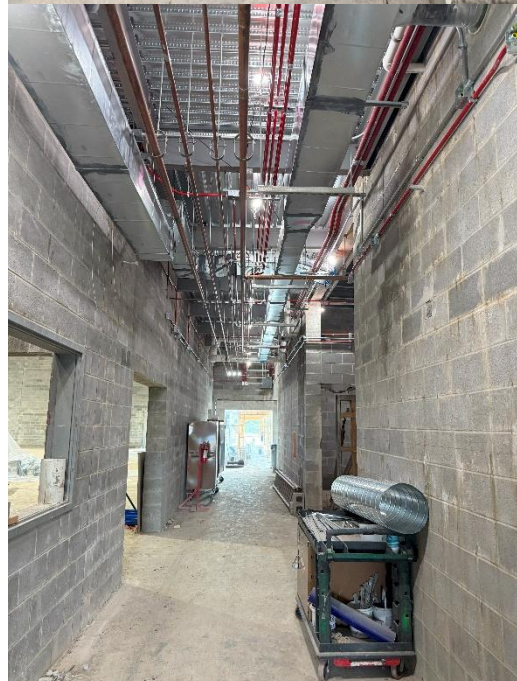
- v) Piping and ductwork for the Area D corridor were installed. This area is in the storm shelter. All penetrations that run through storm shelter walls must meet the specific requirements and details for each penetration.

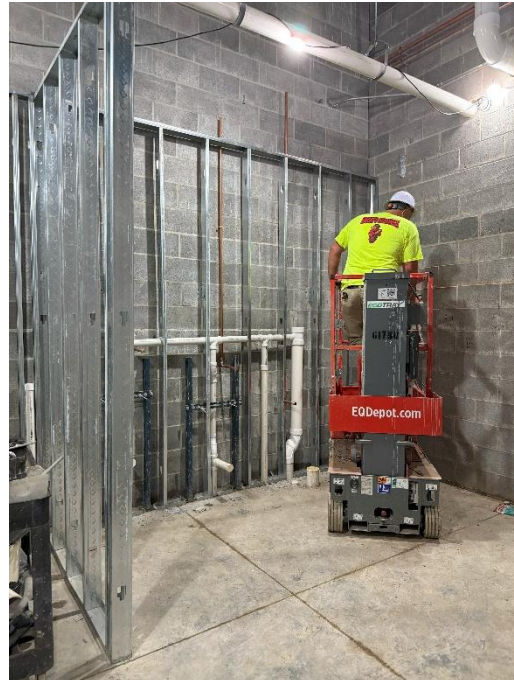
- w) Metal framing was in place in the locker rooms. Plumbing piping was being roughed-in.

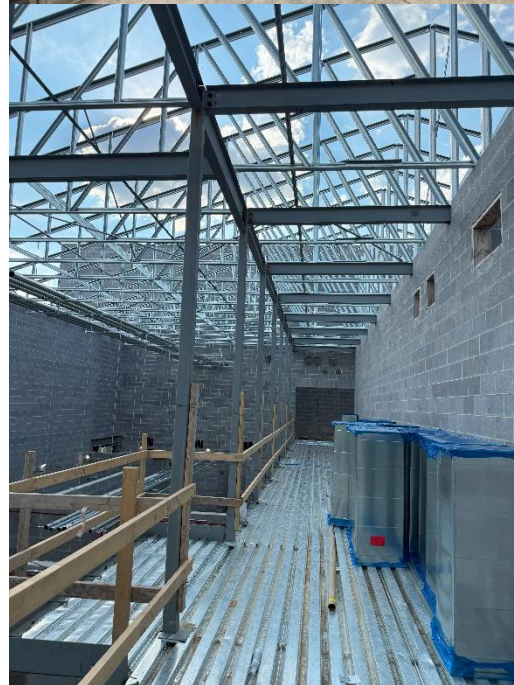
- x) Roof trusses were over the mechanical platform in Area D. Jeremy reported that he plans to have all the deck covered with concrete slabs in the next thirty days. HVAC equipment and ductwork can then be installed.

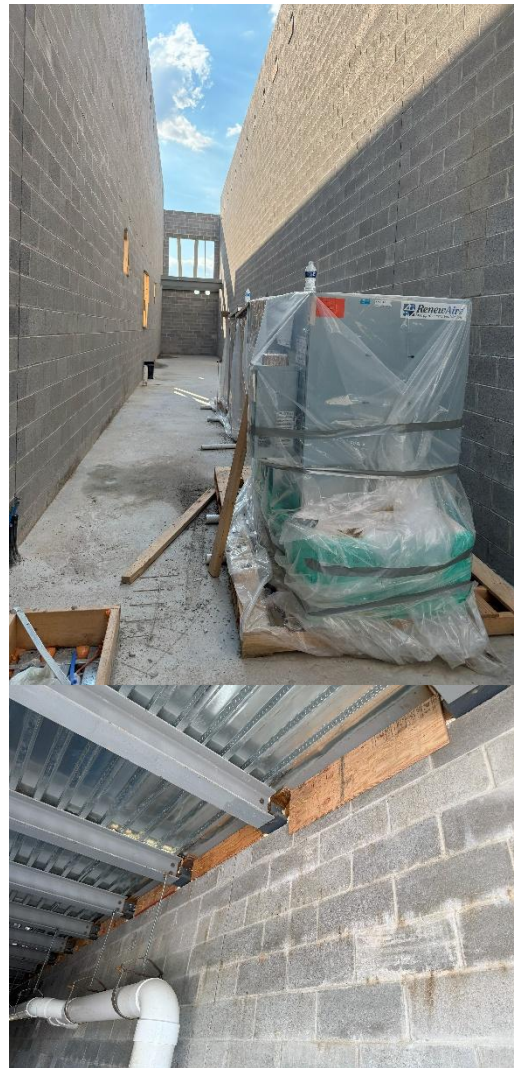
- y) The concrete slab for the mechanical platform on the north side of the gym was in place. HVAC units were being stored near where they will be installed.

- z) Fire treated plywood was used to close the ends of the rood deck for the slab pour. This needs to be reviewed with the building inspector. This is only visible above the mechanical platform.
