FIELD OBSERVATION REPORT

Central Hardin High School – Phase 2, 2019111 -CA8

Date: 9/16/2025 Time: 2:00 PM

Report No: 31

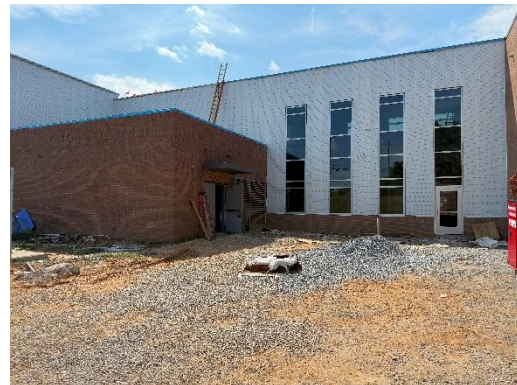
- a) The windows and door were installed in the connector.

The canopy was installed over the doors to the mechanical room.

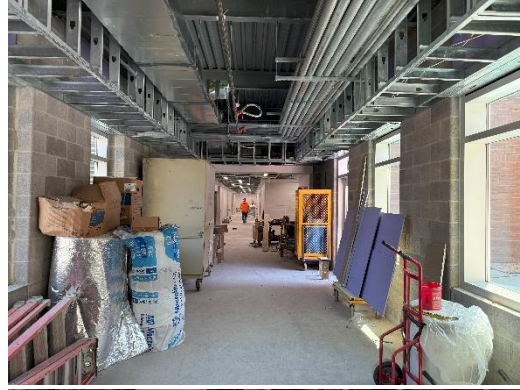
- b) Although the connector will not be turned over to the school, work was progressing in this area.

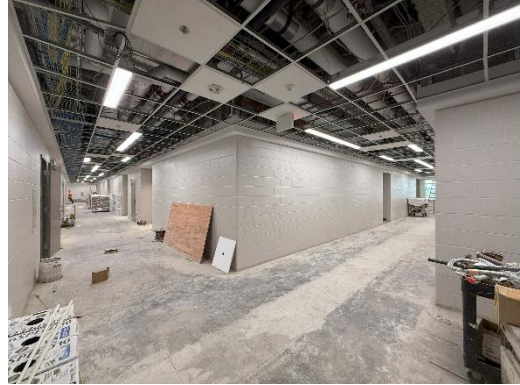
- c) The work is nearing the point where an above ceiling punchlist can be prepared.

The light fixtures were installed in the ceiling grid.

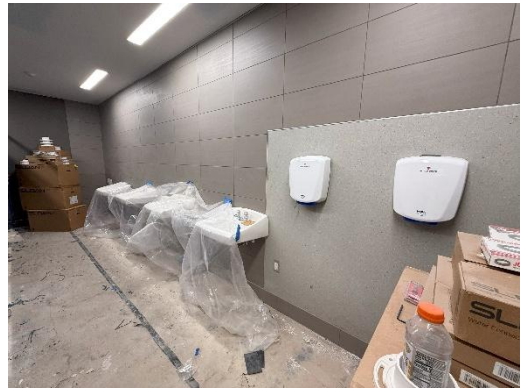
- d) The first-floor student toilets had lavatories, hand driers and finishes installed.

The tile floors were protected.

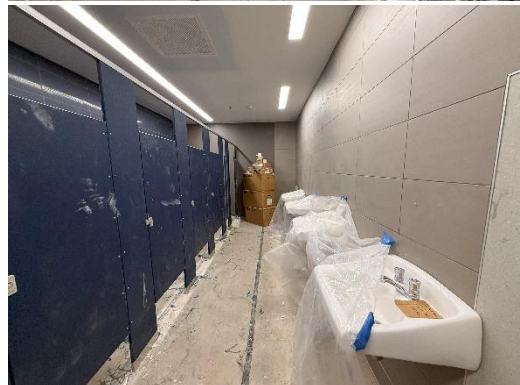
- e) Toilet partitions were installed in the student toilets.

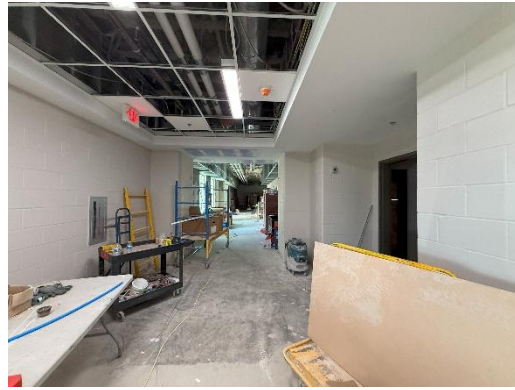
- f) The corridors appeared to be nearing completion.

Some touch-ups will be required for paint on the walls, but for the most part the walls appeared to be uniform.

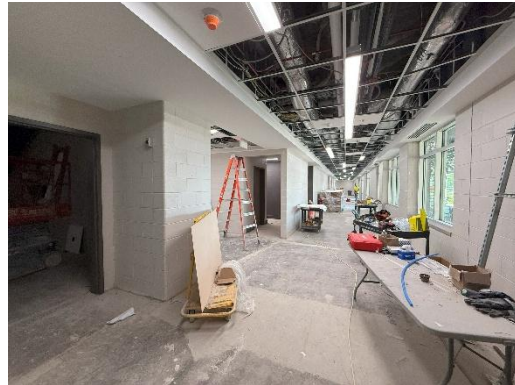
- g) The corridors are still being used for tools and equipment. The corridor floors will be the last to be installed.

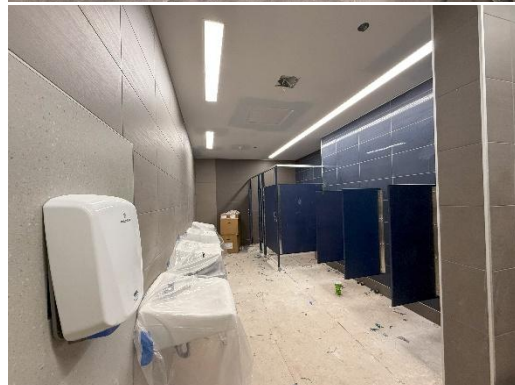
- h) Toilets on the second-floor were also nearing completion.

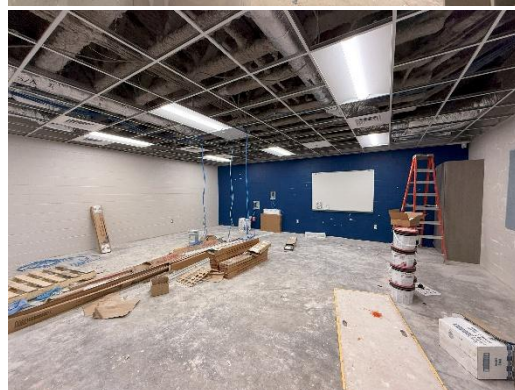
- i) Classrooms on the first floor needed to have above ceiling work completed, tiles dropped and flooring and base installed.

Markerboards were installed.

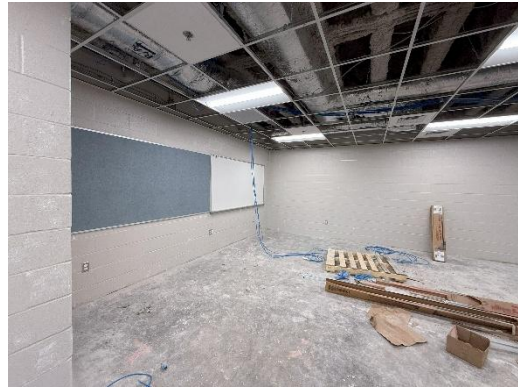
- j) Tack boards were installed.

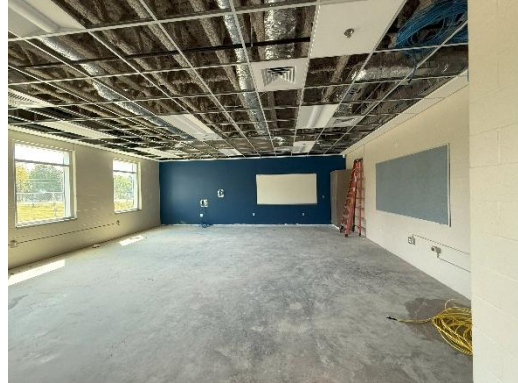
- k) Classrooms were clean and ready for flooring.

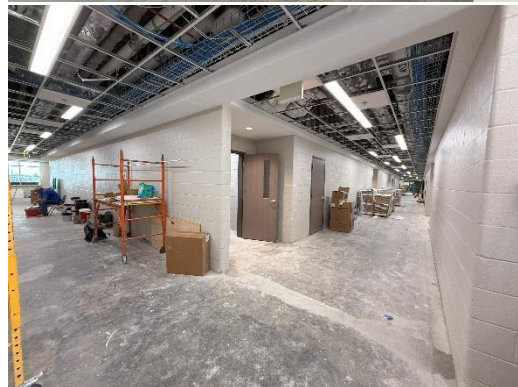
- l) Second-floor corridors were nearing completion.

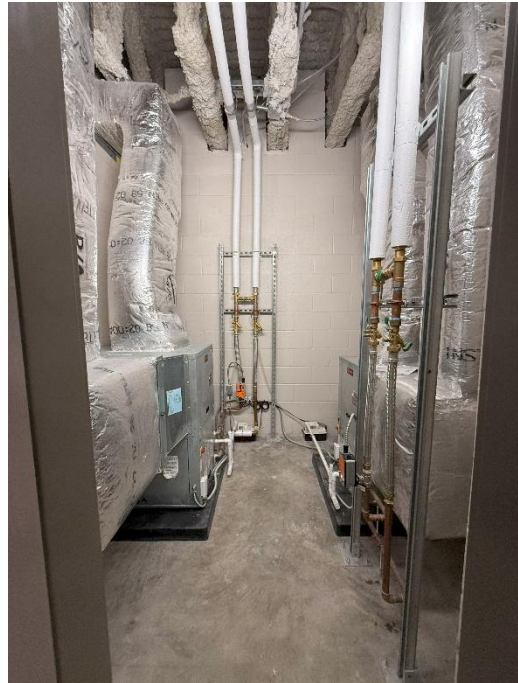
- m) Mechanical equipment was started up and cooling the spaces. Mechanical closets had been cleaned.

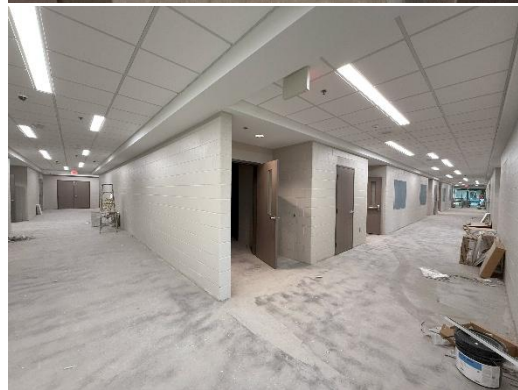
- n) Second-floor corridors had ceilings installed.

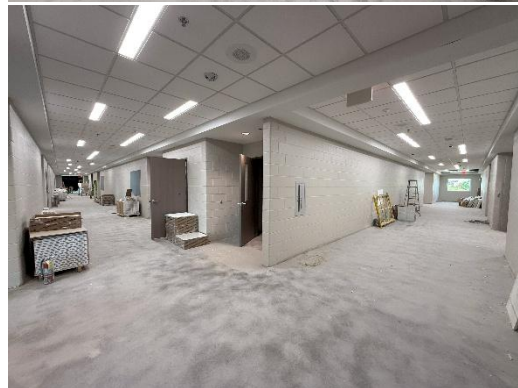
- o) Doors were installed or were being installed.

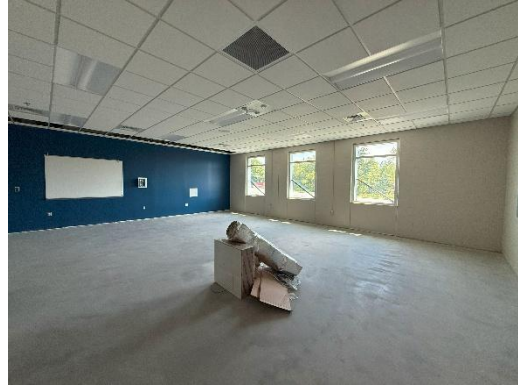
- p) Classrooms typically had ceilings installed on the second floor.

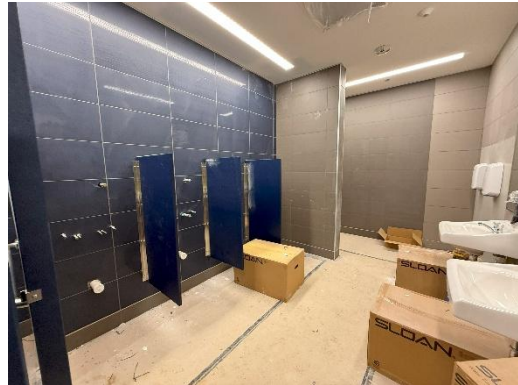
- q) Urinals and water closets were not installed.

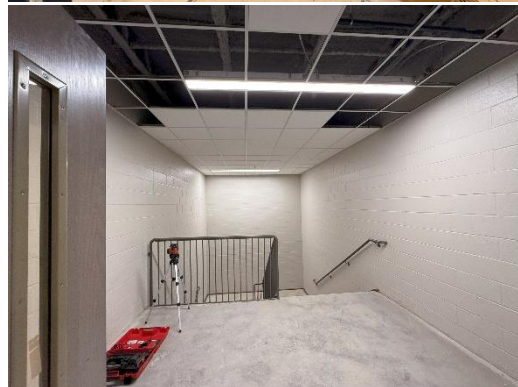
- r) Ceilings were being installed in the two stairs.

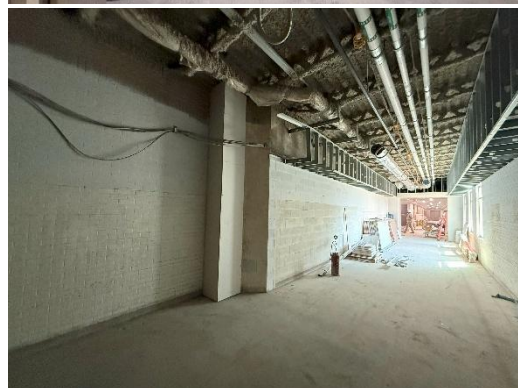
- s) The wall where the original lockers were removed was repaired.

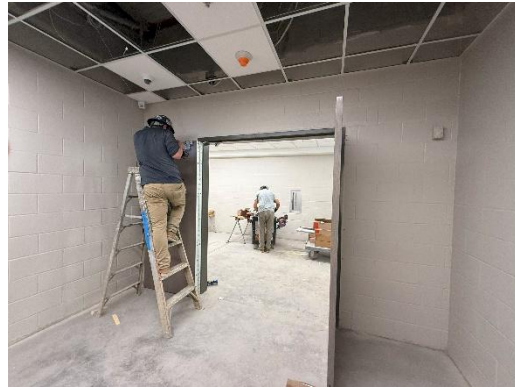
- t) The hole in the south stair enclosure above ceiling had not been sealed with block. This is needed for the fire rating for the stair enclosure.

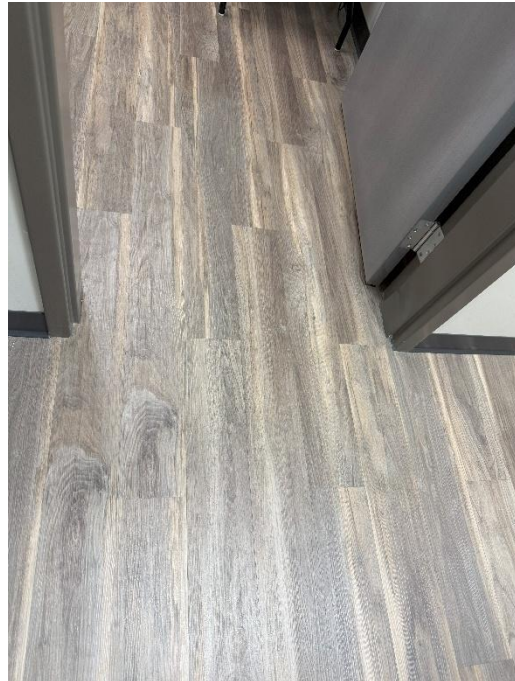
- u) Gill and I reviewed the LVT plank direction in Phase 1. The LVT was laid from east to west and extended into the rooms. This pattern will be used in Phase 2.

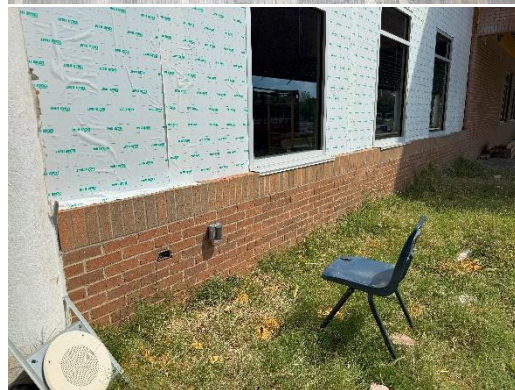
- v) Nawkaw requested that we select a sample brick area on Area D and J to be stained. The brick on the west side of the connector has original brick below the new soldier course.

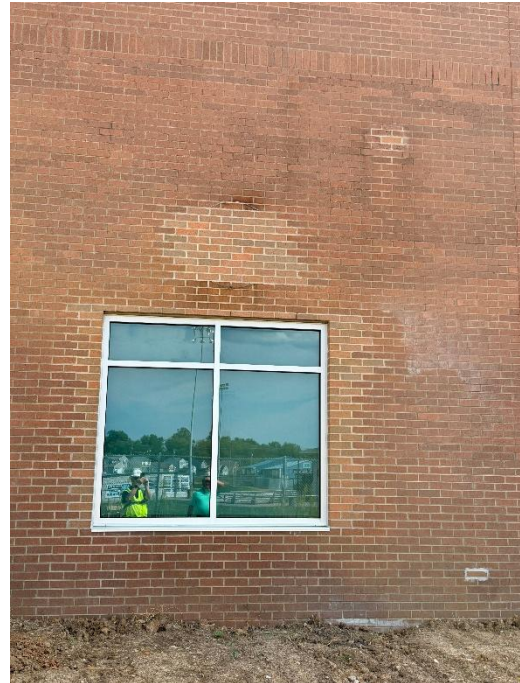
- w) We will suggest that the brick at the classroom window on the north wall of Area D be stained to match the original.

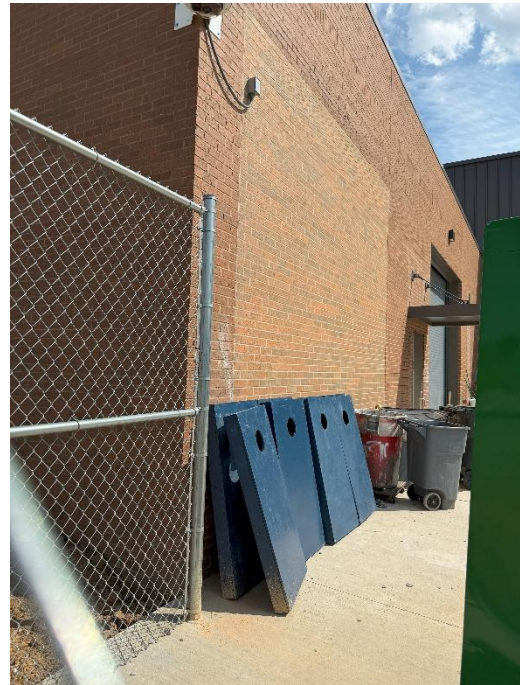
The brick infill panel can be stained to match the existing brick.
