FIELD OBSERVATION REPORT

Child Nutrition Building (Food Service Building, 202276 -CA8)

Date: 9/16/2025 Time: 10:30 AM

Report No: 16

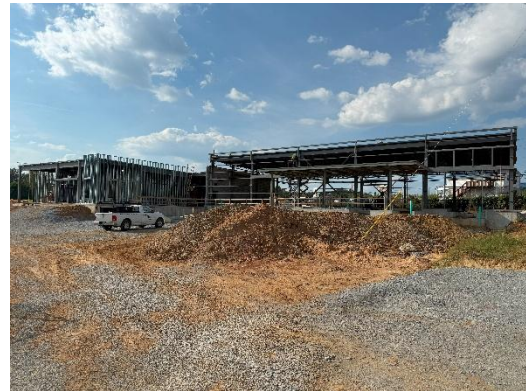
- a) The structural steel frame was in place for the building. The office and warehouse areas were covered with metal roof decking.

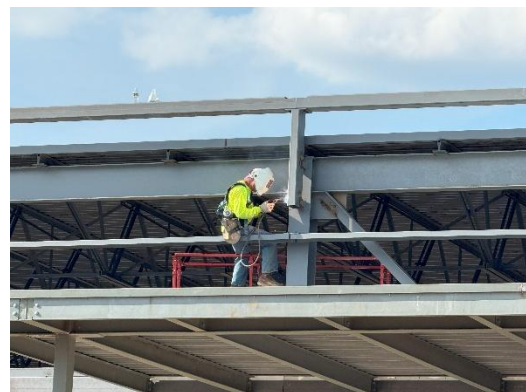
- b) Steel erectors were finalizing connections.

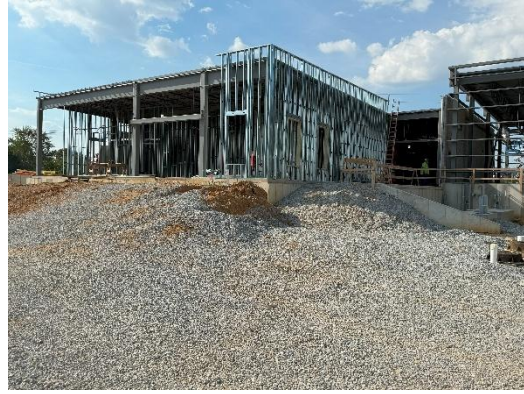
- c) Curtainwall framing was installed around most of the office area.

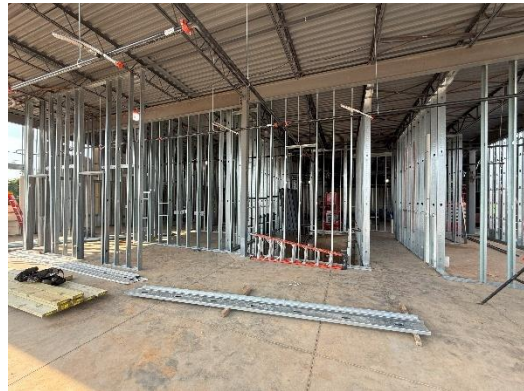
- d) Additional light gauge stud framing was in place in the office area. Hollow metal door frames were installed in the wall framing.

Fire suppression piping was installed in the ceiling spaces.

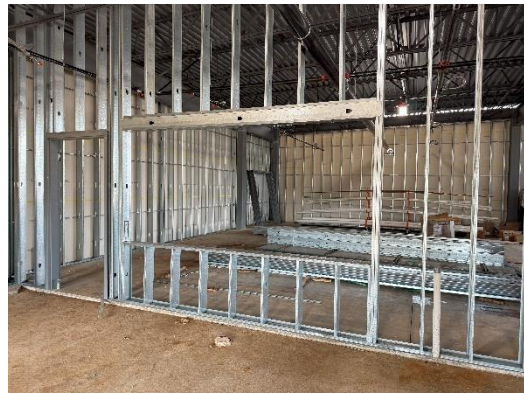
- e) Box headers were in place over interior window openings.

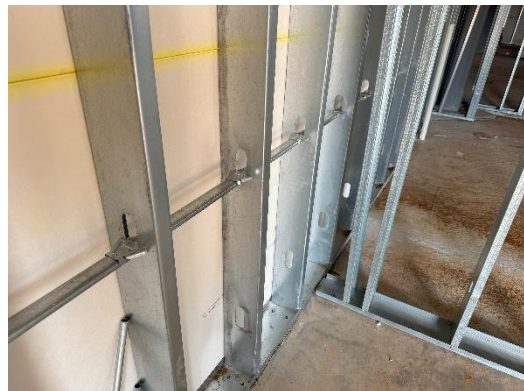
- f) Steel bridging was installed in the curtainwall framing at the exterior of the building. The exterior of the framing was being covered with gypsum sheathing panels.

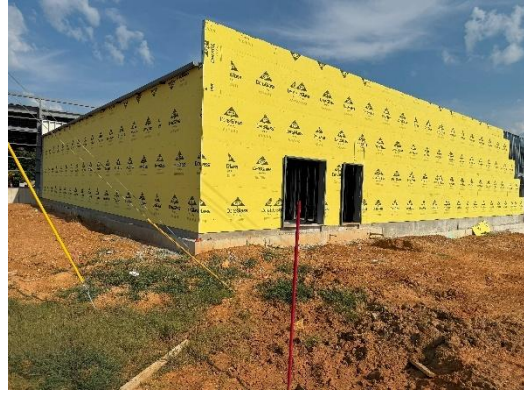
- g) Exterior gypsum sheathing panels were installed on the south and west elevations of the office area. The roof slopes to a gutter on the west side of the building.

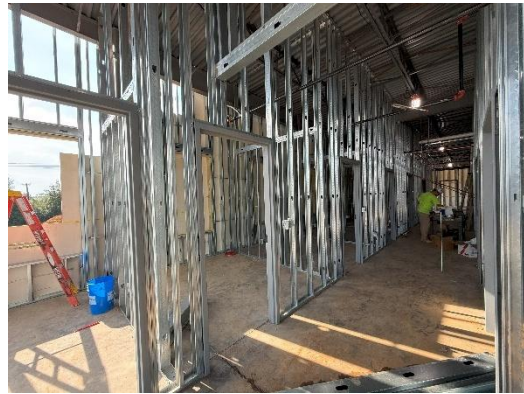
- h) Double jamb studs were in place at the hollow metal frames. A single track supported the cripple studs.

Confirm that this installation meets the structural requirements per the specifications.

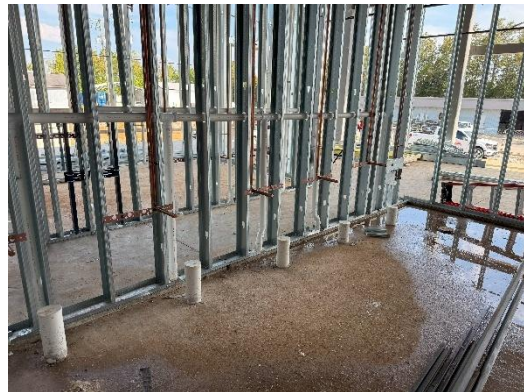
- i) Supply plumbing piping was being installed in the stud walls.

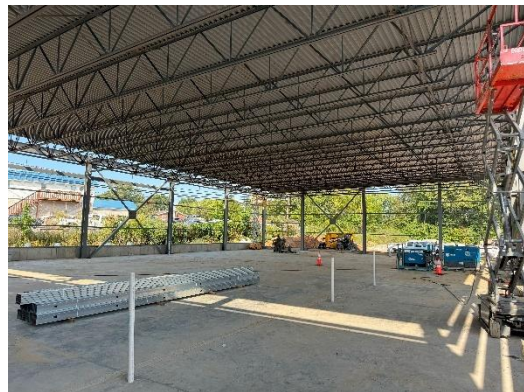
- j) The roof deck over the warehouse area was in place and was being detailed.

The steel frame was reinforced with steel "X" bracing.

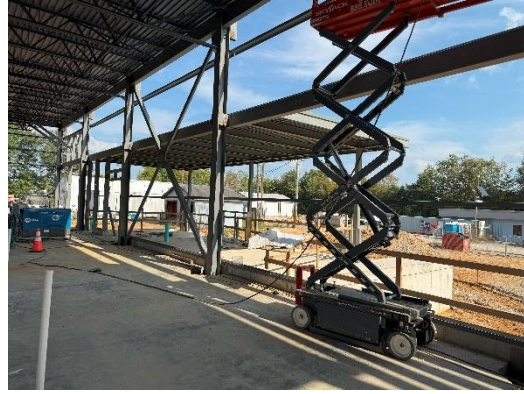
- k) The canopy over the loading dock was covered with metal roof deck.

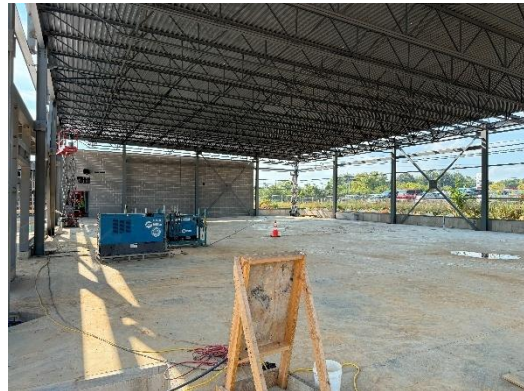
- l) From the north end of the warehouse, the slope of the roof could be seen.

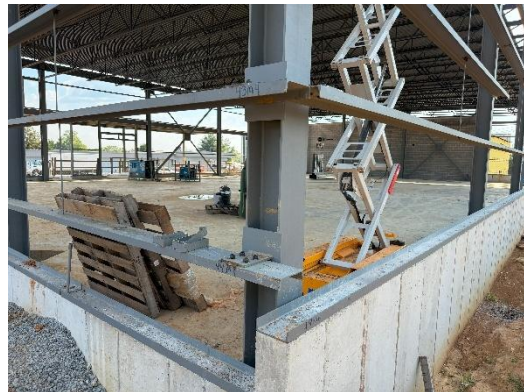
- m) Steel channel girts were in place to carry the exterior steel wall panels.

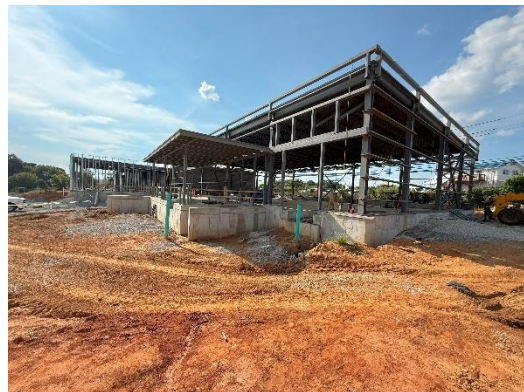
- n) Steel framing projected above the roof to form a parapet at the east and north sides of the roof.
