FIELD OBSERVATION REPORT #15

2025-09 - New Board Office

■ TO:	Kenton County Board of Education 1055 Eaton Drive Ft. Wright, KY 41017	■ DATE:	2025.09.23
ATTENTION:	Mr. Mike Blau		
■ FROM:	Mark Perry mperry@embosdesign.com 906 Monmouth Street Newport, KY 41071 V: 859.431.8612 • D: 859.578.6013	■ PROJECT:	New Board Office KCSD BG#24-084
COPIES TO:	Mr. Matt Rigg; Mrs. Carrie Hooten, Mr. Brian Vanover	PROJECT NO.:	22-106

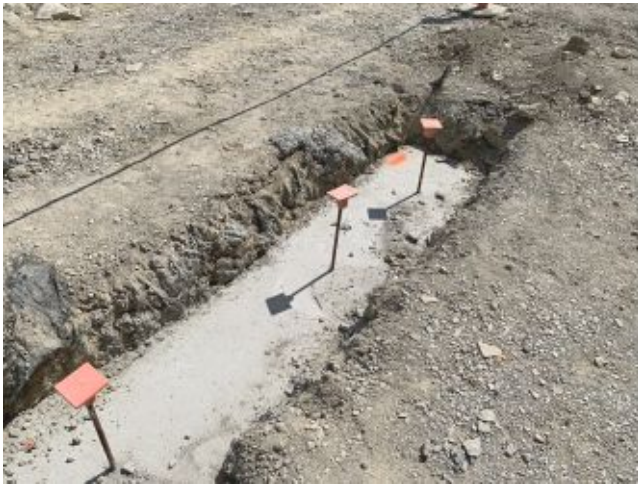
03.01: 2025.09.02 – Footings for exterior patio benches had been poured.

2025.09.02 – Footings for patio benches outside of board room

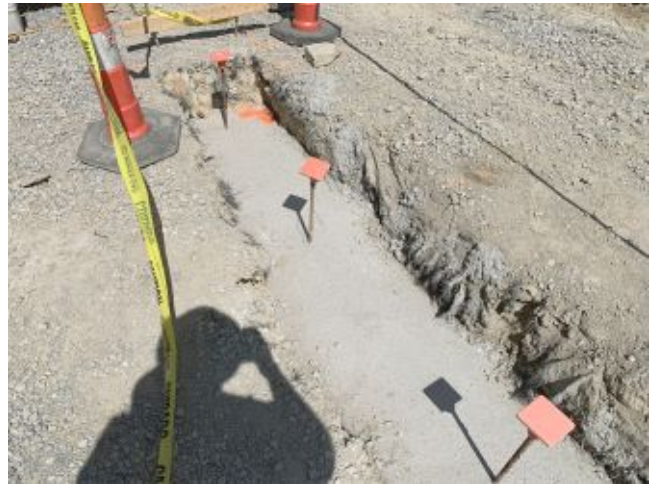
2025.09.02 – Footings for patio benches outside of board room

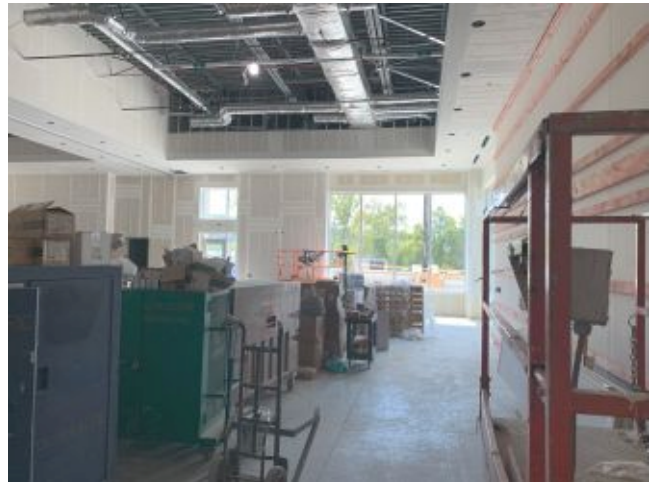
09.02: 2025.09.02 – Gypsum board finishing was nearing completion in the board room. A lack of control joints was pointed out to Monarch.

2025.09.02 – Board room looking south

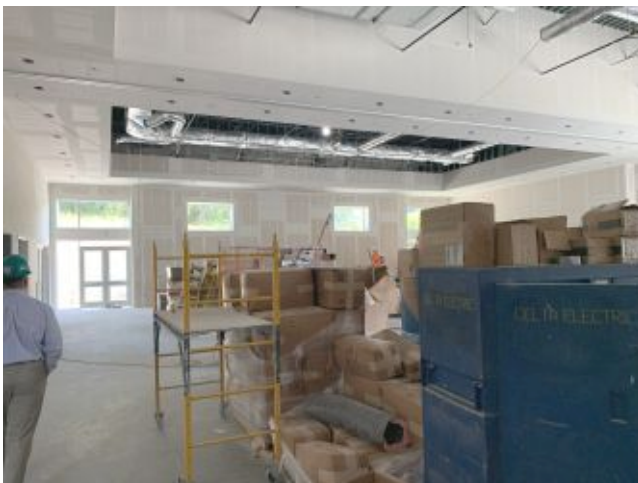
2025.09.02 – Board room looking east

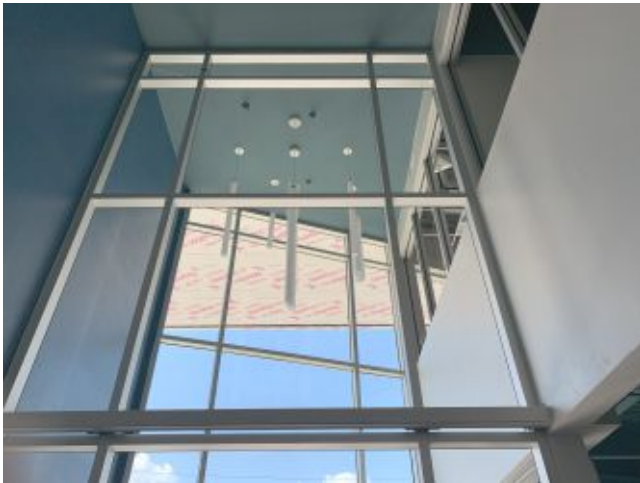
20-28.04: 2025.09.11 – Primary electric had been energized just prior to a planned on-site meeting to review an electrical change of work proposal. Light fixtures had been hung in the entry vestibule, and several corridor lights had been installed at the third floor.

2025.09.11 – Vestibule light fixtures

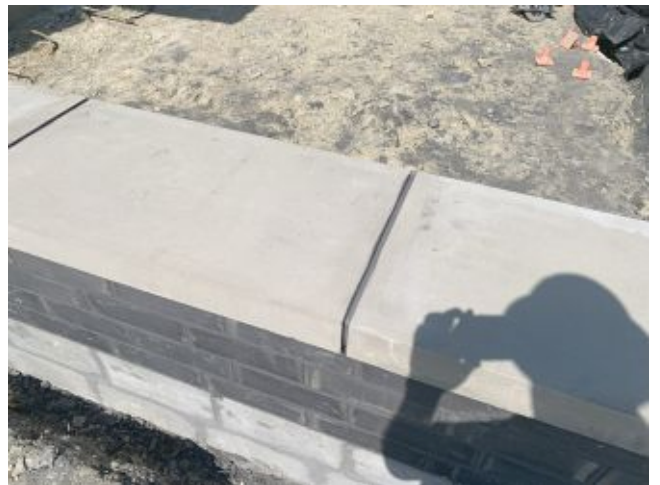
04.01: 2025.09.11 – Masonry benches had been erected at the exterior patio.

2025.09.11 – Patio bench

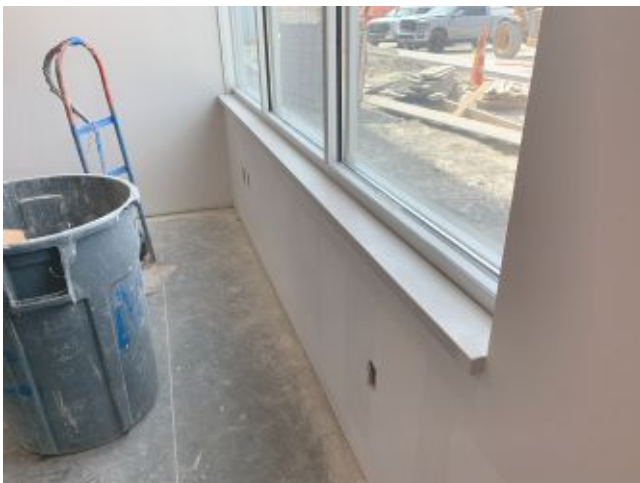
06.03: 2025.09.16 – Solid surface window sill installation appeared largely complete on first and second floors. Third floor sills and countertops had been delivered.

2025.09.16 – Window sill in Office #142

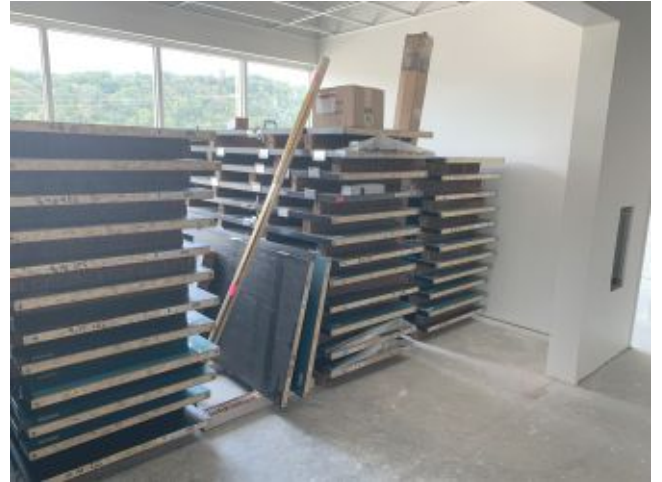
08.01: 2025.09.16 – Third floor wood doors had been delivered.

2025.09.16 – Wood doors staged on third floor

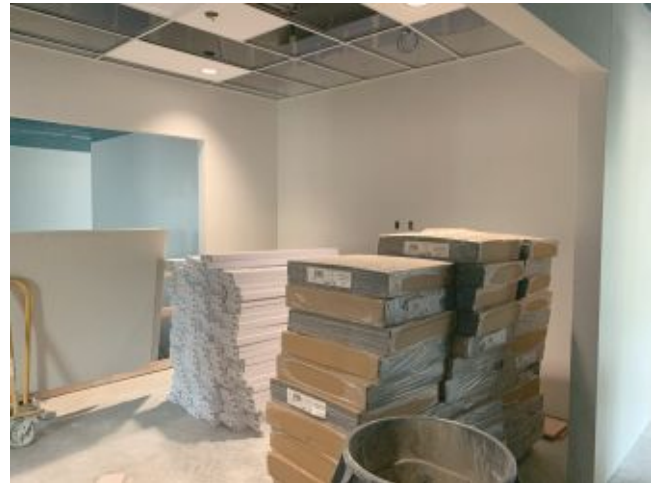
20-28.06: 2025.09.16 – Some second floor light fixtures had been energized. Outlets were reported complete at the second and third floors.

2025.09.16 – Lights energized in Conference Room #212

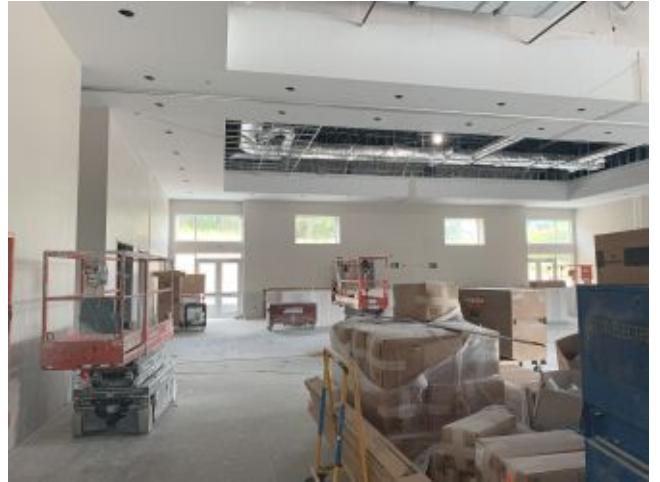
09.06: 2025.09.16 – Missing control joints had been installed in the board room. Walls and ceilings had received paint a first coat of finish paint.

2025.09.16 – Board room looking east

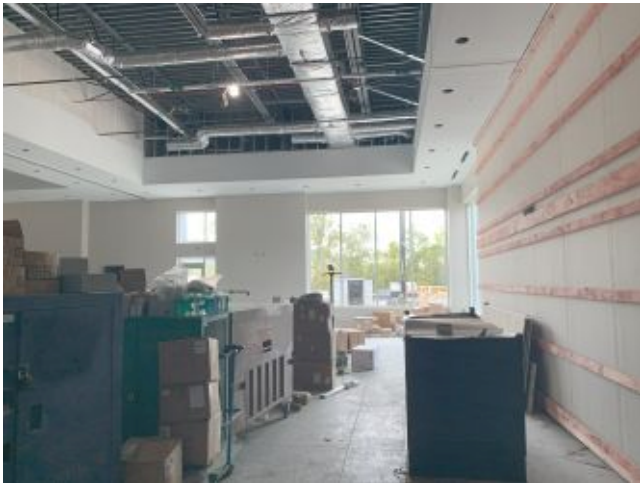
2025.09.16 – Board room looking south
