FIELD OBSERVATION REPORT

Central Hardin High School – Phase 2, 2019111 -CA8

Date: 10/24/2025 Time: 12:30 PM

Report No: 33

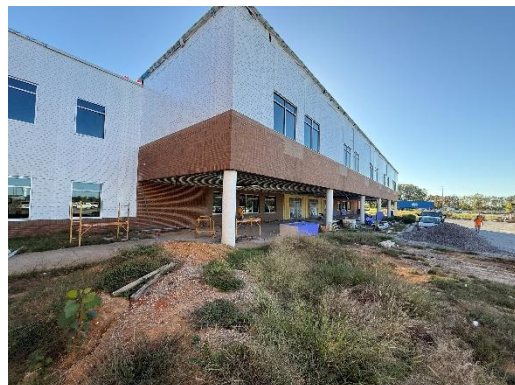
- a) The elevations of Area J with the exposed weather barrier have been measured for the metal panel system. Each panel will have an exact location for placement on the exterior.

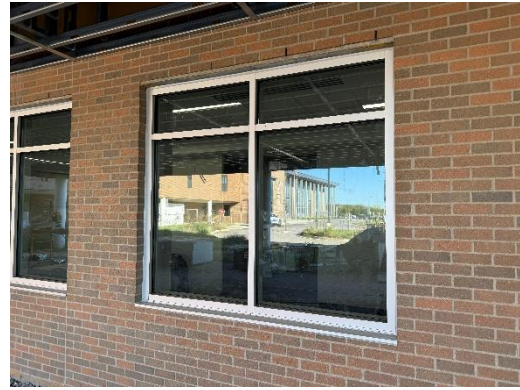
- b) Windows in Area J have been installed, and sealant has been applied at all sides.

We are still waiting on pricing to stain some of the bricks to match surrounding bricks.

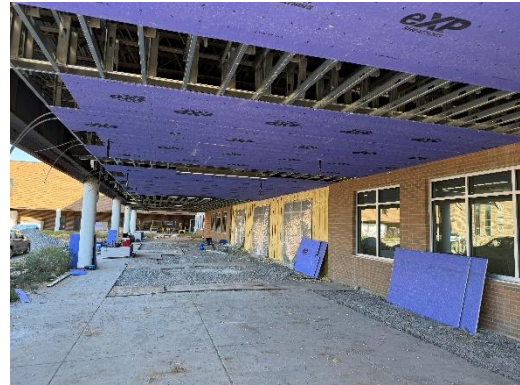
- c) Gill reported that the wallboard backup for the Area J soffit will pause until the fireproofing contractor returns to spray fire resistive material on the structure for the overhang.

We are still waiting on pricing to replace the angle supporting the brick on the overhang.

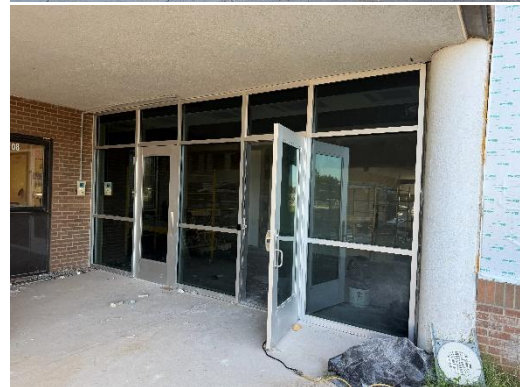
- d) The store front window system at the connecting corridor was in place.

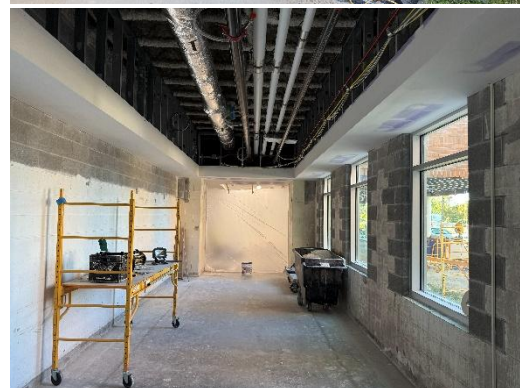
- e) The original connecting corridor to Area H had been sealed off from Area J.

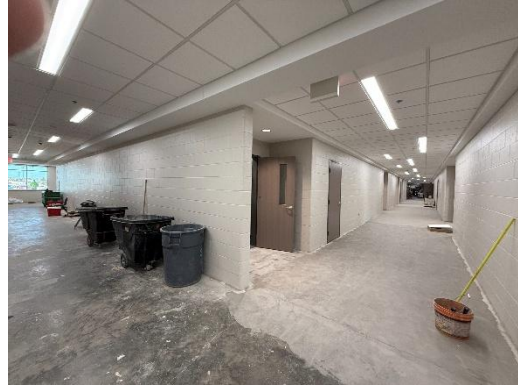
- f) On the first floor of Area J, rubber flooring was being installed in the corridors.

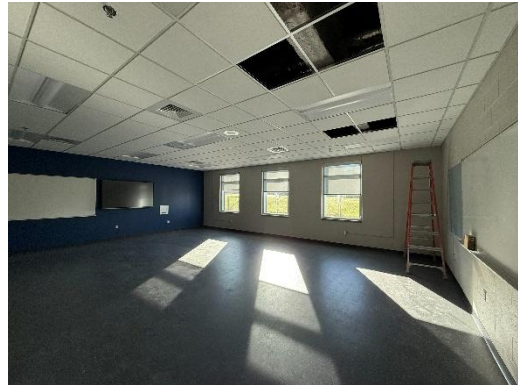
- g) Most of the finishes and accessories are in place on the first floor of Area J.

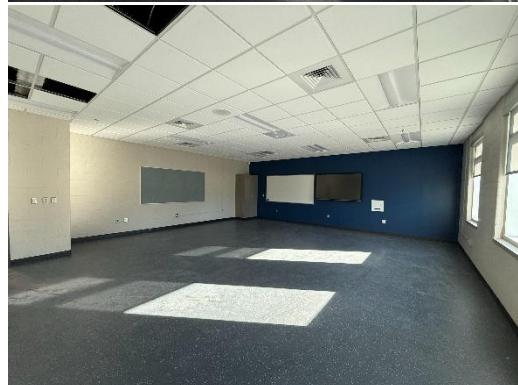
- h) Display boards and the digital displays were installed on the first floor of Area J

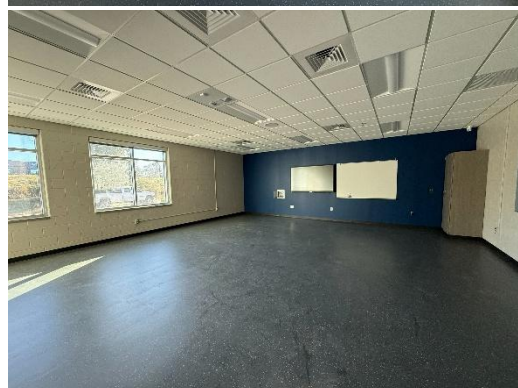
- i) Most ceilings, flooring and wall base were installed on the first floor of Area J.

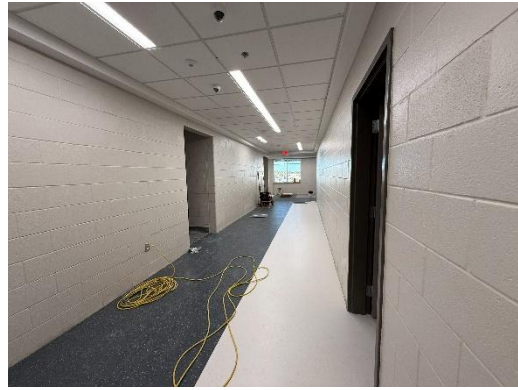
- j) The installation of rubber flooring on the first floor of Area J was nearing completion.

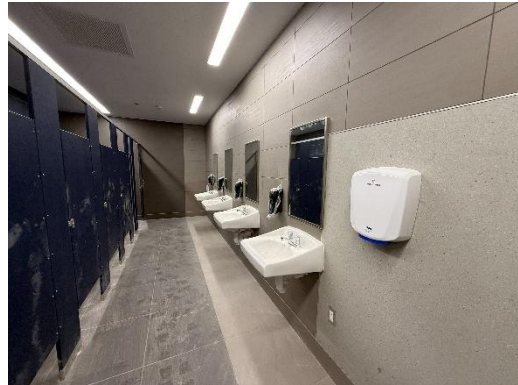
- k) The toilets rooms on the first floor of Area J appeared to be complete except for final cleaning.

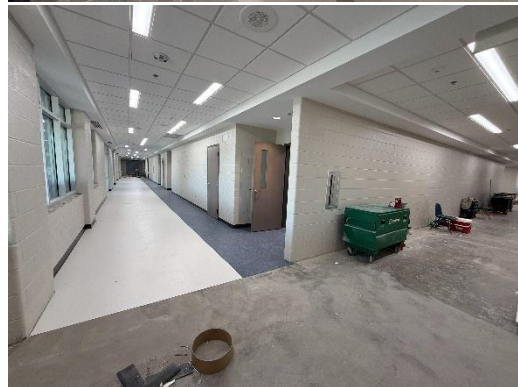
- l) Once flooring is installed, wall base will be installed.

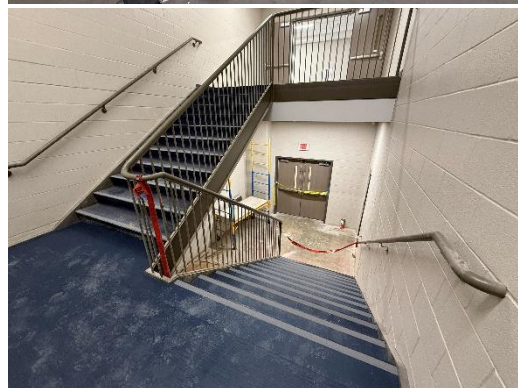
- m) The flooring and treads were installed for the north stair in Area J. The south stair will be the last area to be completed.

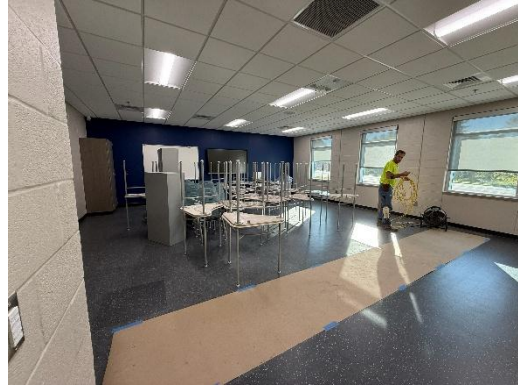
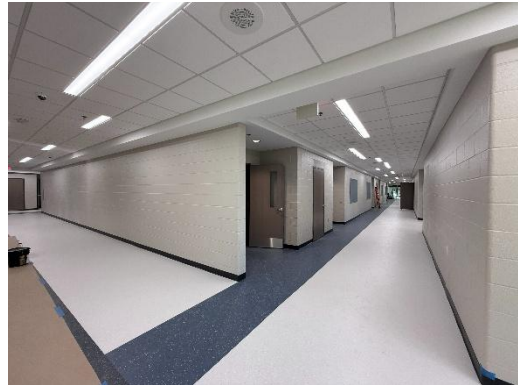
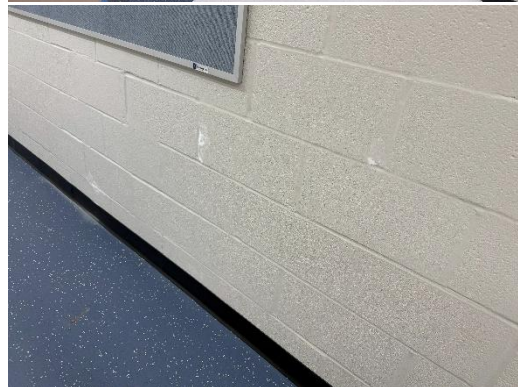
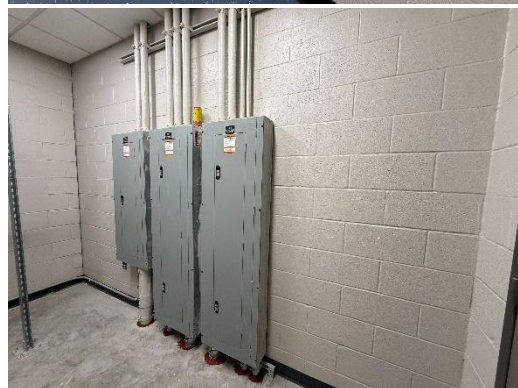
- n) Repairs to the two south classrooms on the second floor were completed. The repairs were almost not perceptible.
- o) The work noted in the punch list for the second floor appeared to be mostly complete.
- p) The mason had repaired the block walls where the original and new block presented uneven appearance.
- q) Pipes and conduits through the second floor slab were properly sealed with fire resistant sealants.

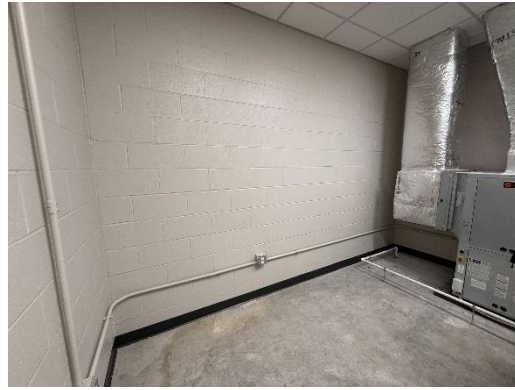
- r) Walls in the storage rooms that had not been properly prepped were corrected.

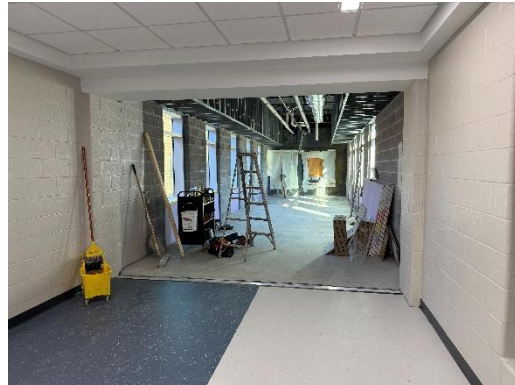
- s) This opening to the connecting corridor to Area H will be sealed before students occupy Area J.

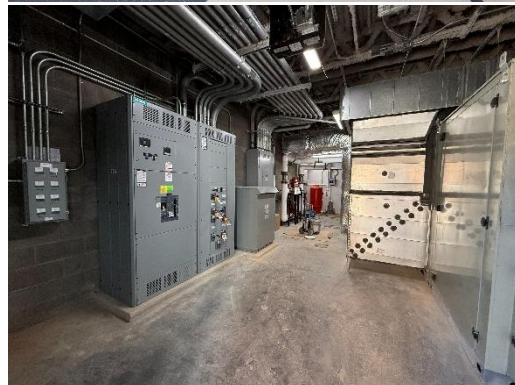
- t) The mechanical room had been cleaned up, and the equipment appeared to be operational.

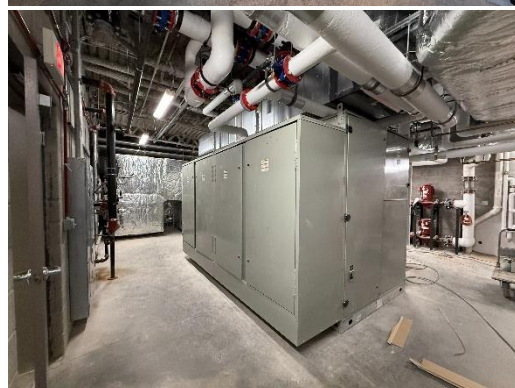
- u) Refer to STW's punchlist inspection for electrical and mechanical items needing correction.
