FIELD OBSERVATION REPORT

Child Nutrition Building (Food Service Building, 202276 -CA8)

Date: 10/14/2025 Time: 10:30 AM Weather: Clear

Observed by: Joseph Jones, AIA Report No: 18

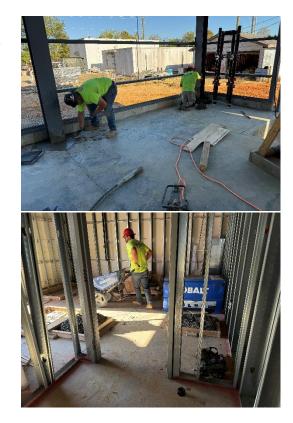
Concrete pads were being poured in the c) mechanical room.

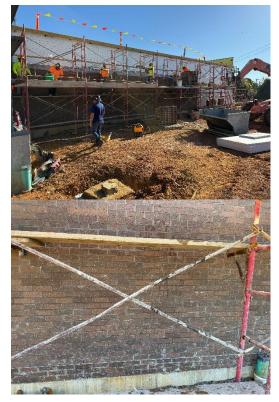
d) Masons were laying brick over rigid insulation on the north side of the office area.

The first three courses below the base flashing had cured enough that the brickwork and joints could be observed. The work appeared to be uniform in appearance.

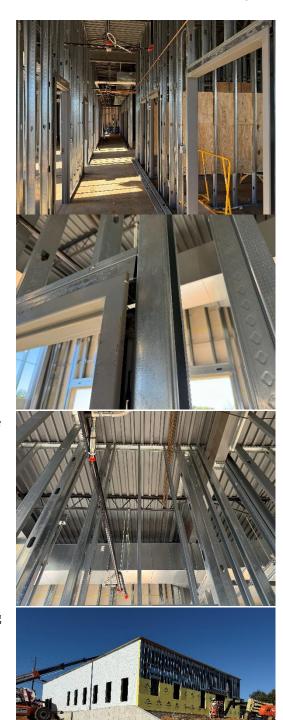
The sheathing and weather barrier was being g) installed on the office area.

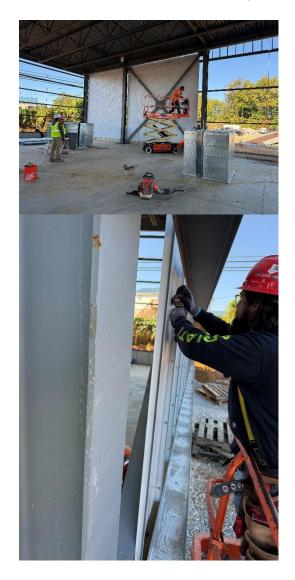
h) The sheet metal liner panels were being installer on the north end of the warehouse.

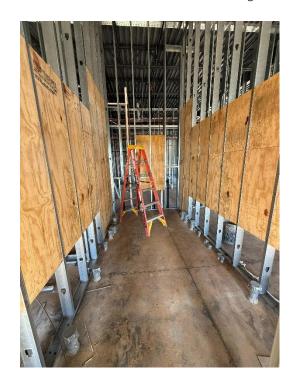
i) Plywood was installed in the data closet.
