FIELD OBSERVATION REPORT

West Hardin Middle School, 202280 -CA8

Date: 10/14/2025 Time: 8:00 AM

Report No: 22

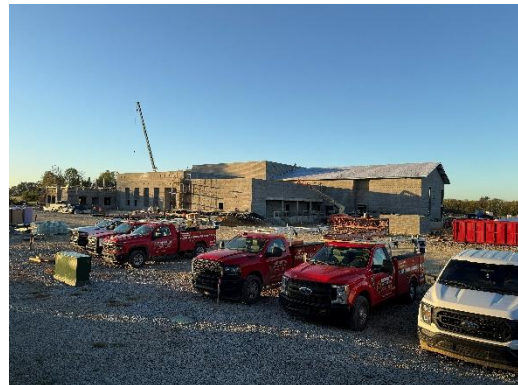
- a) Once covered with brick, windows and roofing, the exterior of northern portions of the building will be nearing completion.

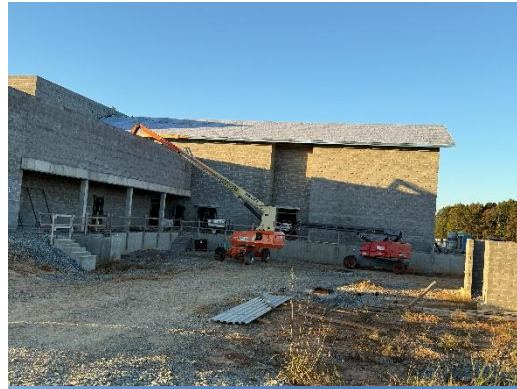
- b) The kitchen loading dock area is defined by the exteriors of Area C and D.

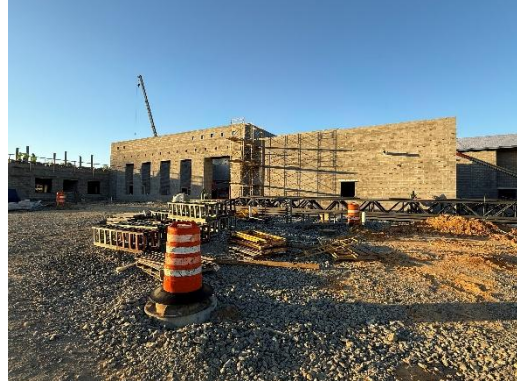
- c) The cafeteria and kitchen exterior walls were in place. Roof structure was in place over the kitchen. The cafeteria is ready to receive its roof structure.

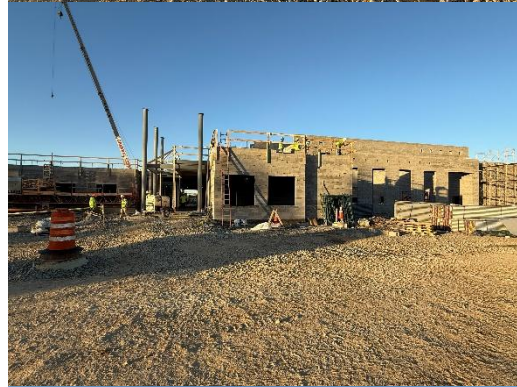
- d) Work was ongoing at the northern end of the building.

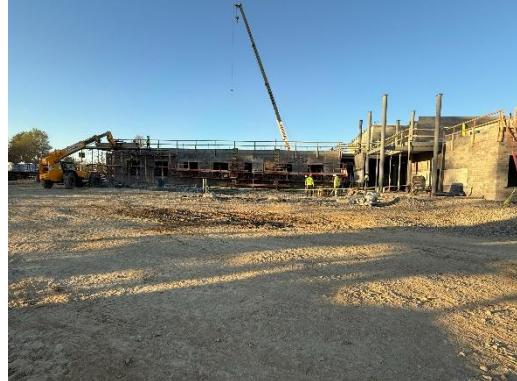
- e) Safety rails were in place around the second floor slab over the north classroom wing.

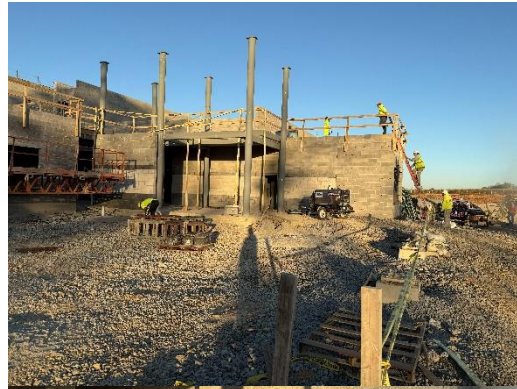
- f) Masons were laying block above the second floor at the north entry to the main corridor.

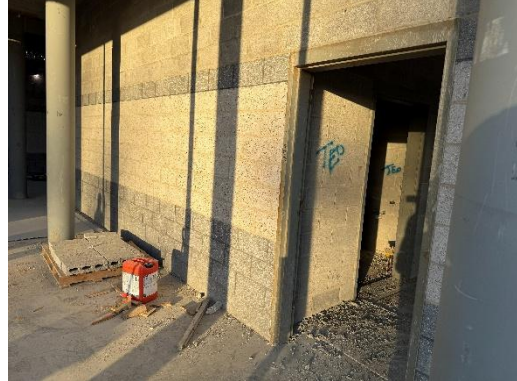
- g) Corridor walls along the main corridor typically have ground faced block to the top of the door frames.

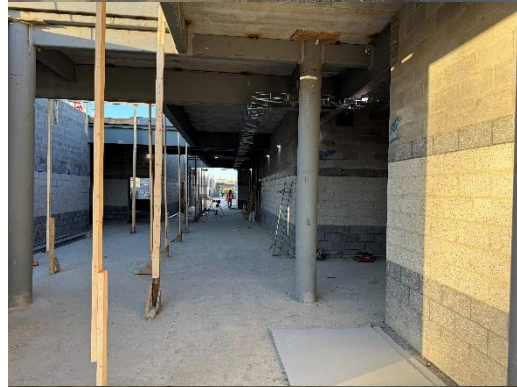
- h) Past the entry lobby on the north end of the main corridor, precast planks can be seen for the second floor

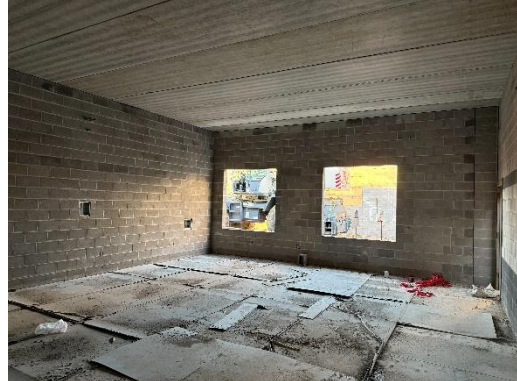
- i) First floor classrooms in the north wing were capped with precast concrete planks. Slabs to have a polished concrete finish were covered with the Skudo board system.

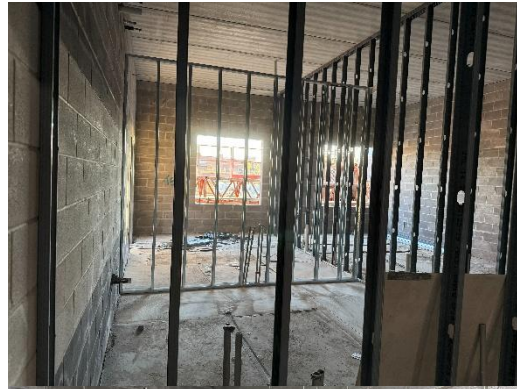
- j) Steel stud walls were installed in areas in the north classroom wing where the wallboard will be the finish surface.

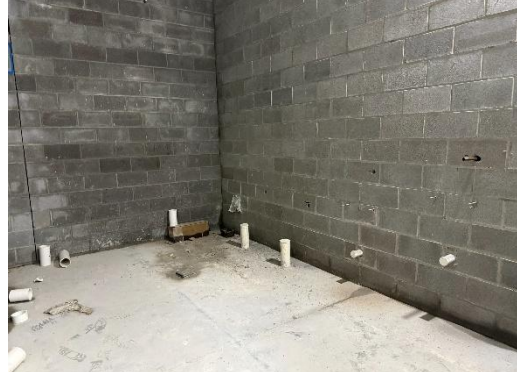
- k) Student toilet rooms were defined by block walls. Plumbing rough-ins were in place.

The block needs to be checked by the tile setters for flatness before the wall tile is installed.

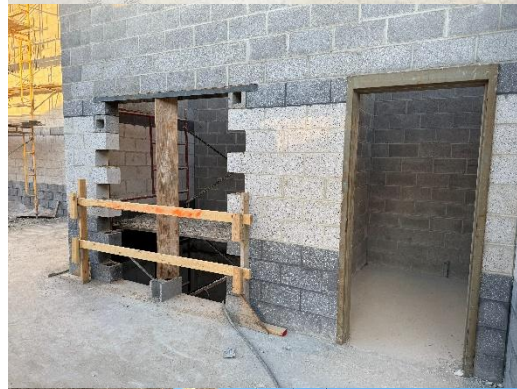
- l) The first floor hoistway door opening was prepared to receive the frame when the levator is installed.

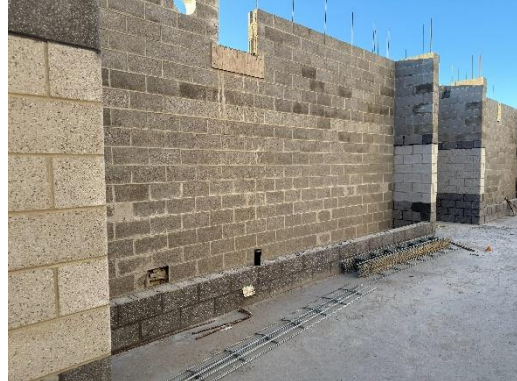
- m) Along the main corridor, alcoves for display cases were formed. These are recessed areas without ground faced block walls.

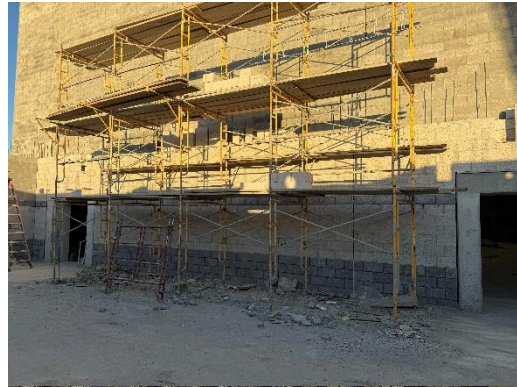
n) The center stair in the main corridor will be against the ground faced block being laid over the gym walls.

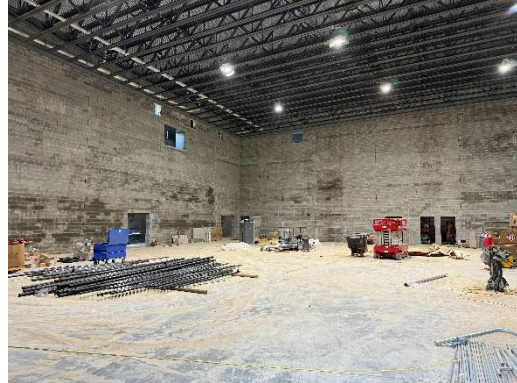
o) As the gym is enclosed it becomes a dry place to store materials.

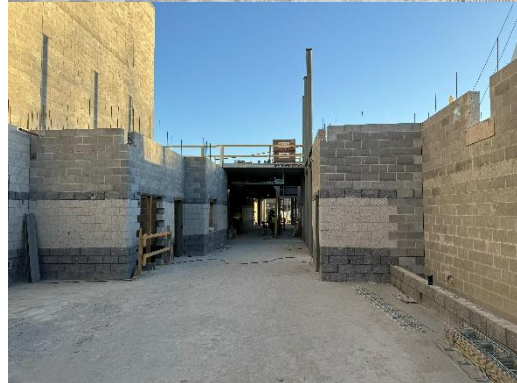
p) Looking to the north from the center of the main corridor, the second floor was being extended to the south.

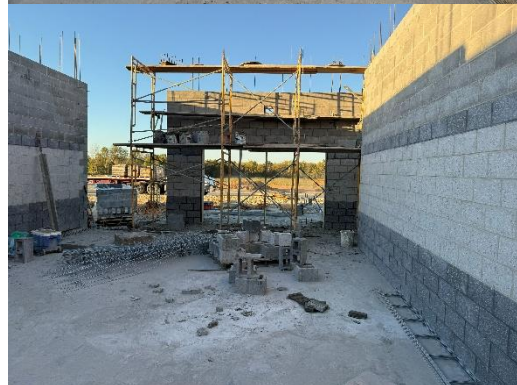
q) The inner wall for the south vestibule for the entry doors to south end of the main corridor was laid.

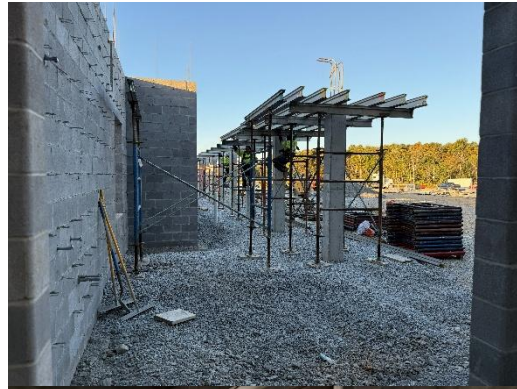
- r) Scaffolding was being installed at the overhang under the library in Area A.

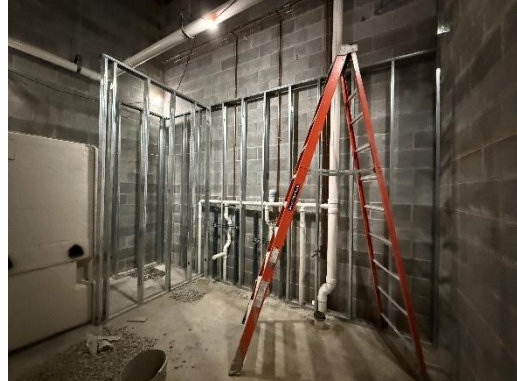
- s) Stud framing and plumbing piping was in place in the gym locker rooms.

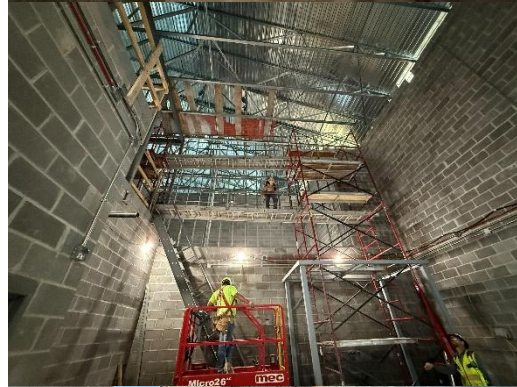
- t) Framers were installing studs for separation walls above the mechanical room.

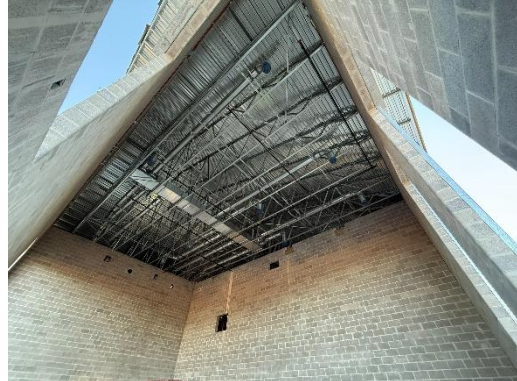
- u) Ductwork was installed over the music rooms in the trusses above.

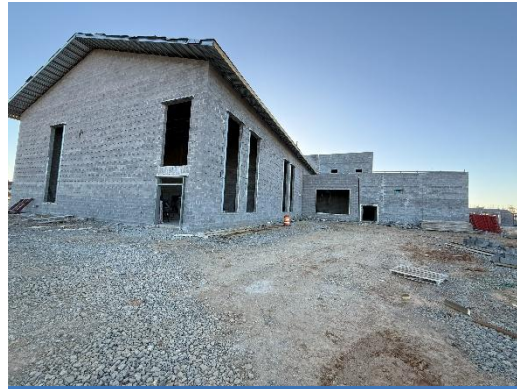
- v) Metal angles were installed around openings in the block walls for Area D. This will allow for spray insulation to be applied and then brick.

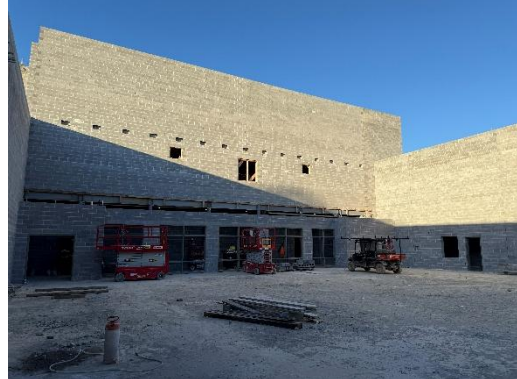
- w) The walls surrounding the cafeteria were in place. This space will have a low sloped built-up-roofing system over metal deck and steel bar joist.

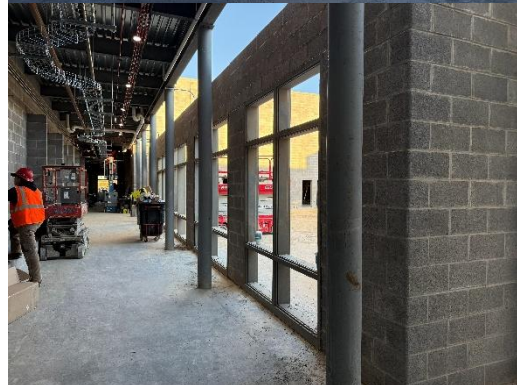
The cafeteria corridor was being defined by block walls and hollow metal window walls.

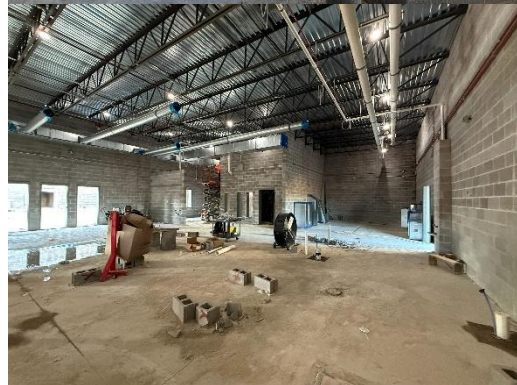
- x) Ductwork, piping and conduits were being installed in the ceiling space for the kitchen.

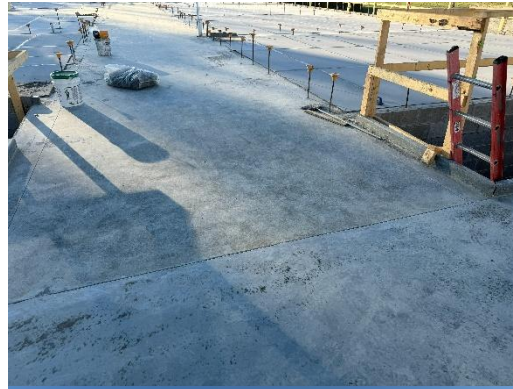
- y) The concrete slab had been poured over the precast concrete planks for the north classroom wing. The slabs were protected by the Skudo board system.

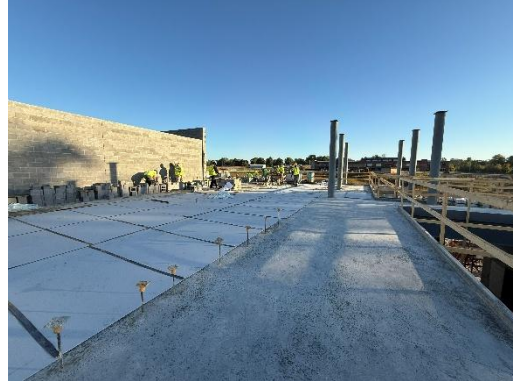
- z) Masons were laying block on the second-floor at the south end of Area B. The topping slab was in place over the precast planks.

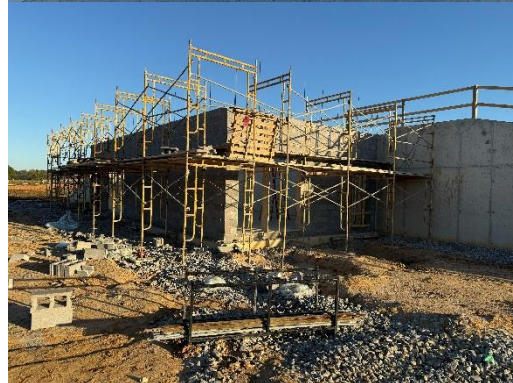
- aa) Block was laid for the first level of the storage/concessions building at the football field.
