FIELD OBSERVATION REPORT #16

2025-10 - New Board Office

■ TO:	Kenton County Board of Education 1055 Eaton Drive Ft. Wright, KY 41017	■ DATE:	2025.10.15
ATTENTION:	Mr. Mike Blau		
■ FROM:	Mark Perry mperry@embosssdesign.com 906 Monmouth Street Newport, KY 41071 V: 859.431.8612 • D: 859.578.6013	■ PROJECT:	New Board Office KCSD BG#24-084
COPIES TO:	Mr. Matt Rigg; Mrs. Carrie Hooten, Mr. Brian Vanover	PROJECT NO.:	22-106

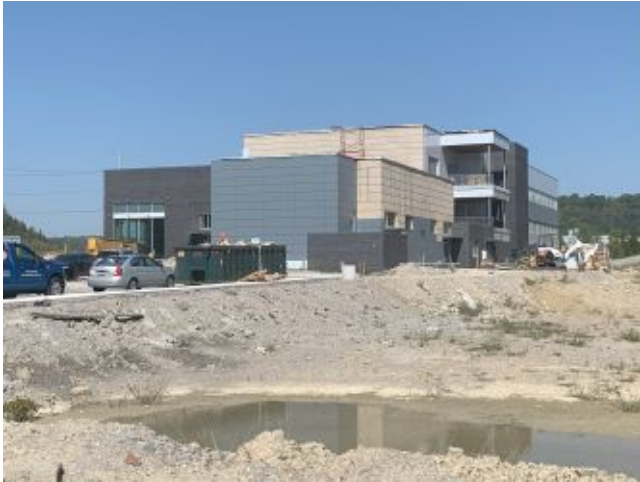
2025.09.30 – Exterior from southeast

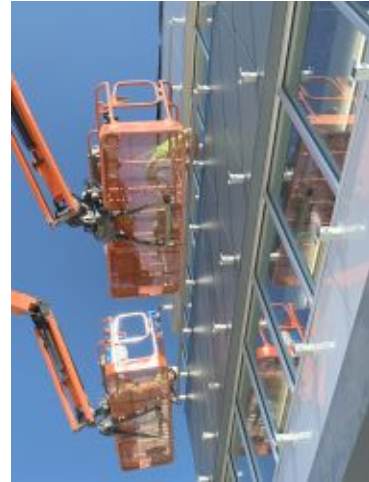
10.02: 2025.09.30 – The installer of the exterior fins was actively installing the first rails at the third floor, north end.

2025.09.30 – Installation of fin rails

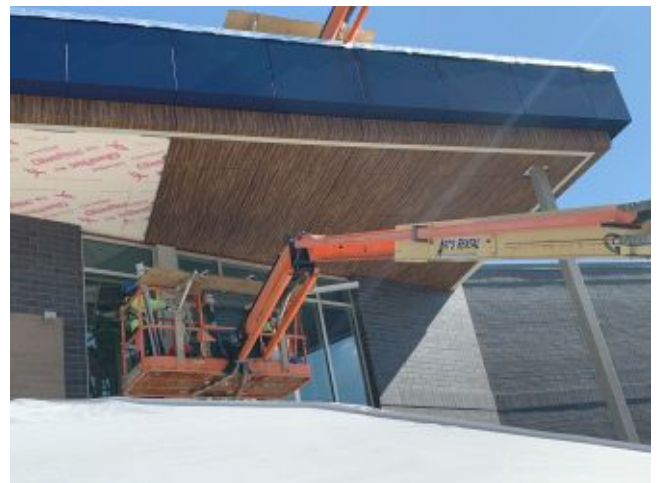
07.01: 2025.09.30 – Composite metal panel installation was occurring above the entry. Only the third floor south wall and 50% of the board room east wall remain incomplete.

2025.09.30 – Exterior above entry

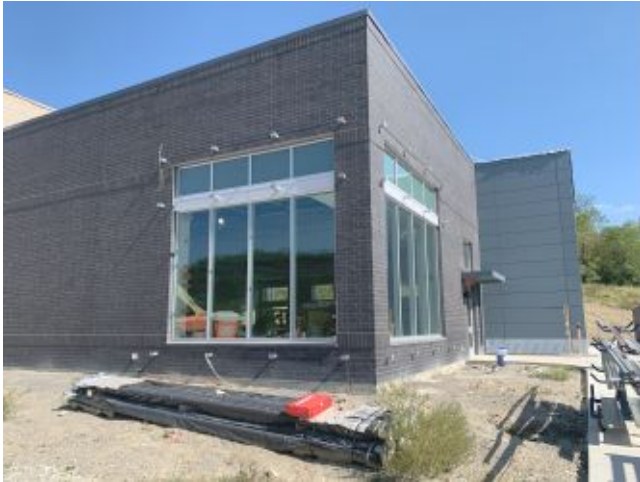
2025.09.30 – Exterior southwest corner

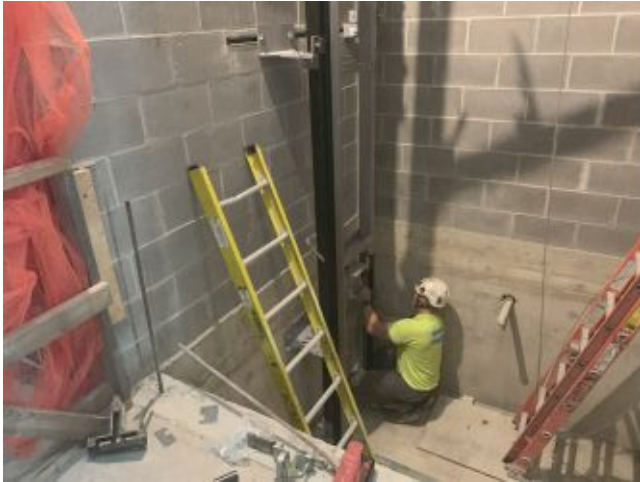
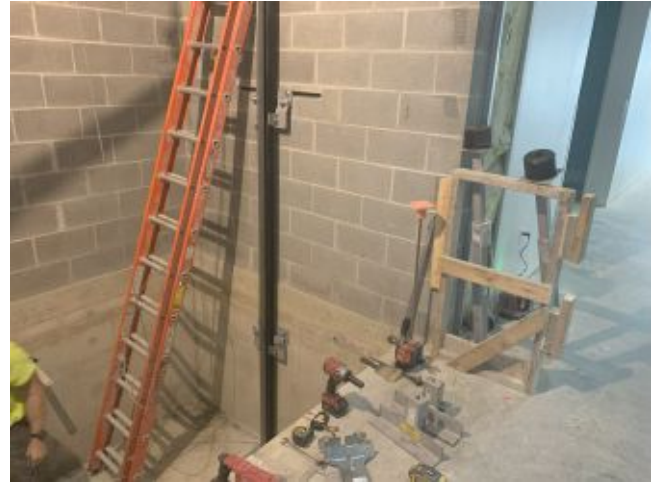
14.01: 2025.09.30 – Elevator installer was active in the elevator pit.

2025.09.30 – Elevator pit

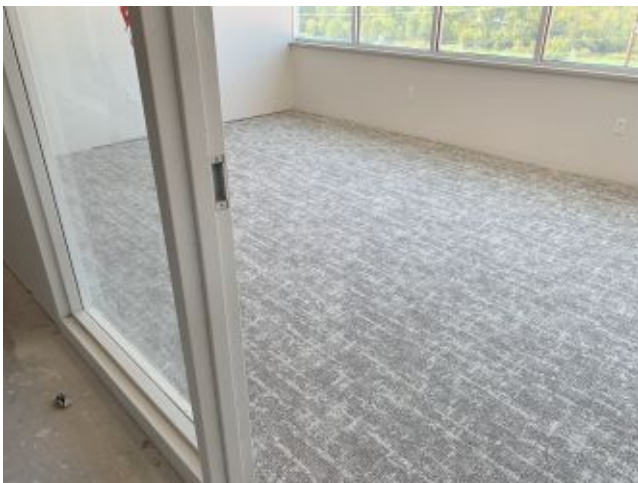
09.02: 2025.09.30 – Carpet tile installation had begun on the third floor.

2025.09.30 – Third floor office with carpet

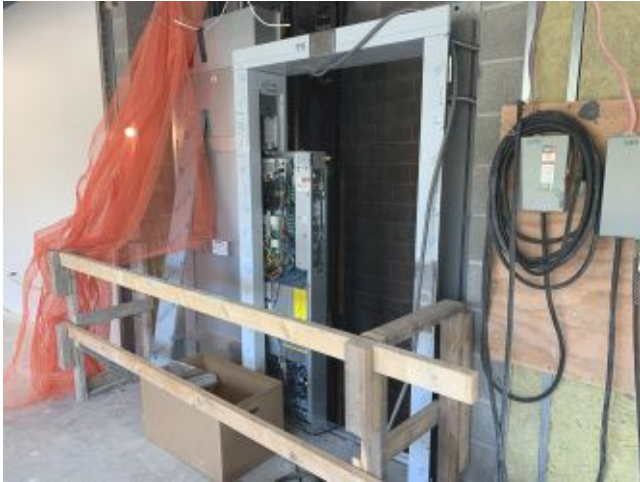
14.02: 2025.10.14 – Elevator installation was on-going. Third floor frame and controls had been set.

2025.10.14 – Third floor elevator

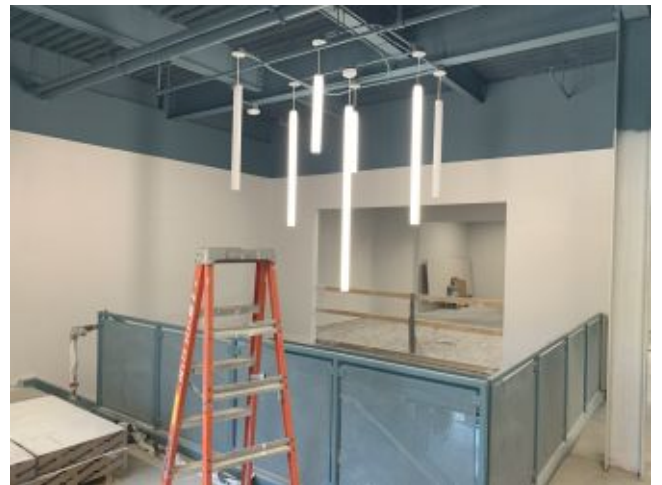
2025.10.14 – Monumental stair

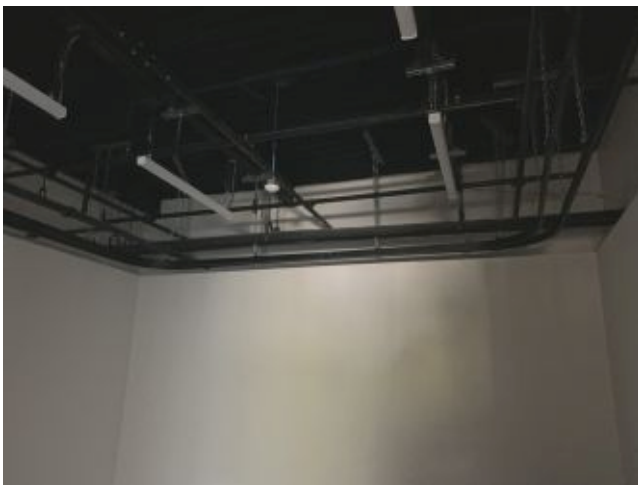
11.01: 2025.10.14 – Rigging appeared complete in the production studio. Awaiting lighting and curtains.

2025.10.14 – Production studio

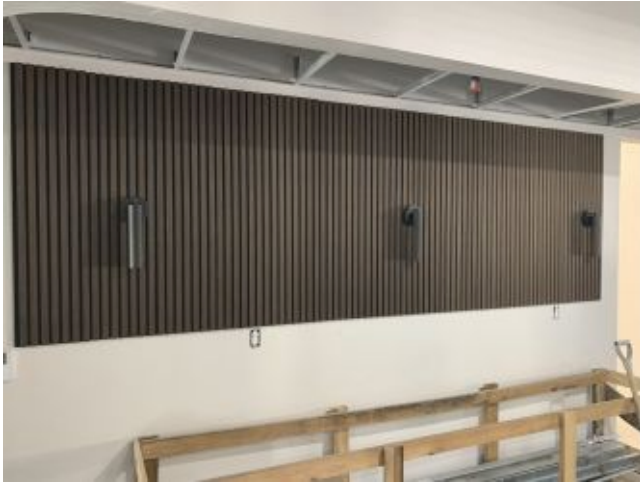
09.04: 2025.10.14 – Wood slat walls had been hung on the first floor at the reception desk and monumental stair. Installation was 50% complete in the board room.

2025.10.14 – Wood slats at base of monumental stair

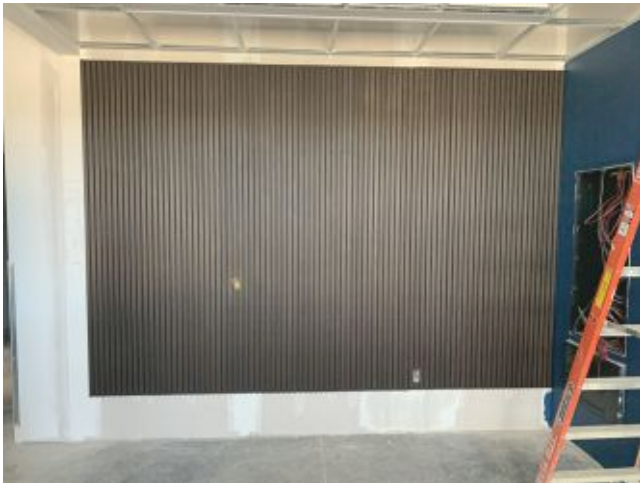
2025.10.14 – Wood slats at Entry Lobby

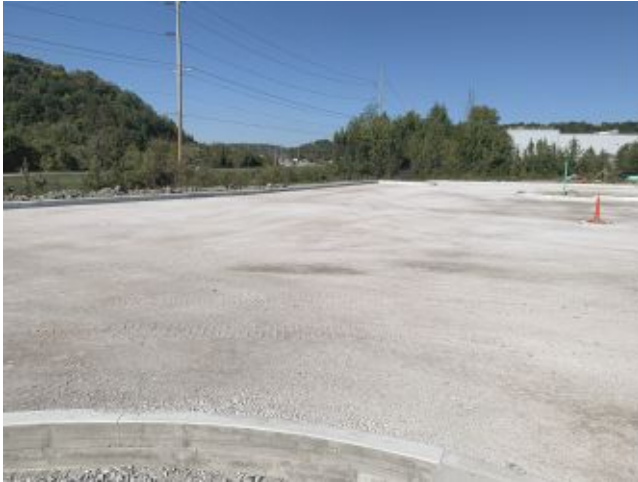
32.02: 2025.10.14 – Concrete curbs had been installed at the north parking lot. DGA had been installed and the area was blocked to traffic in anticipation of base asphalt late next week or the week after.

2025.10.14 – North parking lot
