**CONSENT ITEM B-4**

**OLDHAM COUNTY BOARD OF EDUCATION**

Consider Approval of Change Order #5 to the Site Access Improvements at Various Elementary Schools Ph. 2 project.

DATE: 12/2/25 CO #: Five (05)  
TO: Redlee Construction & PROJECT: Oldham Co. Elementaries Site  
Development, Inc. & Access Imp. – Phase 2  
800 Stonecreek Parkway, Suite 5A Oldham County, Kentucky  
Louisville, Kentucky 40223 BG 24-109  
RTA 23050  
CONTRACT DATE: September 20, 2024 CONTRACT FOR: General Construction

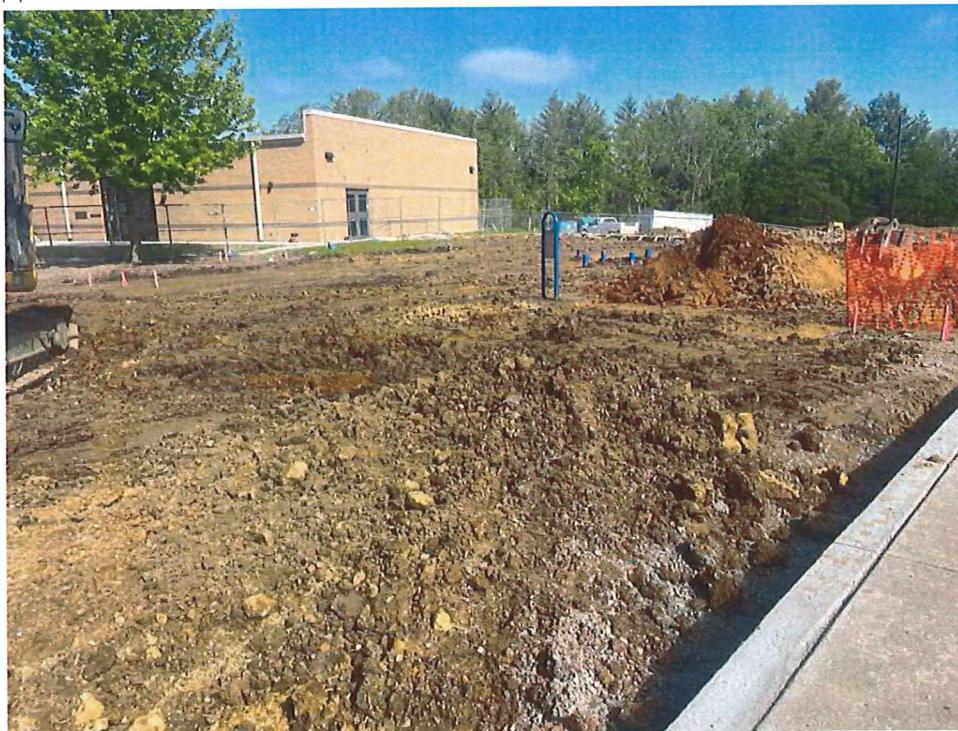
(2)

Area observed for undercut.

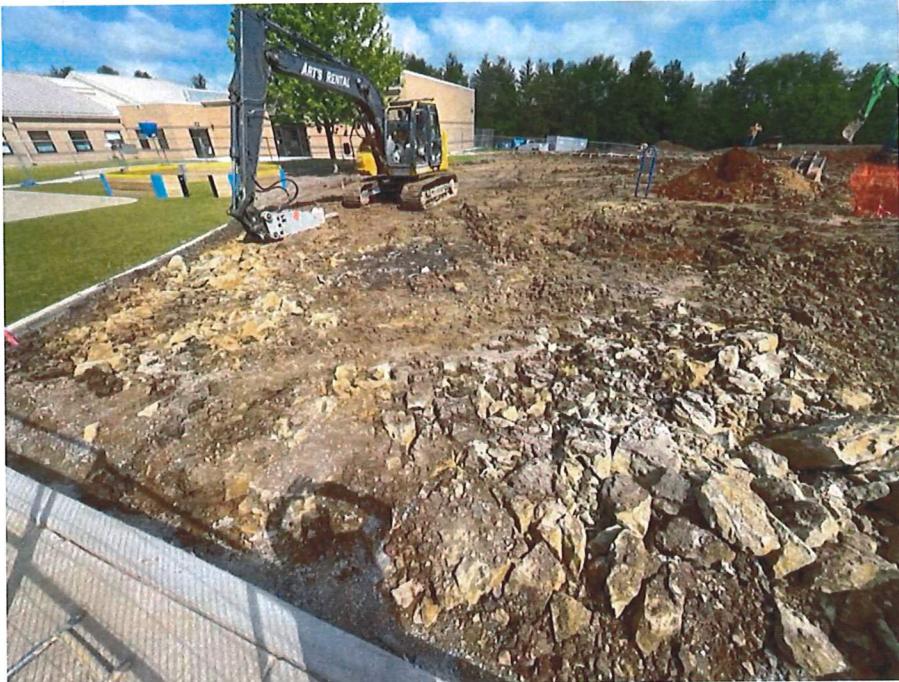
(3)

2 areas of bed rock encountered.  
Area 1 (right) 16' x 9'  
Area 2 (left) 16' x 7'

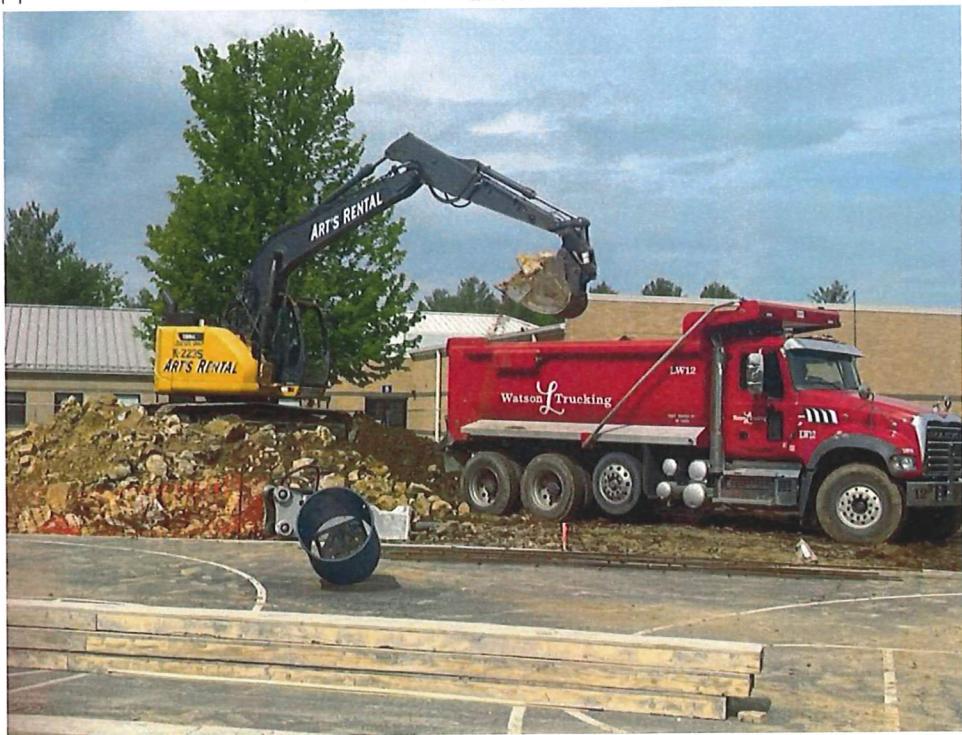
(2)

Contractor observed loading undercut material.

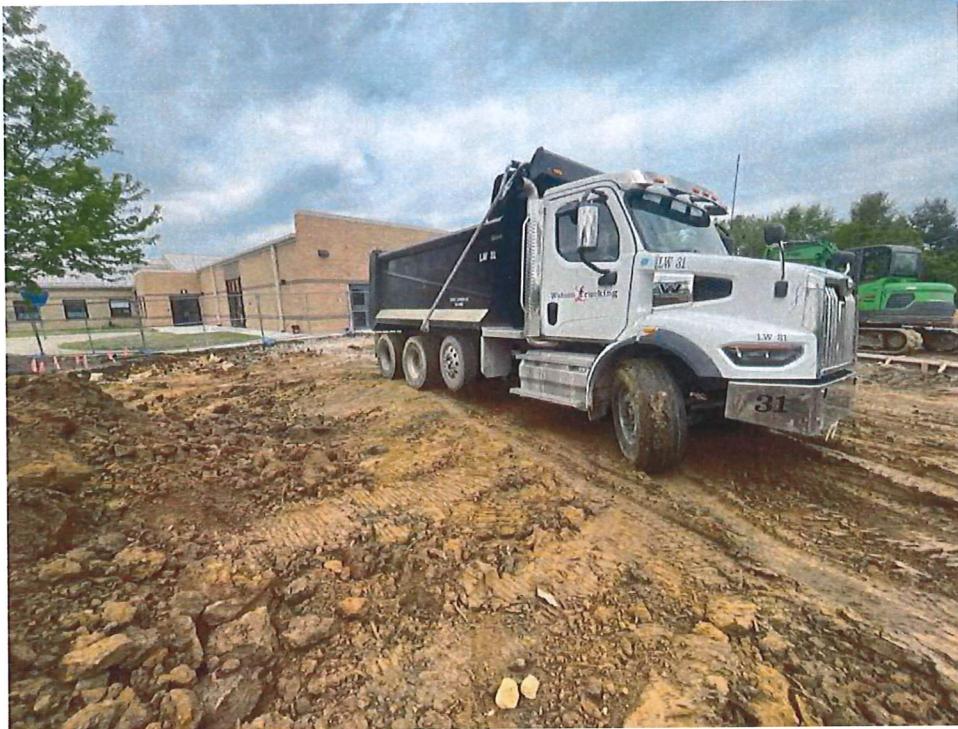
(3)

Proof roll with loaded truck shows material soft with excessive amounts of pumping and rutting 4"-6"

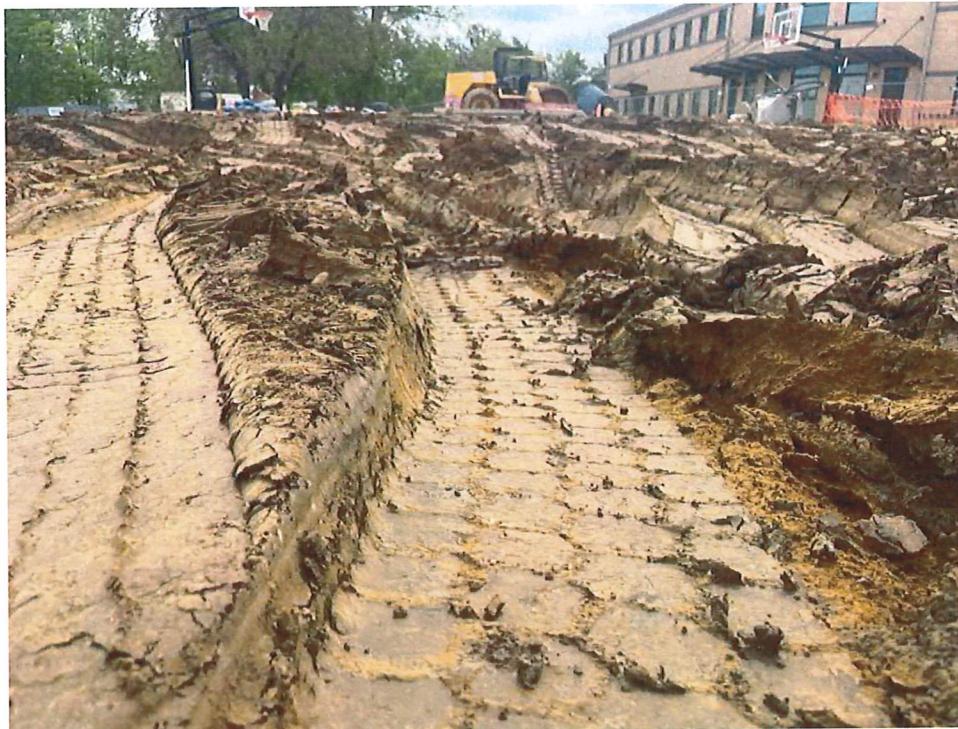
(4)

Rutting from proof-roll shown.

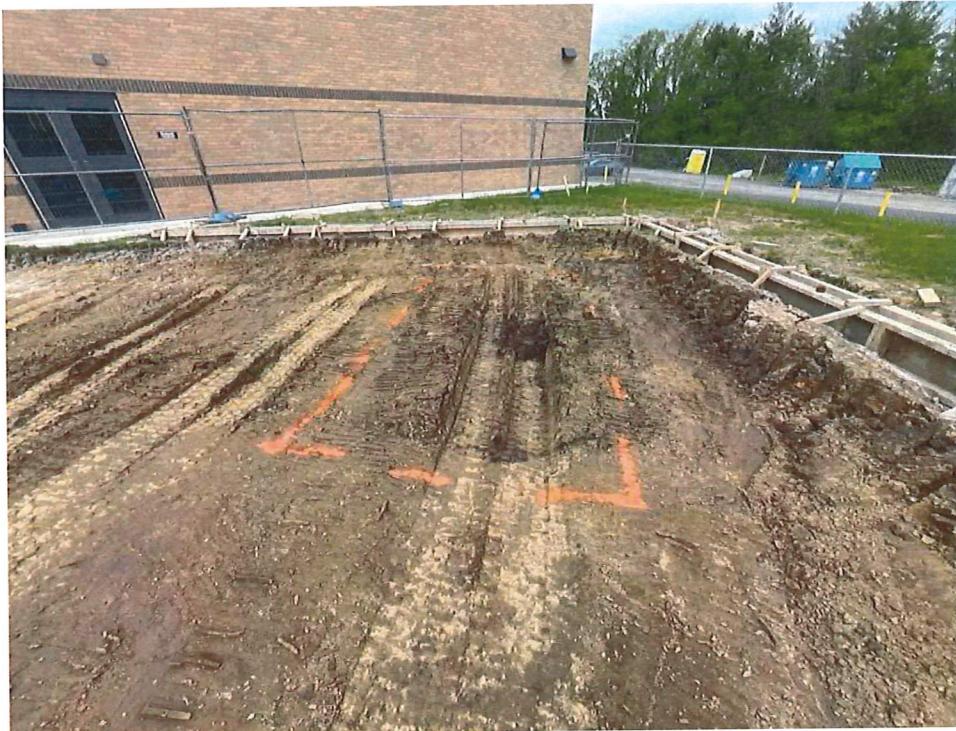
(5)

Area of soft soils encountered after initial undercut was performed.

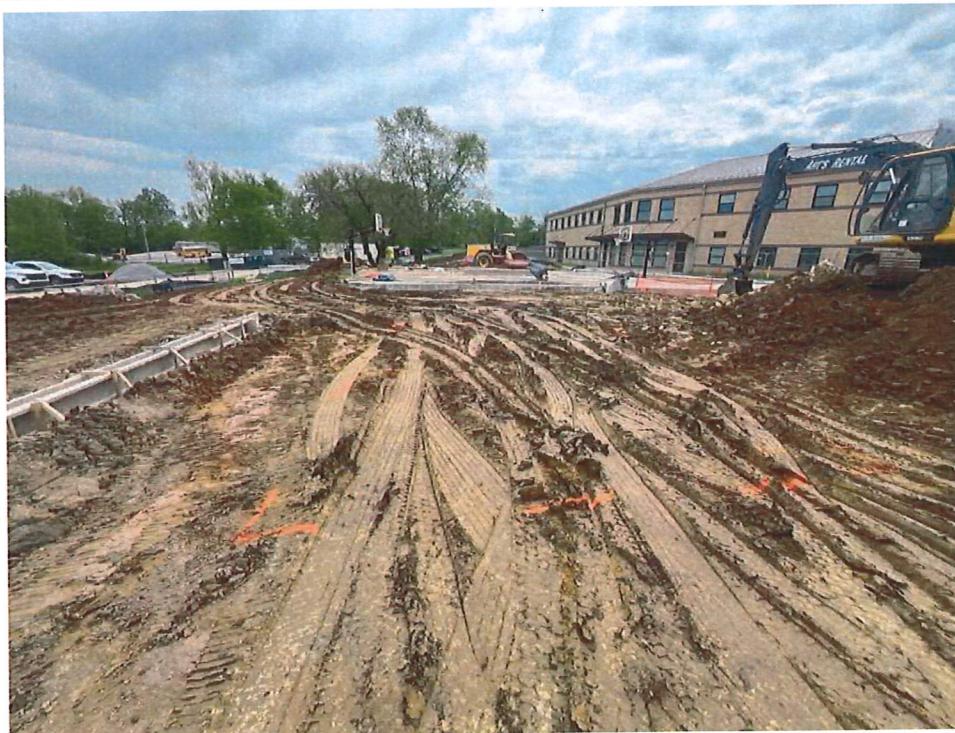
(6)

Area of soft soils encountered after initial undercut was performed.

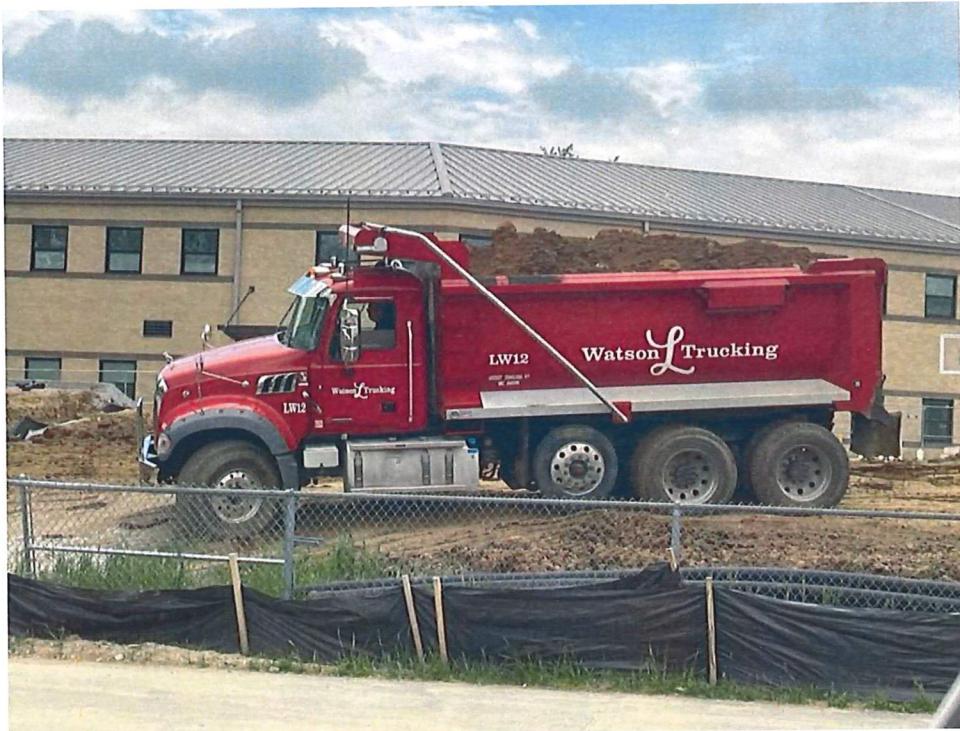
(7)

Dump Truck loaded with approximate average of 15 C.Y per truck. Truck loads removed today totaled 18 trucks.

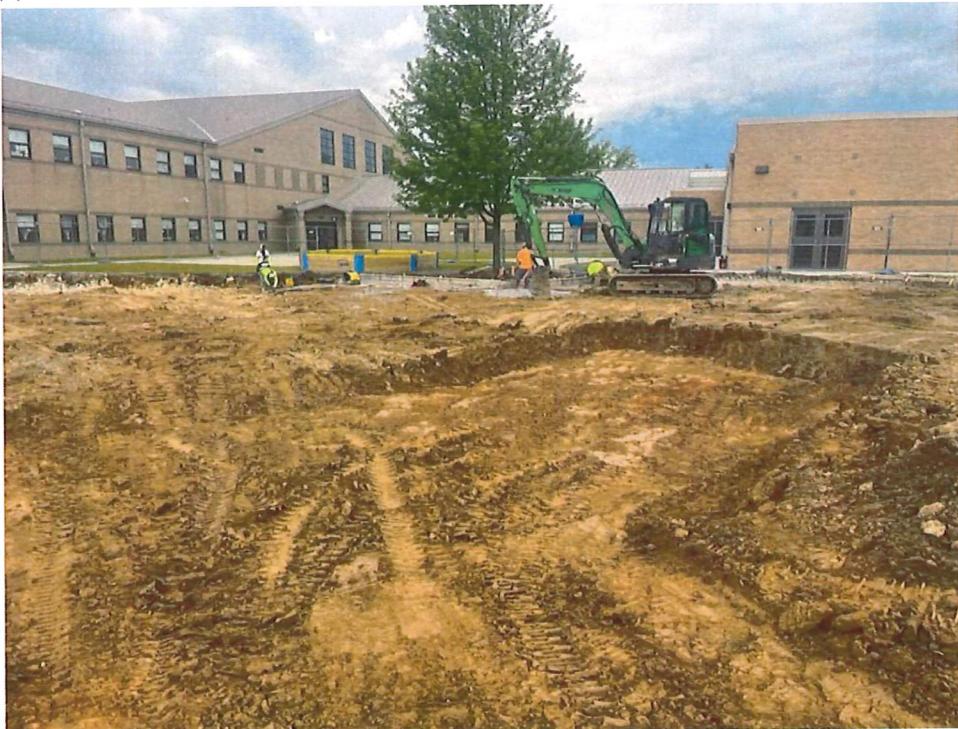
(2)

Area of undercut taken to max depth of 24" below subgrade.

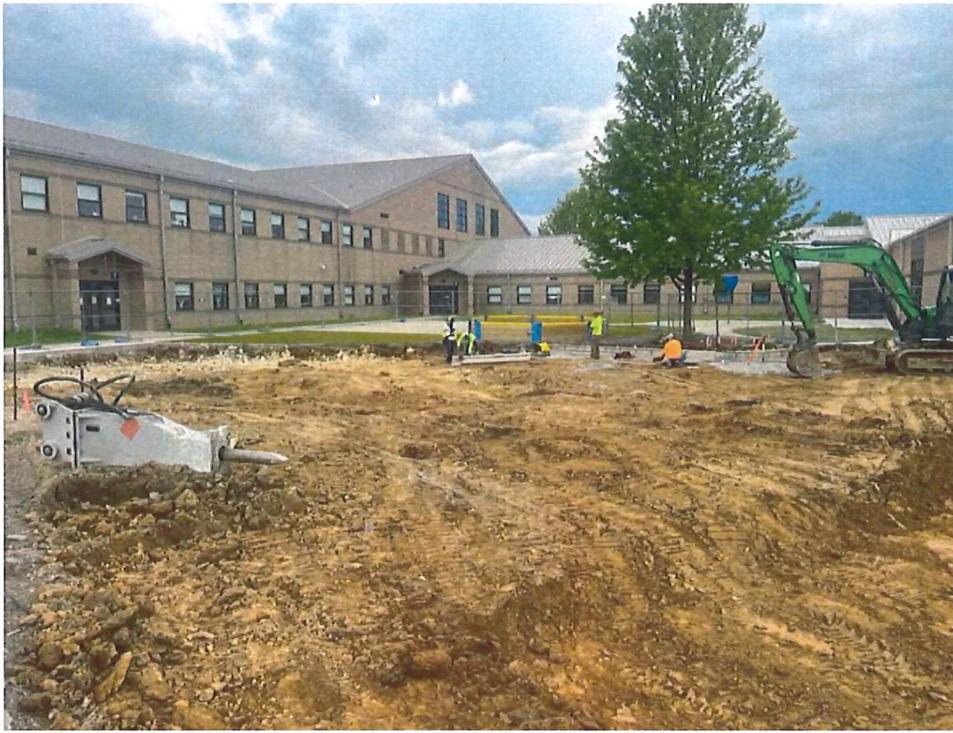
(3)

Area of undercut at 12" below subgrade.

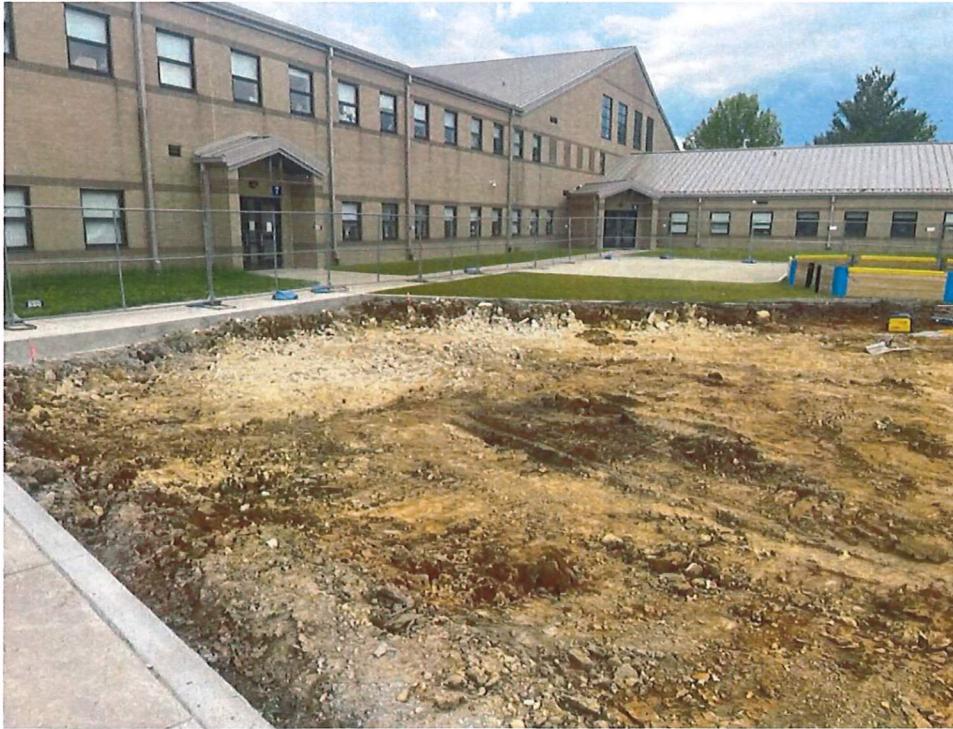
(4)

Area of bedrock removed to 24" below subgrade.

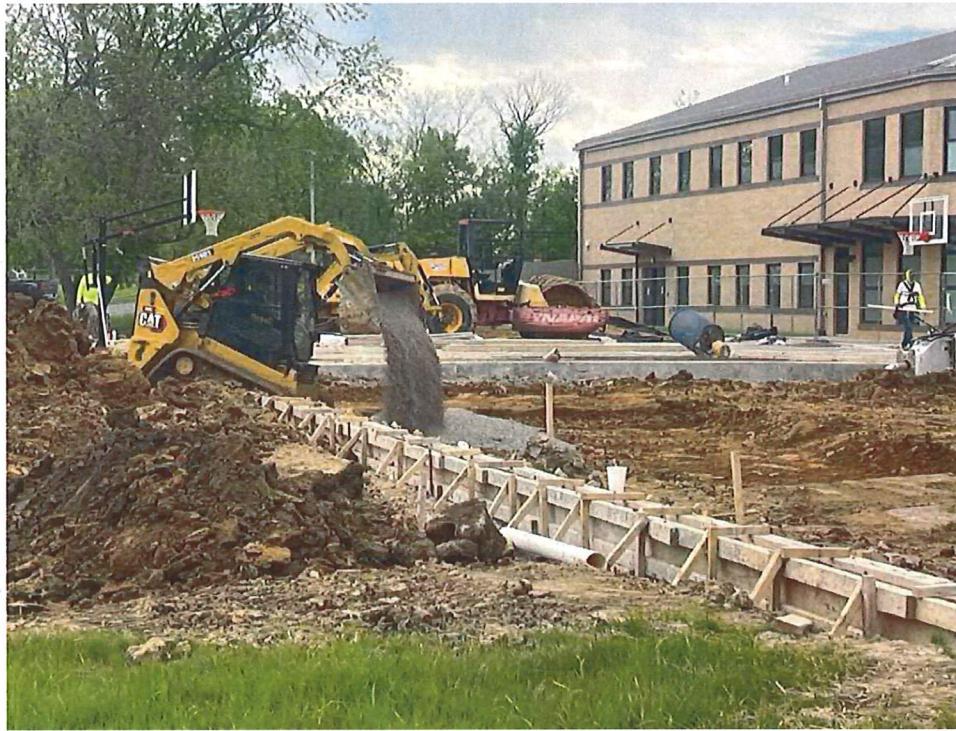
(5)

Contractor observed placing DGA in 8" loose lifts.

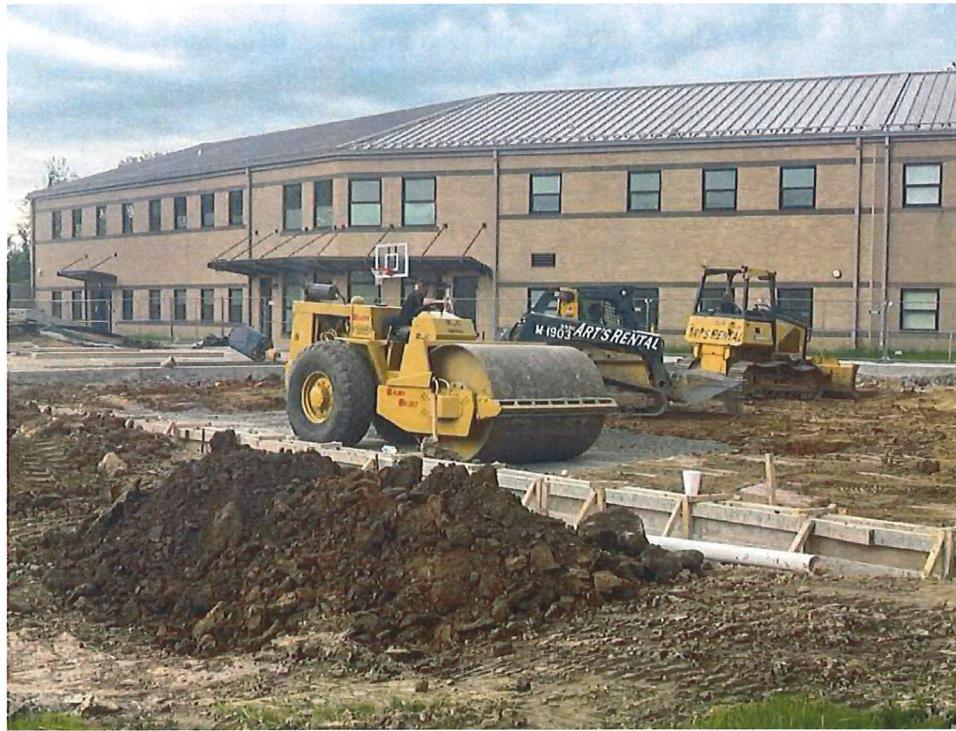
(6)

Consolidation efforts on DGA made with smooth drum roller.

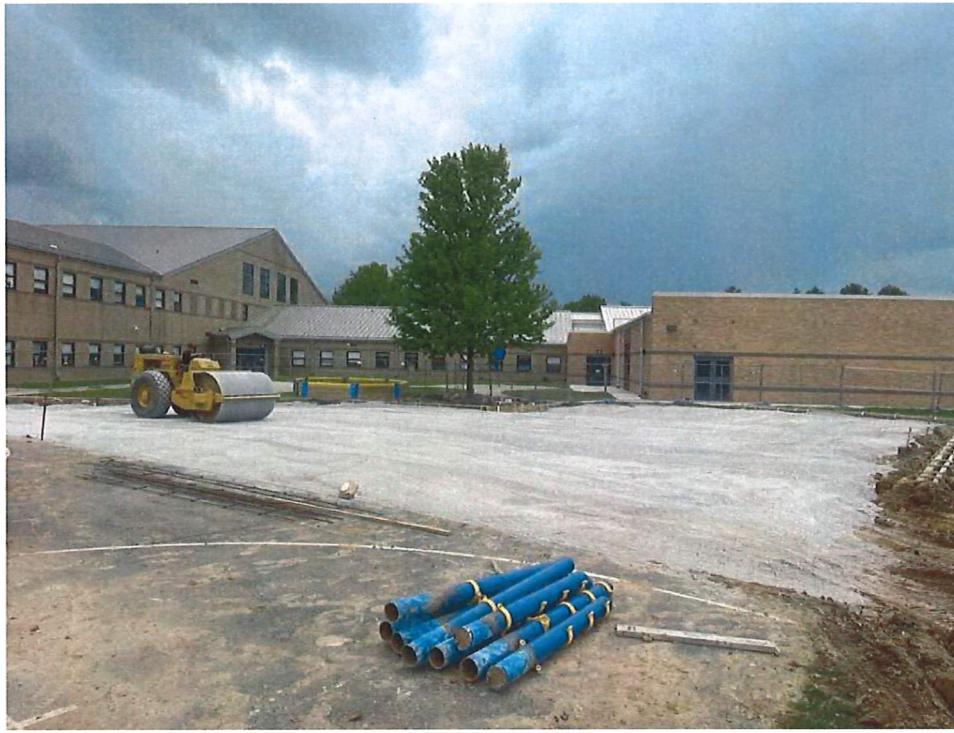
(7)

DGA placed and compacted with smooth drum roller to grade.

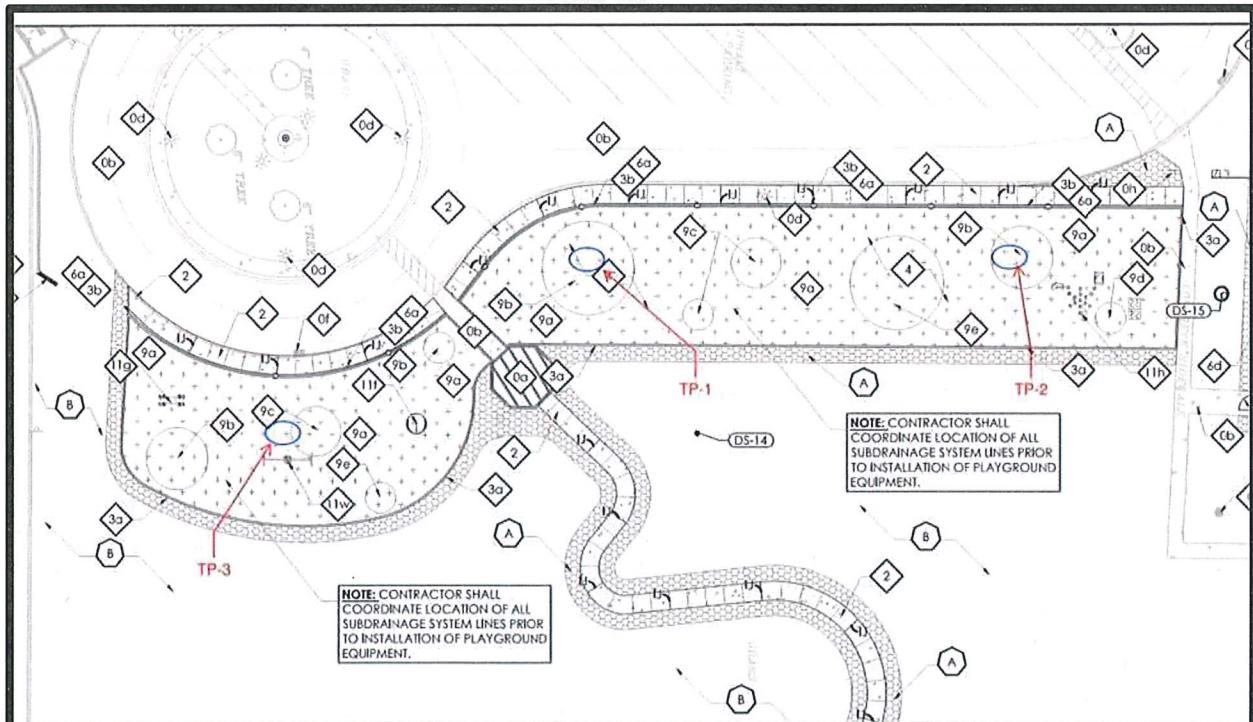
Figure 1: Crestwood Elementary Test Pit Locations

The new playgrounds were generally at or slightly high (4-6") of subgrade elevation. A proof roll with a single axle dump truck was performed. Rutting and pumping of up to 6" was observed. Three test pits were excavated to depths ranging from 16" to 30". Figure 1 below shows the approximate locations of the test pits. The test pits generally showed fill material throughout. A layer of asphalt was observed in all test pits at depths ranging from 8" to 16". In addition, there were some pieces of construction debris observed. Stiff, silty Clay was encountered at termination depths of all three test pits.

We recommend that the playgrounds be undercut 12" or to where stiff clay is encountered, whichever is less. A proof roll should be performed after the undercut is completed and before any backfill is placed. Backfill material may consist of engineered fill soil or dense graded aggregate (DGA) compacted in 8" loose lifts. A sheepfoot compactor should be used for clay and a smooth drum roller should be used for DGA. Roller compactors should weigh a minimum of 10 tons. The use of #57 stone is appropriate for use as fill at elevations above the top of the drains.

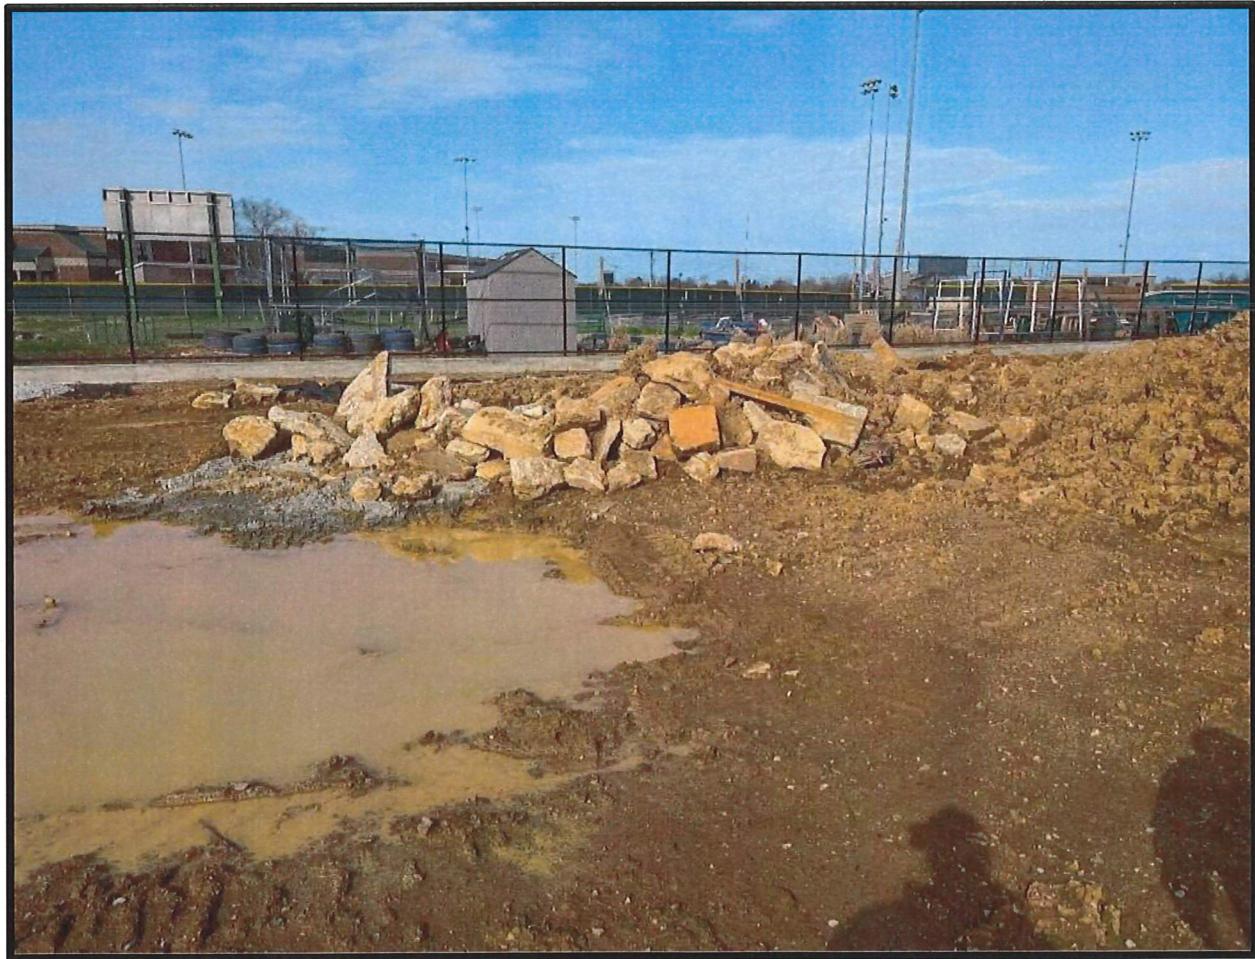
Figure 2: Camden Station Site Conditions

The new playground was generally at or below (12") subgrade elevation. There was standing water and large boulders and cobbles visible during the site walk. A test pit was excavated towards the rear of the playground to a depth of 24". The upper 12" of the subgrade consisted of a soft, wet dark brown clayey silt before increasing in consistency to stiff. Figure 2 shows the general site conditions.

We recommend that the playground be undercut 12" to remove the soft saturated soil. Any boulders or cobbles visible after the undercut should be

removed and replaced with engineered fill or DGA. A proof roll should be performed after the undercut is completed and before any backfill is placed.

We recommend that a layer of #2 stone be walked into the subgrade then backfill material may consist of engineered fill soil or DGA compacted in 8" loose lifts. A sheepfoot compactor should be used for clay and a smooth drum roller should be used for DGA. Roller compactors should weigh a minimum of 10 tons. The use of #57 stone is appropriate for use as fill at elevations above the top of the drains.

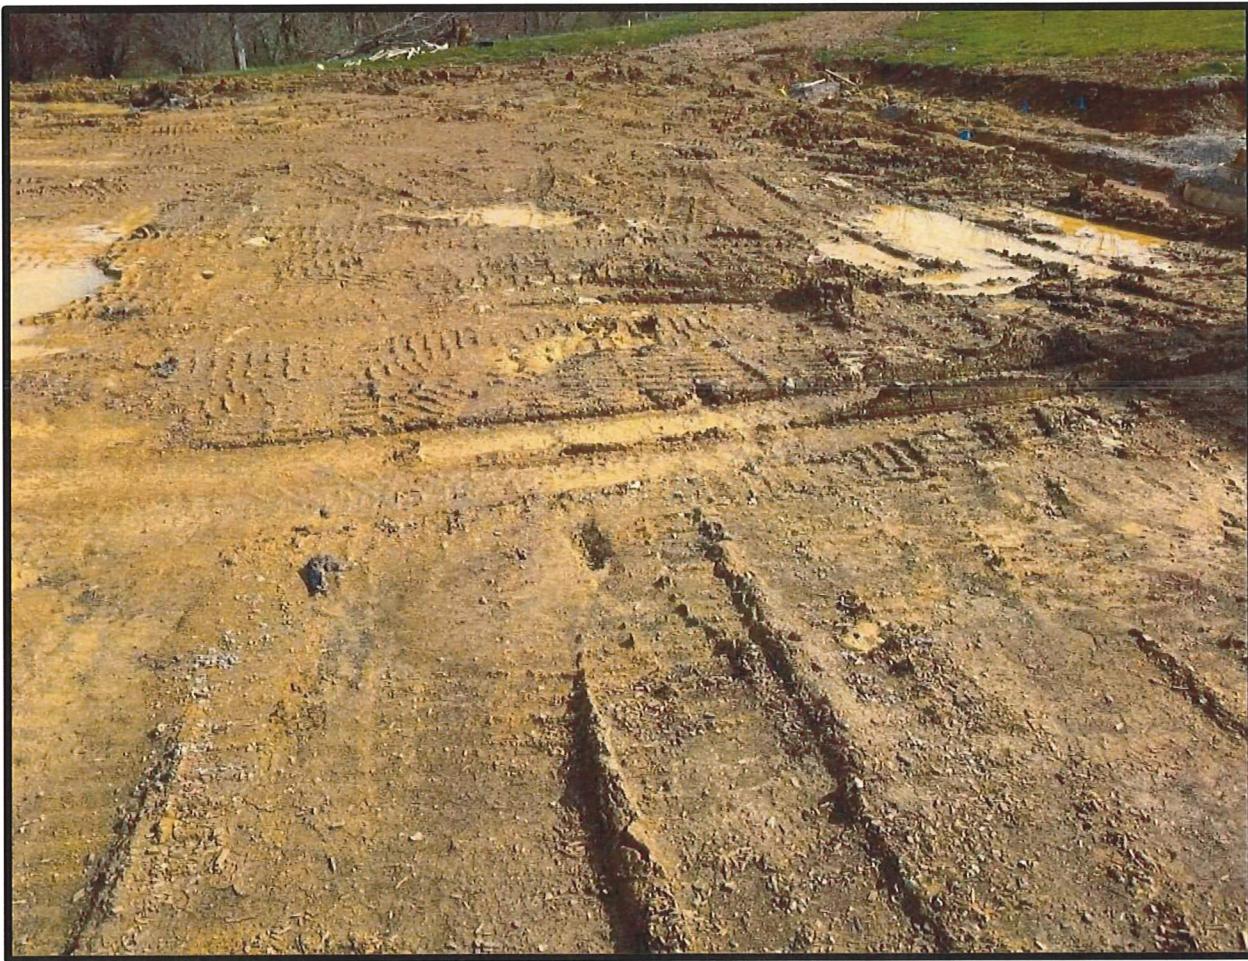
Figure 3: Locust Grove Site Conditions

The new playgrounds were generally at subgrade elevation. There is standing water and organic material visible during the site walk. No equipment was present to proof roll or excavate test pits with. Figure 3 shows the general site conditions including the presence of organic material.

We recommend that the upper playground be undercut 12" to remove the soft, wet subgrade and replaced with a layer of #2 stone that is walked into the subgrade, then engineered fill or DGA.

We recommend that the lower playground be undercut 12" or to below all organic material, whichever is deeper. A proof roll should be performed after the undercut is completed and before any backfill is placed.

We recommend that a layer of #2 stone be walked into the subgrade then backfill material may consist of engineered fill soil or dense graded aggregate (DGA) compacted in 8" loose lifts. A sheepfoot compactor should be used for clay and a smooth drum roller should be used for DGA. Roller compactors should weigh a minimum of 10 tons. The use of #57 stone is appropriate for use as fill at elevations above the top of the drains.

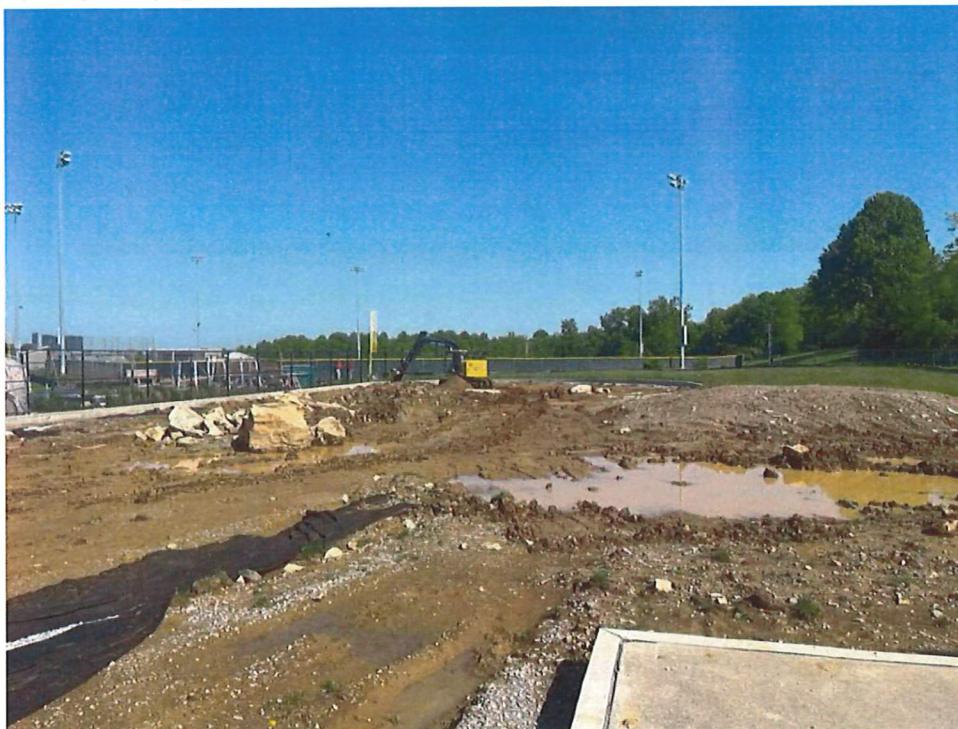
(2)

Site overview of playground area shown for undercut.

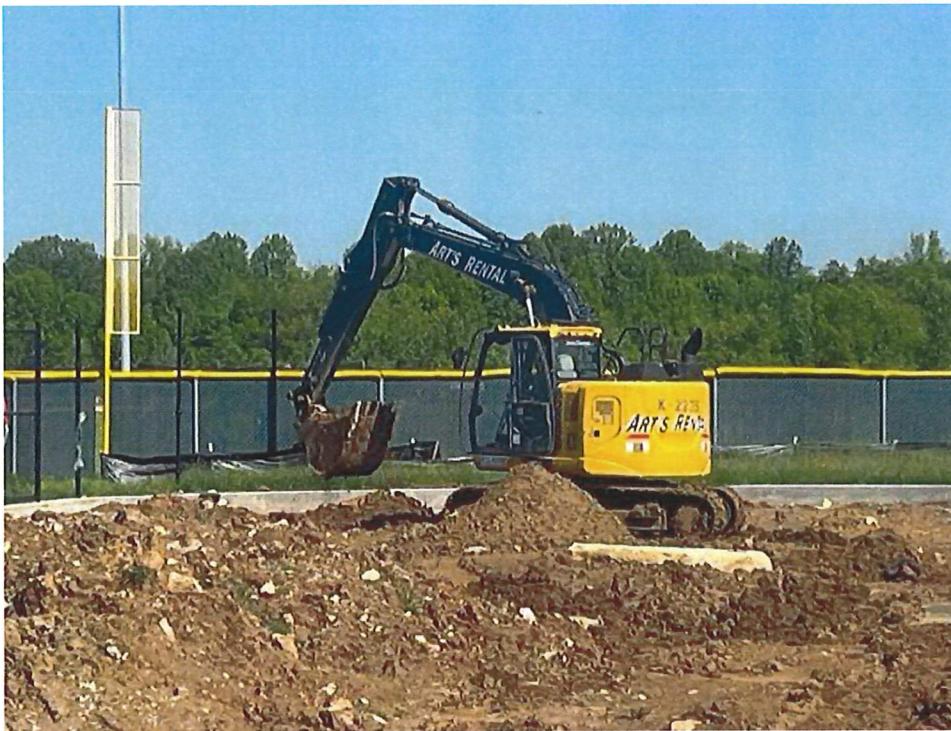
(3)

Contractor observed under cutting material with excavator.

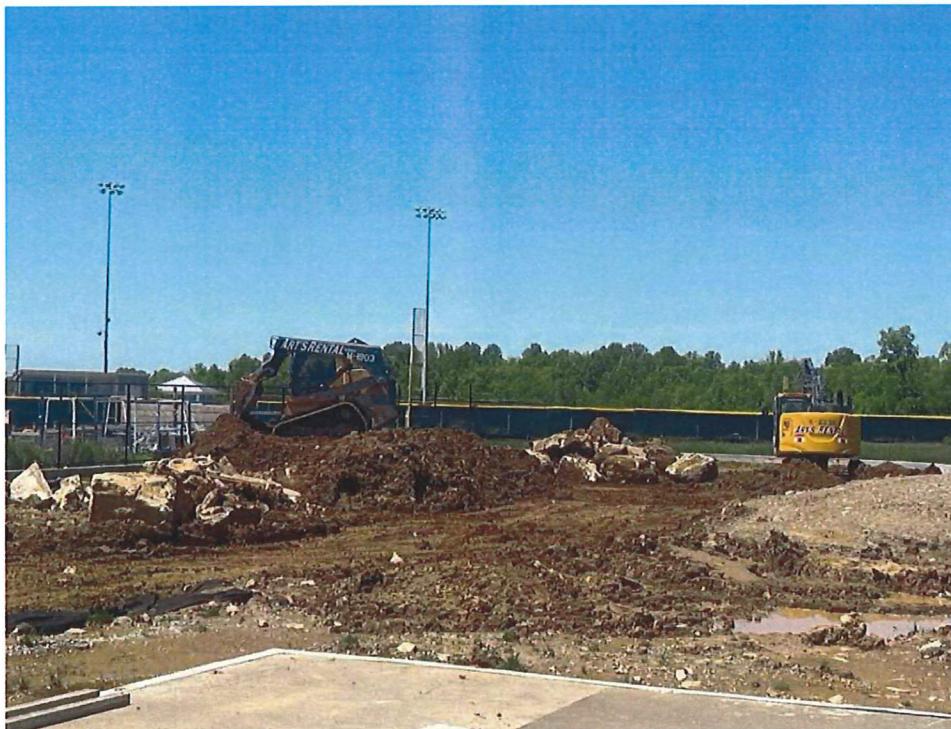
(4)

Contractor observed stock piling material to be removed.

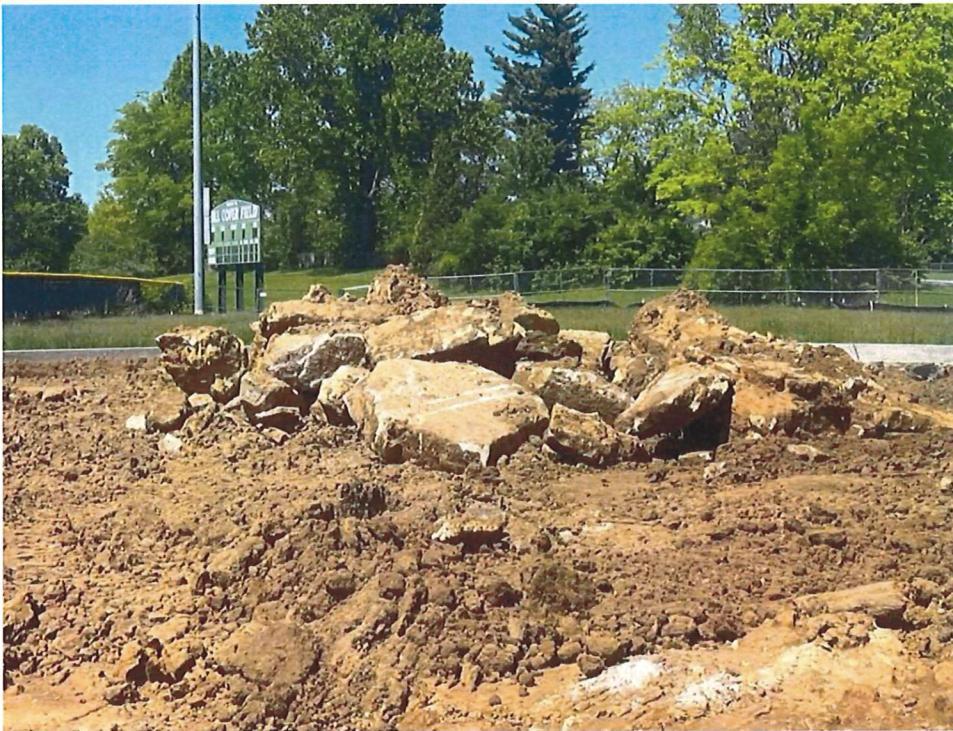
(5)

Rock and cobbles removed and stock piled.

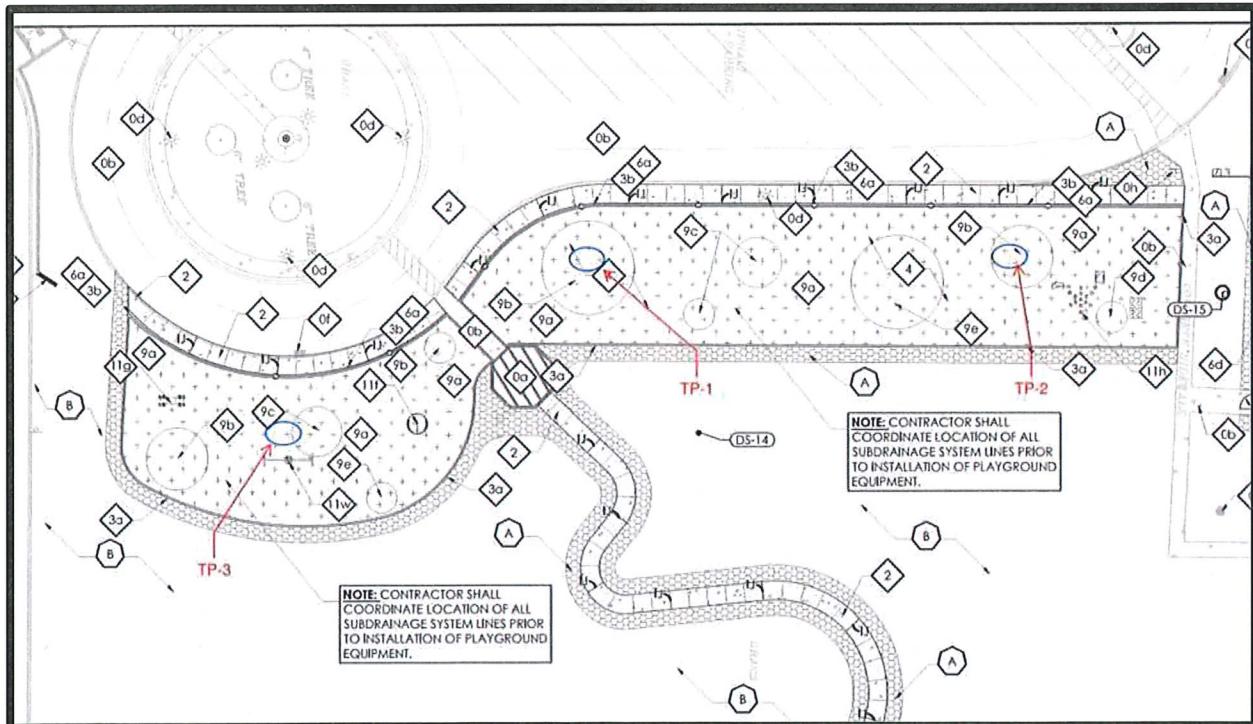
Figure 1: Crestwood Elementary Test Pit Locations

The new playgrounds were generally at or slightly high (4-6") of subgrade elevation. A proof roll with a single axel dump truck was performed. Rutting and pumping of up to 6" was observed. Three test pits were excavated to depths ranging from 16" to 30". Figure 1 below shows the approximate locations of the test pits. The test pits generally showed fill material throughout. A layer of asphalt was observed in all test pits at depths ranging from 8" to 16". In addition, there were some pieces of construction debris observed. Stiff, silty Clay was encountered at termination depths of all three test pits.

We recommend that the playgrounds be undercut 12" or to where stiff clay is encountered, whichever is less. A proof roll should be performed after the undercut is completed and before any backfill is placed. Backfill material may consist of engineered fill soil or dense graded aggregate (DGA) compacted in 8" loose lifts. A sheepfoot compactor should be used for clay and a smooth drum roller should be used for DGA. Roller compactors should weigh a minimum of 10 tons. The use of #57 stone is appropriate for use as fill at elevations above the top of the drains.

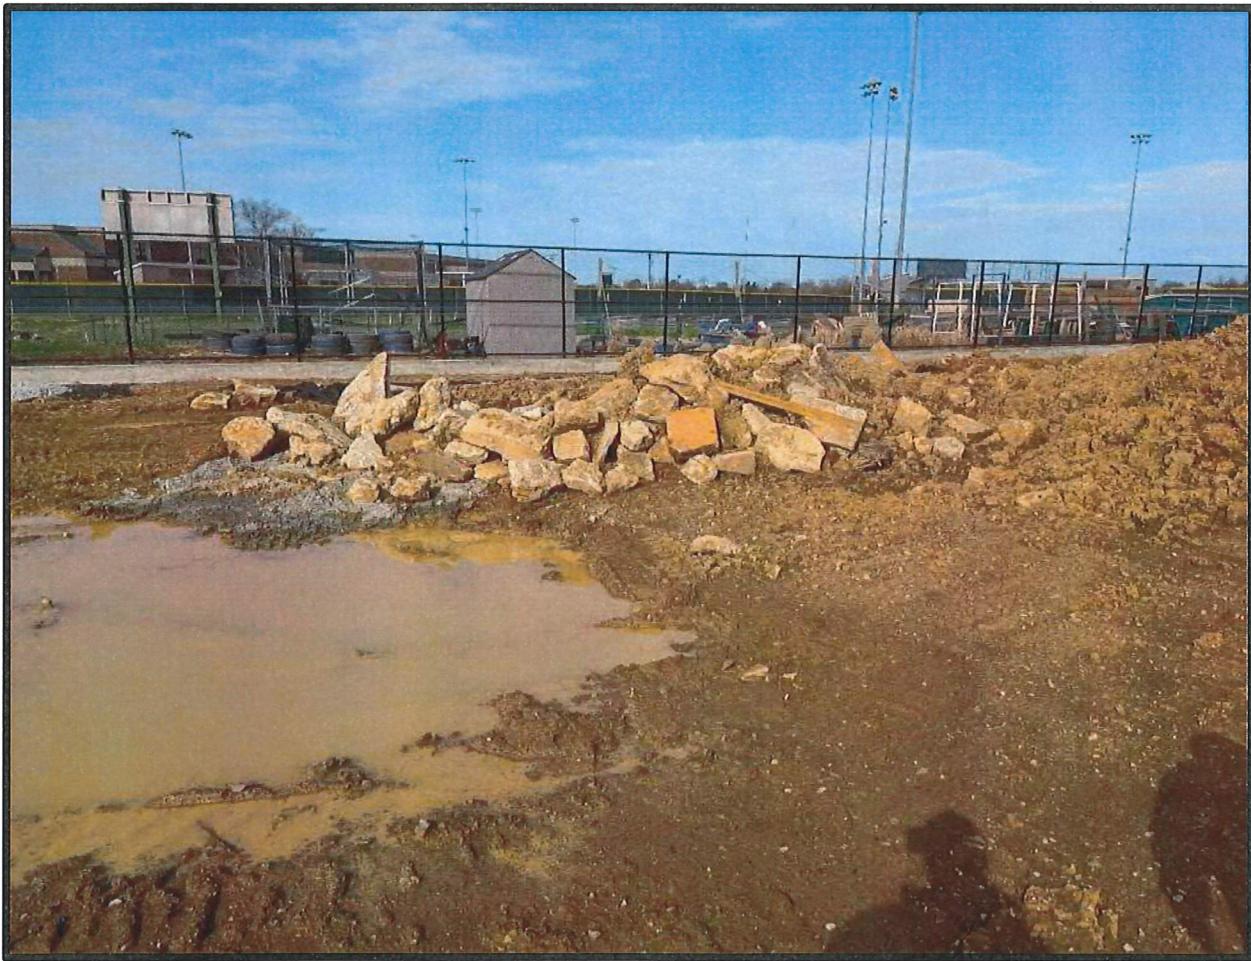
Figure 2: Camden Station Site Conditions

The new playground was generally at or below (12") subgrade elevation. There was standing water and large boulders and cobbles visible during the site walk. A test pit was excavated towards the rear of the playground to a depth of 24". The upper 12" of the subgrade consisted of a soft, wet dark brown clayey silt before increasing in consistency to stiff. Figure 2 shows the general site conditions.

We recommend that the playground be undercut 12" to remove the soft saturated soil. Any boulders or cobbles visible after the undercut should be

removed and replaced with engineered fill or DGA. A proof roll should be performed after the undercut is completed and before any backfill is placed.

We recommend that a layer of #2 stone be walked into the subgrade then backfill material may consist of engineered fill soil or DGA compacted in 8" loose lifts. A sheepfoot compactor should be used for clay and a smooth drum roller should be used for DGA. Roller compactors should weigh a minimum of 10 tons. The use of #57 stone is appropriate for use as fill at elevations above the top of the drains.

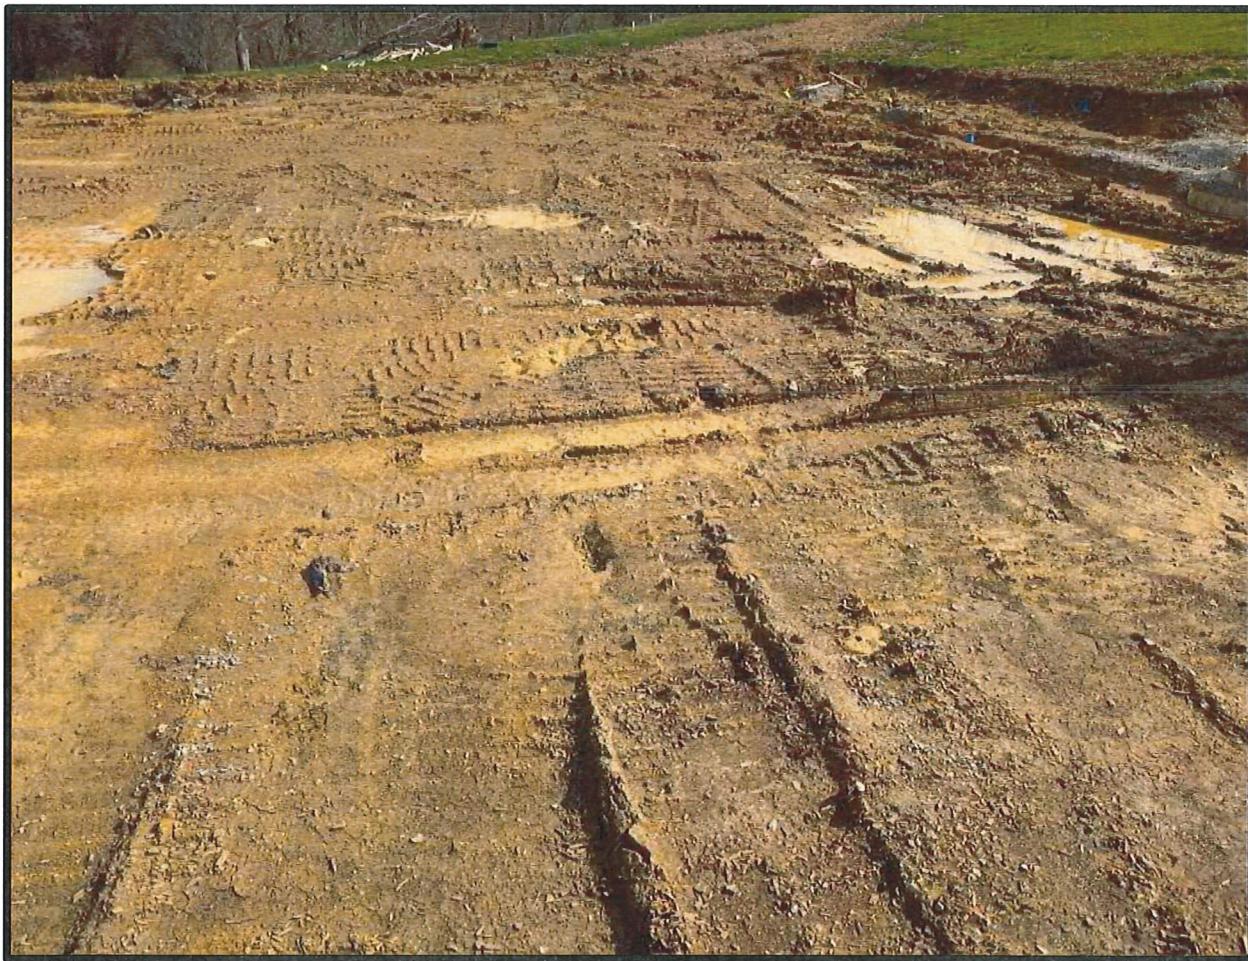
Figure 3: Locust Grove Site Conditions

The new playgrounds were generally at subgrade elevation. There is standing water and organic material visible during the site walk. No equipment was present to proof roll or excavate test pits with. Figure 3 shows the general site conditions including the presence of organic material.

We recommend that the upper playground be undercut 12" to remove the soft, wet subgrade and replaced with a layer of #2 stone that is walked into the subgrade, then engineered fill or DGA.

We recommend that the lower playground be undercut 12" or to below all organic material, whichever is deeper. A proof roll should be performed after the undercut is completed and before any backfill is placed.

We recommend that a layer of #2 stone be walked into the subgrade then backfill material may consist of engineered fill soil or dense graded aggregate (DGA) compacted in 8" loose lifts. A sheep's foot compactor should be used for clay and a smooth drum roller should be used for DGA. Roller compactors should weigh a minimum of 10 tons. The use of #57 stone is appropriate for use as fill at elevations above the top of the drains.

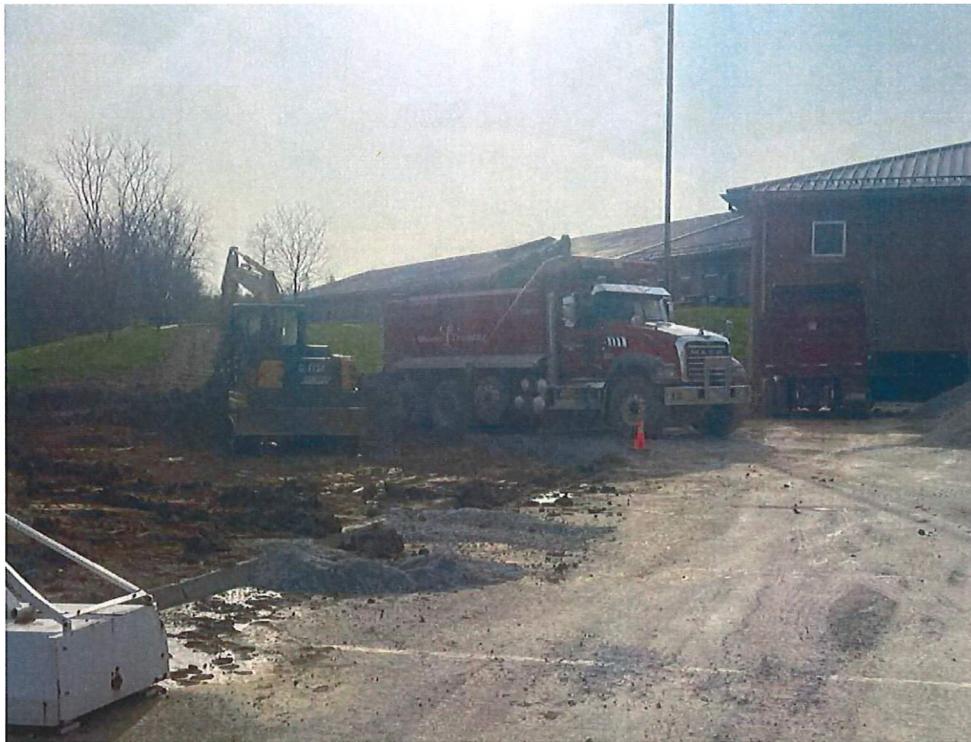
(3)

12" of organic material removed per engineered recommendation.

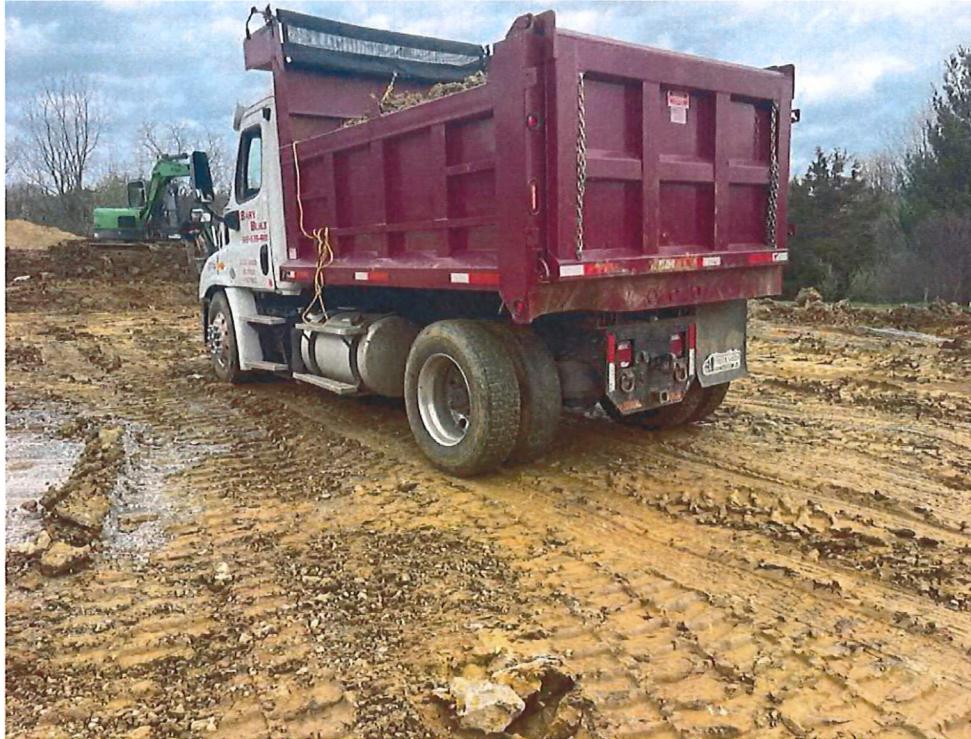
(7)

Proof roll with loaded truck shows material stiff with little movement, 2" or less rutting.
