**CONSENT ITEM B-4**

**OLDHAM COUNTY BOARD OF EDUCATION**

Consider Approval of Change Order #5 to the Site Access Improvements at Various Elementary Schools Ph. 2 project.

DATE: 12/2/25 CO #: Five (05)  
TO: Redlee Construction & PROJECT: Oldham Co. Elementaries Site  
Development, Inc. & Access Imp. – Phase 2  
800 Stonecreek Parkway, Suite 5A Oldham County, Kentucky  
Louisville, Kentucky 40223 BG 24-109  
RTA 23050  
CONTRACT DATE: September 20, 2024 CONTRACT FOR: General Construction

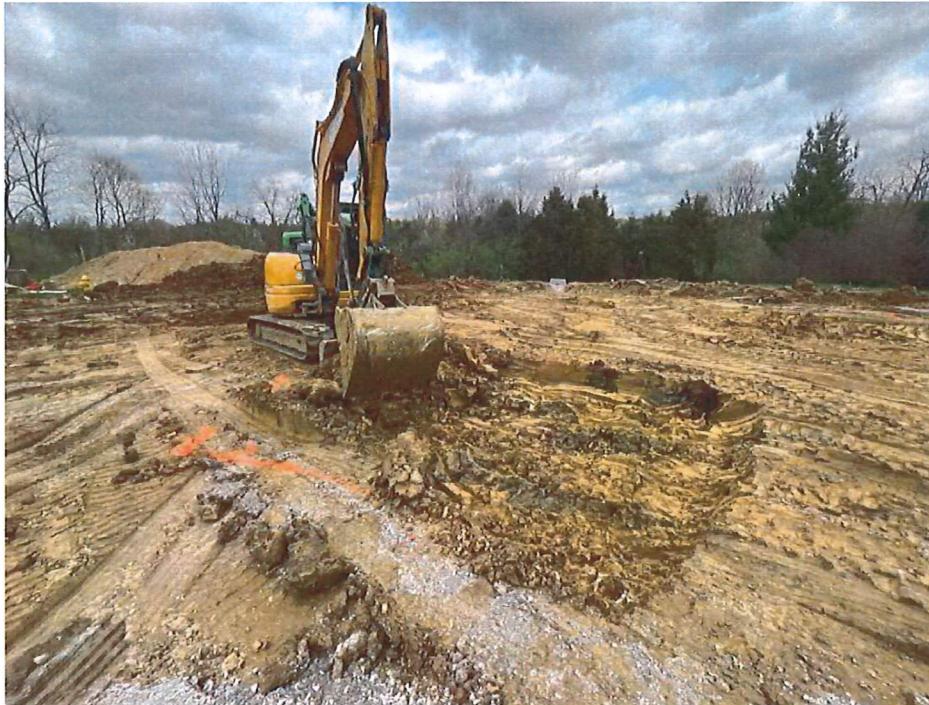
**Area B**

Contractor observed removing soft soils.

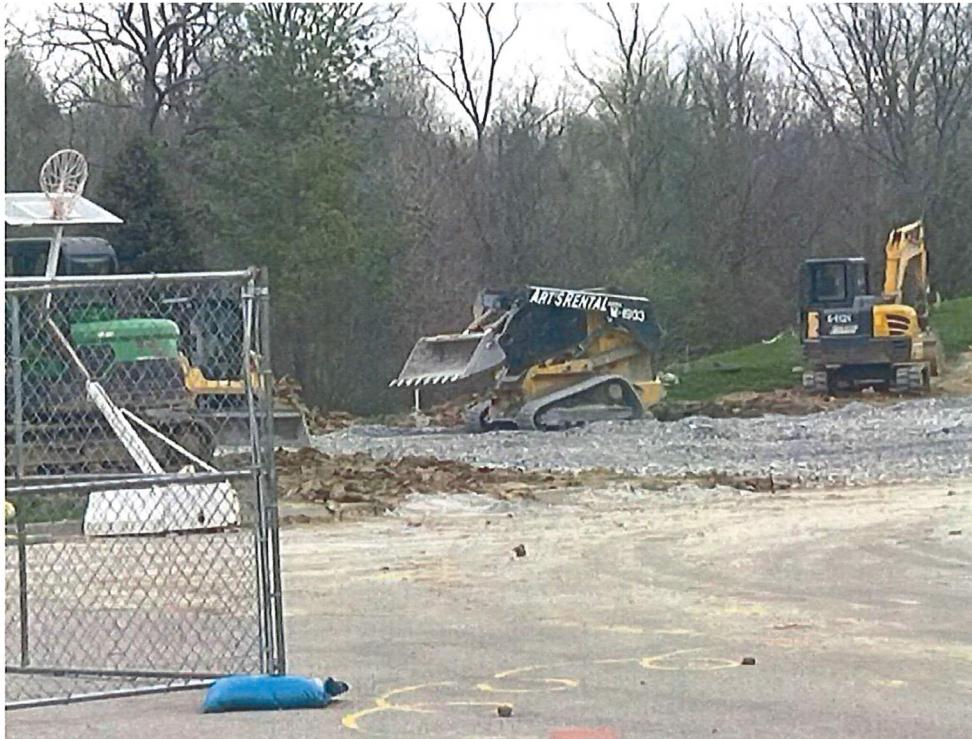
(11)

Contractor observed placing #3 stone.

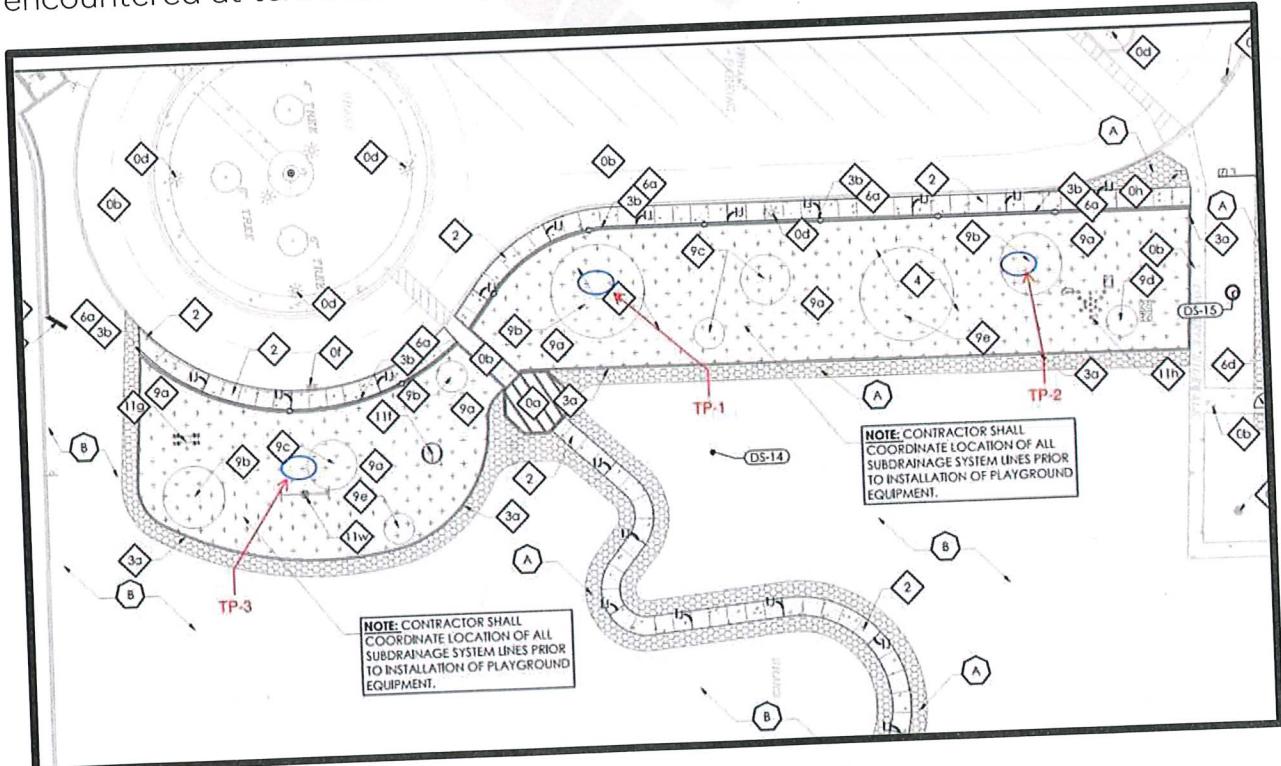
Figure 1: Crestwood Elementary Test Pit Locations

The new playgrounds were generally at or slightly high (4-6") of subgrade elevation. A proof roll with a single axle dump truck was performed. Rutting and pumping of up to 6" was observed. Three test pits were excavated to depths ranging from 16" to 30". Figure 1 below shows the approximate locations of the test pits. The test pits generally showed fill material throughout. A layer of asphalt was observed in all test pits at depths ranging from 8" to 16". In addition, there were some pieces of construction debris observed. Stiff, silty Clay was encountered at termination depths of all three test pits.

We recommend that the playgrounds be undercut 12" or to where stiff clay is encountered, whichever is less. A proof roll should be performed after the undercut is completed and before any backfill is placed. Backfill material may consist of engineered fill soil or dense graded aggregate (DGA) compacted in 8" loose lifts. A sheepfoot compactor should be used for clay and a smooth drum roller should be used for DGA. Roller compactors should weigh a minimum of 10 tons. The use of #57 stone is appropriate for use as fill at elevations above the top of the drains.

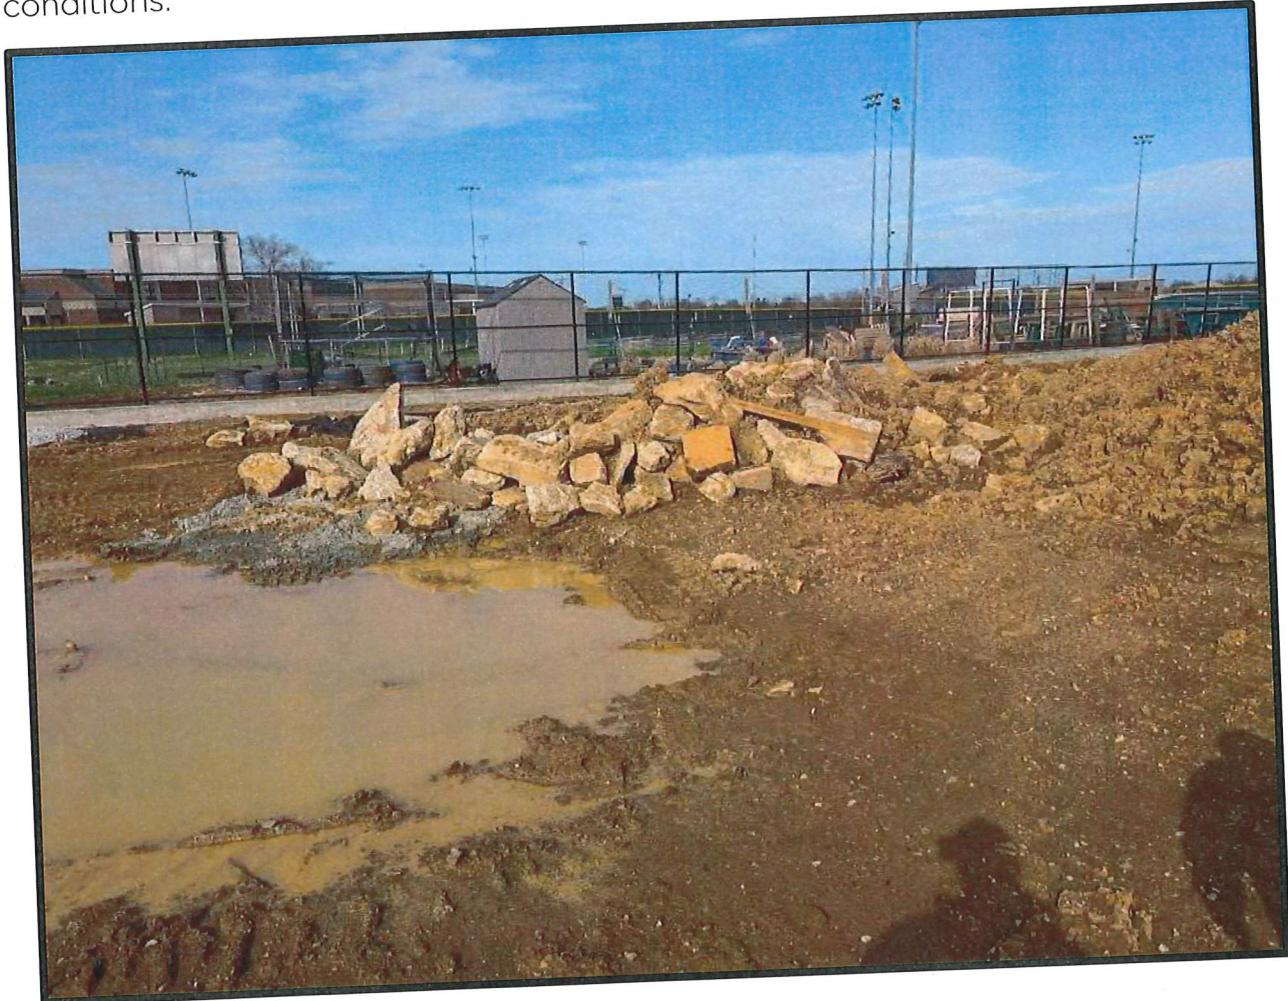
Figure 2: Camden Station Site Conditions

The new playground was generally at or below (12") subgrade elevation. There was standing water and large boulders and cobbles visible during the site walk. A test pit was excavated towards the rear of the playground to a depth of 24". The upper 12" of the subgrade consisted of a soft, wet dark brown clayey silt before increasing in consistency to stiff. Figure 2 shows the general site conditions.

We recommend that the playground be undercut 12" to remove the soft saturated soil. Any boulders or cobbles visible after the undercut should be

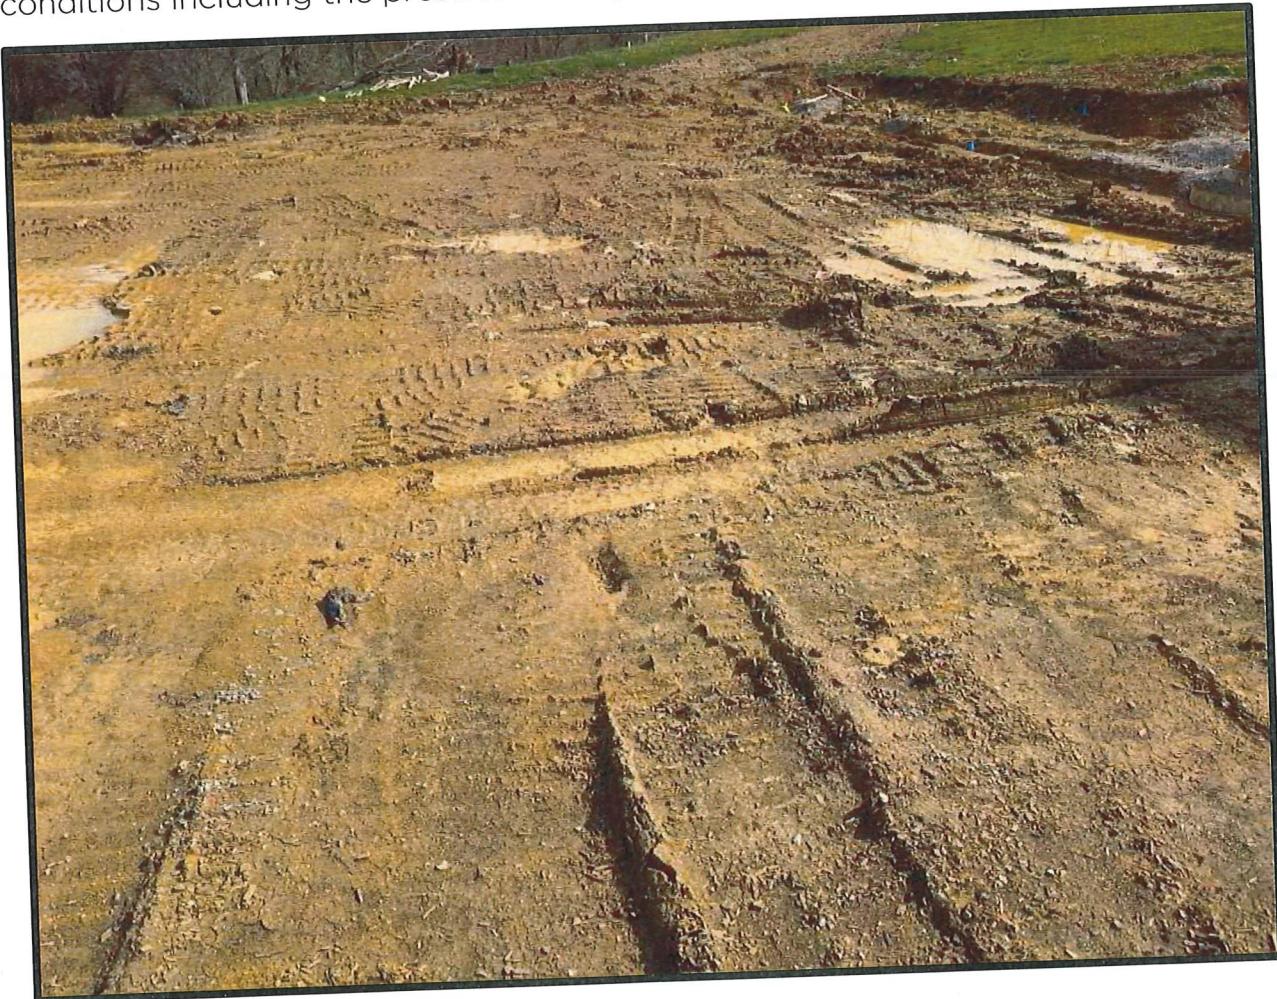
Figure 3: Locust Grove Site Conditions

The new playgrounds were generally at subgrade elevation. There is standing water and organic material visible during the site walk. No equipment was present to proof roll or excavate test pits with. Figure 3 shows the general site conditions including the presence of organic material.

We recommend that the upper playground be undercut 12" to remove the soft, wet subgrade and replaced with a layer of #2 stone that is walked into the subgrade, then engineered fill or DGA.

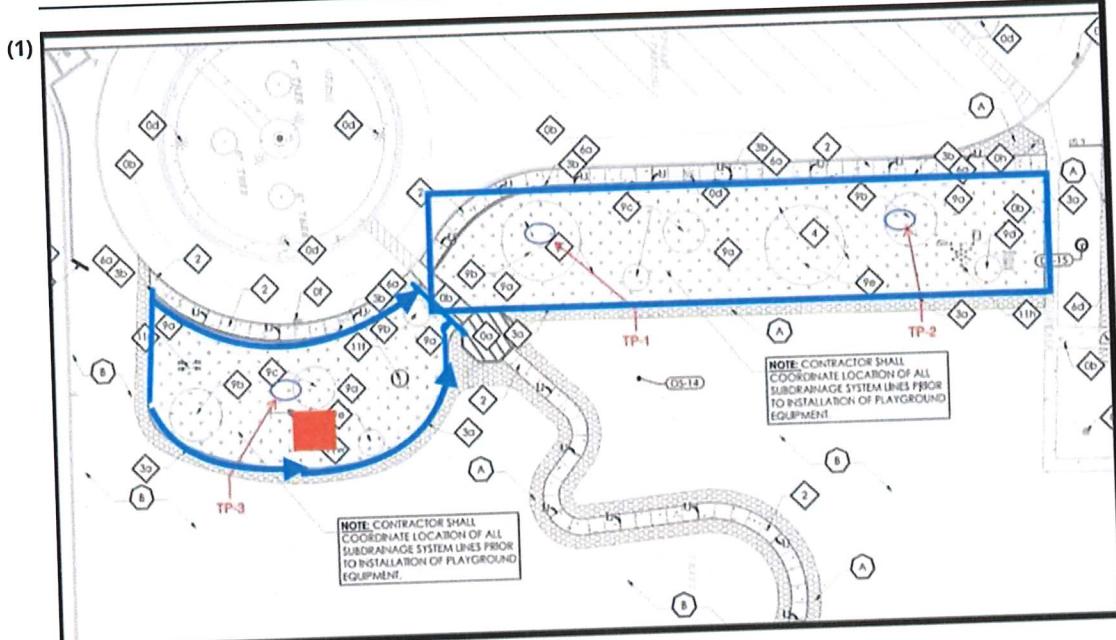
Solid Ground rep was on site today to observe undercut, and proof rolling of material in areas highlighted in blue on plans, highlighted in red are areas of soft soils found in proof rolling in excess of the 12" undercut.

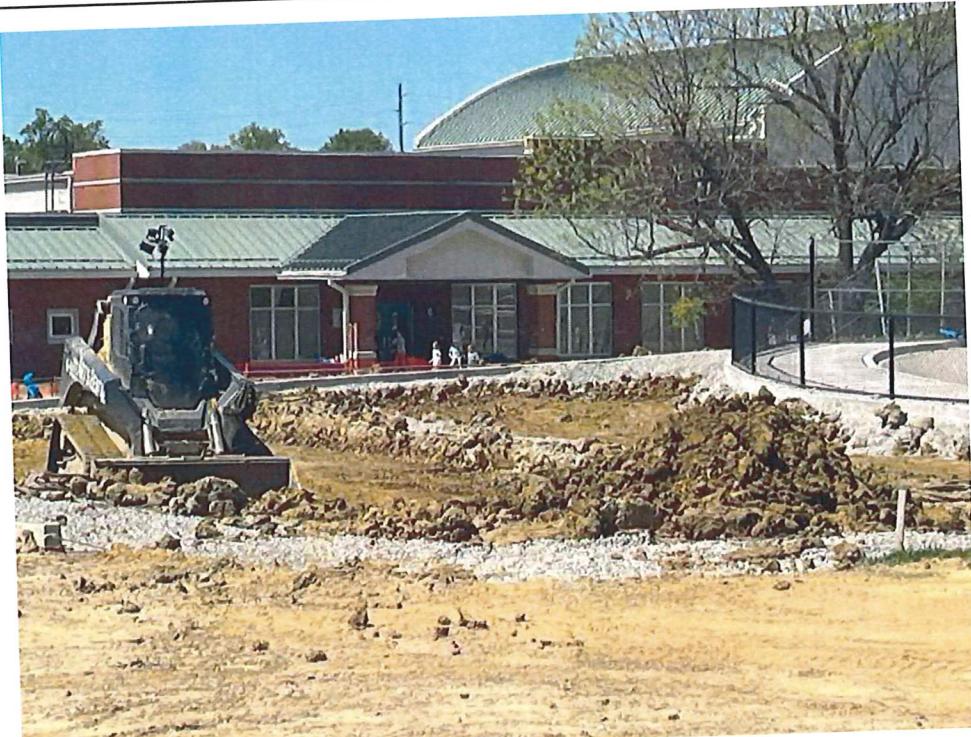
(3)

Undercut soil removed by contractor.

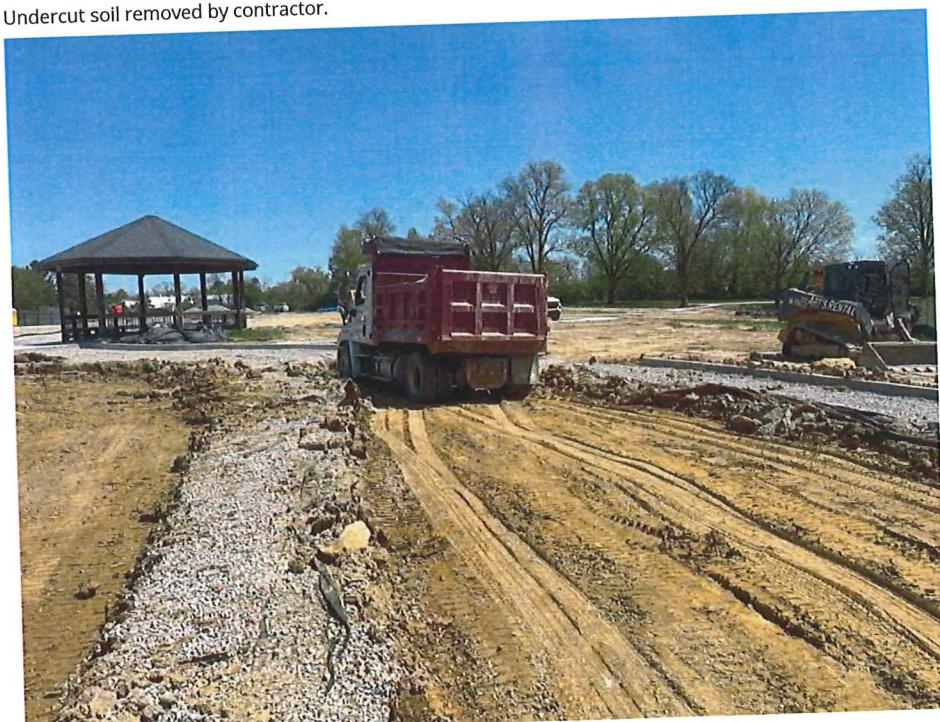
(4)

Proof roll with loaded truck shows soft soils in excess of recommend 12" undercut in 12' by 12' area. All other areas show material stiff with minimal amounts of rutting no more than 2".

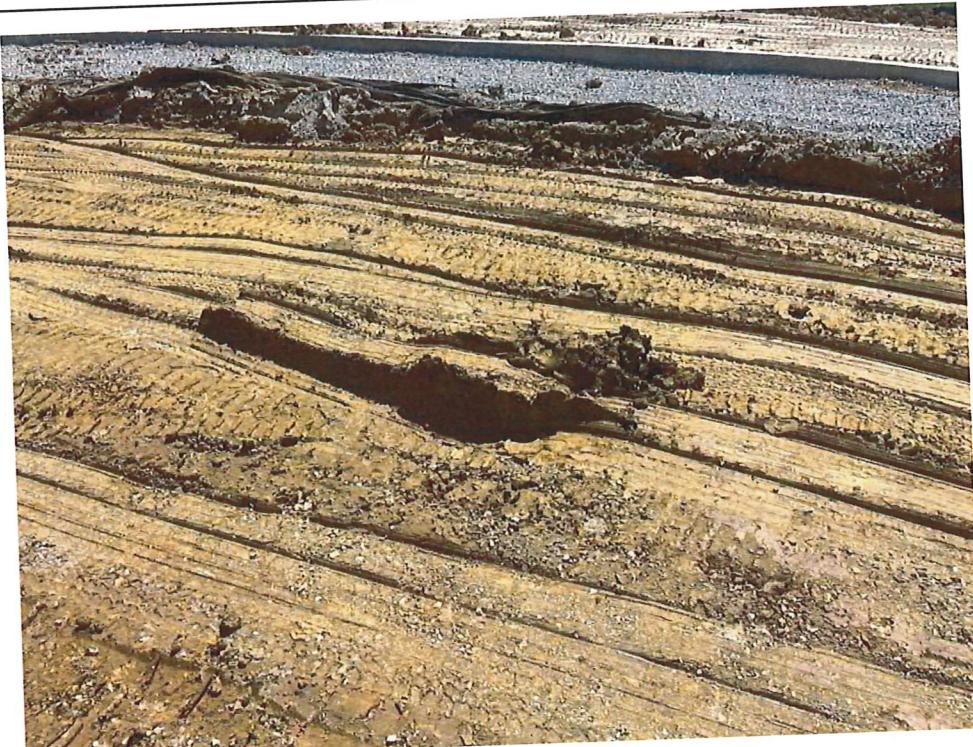
(5)

Created: Wed, 4/23/2025  
12' x 12' Area of soft soils encountered. (Highlighted in red on plans.)

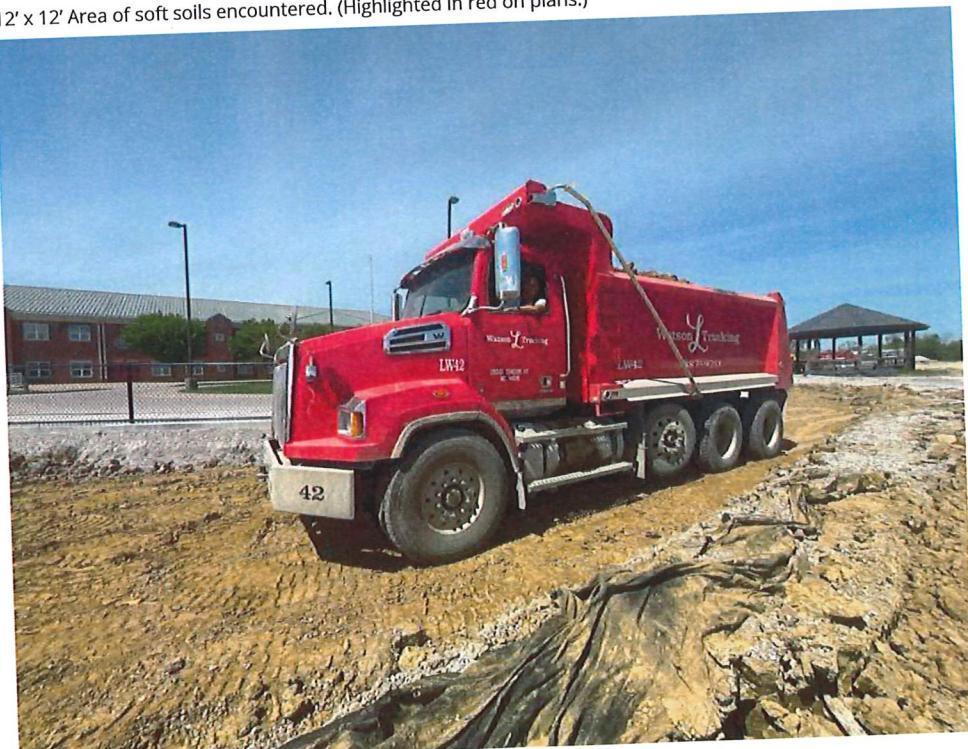
(6)

Created: Wed, 4/23/2025  
Proof roll with loaded truck shows material stiff with little to no movement.

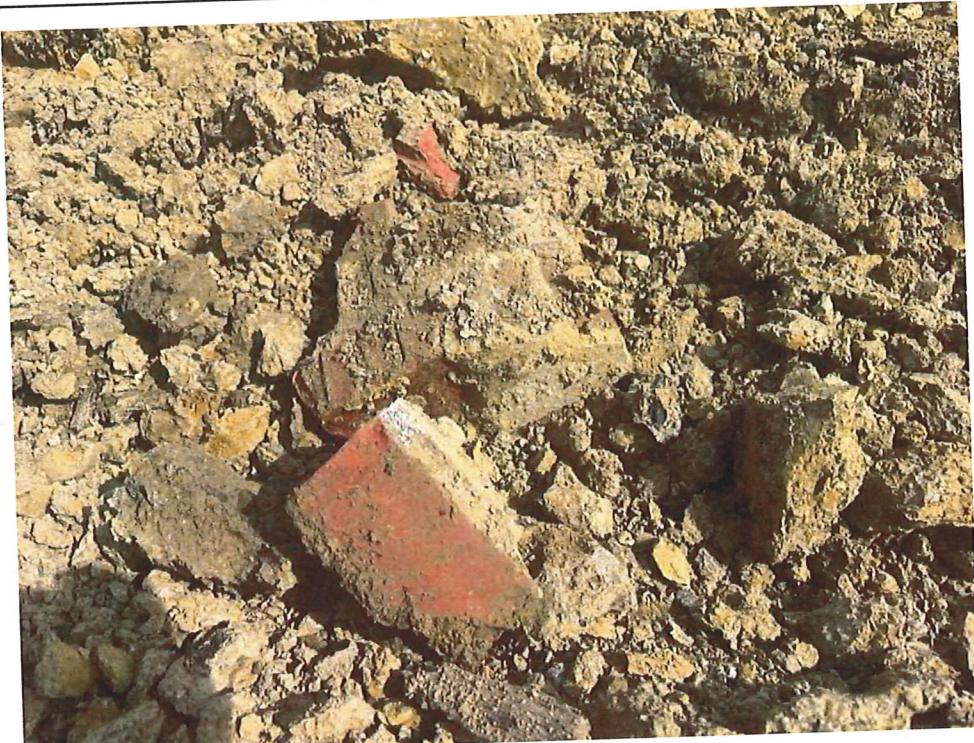
(9)

Construction debris found in excavation.

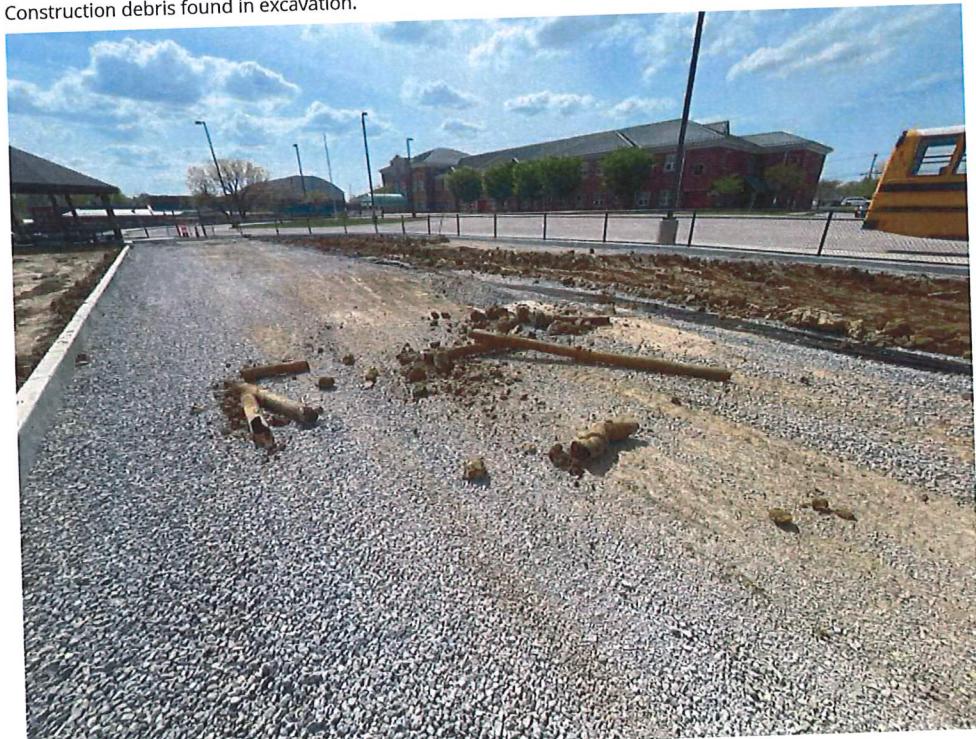
(10)

Construction debris found in excavation.

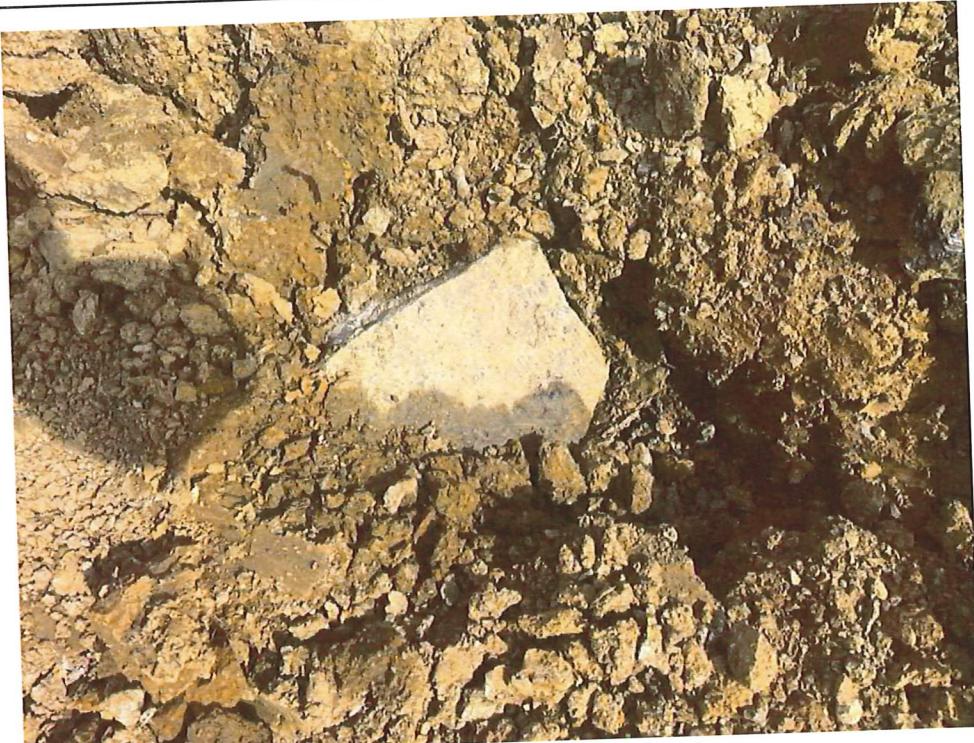
(11)

Construction debris found in excavation.

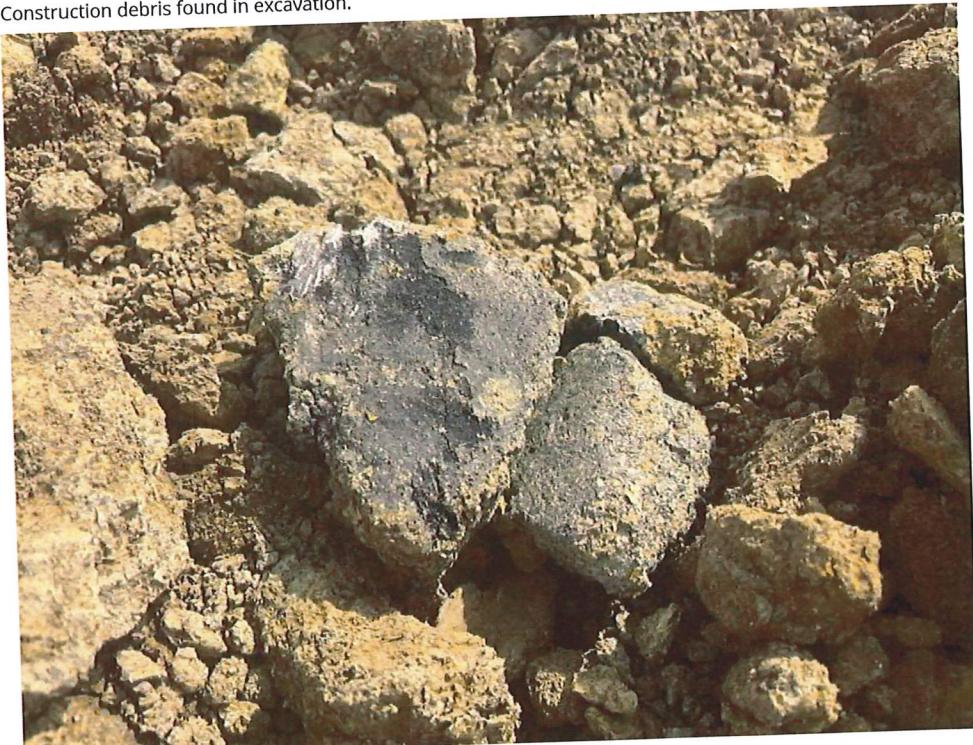
(12)

Small amounts of asphalt found in excavation.

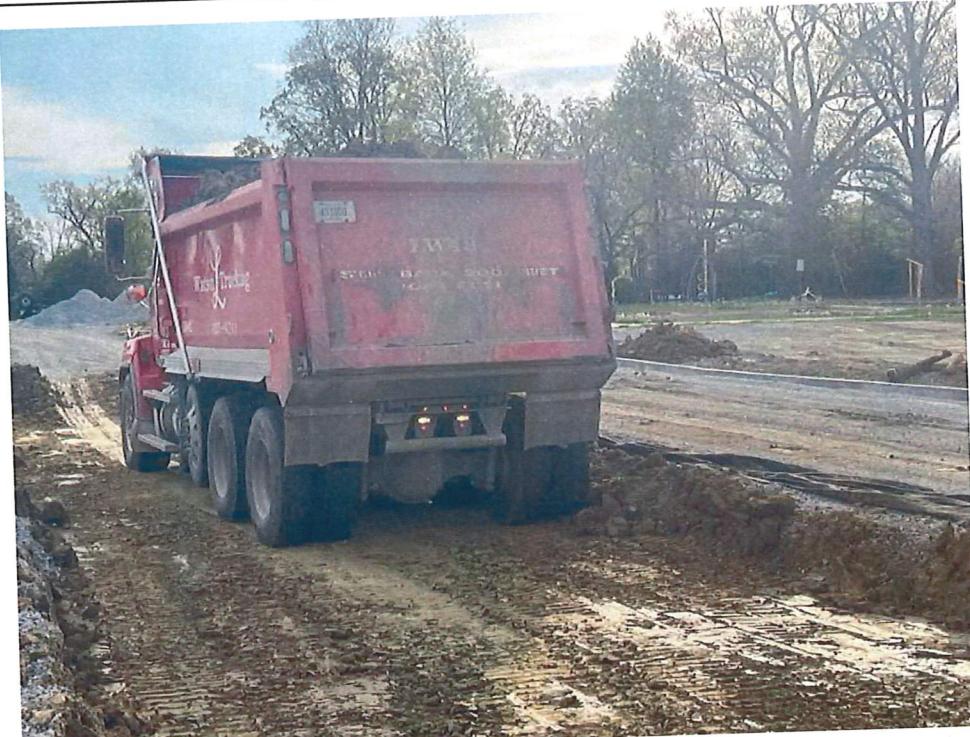
(3)

Proof roll with loaded truck shows material stiff with minimal movement of rutting less than 2".

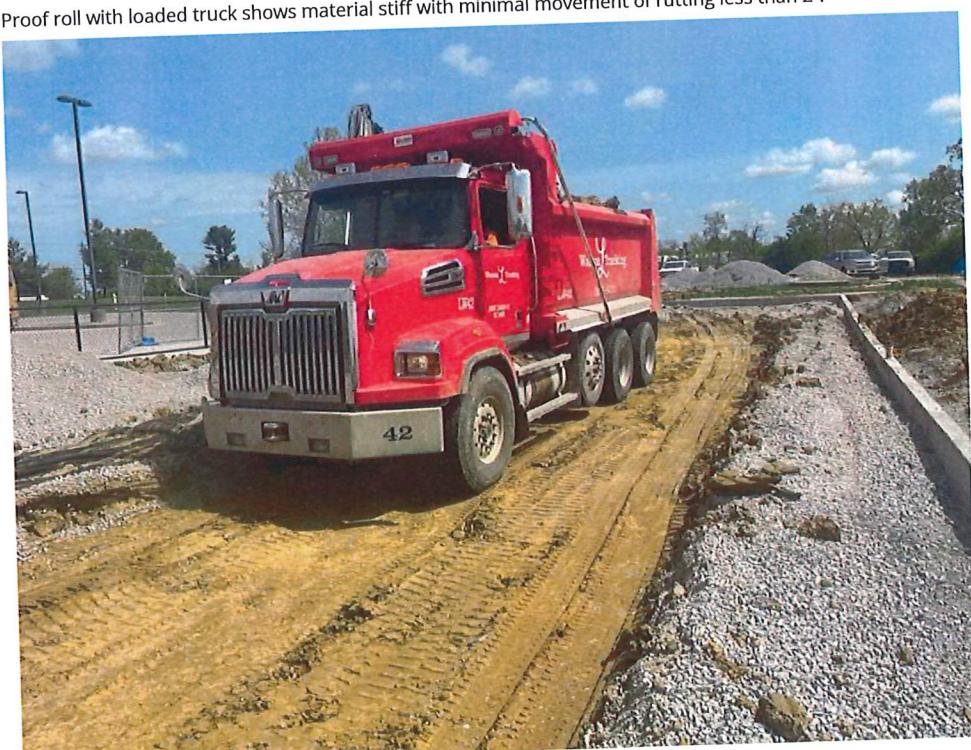
(4)

Proof roll with loaded truck shows material stiff with minimal movement of rutting less than 2".

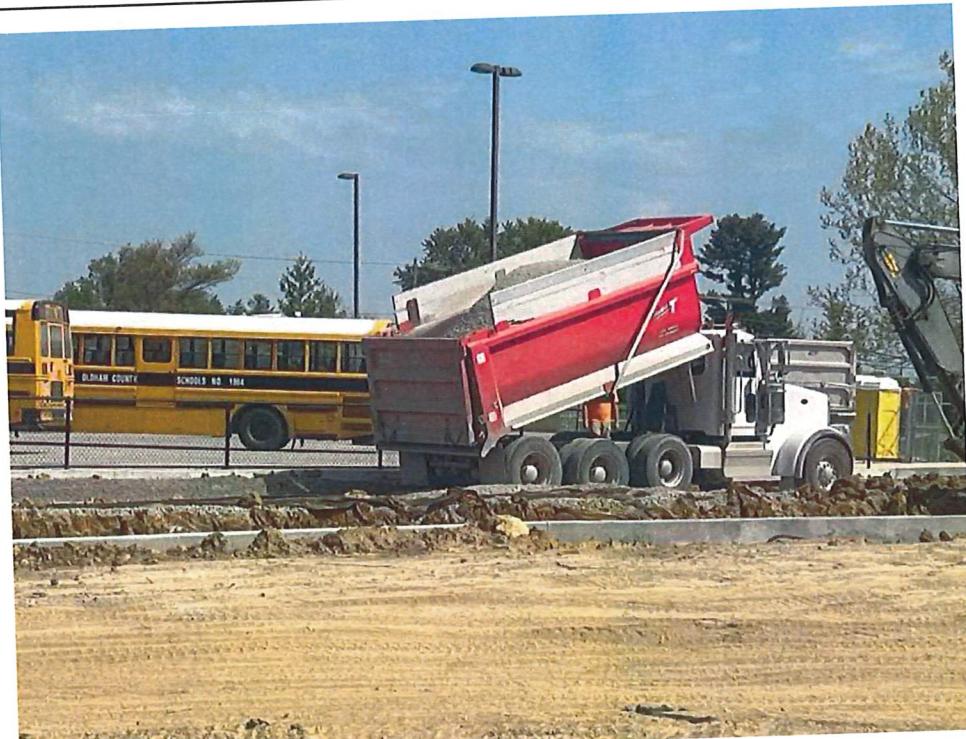
(5)

DGA delivered to undercut area.

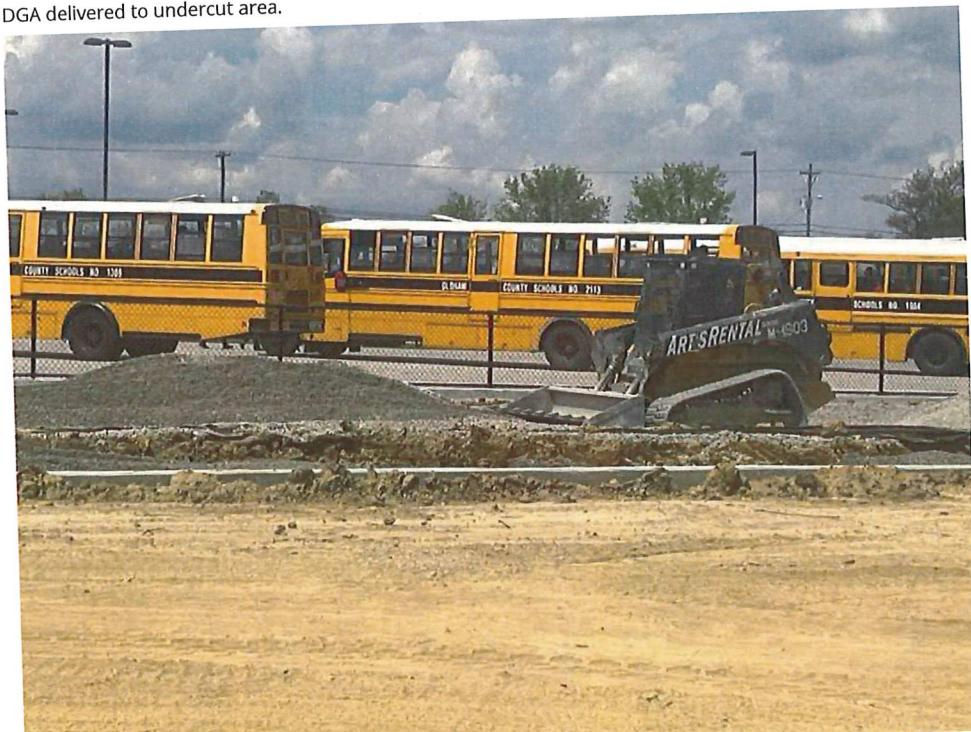
(6)

Contractor observed placing DGA in 6" loose lifts.

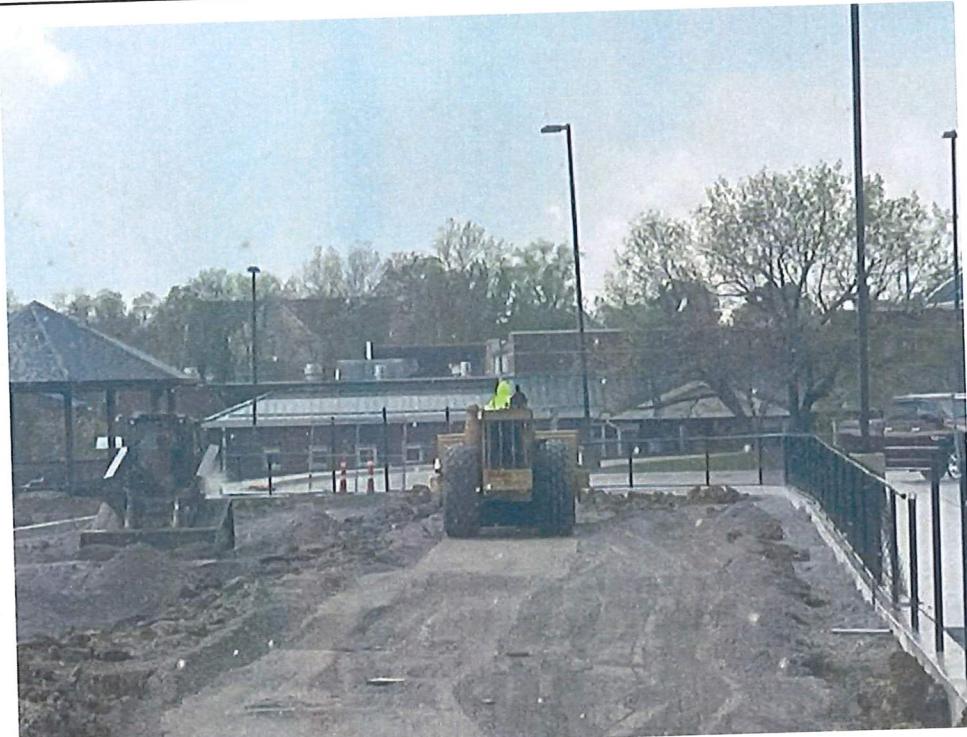
(7)

Compaction efforts made with vibrating smooth drum roller.

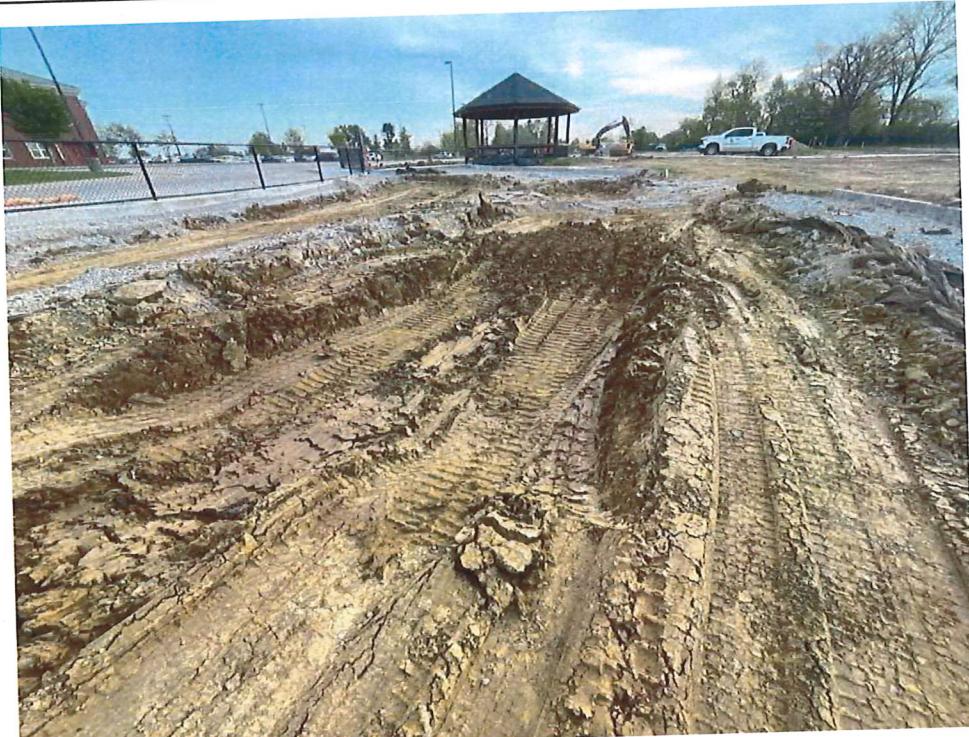
(9)

12' x 15' area of soft soils removed for proof roll.

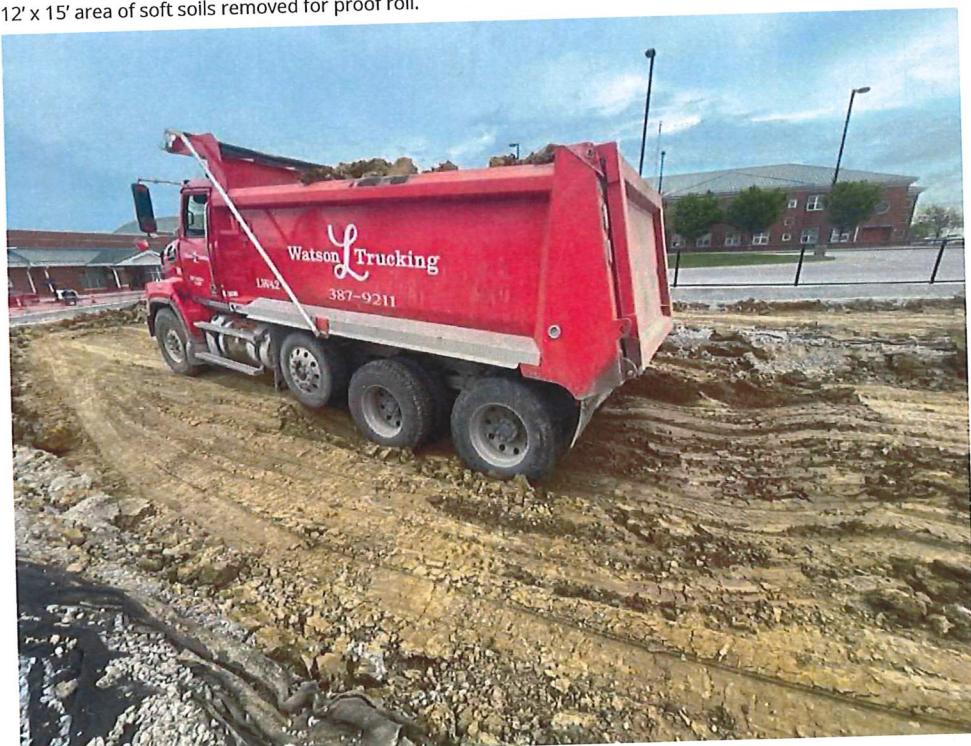
(10)

Proof roll with loaded truck shows material stiff with minimal movement of rutting less than 2".
