FIELD OBSERVATION REPORT

Central Hardin High School – Phase 2, 2019111 -CA8

Date: 12/9/2025 Time: 12:30 PM

Report No: 35

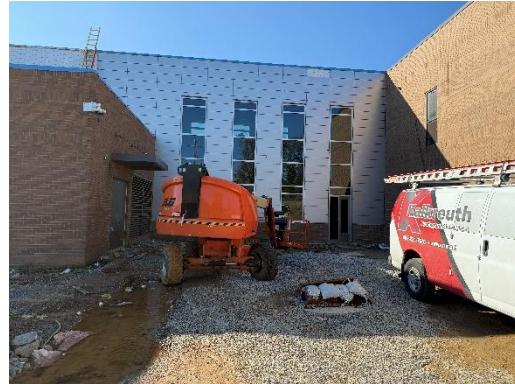
- a) Flat metal panels were installed on the east side of the new connector between Areas J and H. The panels installers will move to the west side of Area J.

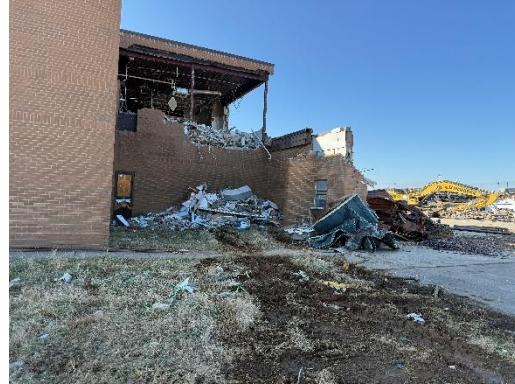
- b) The northern section of the two-story area will be demolished when the crew specializing in selective demolition returns to the site.

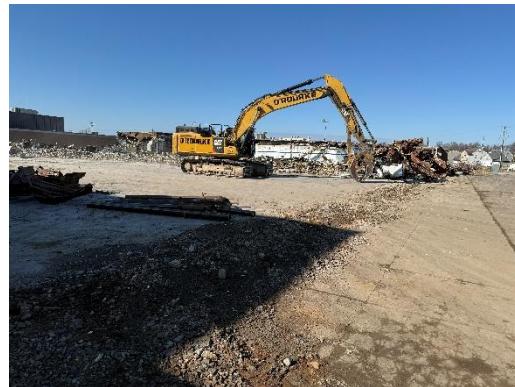
c) The demolition of area 2B continued to the north. The slab remains but it needs to be removed for the parking lot in the area.

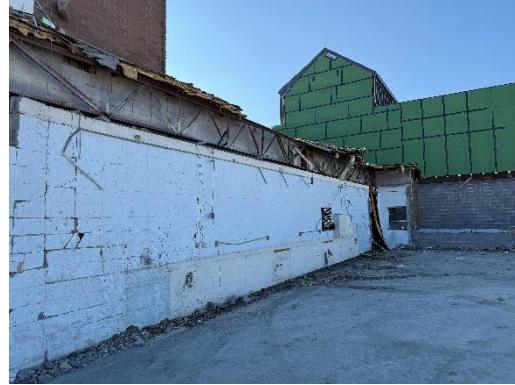
d) The wall between the two-story and one-story to the north of Area H will be removed.

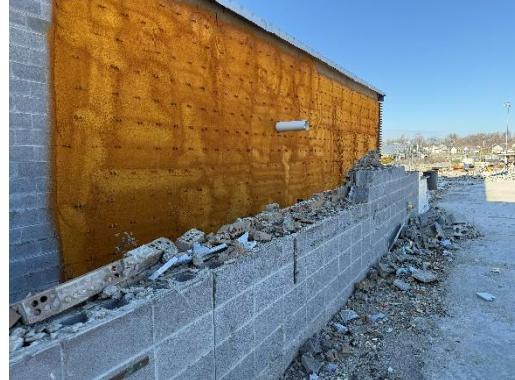
e) The wall with the spray foam insulation is the exterior of the new kitchen. It will be covered with brick. The block wall will be removed.

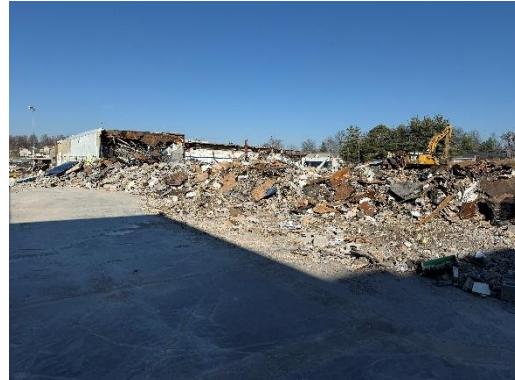
f) The mechanical room and the old kitchen were the last remaining rooms in the one-story area.

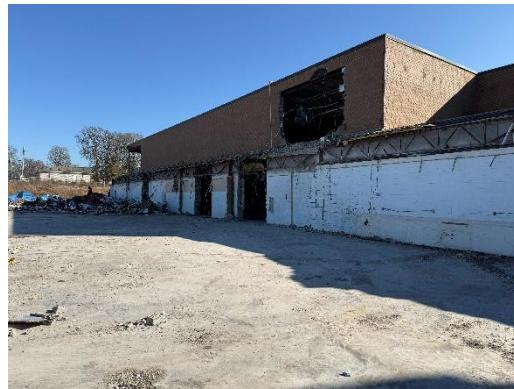
g) The existing project to the north of Area H will be removed.

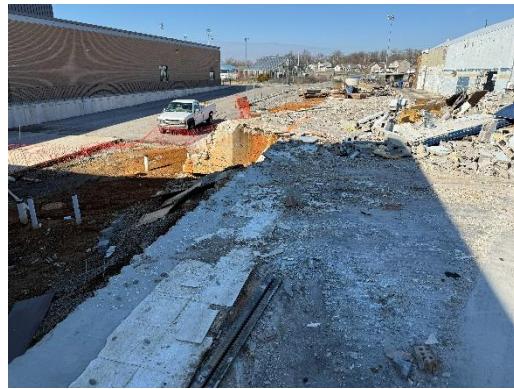
h) Looking toward Area D and the kitchen loading driveway, the area to the east will be cleaned up and made part of the new parking lot in the area.

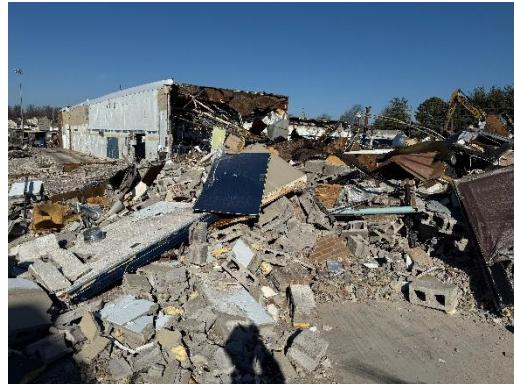
i) The standing construction is the old mechanical room which will be removed.

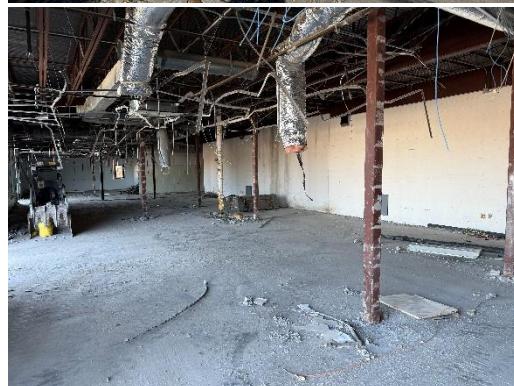
j) Inside Area H, ductwork and wiring still needs to be removed.

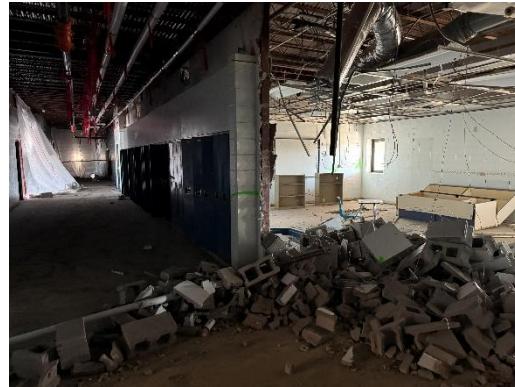
k) Some block walls remain to be removed. We discussed the existing stack bond walls to remain. These will be cut at the new running bond walls and separated with a vertical control joint. New door openings in the stack bond areas will be repaired with stack bond.

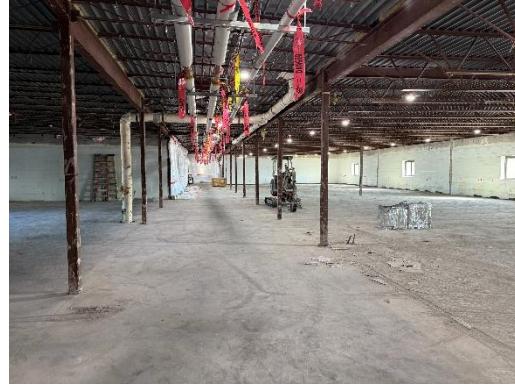
l) Existing utilities to remain were marked with hazard tape. These serve the renovated Area J.

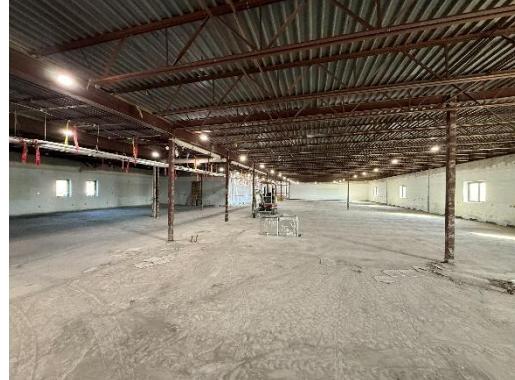
m) Some sections of Area H were completely stripped of original block walls.

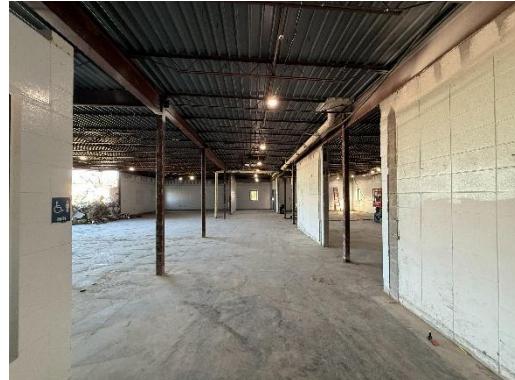
n) The remaining walls are in relatively good condition.

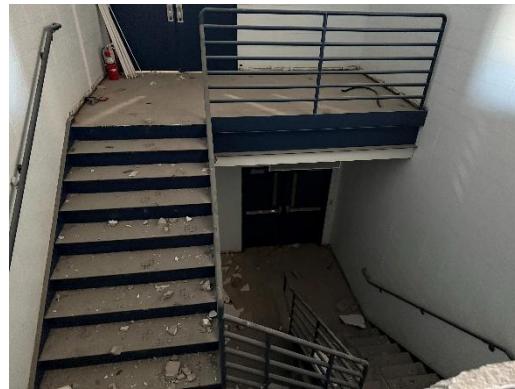
- o) The original stairs will be reused in the renovation.

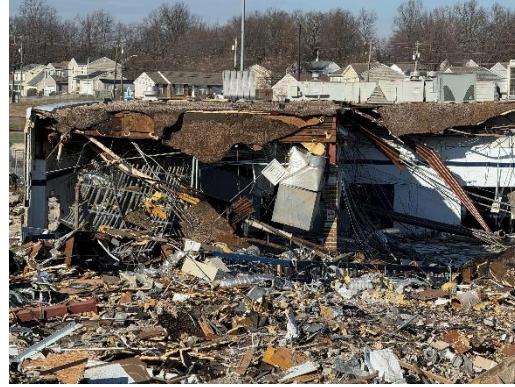
- p) A closeup of the one-story demolition indicates the progressive removal of roofs, walls, and equipment.

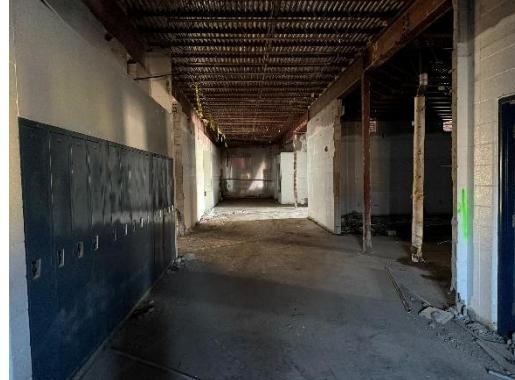
- q) Some items remain to be removed such as the original metal lockers.
