## FIELD OBSERVATION REPORT

Child Nutrition Building (Food Service Building, 202276 -CA8)

Date: 12/2/2025      Time: 8:30 AM

Report No: 23

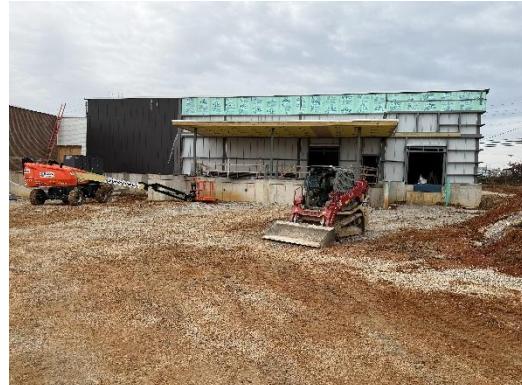
- a) Metal panels were being installed on the warehouse.

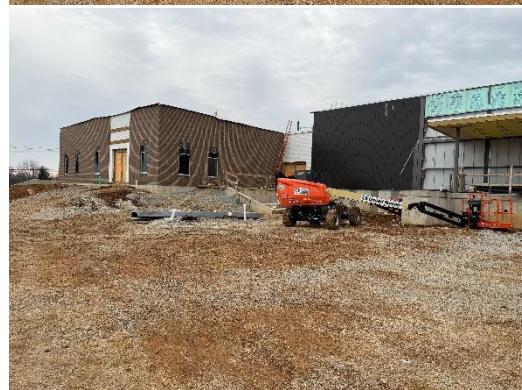
- b) The office area was enclosed to allow for interior work to be done.

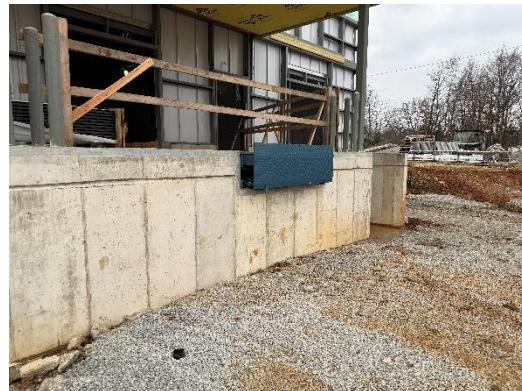
c) The dock area leveler was placed in the recess. It was not shimmed and connected to the concrete. When this is done, the front and top will align with the dock wall and walkway.

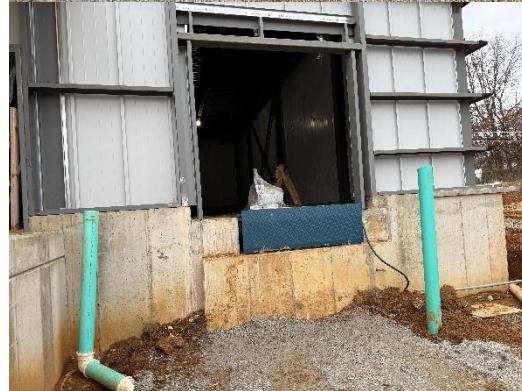
The interior dock leveler was also placed in position but not shimmed and connected. When this is done, the front and top will align with the dock wall and warehouse slab.

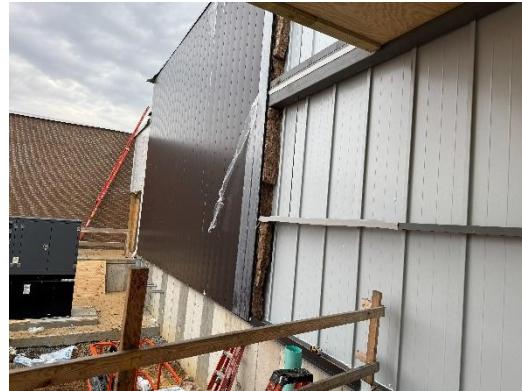
d) The bronze metal panels were being installed over the fiberglass insulation. The panels appeared to be holding the batts firmly in place without causing bulging in the panels. The insulation appeared to be continuous from top to bottom.

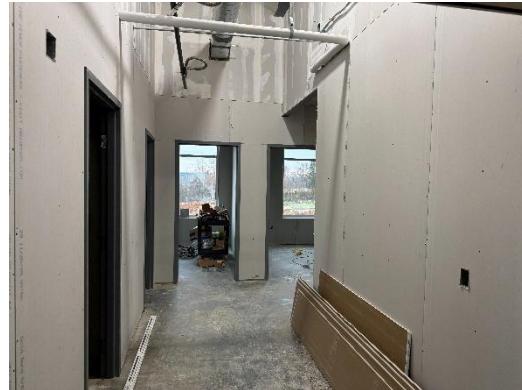
e) Wallboard was being hung in the office area. It was not being finished because temporary heat was not started. Brad reported that temporary heat will be applied to the building on Monday, December 15. This will allow the finishers to tape and spackle the joints and spackle the screw heads.

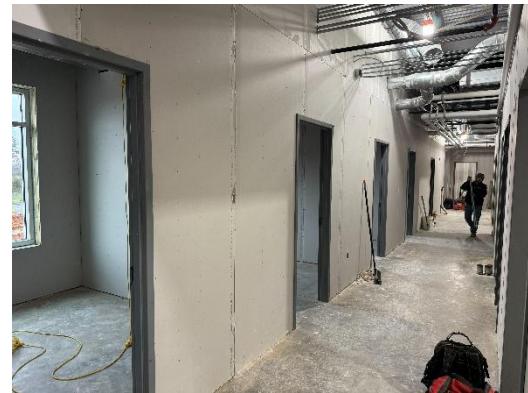
f) Control joints need to be installed in the wallboard at 30' on center from the slab to the top of the walls.

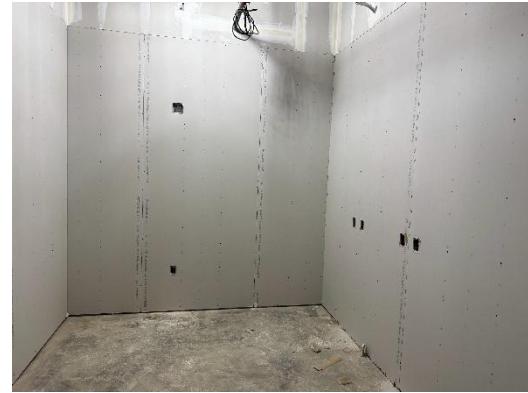
g) Electrical outlets were cut into the wallboard.

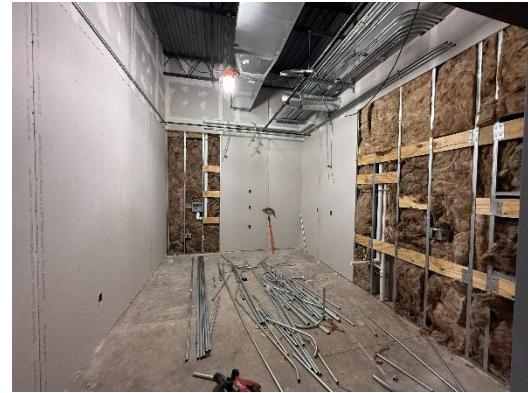
h) Wallboard was not being hung where plumbing and electrical work was yet to be complete.

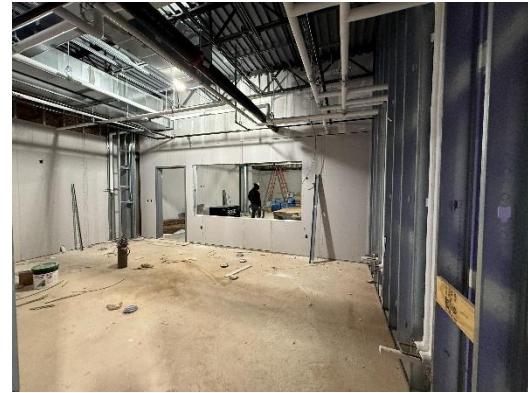
i) Wallboard was hung in the demo kitchen.

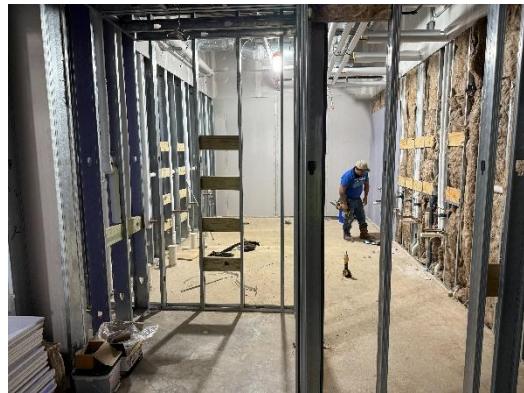
j) Mold and moisture resistant wallboard was being hung in the toilets.

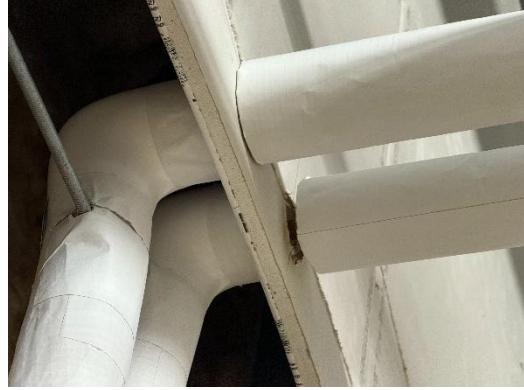
k) Refer to the Field Observation Report from CMTA concerning making pipe insulation continuous through wallboard and through the walls.

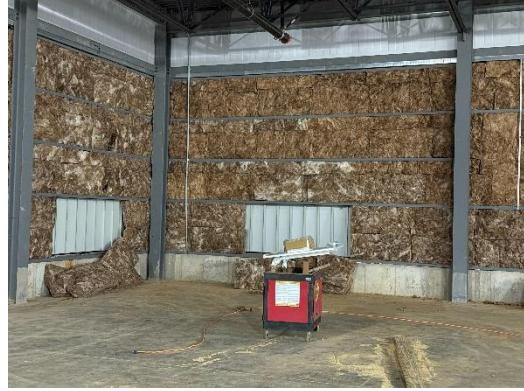
l) Batt insulation was being installed on the exterior walls that will be behind the freezer. The batts were set in place but the steel straps were not yet installed to hold them firmly in place.

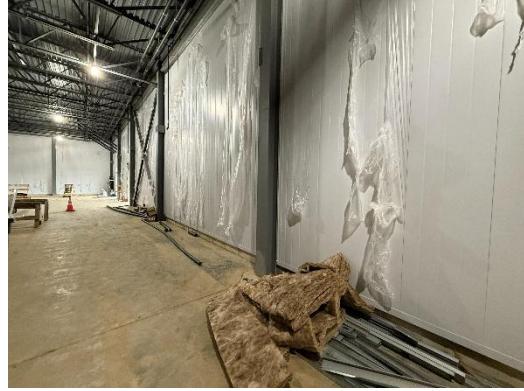
m) There was no light at the edges of the liner panels which had been sealed before the batt insulation and exterior panels were installed.

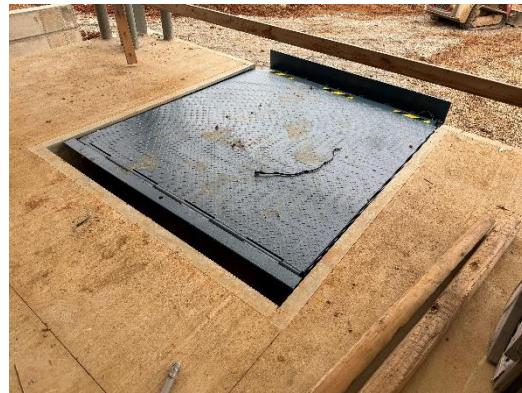
n) The leveler in the dock walkway will fill the recess in the concrete walk.

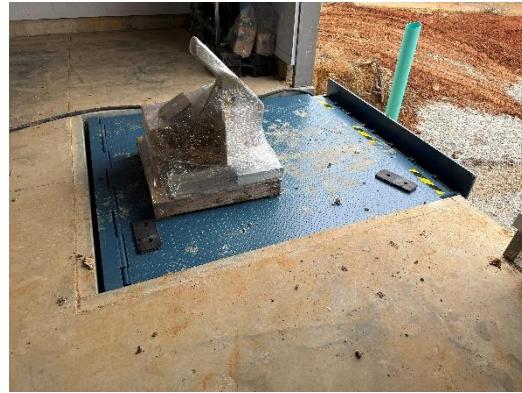
o) The leveler in the warehouse will fill the floor slab recess.
