## FIELD OBSERVATION REPORT

West Hardin Middle School, 202280 -CA8

Date: 12/9/2025    Time: 10:00 AM

Report No: 25

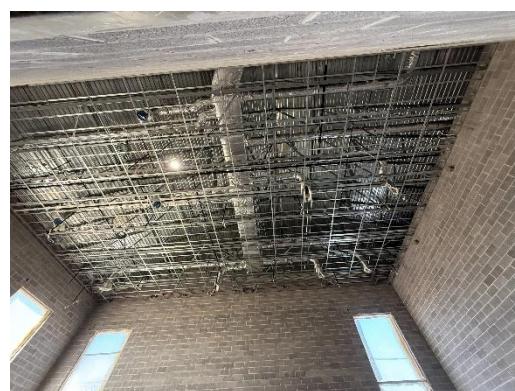
- a) The band room ceiling will have wallboard on the metal framing covered with black spray acoustic insulation. Lay in ceiling clouds and acoustic panels will be under that.

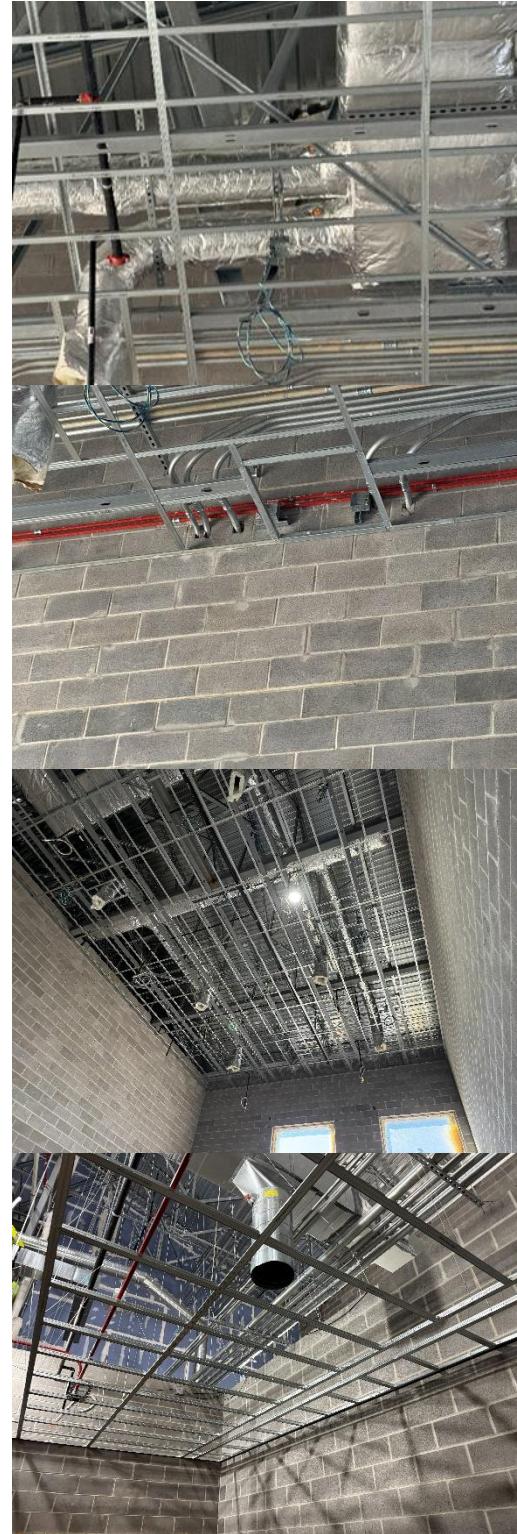
e) The metal framing for the wallboard ceiling over the student toilets in Area D were in place. We discussed moving the drivers for the LED light fixture to the platform for maintenance and replacement.

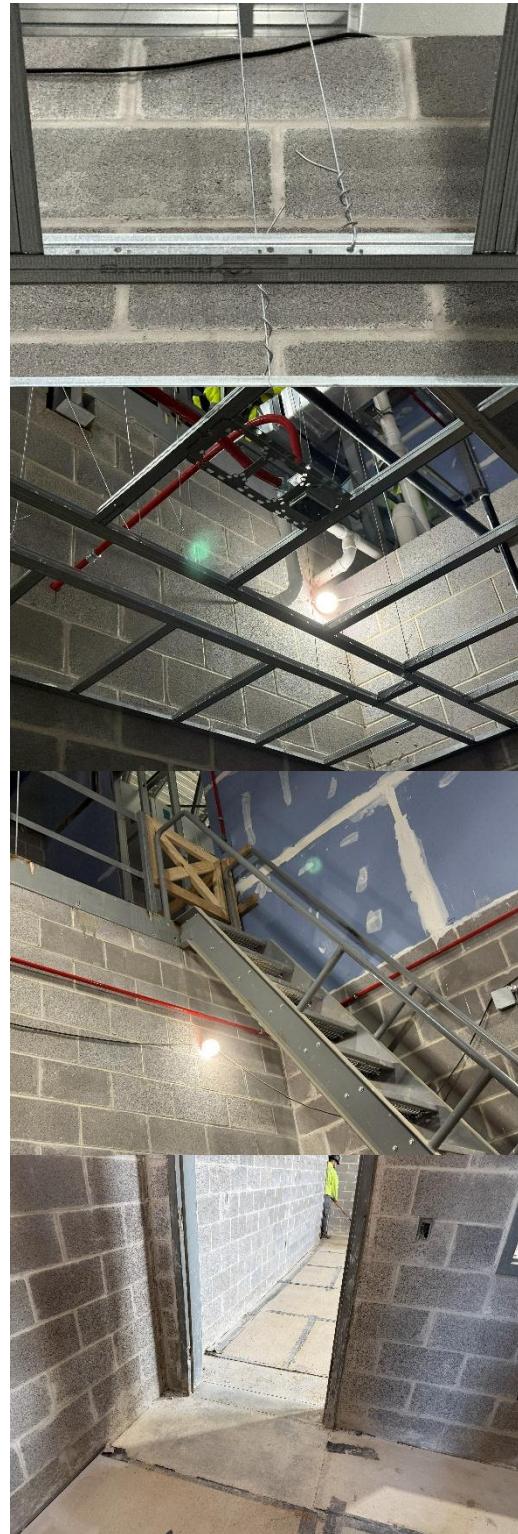
- i) Jeremy noted that the door frame to the music office was reinstalled with the bottom out of line. This will need to be repaired.

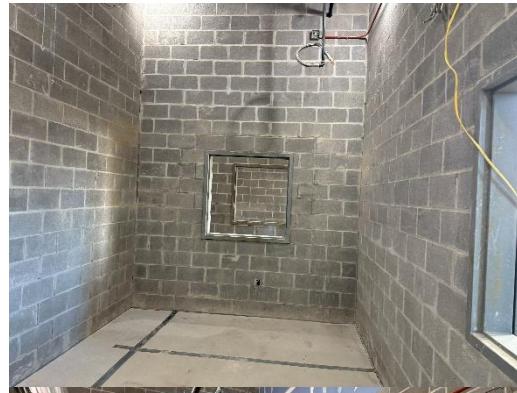
j) The frame for the window into the practice room had been properly reinstalled.

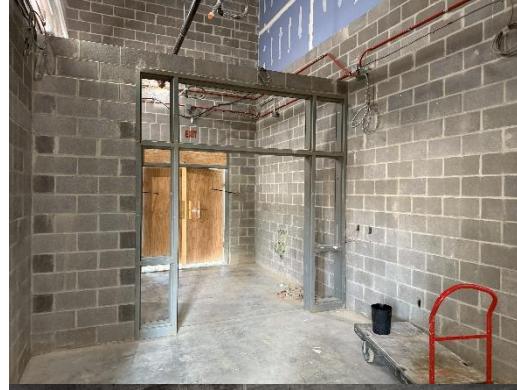
k) Entry and exit doors will typically have electronic controls and security. It is important to run wiring to the proper location to connect the specified devices.

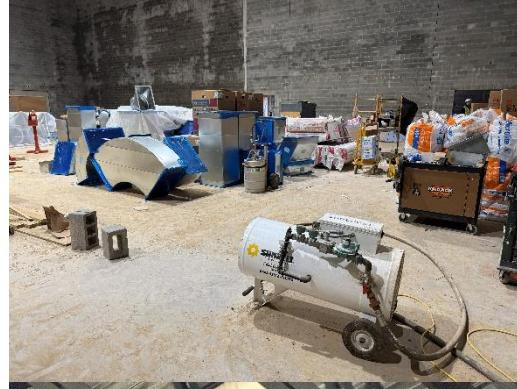
l) Temporary heat was being applied to the gym which is being used for storage and assembling building components.

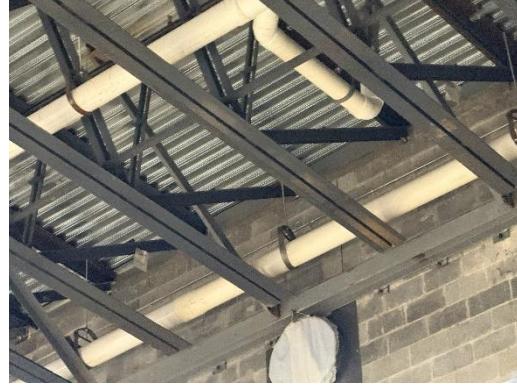
m) The additional angle bracing for the top of the gym wall was in place.

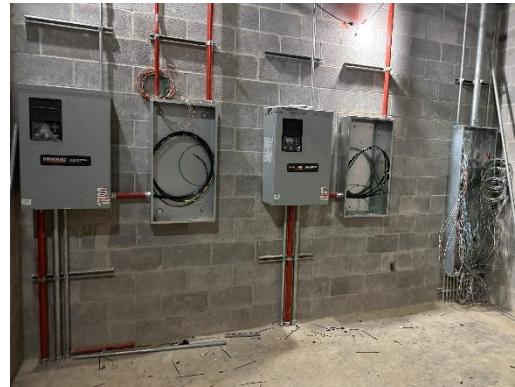
n) The electrical room for the storm shelter was being fit up with electrical panels and conduits.

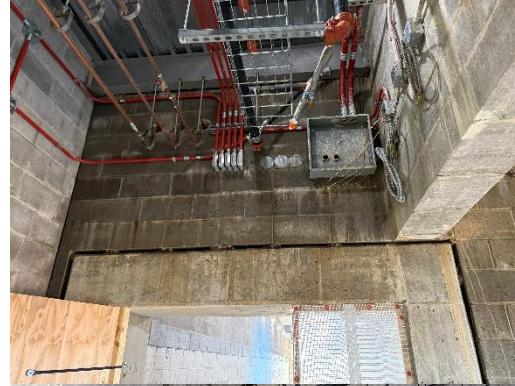
o) Small pipes and conduits can pass through the perimeter walls of the storm shelter. If these are grouped together, shielding may be required to meet storm shelter requirements.

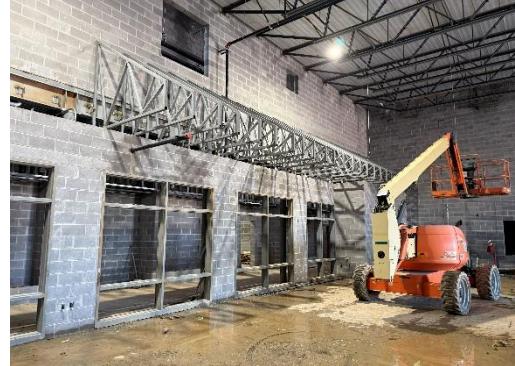
p) Tubular framing was being installed at the cafeteria corridor wall. This will support the sloped "roof" like was installed at EHMS.

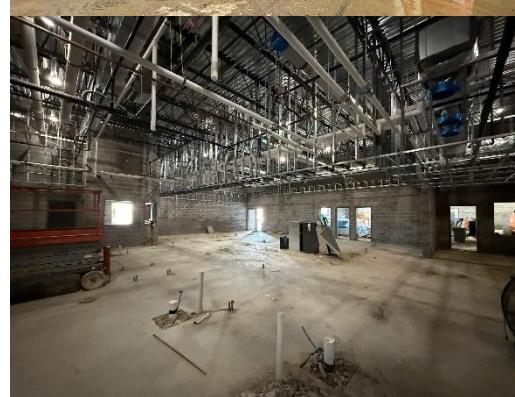
q) The kitchen was relatively clean and dry. Temporary heat had been applied to the room.

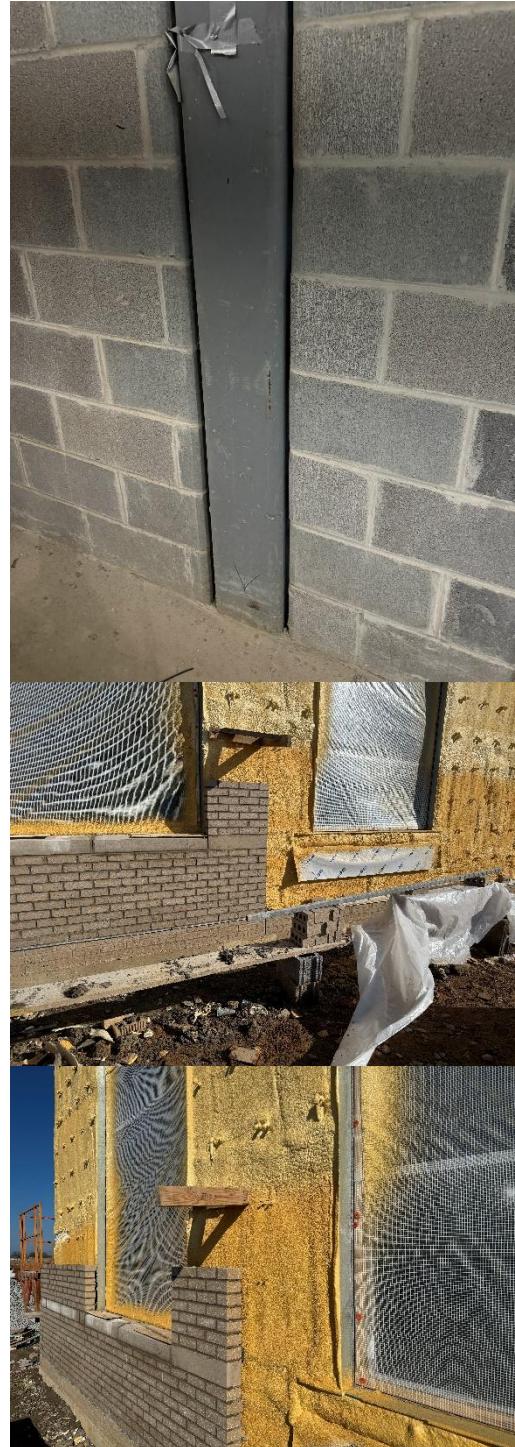
r) Steel tube columns occur in block walls in the building. A bullnose was installed in the block and the column has radii on the corners. The caulk joint needs to be recessed past the radii.

The vinyl base may not adhere to the radius. The base can be extended into the joint between the column and the block and the caulk joint continued to the floor to hold the base in place.

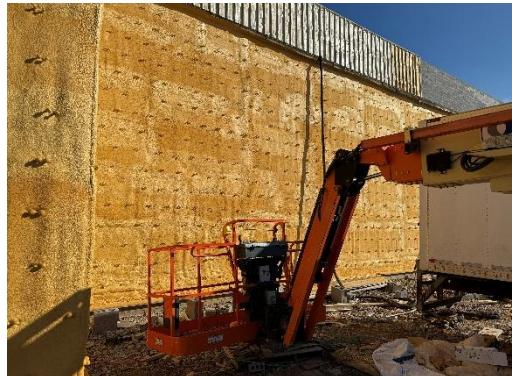
- u) The spray foam insulation installer was continuing to spray additional walls if the air temperature is above 10<sup>0</sup> F.

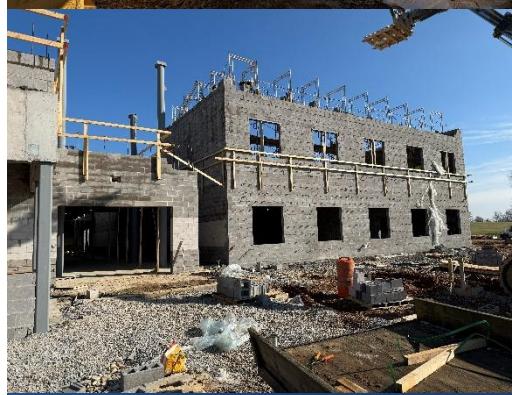
- v) Concrete block on the southernmost classroom wing was being laid up to eave height.

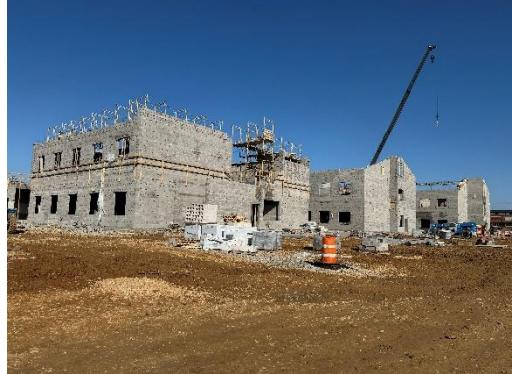
- w) Concrete block was close to being topped on all three classroom wings.

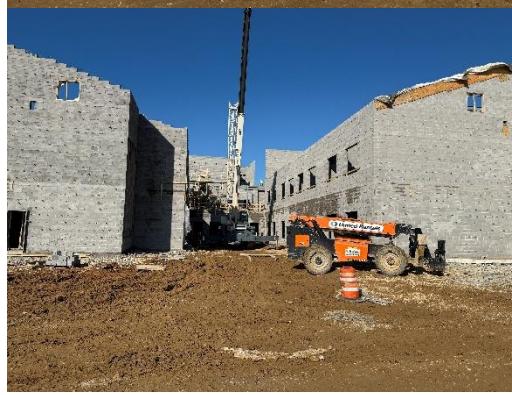
- x) The concrete block walls between the classroom wings were being laid to eave height.

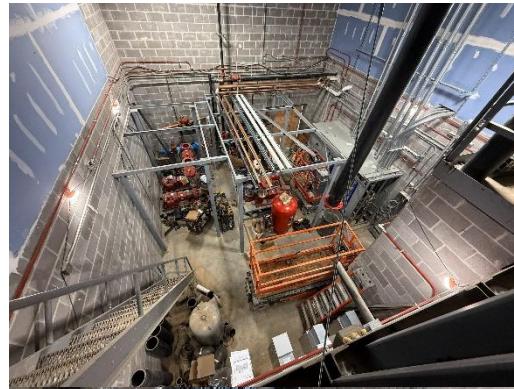
y) With the support framing in place in the main mechanical room, equipment was filling up the room.

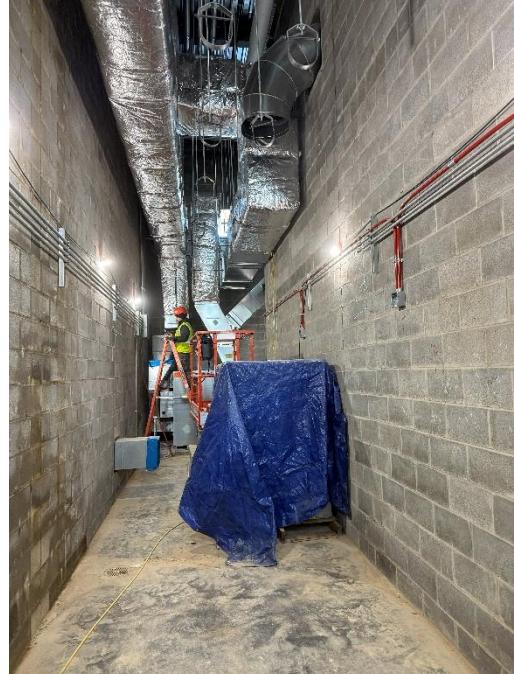
z) The mechanical platform around the gym, is filling up with ductwork and heat pump units. The floor was being cleaned by the mechanical crew while I was there.

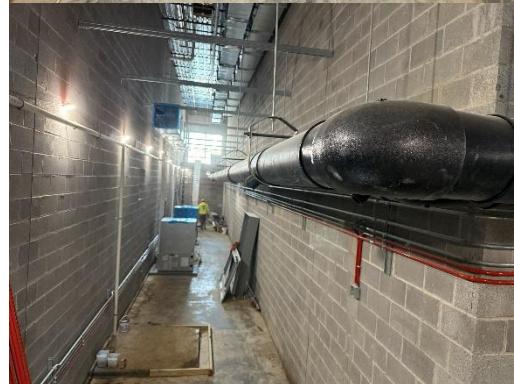
aa) Hydronic piping carrying water from the geothermal wells was being extended around the gym in the mechanical platform.

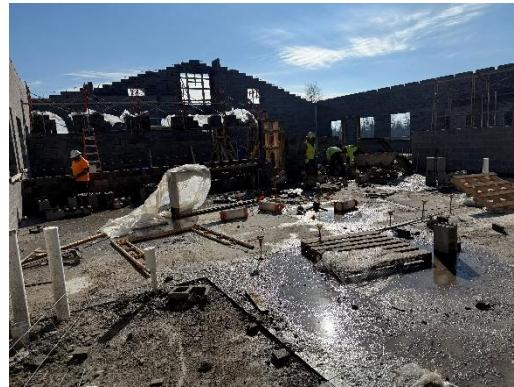
bb) Interior block walls were laid in the middle classroom wing.

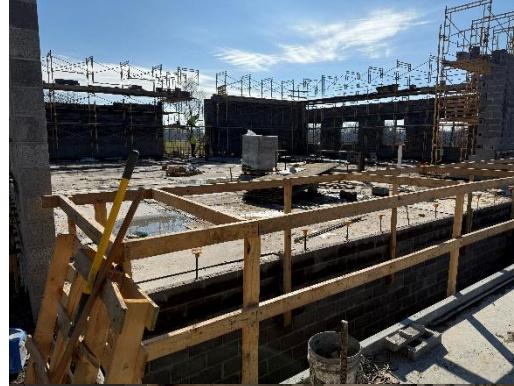
cc) Masons were preparing to lay concrete block in the southernmost classroom wing.

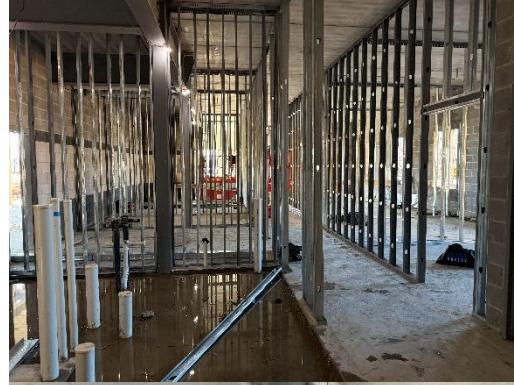
dd) Metal wall framing had been installed in the administration area.

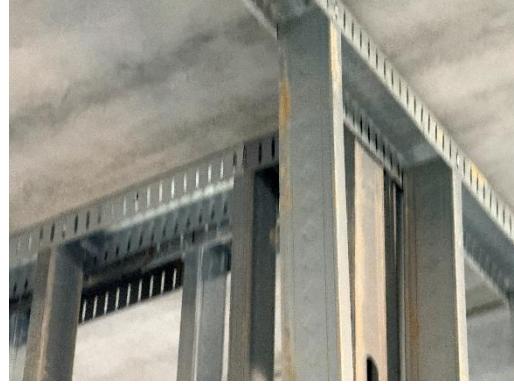
ee) Slotted ceiling track was used at the tops of walls as specified.

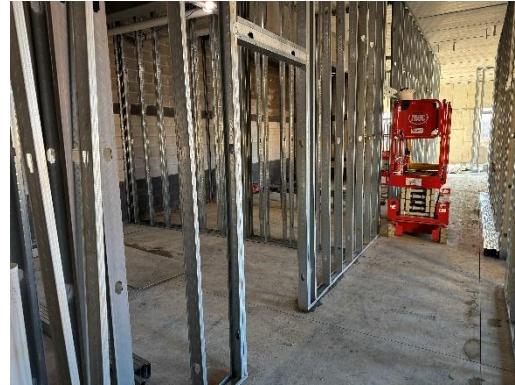
ff) Double studs and boxed headers were being installed around door openings as detailed.

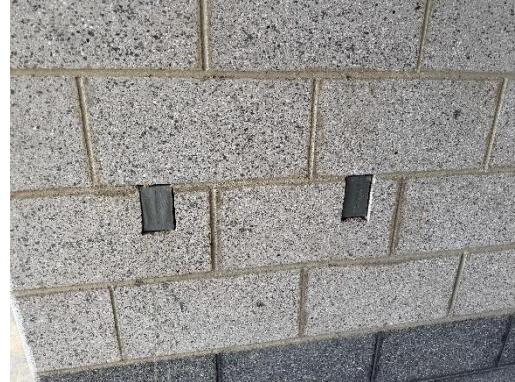
gg) We noted that the mason was doing a good job of cutting blocks to fit around the electrical switch and outlet back boxes.
