FIELD OBSERVATION REPORT

Child Nutrition Building (Food Service Building, 202276 -CA8)

Date: 1/13/2026 Time: 9:30 AM

Report No: 26

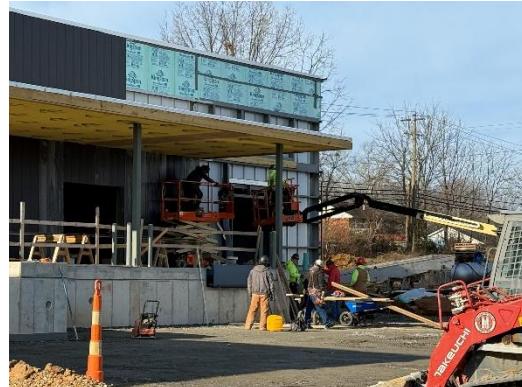
- a) The sheet metal crew was completing the last area requiring exterior metal panels.

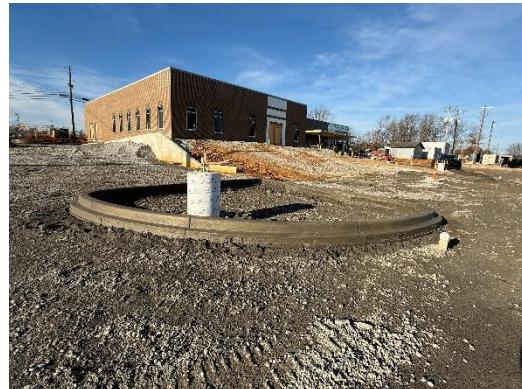
- b) The concrete curbs were poured earlier in the day with a curb machine.

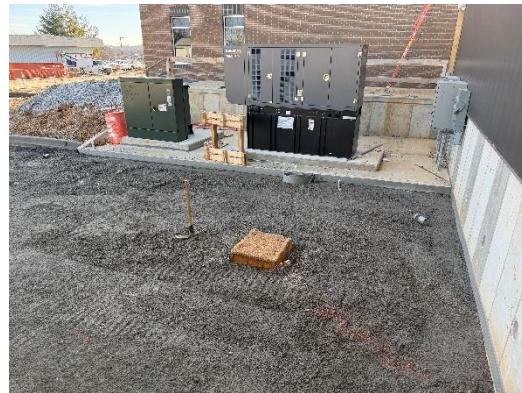
c) Crushed stone was placed in the areas to be paved.

After the OAC meeting we moved 4 steel pollards from the front of the warehouse to the drive in front of the transformer and generator. We determined that they needed more protection than the building since the foundation at the building is high enough to catch a truck bumper.

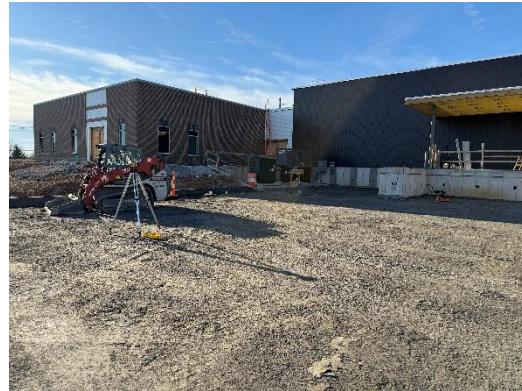
d) We moved two bollards to protect the concrete projection from the dock between the compactor and the dumpster.

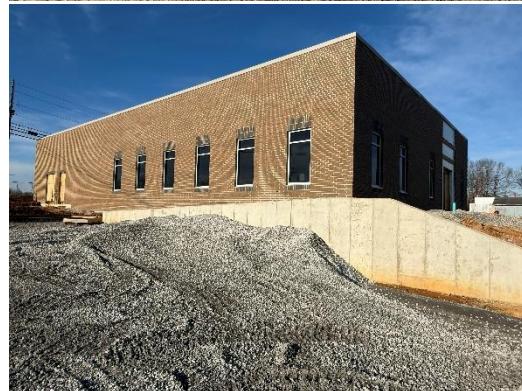
e) Crushed stone was being placed for the parking lot and ramp to the office entrance.

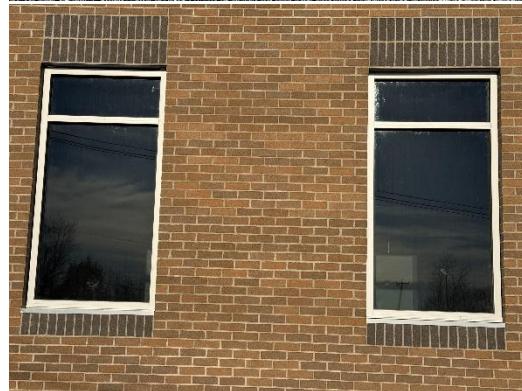
f) The brick was cleaned and it looks much better.

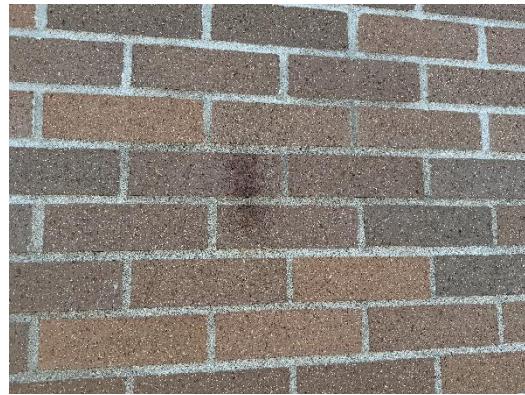
g) There is one stain on the brick on the east elevation that does not appear from the masonry operations.

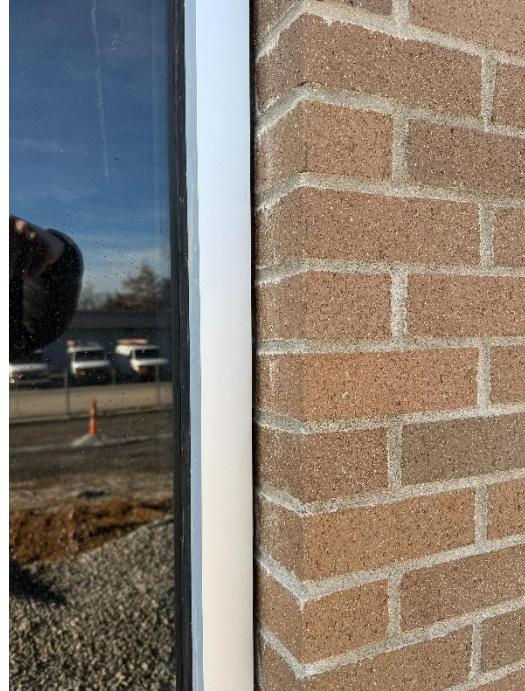
h) The aluminum window frames have not yet been sealed to the brick.

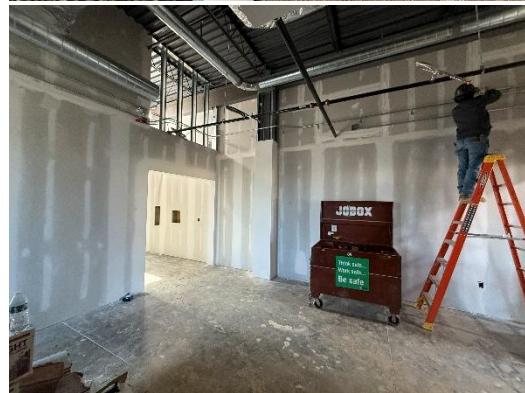
i) The wallboard joint compound had been sanded.

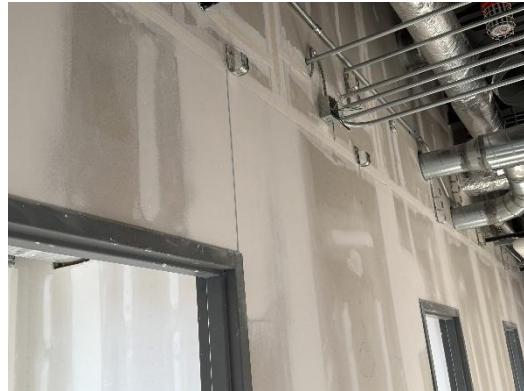
j) The control joints that were required for walls over 30' were in place.

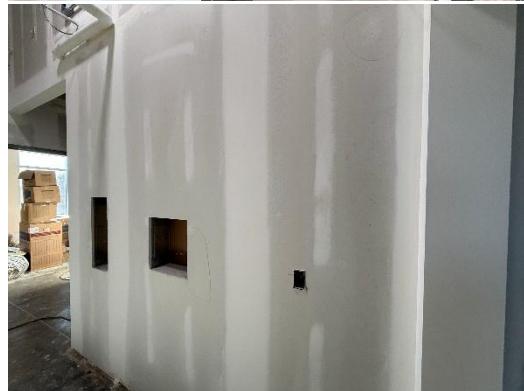
k) Back boxes in walls were prepared to receive the devices.

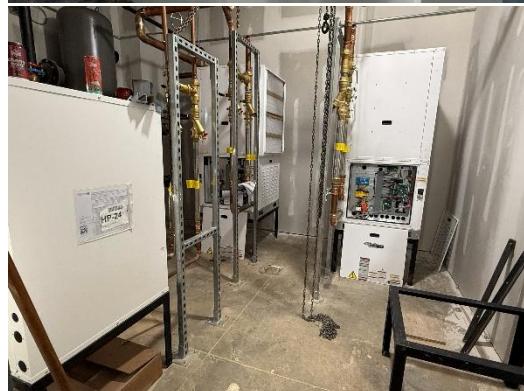
l) The heatpumps were being connected. On 1-14-26 a Teams meeting was conducted to rearrange some of the installed components to facilitate the removal of the heatpumps when necessary. The discussion about this is ongoing.

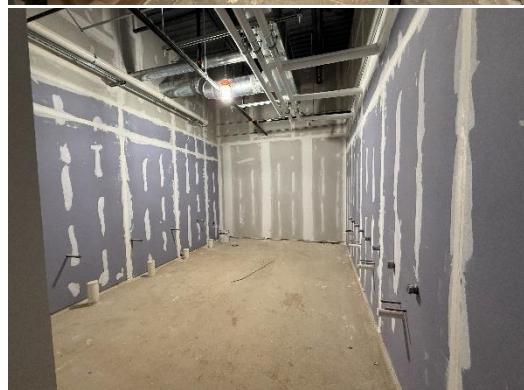
m) The walls in the toilets appeared to be ready for tile.

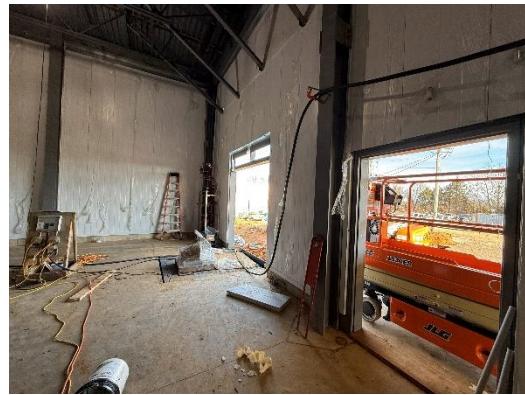
- n) The overhead doors were not installed but at scheduled in the next few days.

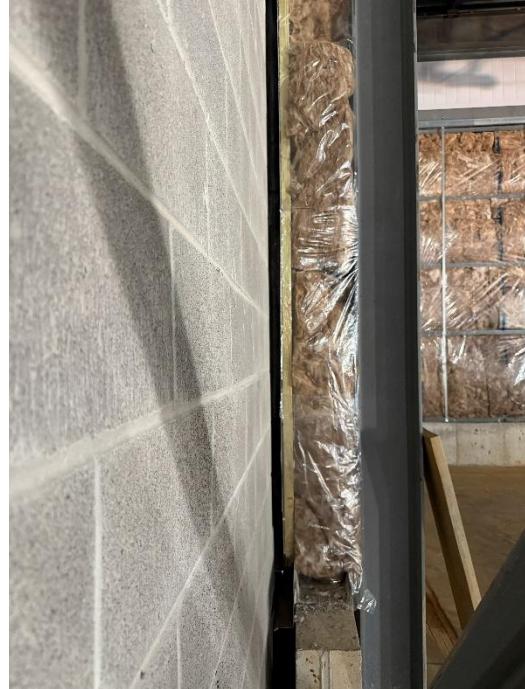
- o) It appears that the expansion joint between the office area and dry food storage was successfully installed.

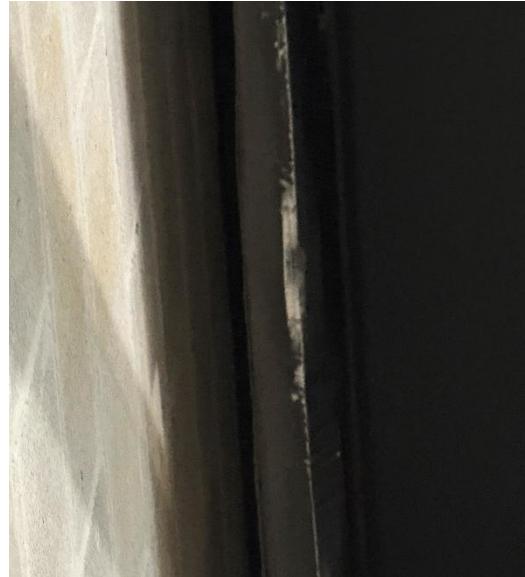
- p) Light appears to be getting into the expansion joint at the roof. This needs to be corrected.

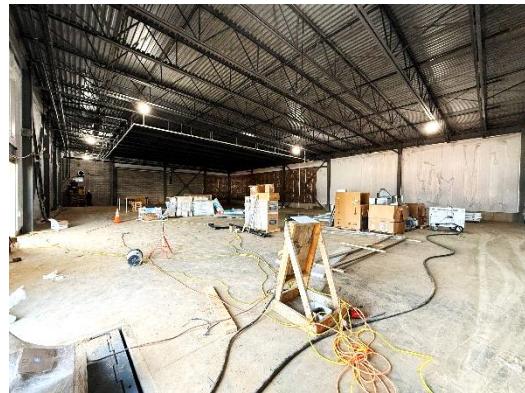
q) Preparations were made to install the walk-in box when it arrives on site.
