FIELD OBSERVATION REPORT

West Hardin Middle School, 202280 -CA8

Date: 1/13/2026 Time: 12:30 PM

Report No: 28

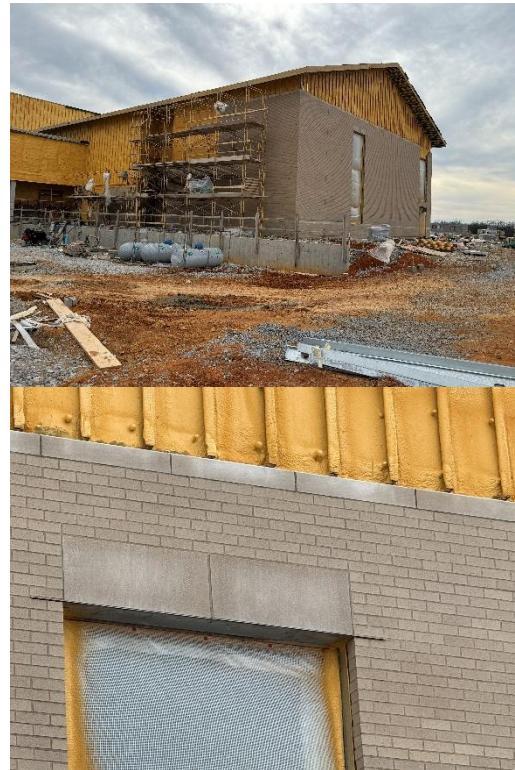
- a) At the west end of Area D, bricks were laid to high point where metal panels will be under the eaves and on the gable ends. Furring was in place to receive the metal panels.

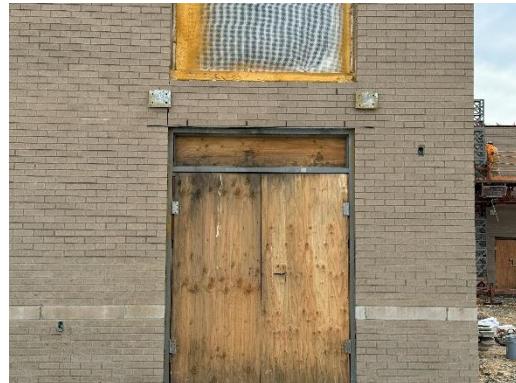
- c) Metal plates were in place to attach the metal canopy over the exit door from the band room. The canopy needs to flash into the brick wall.

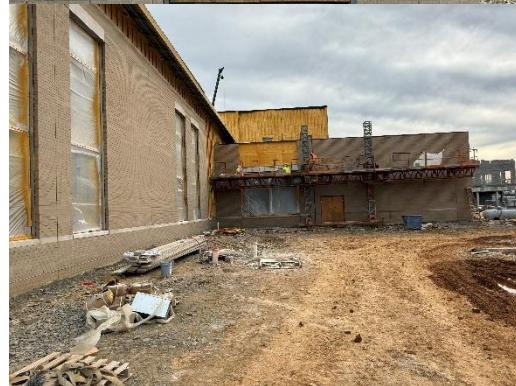
- d) Bricks were laid on the south side of Area D and on the west side at the art room.

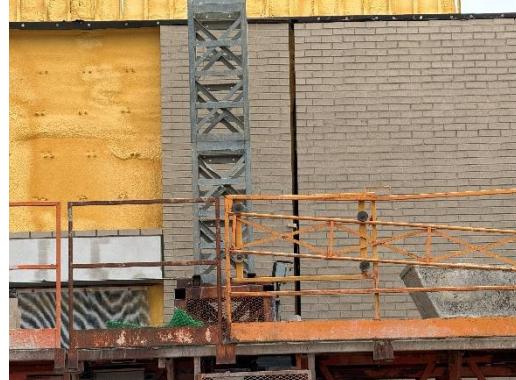
- e) At the middle of the west wall an expansion joint occurs between the storm shelter and the rest of Area D. It is filled with a rubber gasket.

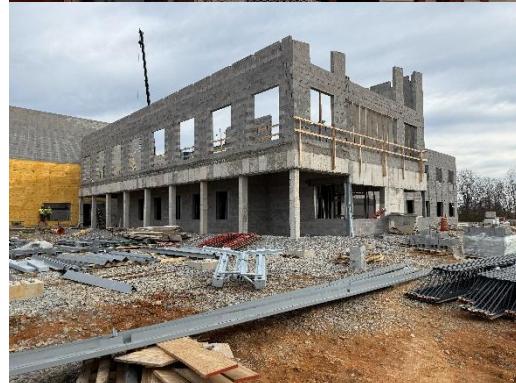
- f) Concrete blocks were laid to top of the walls around the library.

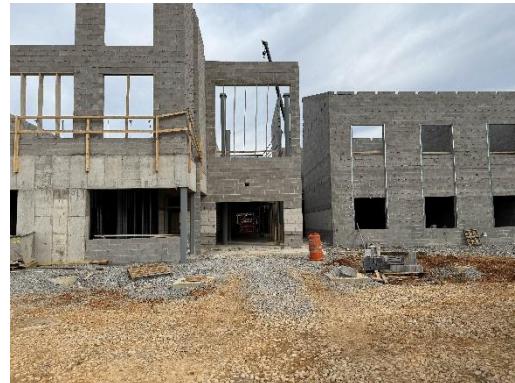
- g) The inner wall of the entrance vestibule was in place.

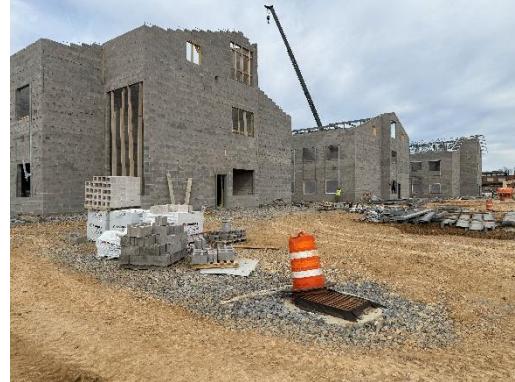
- h) All three classroom wings were topped out. The southernmost wing was not capped with the raked beam at the gable end. The completion of the wings is progressing from north to south.

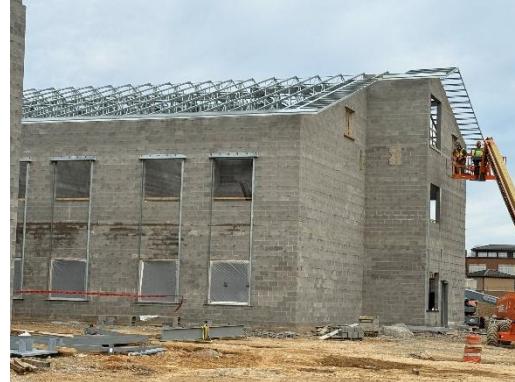
- i) The northernmost classroom wing was covered with light gauge metal roof trusses.

The extensions over the gabled end were being installed. Structural metal deck will be placed on the trusses and then insulation and sheet metal roofing will be installed.

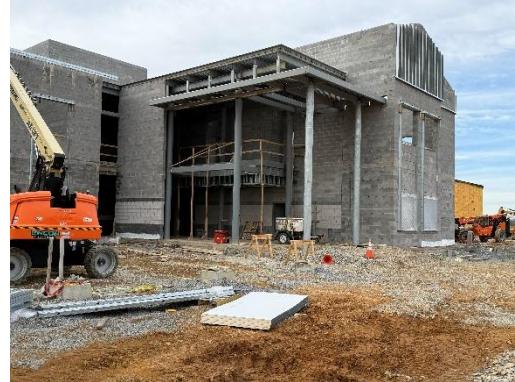
- j) The steel framing for the north entrance was in place. The open sides of the vestibule will be covered with glass curtainwalls.

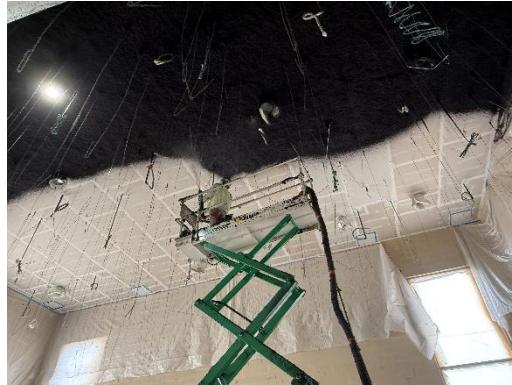
- k) K-13 acoustical insulation was being sprayed on the wallboard ceiling in the band room. Acoustical tile and acoustical panel clouds will be hung under the upper ceiling.

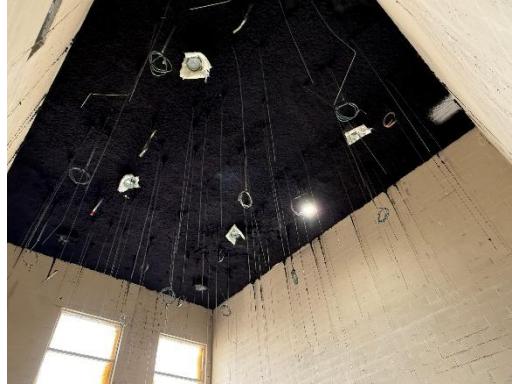
- l) K-13 was already in place in the vocal music room.

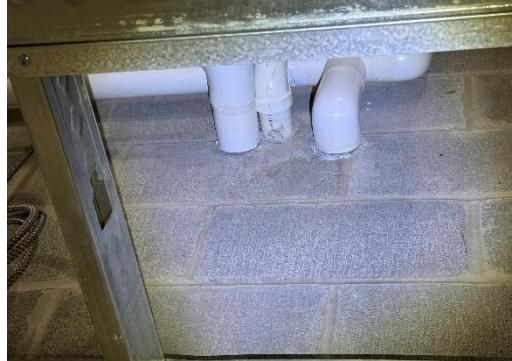
- m) During a walkthrough on Monday, Austin Bailey, Michael Warren, Jeremy Miller, and I observed work above areas where wallboard ceiling and soffits were about to be installed. We were confirming that insulation of water piping was continuous into walls to prevent condensation. The plumber confirmed that Armaflex insulation was in the walls and was extended to the insulation outside the walls.

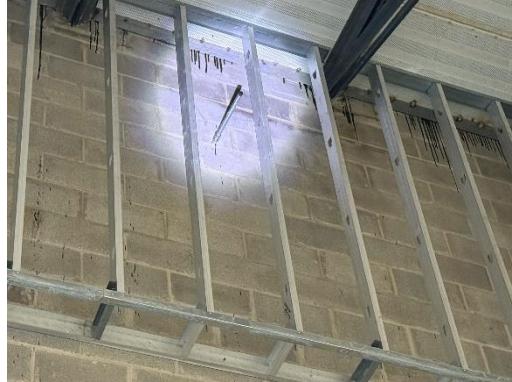
- n) We also looked at places where piping and conduits penetrated through fire resistant rated walls. Jeremy needs to confirm if the electricians can continue to use mortar in block walls as a penetrant seal with the state building inspector. Also refer to TEK Note 3A from the National Concrete Masonry Association, attached.

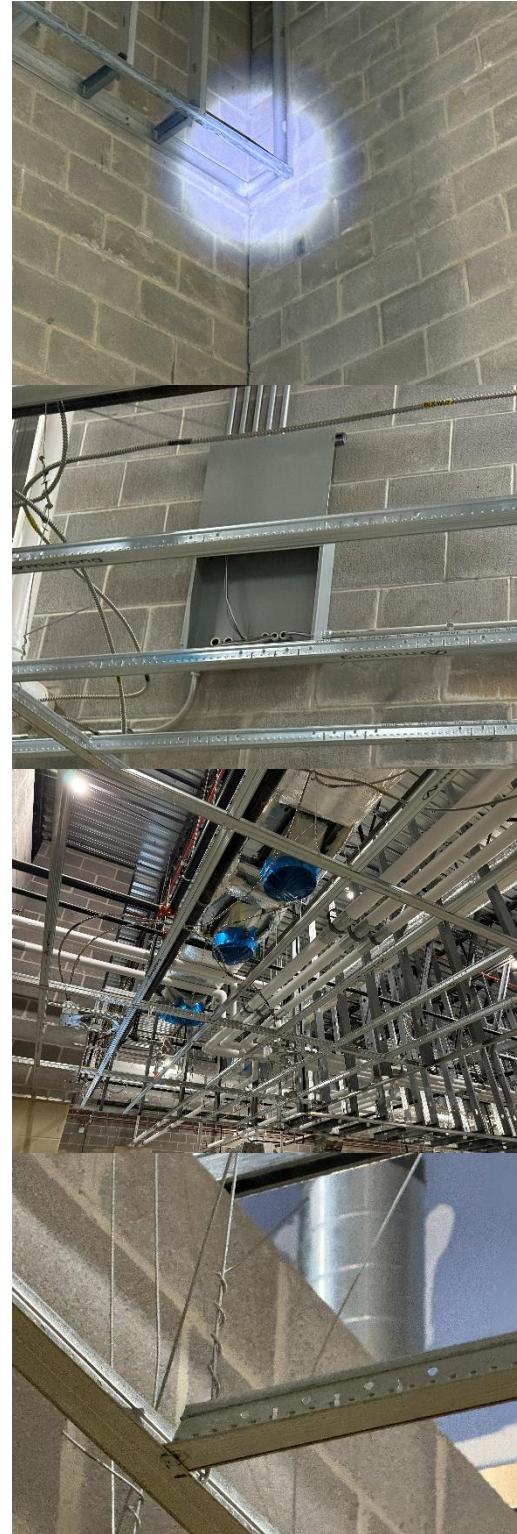
- p) Electrical panels above wallboard ceilings must be accessible. A properly placed access panel is required for this electrical box.

- q) The return grilles for the ductwork above this wallboard soffit need to be placed so that they are aligned and are equally spaced.

- r) Suspension wires for wallboard soffits and acoustical ceilings need to be tied to the grids with four tight turns (2-1/2" span of the wire). Do not leave ends of wires out from the wire creating a hazard for maintenance personnel.

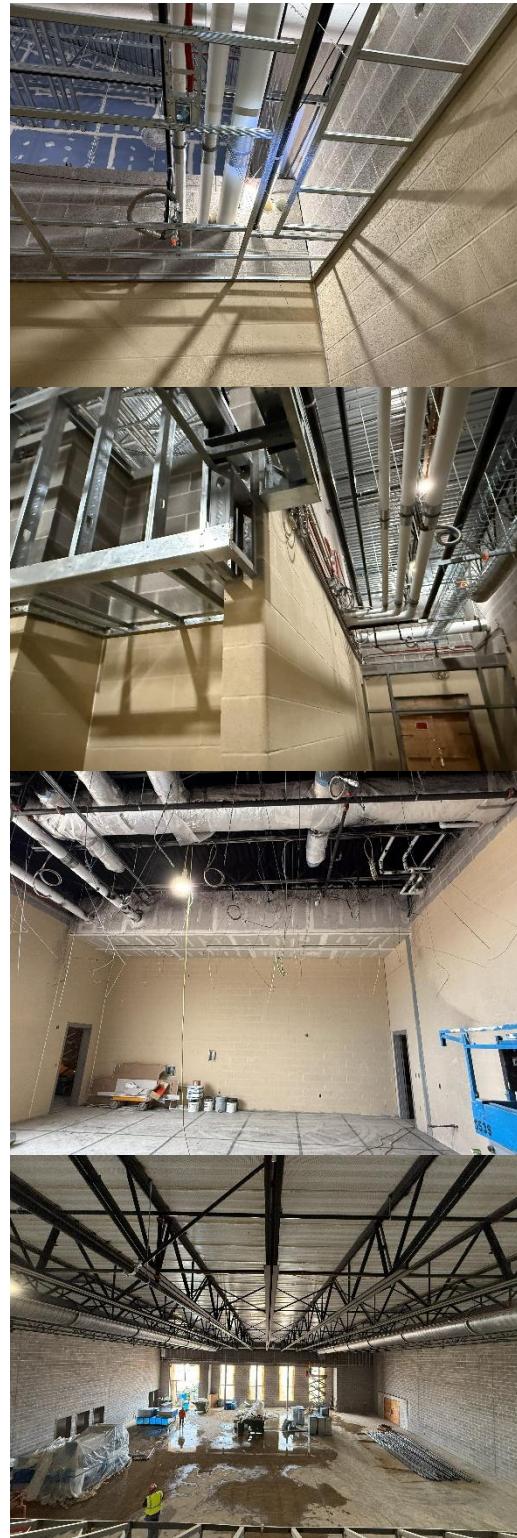
- s) Install hanger wire as near to vertical as possible. Ensure that wires at recessed light fixtures do not impinge on the fixtures so they cannot be properly installed.

- t) Jeremy has instructed the light gauge framer to install the framing at bullnose block corners so that the wallboard can fit between the framing the ends of the bullnose.

- u) Jeremy had the wallboard soffit in the art room extended to the west to cover the roof beam above. The rest of the roof structure was covered with K-13.

- v) Round spiral metal ductwork was hung over the cafeteria.

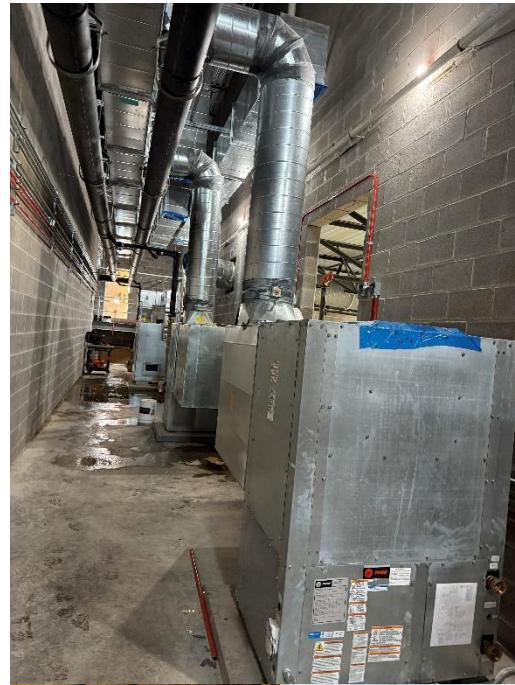
- w) Although there was some water on the floor, the platform areas were being kept clean. The water is the result of some roof areas not being complete.

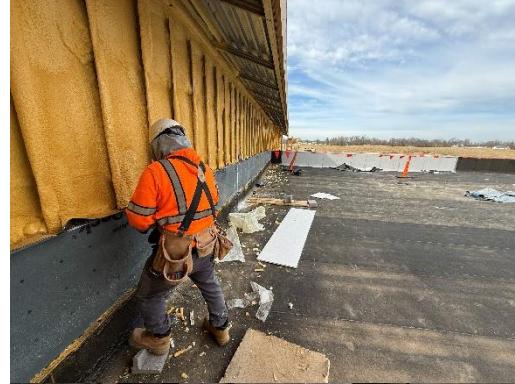
- x) Sheathing was being extended above the kitchen roof to receive the base flashings.

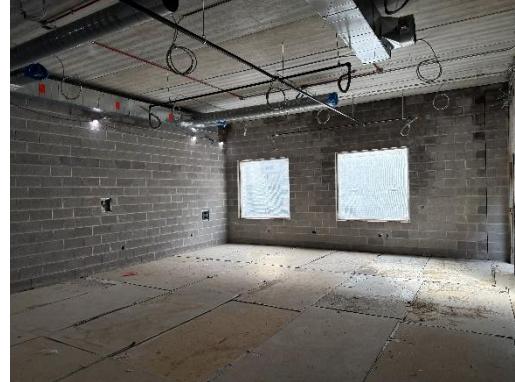
- y) Ductwork was being hung over the first-floor classrooms.

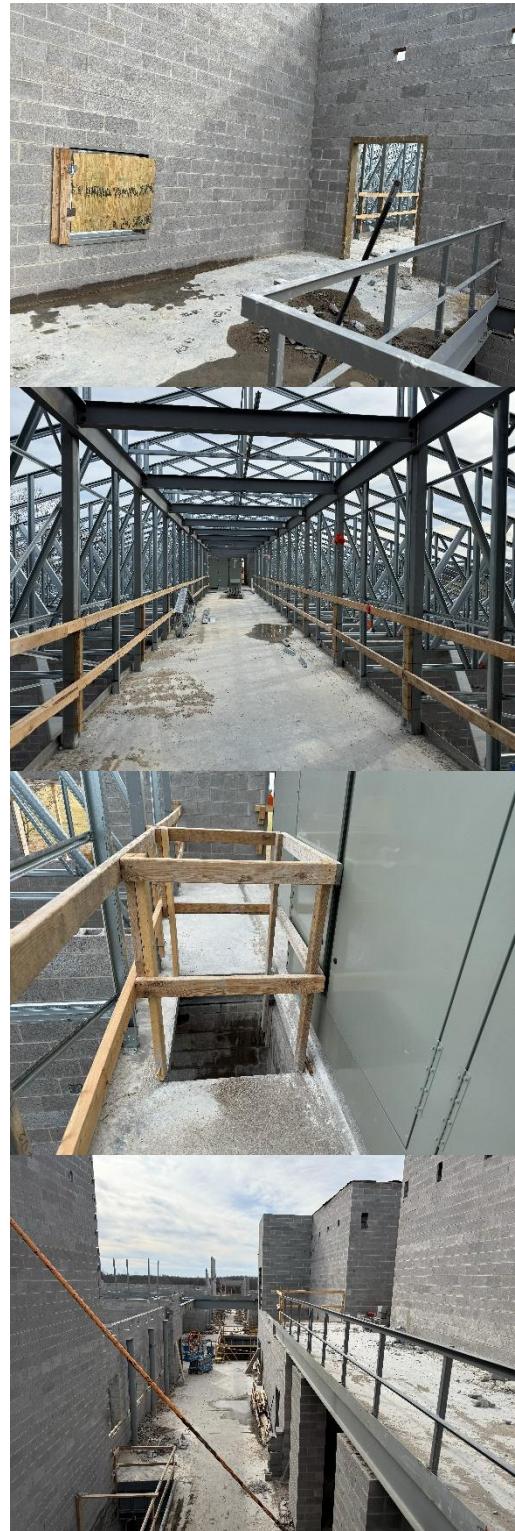
- z) The platform over the second-floor corridor and classroom wings was in place in Area A. The opening with the plywood door leads to the northern vestibule roof.

The doorway leads to the platform over the classroom corridor.

- aa) The platform over the classroom corridor was in place. The toe guard plates along each side of the platform also acts as a water stop from spills on the platform. Make sure that the toe guard is continuous.

- bb) The openings for the vertical ladders to the second floors will need permanent steel railings and a gate. A temporary wood railing was in place.

- cc) The platform will eventually extend to the north end of the building over the main corridor on the second floor.

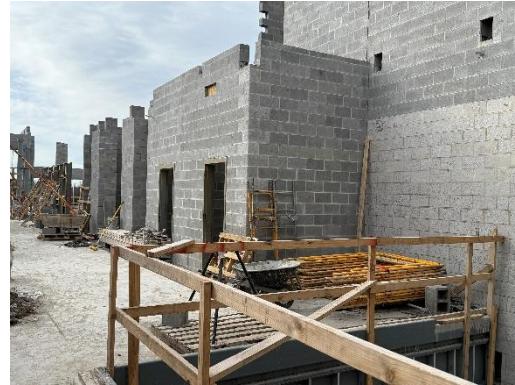
- dd) The elevator shaft extends to the platform so that people and equipment can be moved to and from the first floor.

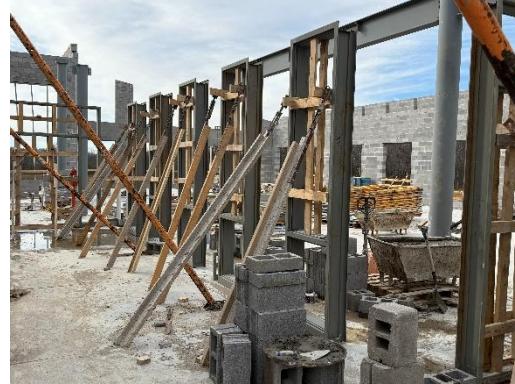
- ee) Hollow metal window frames were in place along the main corridor looking into the library.

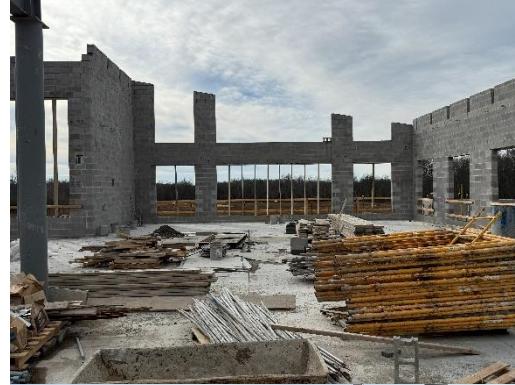
- ff) Looking south in the library, the roof and the ceiling will slope with the tops of the block walls.

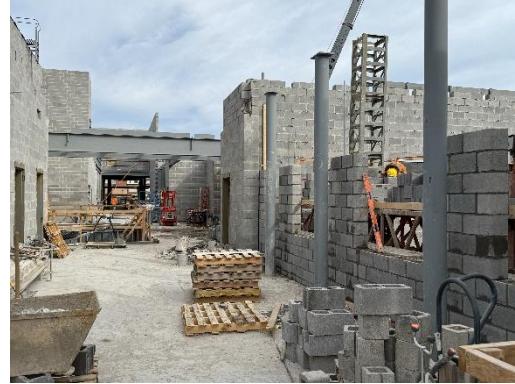
- gg) The main corridor on the second floor will be covered with the platform and the roof above.

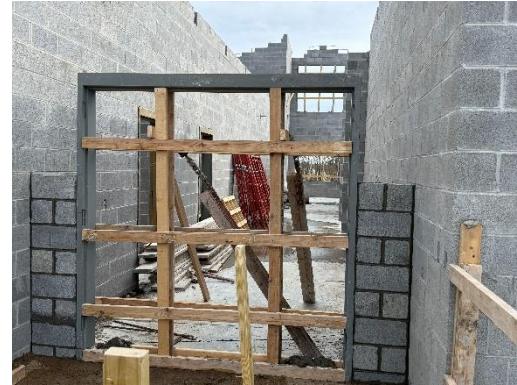
- hh) A double door frame was in place into the corridor into the classroom wing on the second floor.
