## FIELD OBSERVATION REPORT

Central Hardin High School – Phase 2, 2019111 -CA8

Date: 2/18/2026 Time: 8:30 AM

Report No: 40

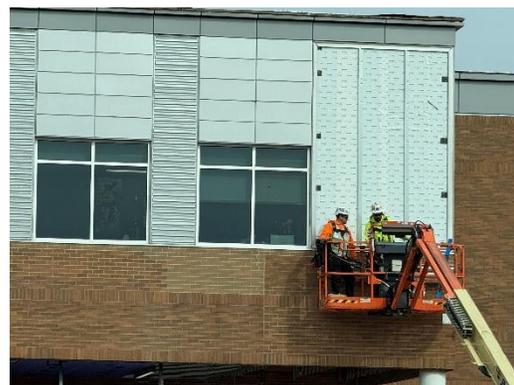
- a) Sheet metal workers at the south end of Area J with the metal panel installation. They still have a significant amount of work to complete on Area J.

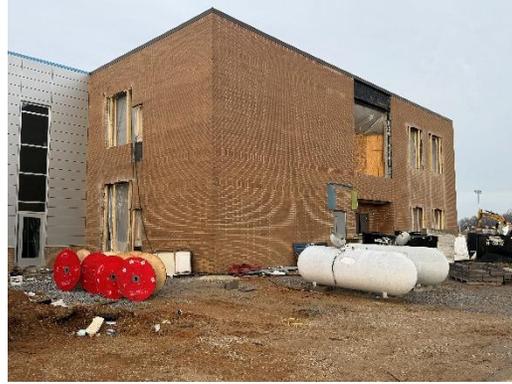
- b) The new window openings were cut into the existing exterior walls on Area H.

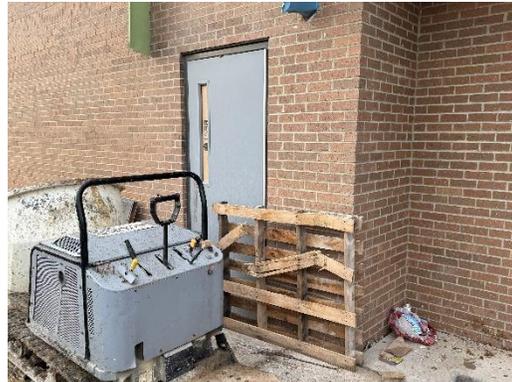
- c) The new hollow door was installed into the existing stairwell at the east end of Area H.

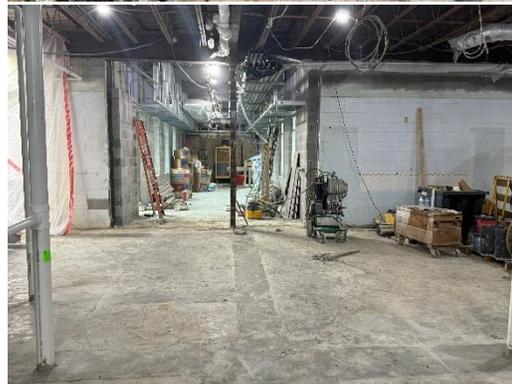
- d) A variety of work was underway on the first floor of Area H including CMU walls, hollow metal door frames, electrical conduits, metal ductwork and plumbing.

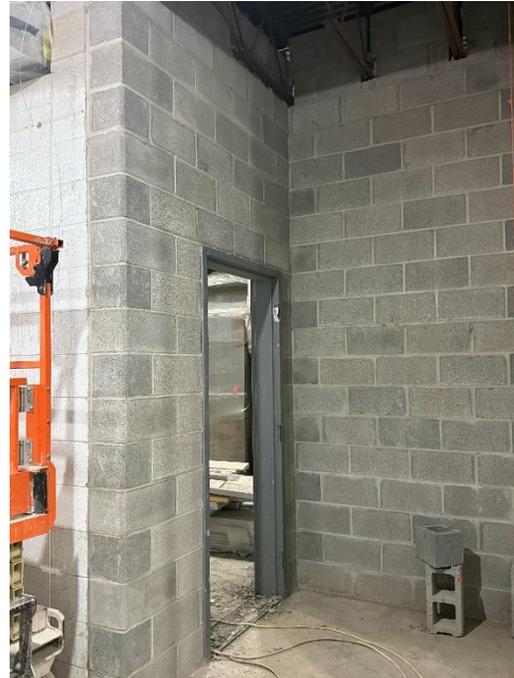
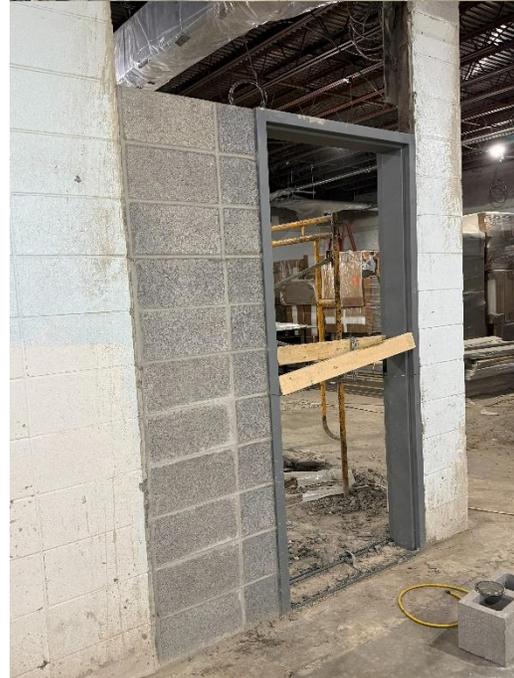
- e) After concerns were raised about the block coursing in recesses for the new classroom doors, remedial work has been done to correct the defects.

It is important for block coursing to align with the tops of the hollow metal door frames in every location.

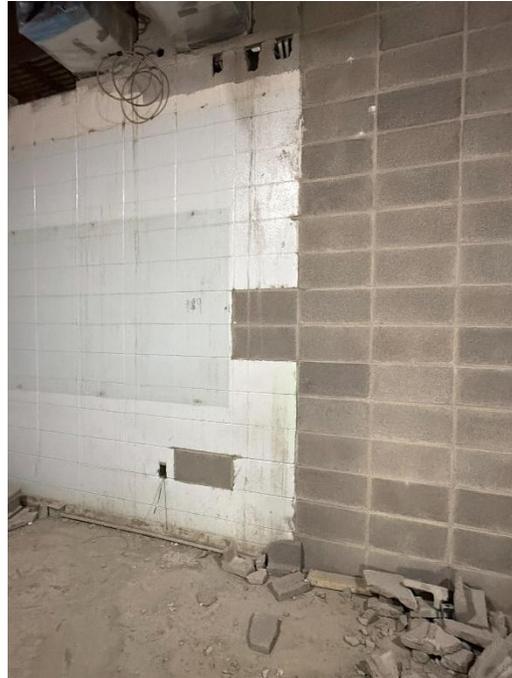
- f) Stack bond coursing was laid where existing stack bond coursing was used in the original areas of the building. In some cases, existing blocks were replaced when they were found to be defective.

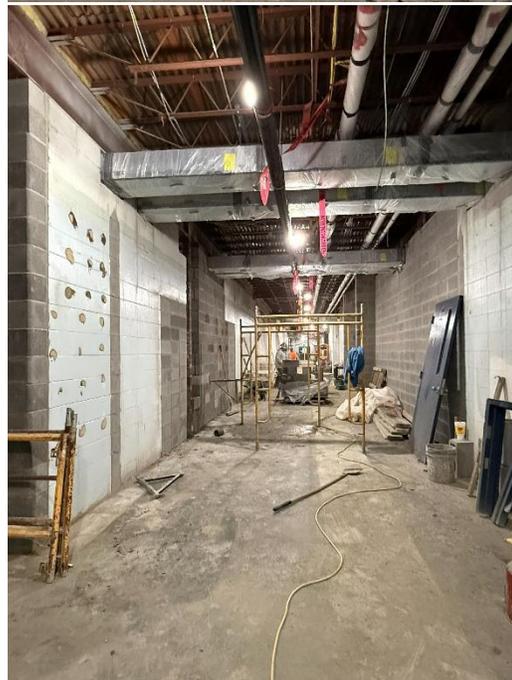
- g) Sheet metal ductwork was hung on both floors. This work must be covered if spray fireproofing is applied after the ducts are hung.

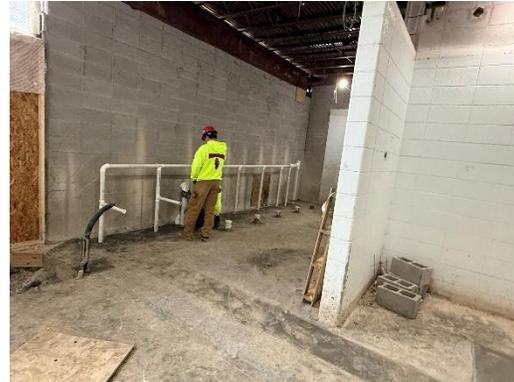
- h) Due to the revised locations of plumbing fixtures for new room locations and layouts, the concrete floor slabs have been cut and the earth trenched to receive new sanitary sewer piping.

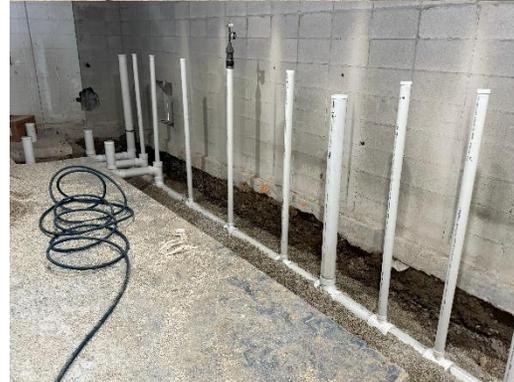
PVC drain and vent piping were extended above floor at new fixture locations.

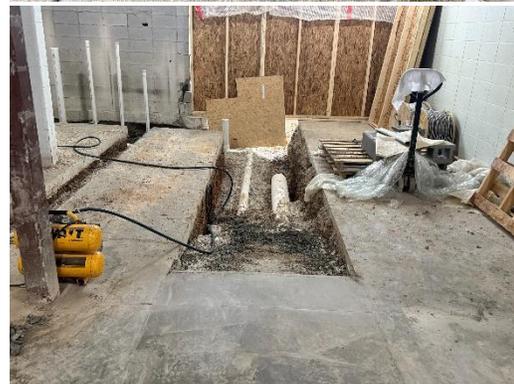
- i) In some cases, new storm piping will be extended below floor slabs into Area G and then on to storm piping installed on site.

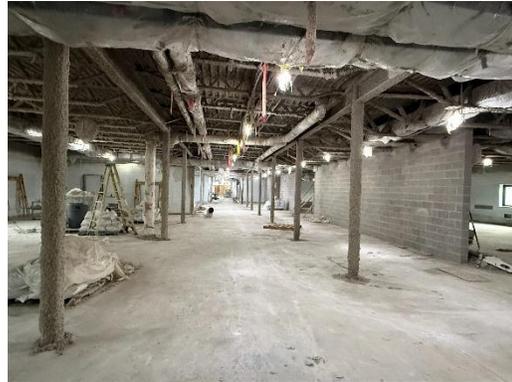
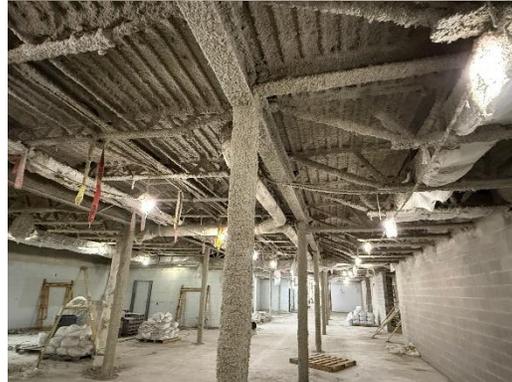
- j) Spray fireproofing materials had been applied to the steel structure on the second floor.

Gill had hoped that the installer would return to complete their work as the weather warmed as material is water based and susceptible to cold temperatures.

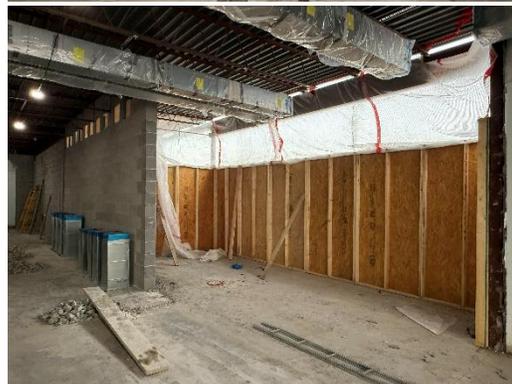
- k) The second floor was very warm due to temporary enclosure being kept in place and rising heat from the first floor.

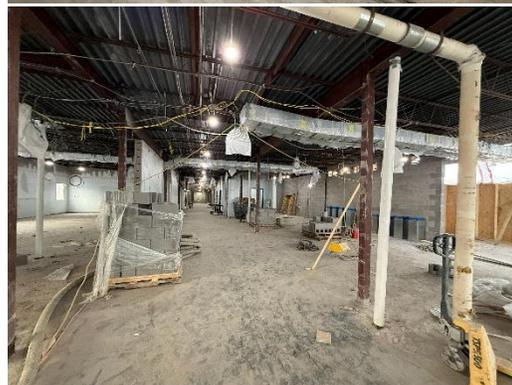
- l) Ductwork and piping have to be covered where hung under areas to be covered with spray fireproofing materials.

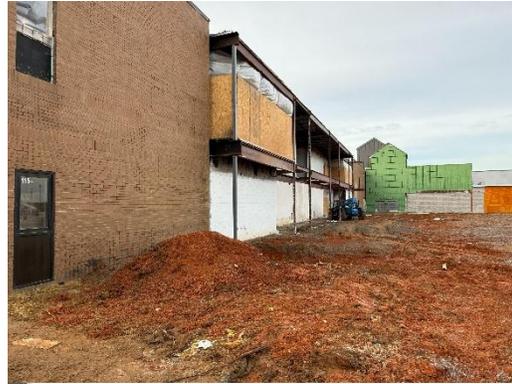
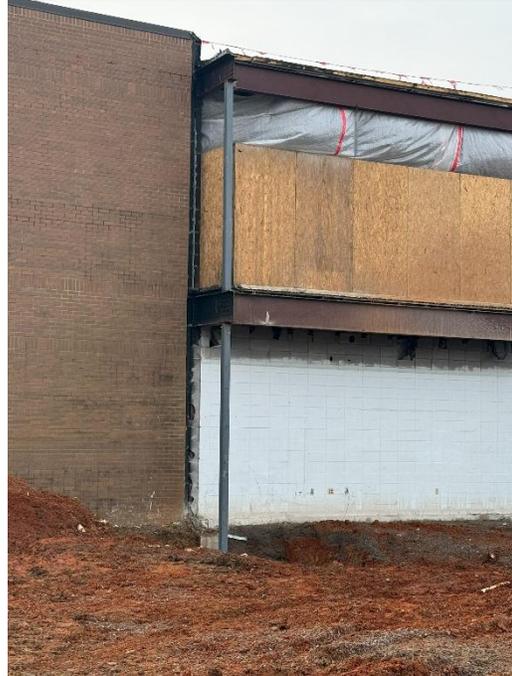
- m) Most of the original building has been cut away to prepare for the Area G connection along the north side of Area H.

The column supporting the corner of Area H was too far into Area G to reuse. The tube column with gray primer is new to support this corner.

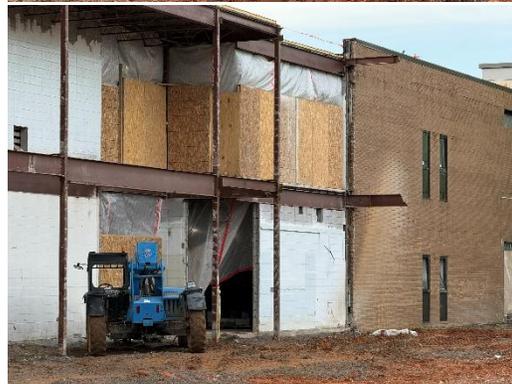
- n) A similar situation occurs to the west of Areas H and G, but there is an existing column in place. The original projecting beams will be cut base to the face of Area H.

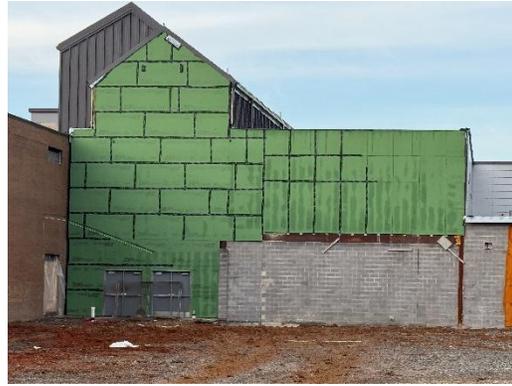
- o) The green wall is a temporary enclosure at the east side of Phase 1. This needs to be maintained until Area G is enclosed and then the temporary wall will be removed.

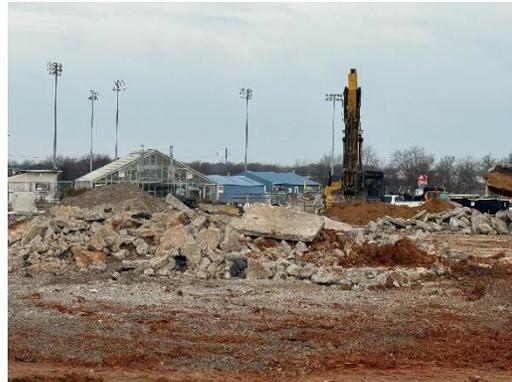
- p) The debris piles at the original one-story portion of the school are getting smaller.

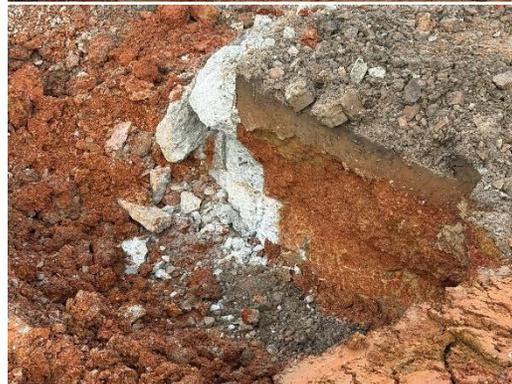
- q) An original foundation remained on the east side of the demolition area. The excavator was moving in the direction and eventually all the original structure will be removed including the slab, foundations and below slab utilities.

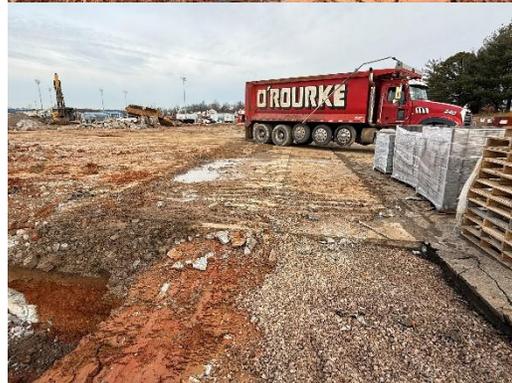
Dump trucks were constantly picking up loads to be delivered to the dump site and then returning for more.

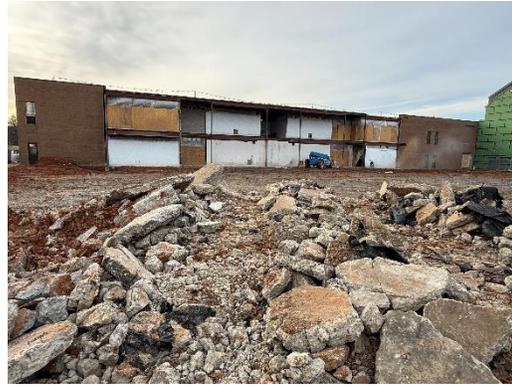
- r) Looking to the south at Area H, about 3/4s of the original slab has been removed.

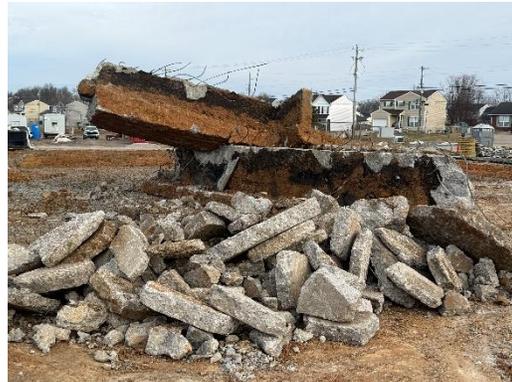
- s) Most of the remaining materials include concrete slabs and foundations.

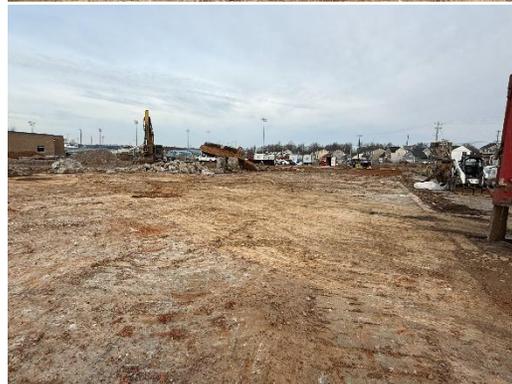
- t) Gill reported that the next step after demolition will be for Phillips Brothers to install below grade sewer piping to the north face of Area G.

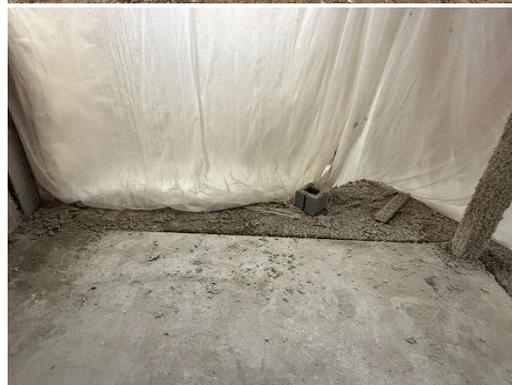
- u) Gill was scheduled to return to the building just as the snow and ice storm hit. He plans to return to cut down the high slab at the second floor between Area F and H. He also plans to anchor the roof ladder to the main gym roof.
