FIELD OBSERVATION REPORT

Child Nutrition Building (Food Service Building, 202276 -CA8)

Date: 2/18/2026 Time: 10:30 AM

Report No: 27

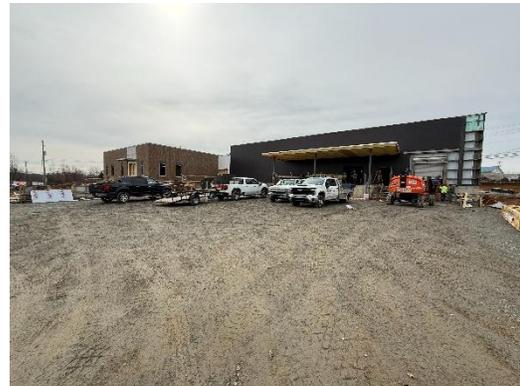
- a) The project was approaching completion with the final details to complete the exterior of the building either underway or scheduled in the next week or so.

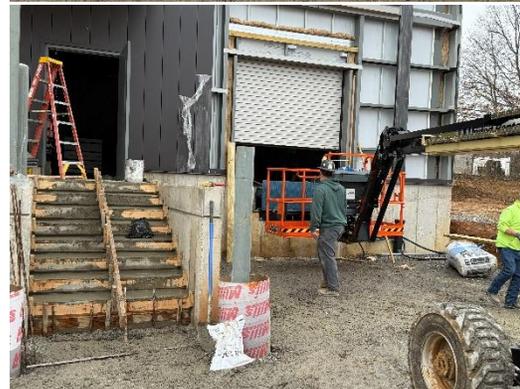
- b) The overhead doors were installed in openings into dry food storage.

The sheet metal siding was being completed at the overhead doors.

The concrete steps to the loading dock had just been poured.

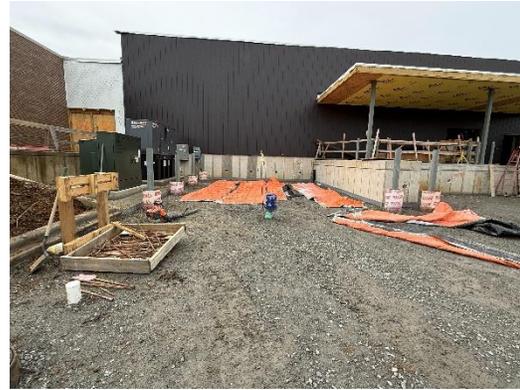
- c) Concrete filled steel pipe bollards had been placed to protect the transformer and generator.

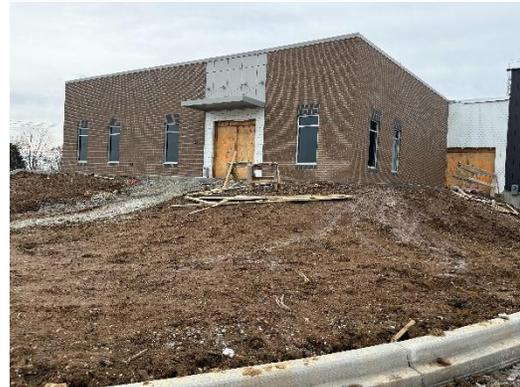
- d) The site in front of the office will be one of the last areas to be graded and connected to driveway.

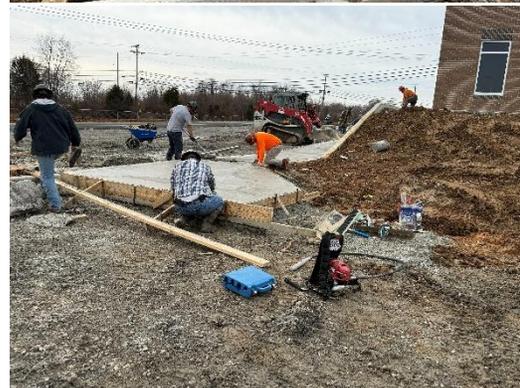
- e) Site concrete was being poured along the south face of the office building.

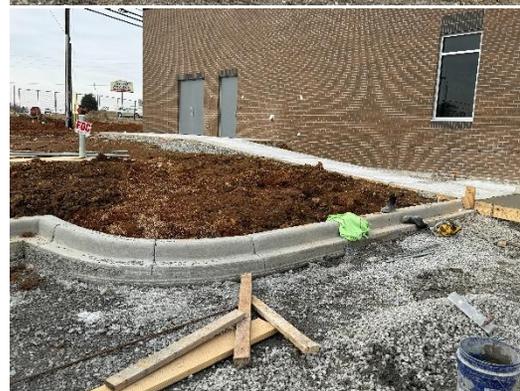
- f) Curbs and walks were in place at the southwest corner of the site.

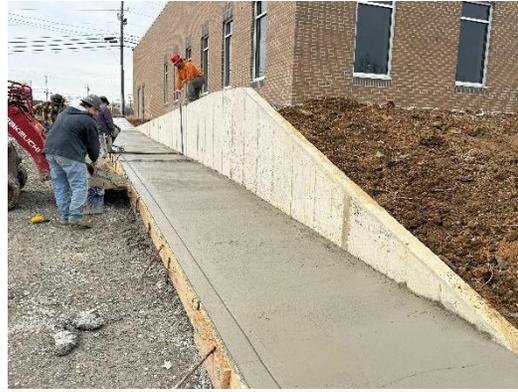
- g) The concrete ramp to the south of the office area was being poured.

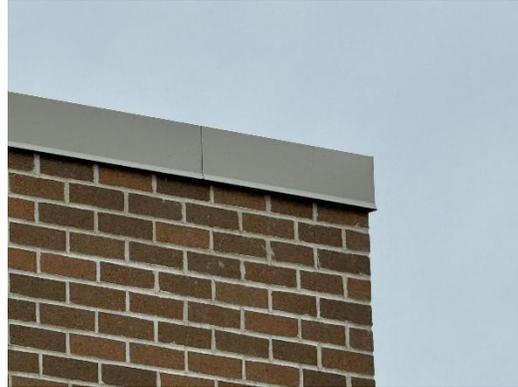
- h) Sheet metal copings were being installed around the top of the exterior of the building.

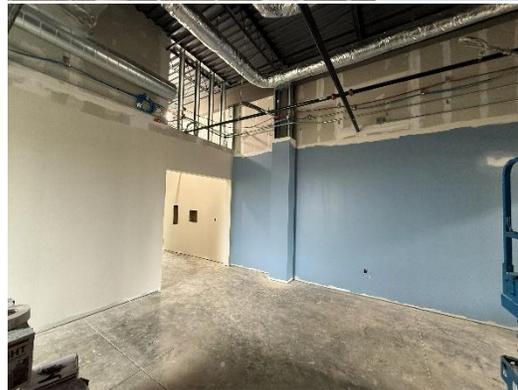
- i) The finished coat of paint had been applied in most of the office area.

The finish on the wallboard walls appeared to be uniform in appearance.

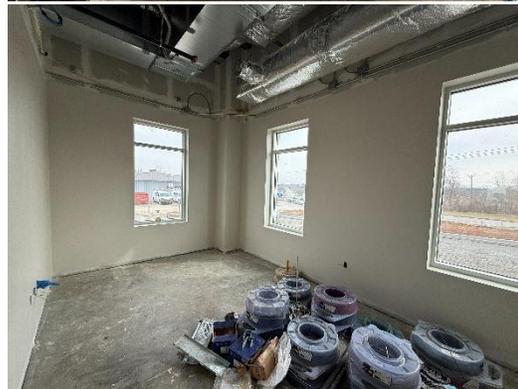
- j) Office walls had been painted, and the walls were uniform in appearance.

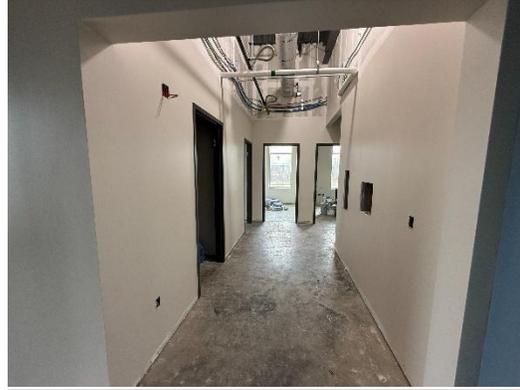
- k) The corridor in the office area had been painted. The wallboard finish appeared to be uniform.

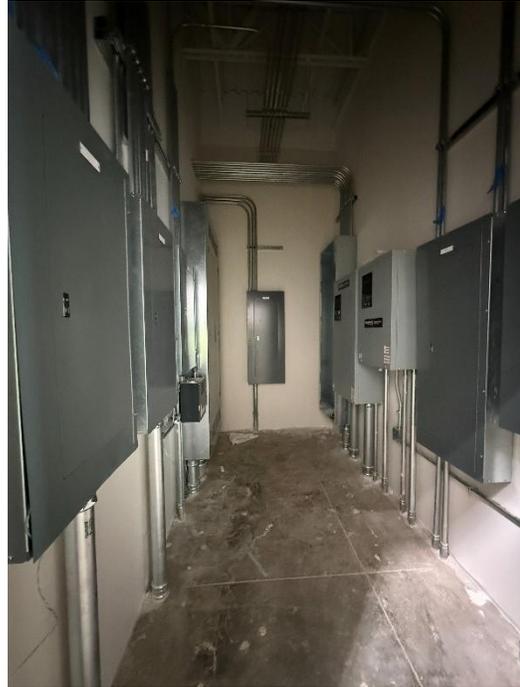
- l) Panels in the electrical room were filled with breakers and the covers were in place.

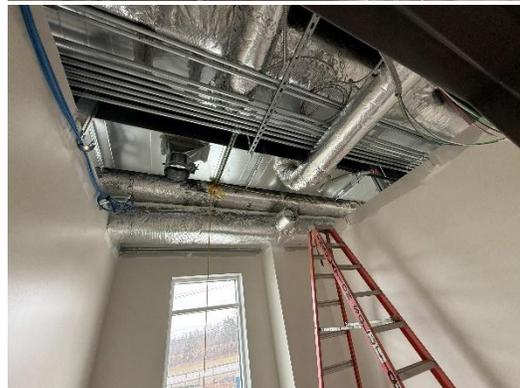
- m) Ductwork was being installed ahead of the above ceiling inspection.

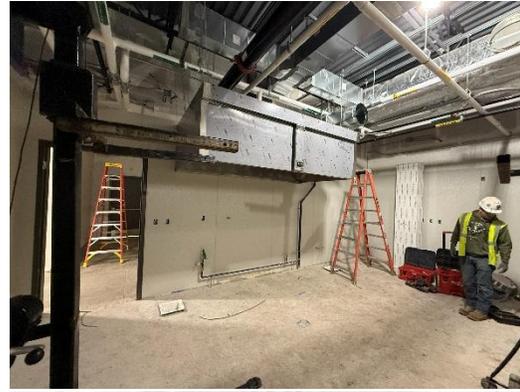
- n) The range hood was in place in the demo kitchen in the office area.

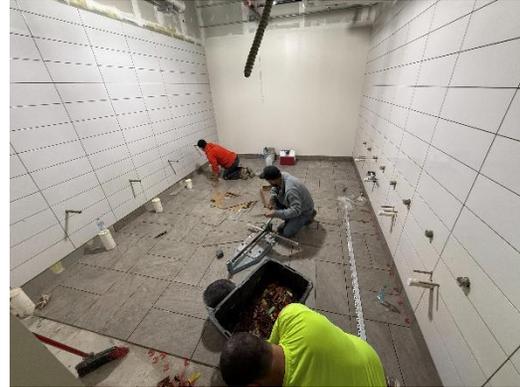
- o) Tile setters were laying tile floors in the toilets. They were using spacers for uniform joints.

The wall tiles were mostly in place.

From the corridor, the work appeared to be uniform. The joints were not yet grouted.

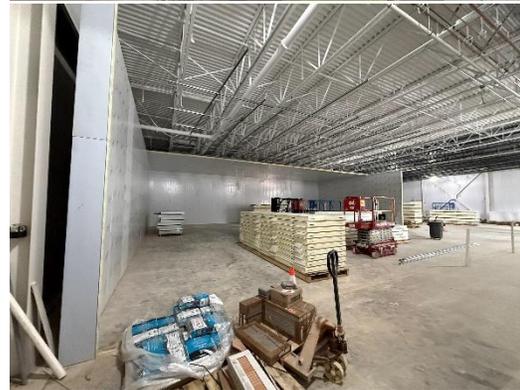
- p) More of the freezer box was in place including the roof.

Once the box is in place, the fire suppression contractor will need to crawl above the box to install the sprinkler heads down into the box.

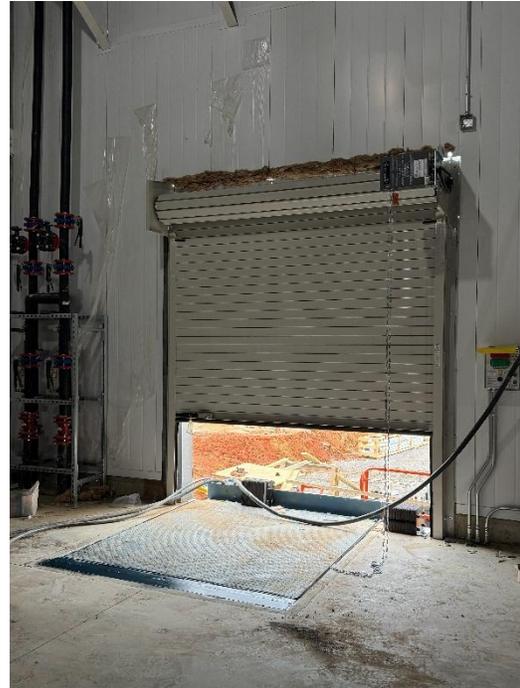
- q) The overhead doors were being installed in conjunction with the wall panels in the area.

The controls were not yet installed.

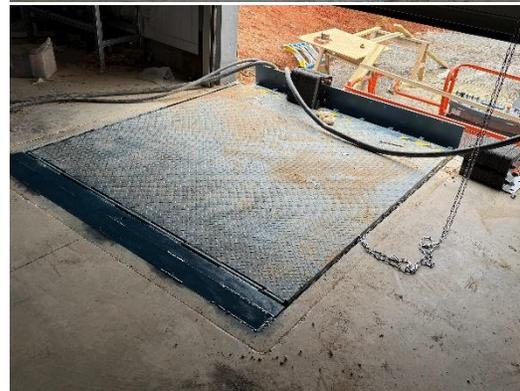
- r) The dock levelers were secured to the pits. The edges of the ramps were fitted with brushes to keep rodents out of the building.

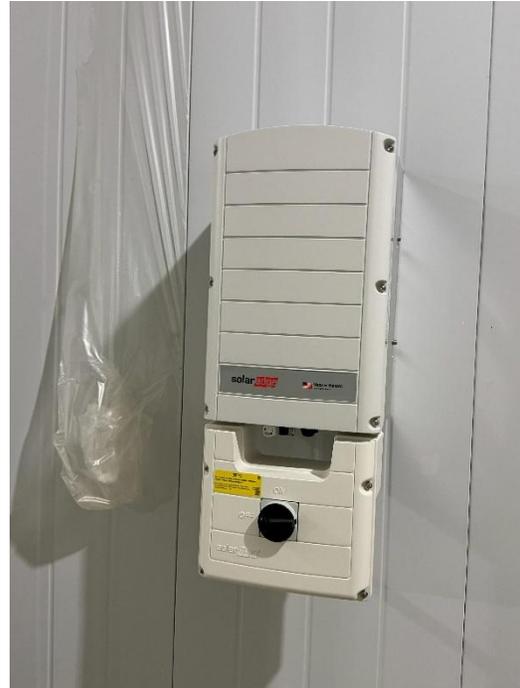
- s) The controller for the solar panels was mounted on the dry storage wall. The shipment of the panels was delayed.

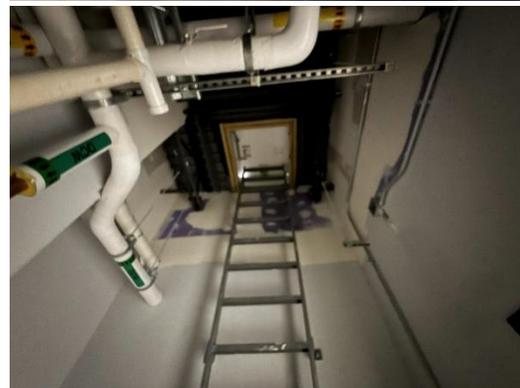
- u) Light could be seen at the roof hatch. It may not have been shut properly.

The rail extenders were not yet installed on the roof ladder.

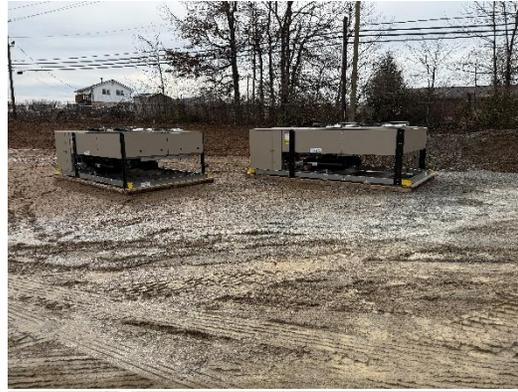
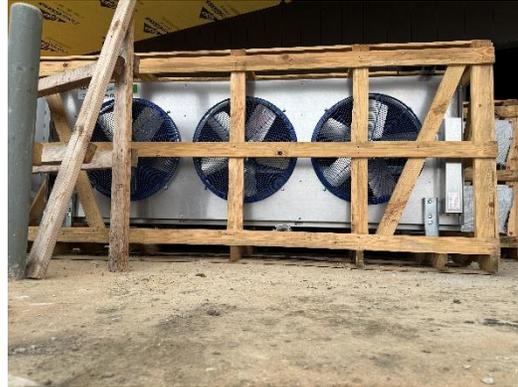
- v) The condenser racks were on site for the freezer. These units are redundant so that if one breaks down the other will keep the food frozen. These will be set on concrete pads to the west of the office area.

- w) The evaporator coil units were on site. These will be placed on the tops of the freezer box.

A transfer switch needs to be installed to cycle the two units automatically.
