FIELD OBSERVATION REPORT

West Hardin Middle School, 202280 -CA8

Date: 2/18/2026 Time: 9:30 AM

Report No: 29

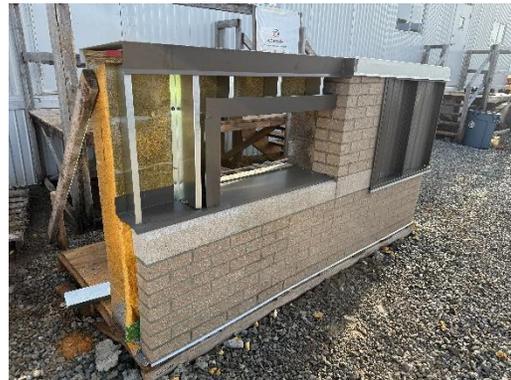
- a) The sample panel is nearing completion with the aluminum window being the remaining item to arrive on site.

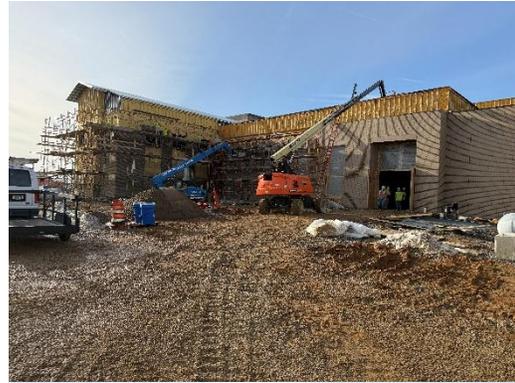
- b) Bricks were being installed on area C and B.

With the warmer weather, the masons were working without tents over the scaffolding to keep the mortar from freezing.

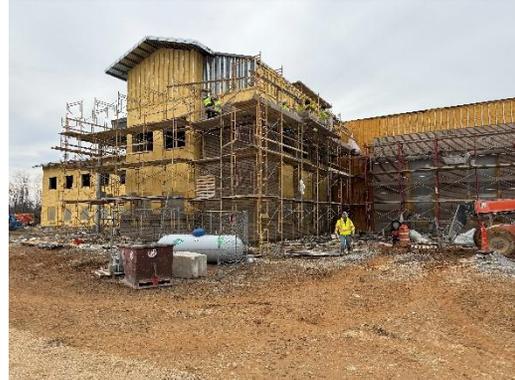
Bricks were being installed over spray foam insulation on the northmost area of the building. This area includes the entrance for bus arrivals and departures.

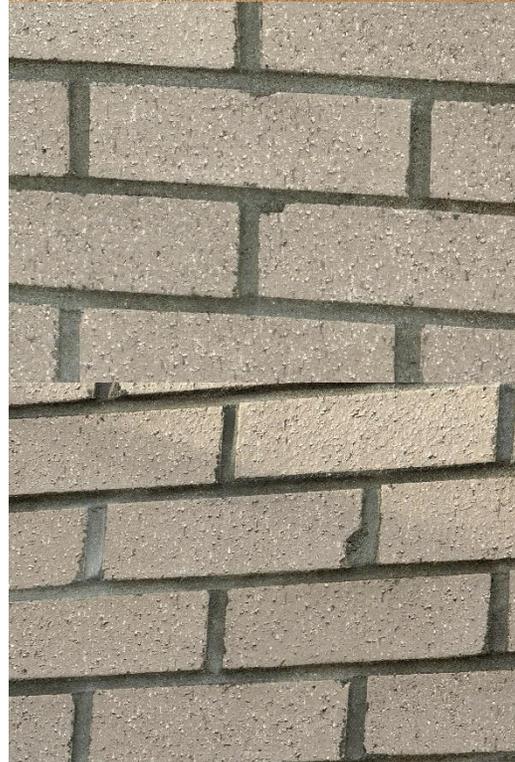
- c) Now that the tents are not covering the brickwork, Jeremy, Brandon and I observed a number of bricks with chipped corners. These were especially visible near the entrance to the cafeteria.

Jeremy said that he would relay our concerns to Bailey's for remedial actions to correct and avoid these defects.

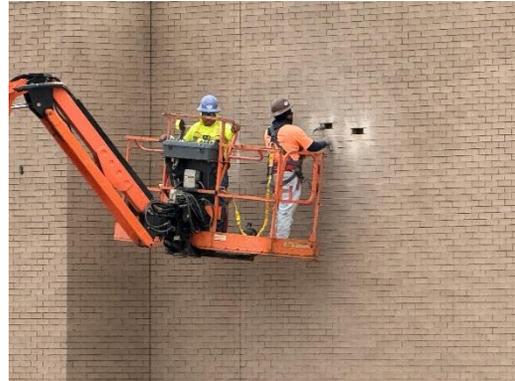
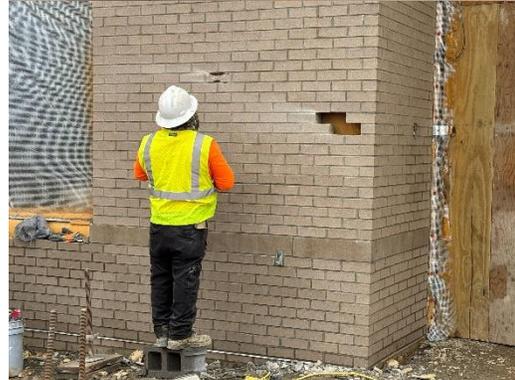
- d) Later in the day, I observed Bailey's crew removing chipped bricks in preparation for replacing them.

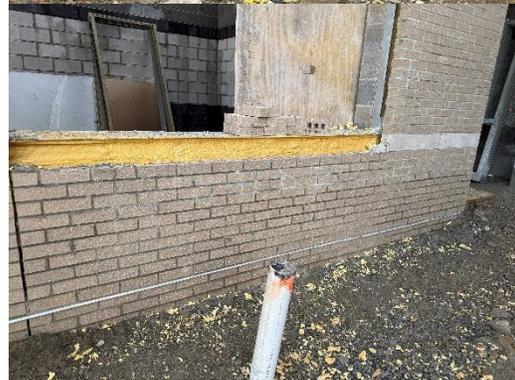
- e) We also observed that the brick and stone at the Family Resource entrance were not level and the mortar appeared to be failing. Jeremy reported the mortar appeared to have been frozen.

It was our recommendation that this section of wall be torn down and replaced with new bricks and stone.

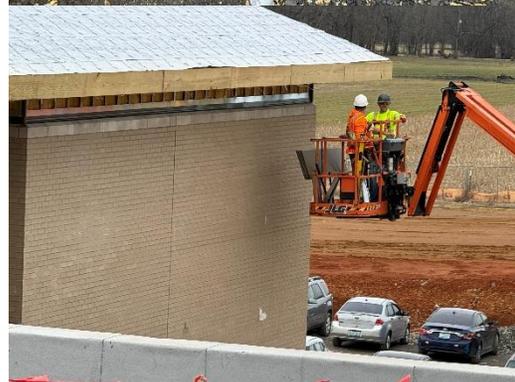
- f) Metal panels were being installed around the eaves of Area D.

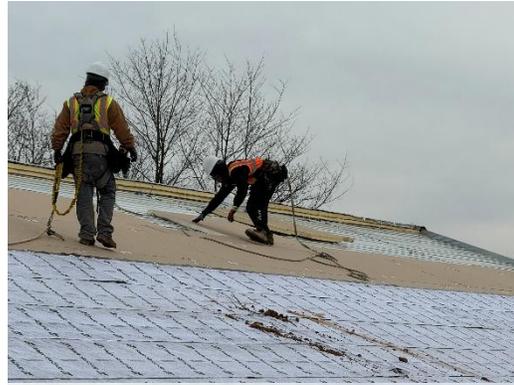
- g) Roofers were installing insulation and vapor barrier in preparation for installing the metal roof panels over the northernmost classroom wing.

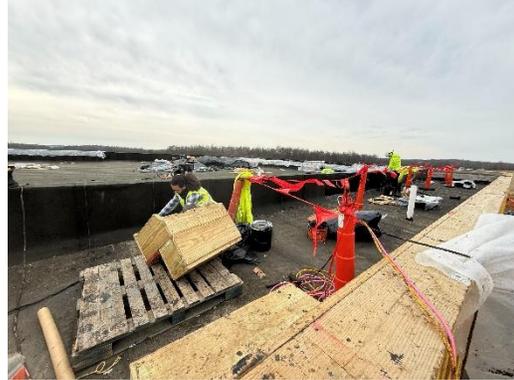
- h) Roofers were working on the gym/storm shelter roof. They were installing base flashing in preparation for the installation of the sheet metal copings around the roof area.

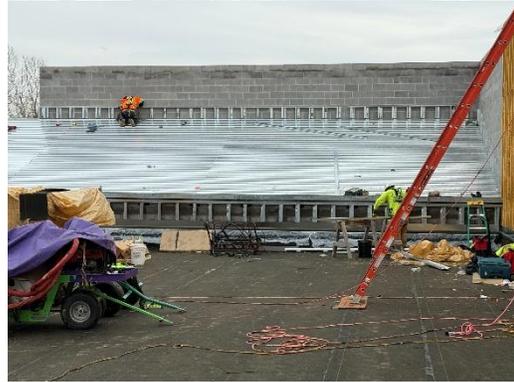
- i) Framers were working on the backing wall on Area B to prepare the wall for the base flashing that will tie into the sloped metal roofing.

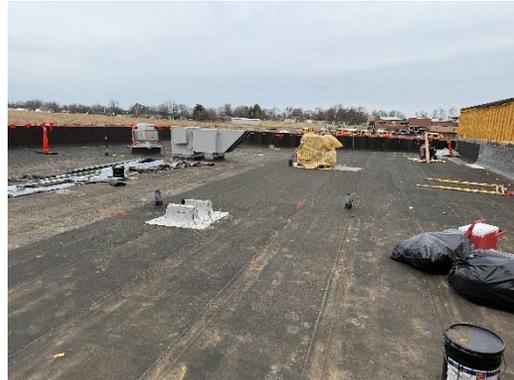
- j) Rooftop units serving the kitchen equipment were in place.

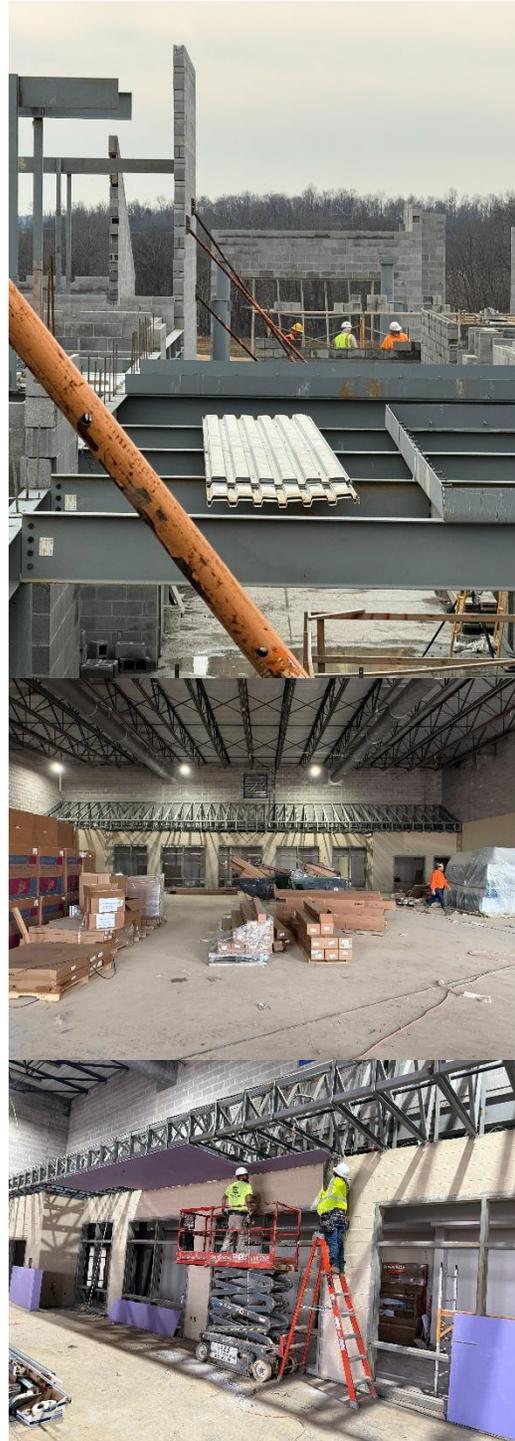
- k) Although braced, some of the CMU walls appeared to be unbraced for some distance making them susceptible to displacement from high winds. Before connecting roof structure to them, the walls need to be checked for plumb and joint damage.

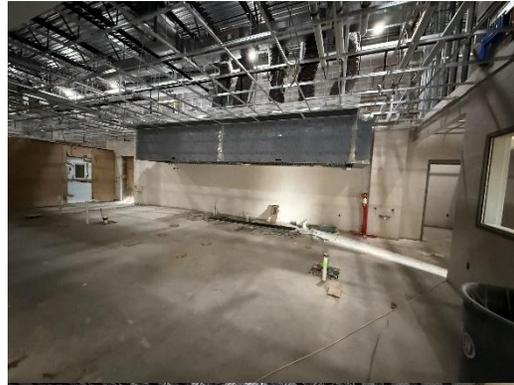
- l) Work was progressing in the cafeteria.
Round ductwork was in place overhead.

- m) The fire suppression lines that were hung below the awning, had been raised above the awning. Wallboard was being hung underneath the awning framing.

- n) The kitchen range hood and cooler/freezer boxes were installed in the kitchen.

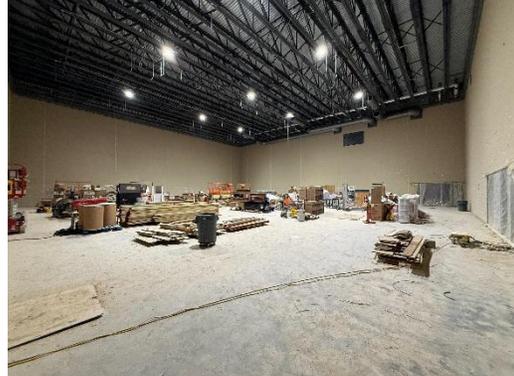
- o) The gym/storm shelter room was dry and used for storage.

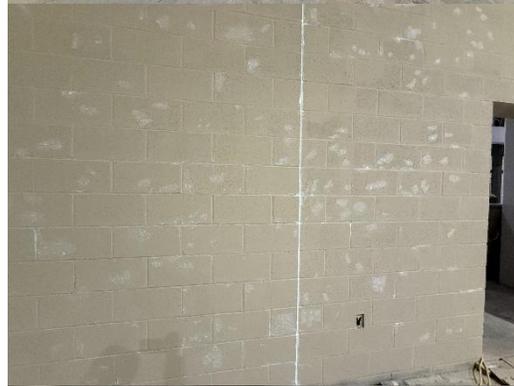
- p) A great deal of wall repaired had been made on the CMUs in the gym.

Jeremy expressed his concern that the heavy weight storm shelter blocks have a wavy appearance. This will be evaluated as the walls are finished.

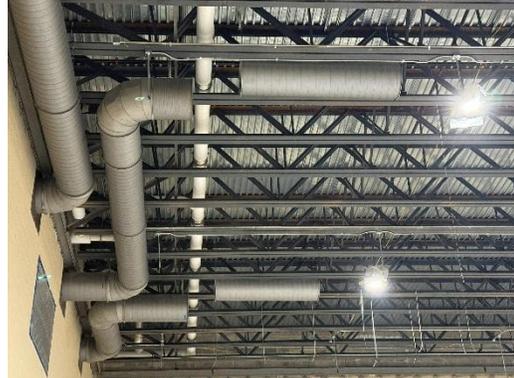
- q) Round ductwork was being installed in the ceiling space of the gym.

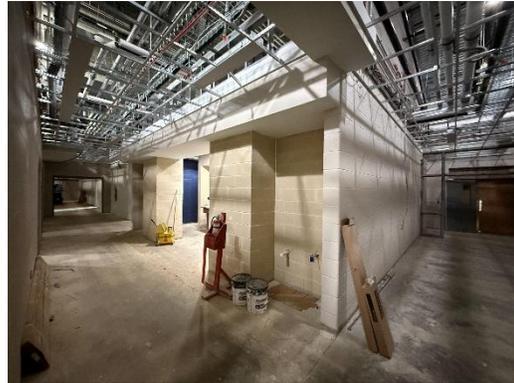
- r) The walls in Area D have received the final coat of paint. Even though the CMUs still have defects, most have been repaired.

- a) Special inspection reports with emphasis on the storm shelter area.
- b) Keep as-builts up to date.
- c) Provide punch lists for block defects in Area D.

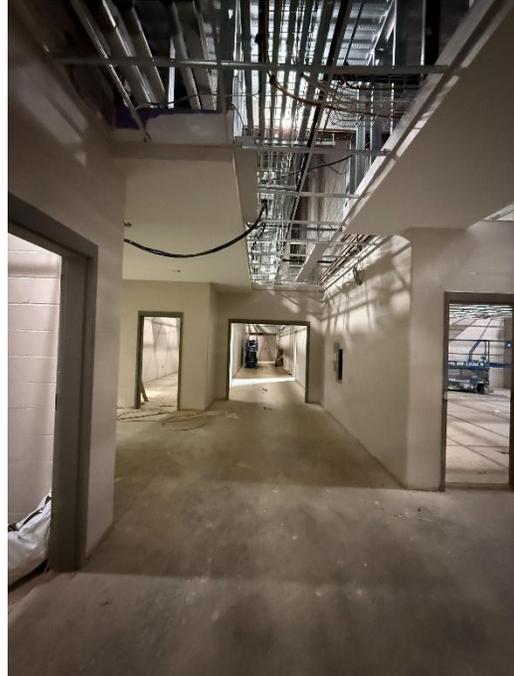
- s) Ceiling grids had been hung in Area D corridors and rooms. An above ceiling inspection by code officials and architects and engineers will be conducted in the next two weeks.

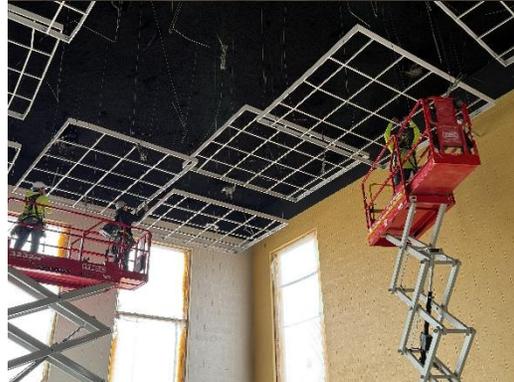
- t) The grids for the clouds over the band room were being hung.

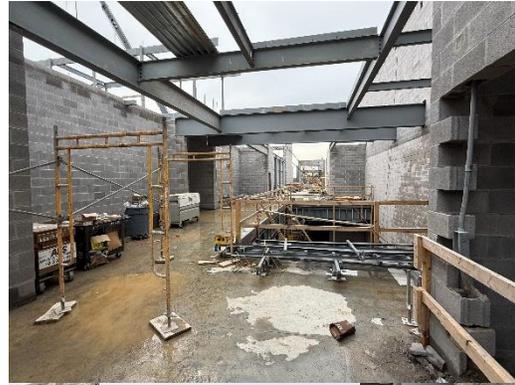
- u) Structural steel framing was being hung over the center of the main corridor. This will support the mechanical platform over the second floor.

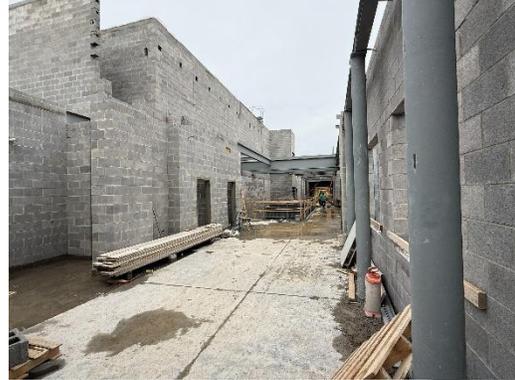
- v) Framing and walls still need to be installed over the southern portion of the main corridor so the platform and roof structure can be installed.

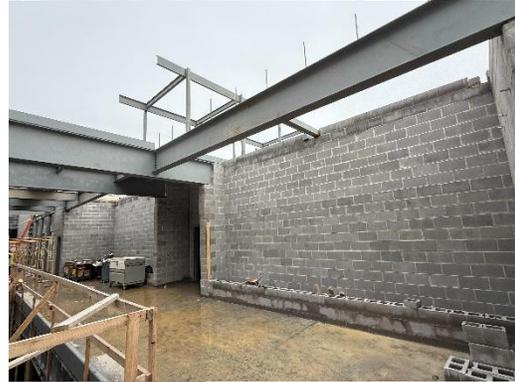
- w) The steel framing above the classroom wings was being erected.

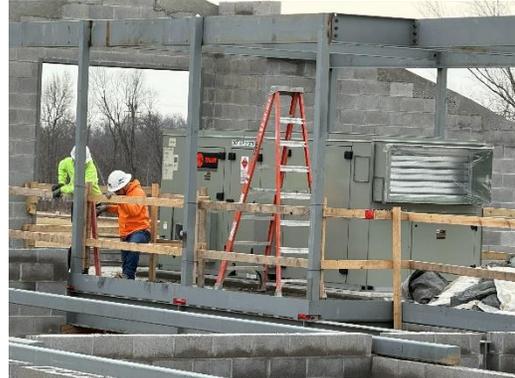
- x) The columns that support the light gauge metal trusses over the classroom wings incorporate the railing along the platform above the second-floor classroom corridors.

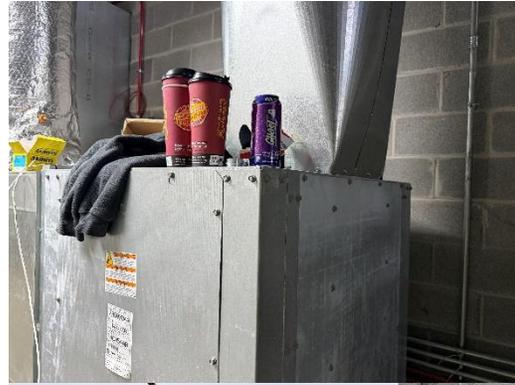
- y) Workers tend to use installed equipment as tables for their drinks. If one of these spills down into the enclosures very expensive equipment may be damaged.

Jeremy has told me that this issue is a regular point of emphasis at the foreman's meetings.

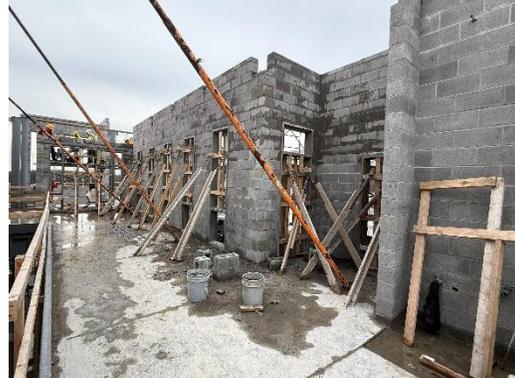
- z) CMUs were being laid next to the library on the second floor.

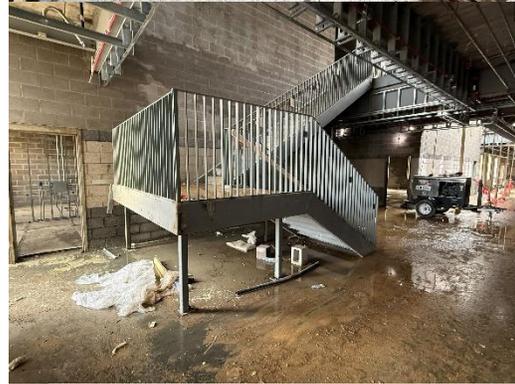
- aa) Despite efforts to keep mud out of the building, the main corridor is being covered with it. This floor will have a terrazzo finish.

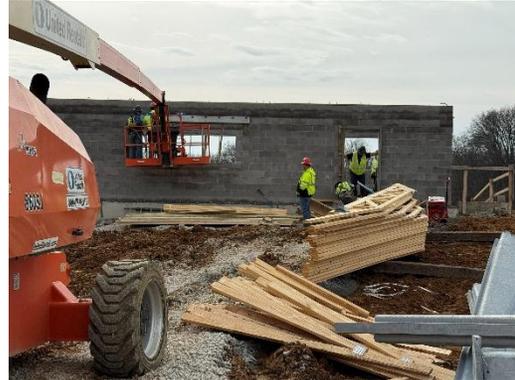
- bb) Preparations were underway to install the wood roof trusses over the athletic building to the south of the site.
