## FIELD OBSERVATION REPORT

Child Nutrition Building (Food Service Building, 202276 -CA8)

Date: 3/11/2026 Time: 9:00 AM

Report No: 30

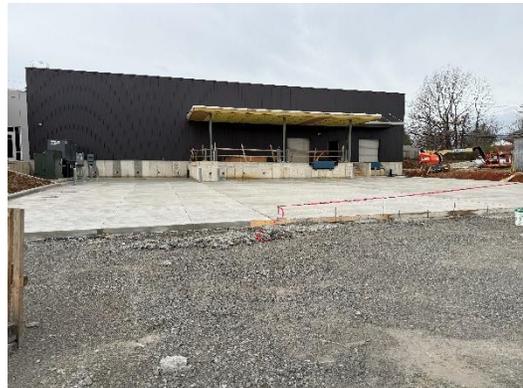
- a) All the concrete apron was poured in front of the dry food storage portion of the project.

The loading dock canopy was not yet covered with sheet metal soffit and fascia.

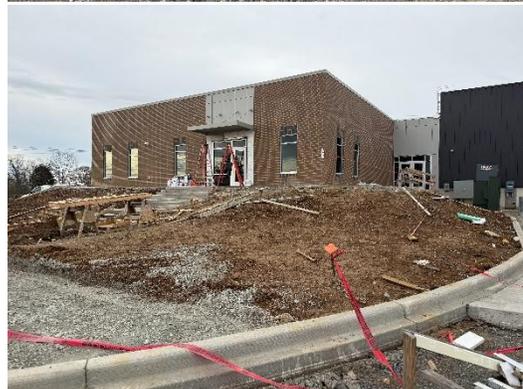
- b) The exterior of the office area of the building appeared to be nearing completion.

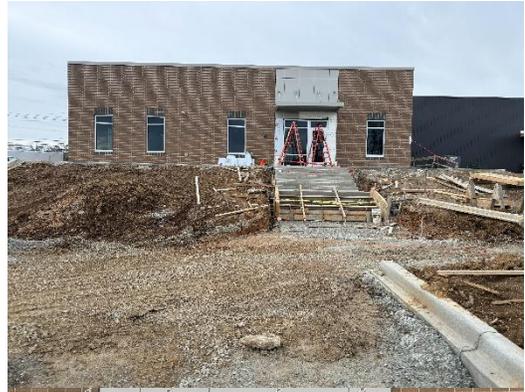
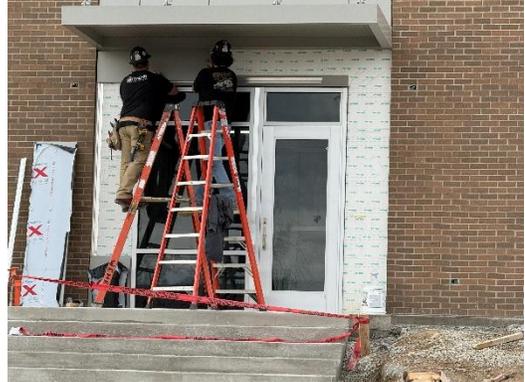
- c) Site work was slowed by recent rains.

The metal panels at the main entrance storefront doors and framing were being installed.

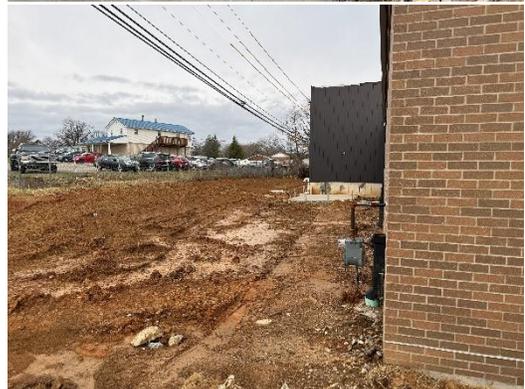
- d) The concrete pad for the original condensing unit had been poured.

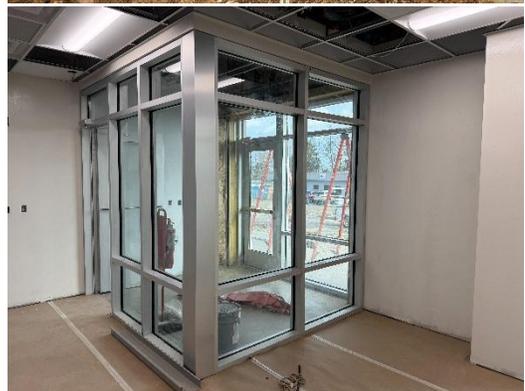
- e) The interior vestibule storefront framing and glass were installed.

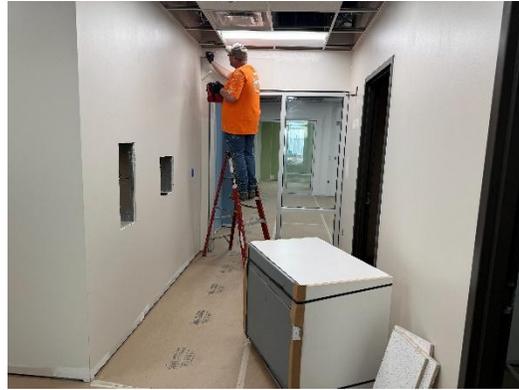
- f) Painters were applying the final coat of paint in the office area.

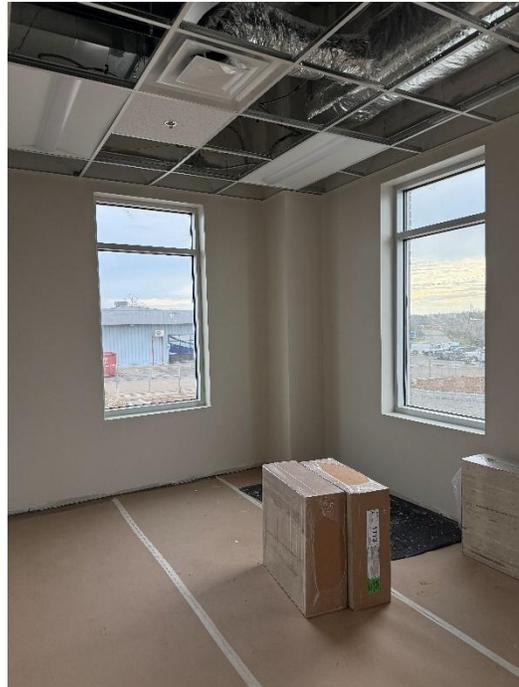
- g) Ceiling grids, light fixtures, GRDs, sprinkler heads and occupancy sensors were installed in ceiling tiles for the above ceiling inspection conducted on this day.

Refer to the report from CMTA concerning their comments about the mechanical and electrical work above ceiling and installed in the grid.

Due to the nature of the work, if one item was cited as a deficiency, it was typically repeated numerous times. Refer to the architectural comments at the end of this report.

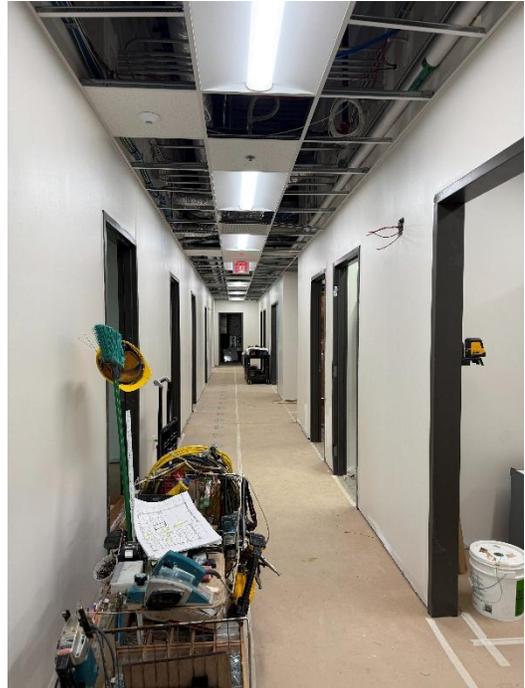
- h) Protection board had been placed over the recently installed vinyl plank flooring.

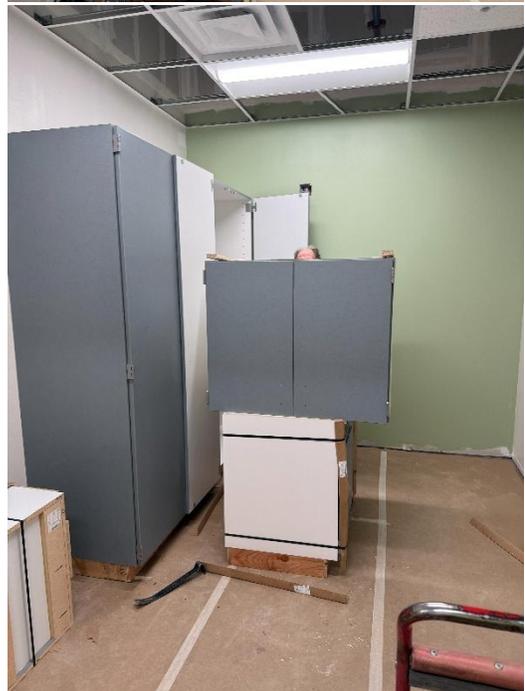
- i) Plastic laminate cabinets were being installed in the office area.

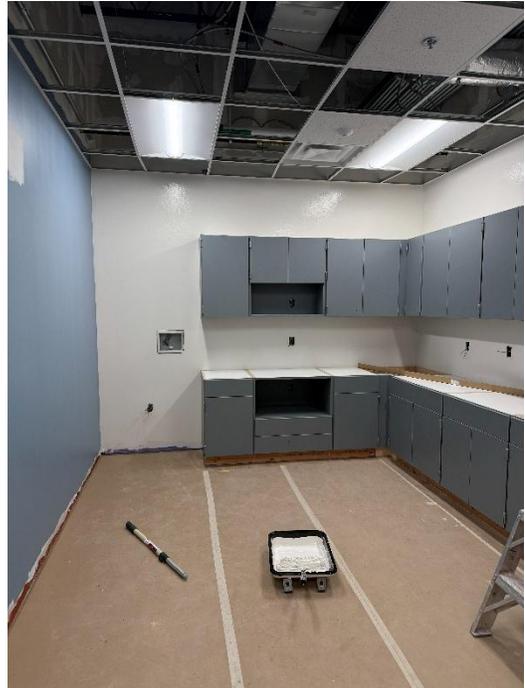
- j) Base and wall cabinets were installed in the Break Room.

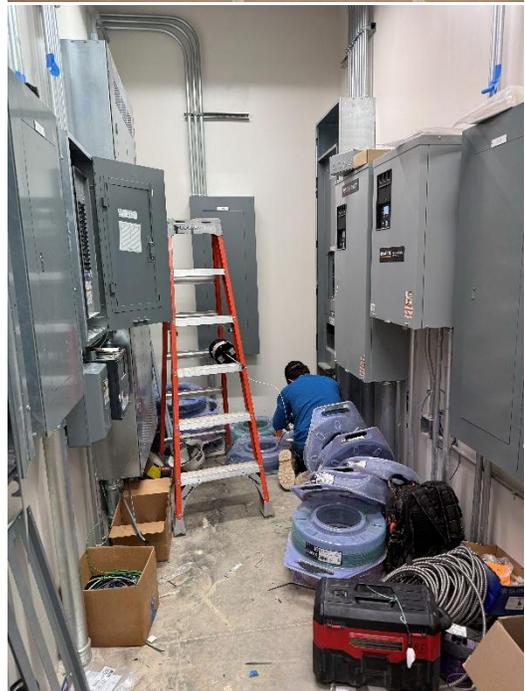
- k) Electricians were pulling wire into the electrical panels.

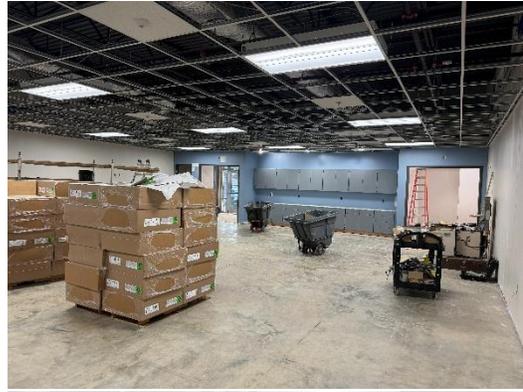
- l) Plastic laminate cabinets were installed in the Training Room.

Acoustical ceiling panels were stored for installation after the above ceiling work is approved.

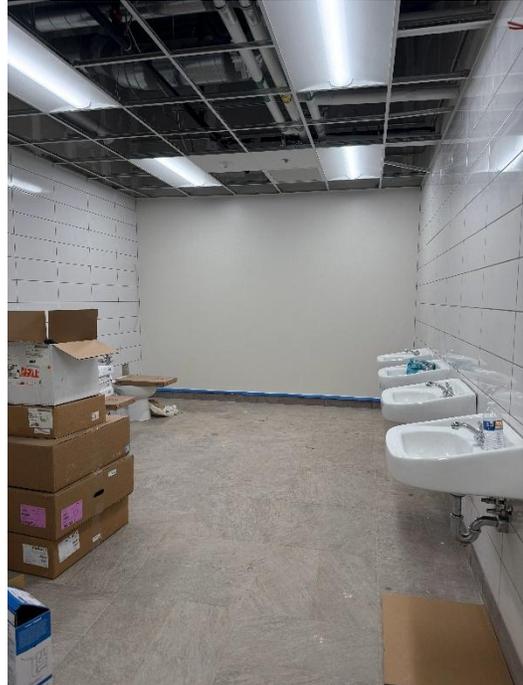
- m) Ceramic floor and wall tiles were installed in the toilets. Plumbing fixtures were installed. Toilet compartments and accessories were yet to be installed.

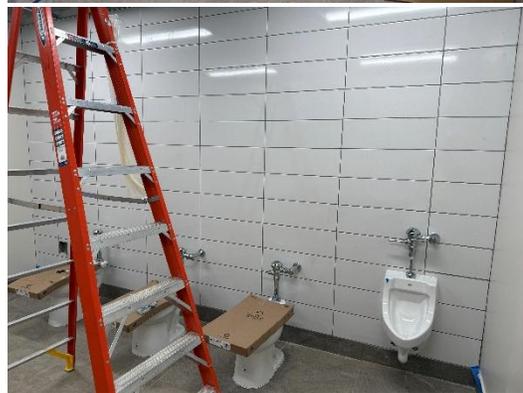
- n) Toilet fixtures were sealed to the floor and walls as specified.

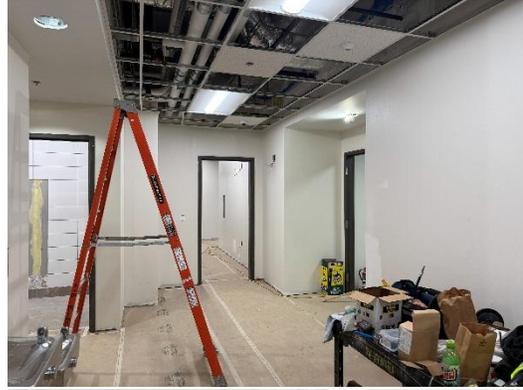
- o) Walls and door frames were being painted in the entry corridor into the toilets and the Training Room.

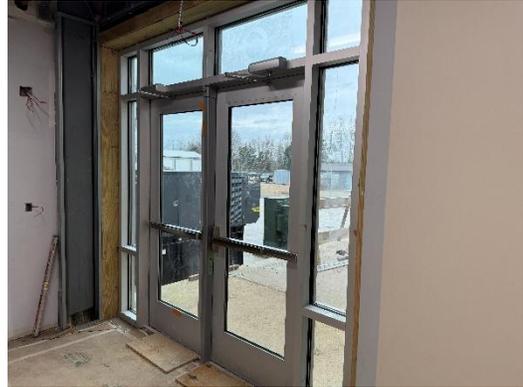
- p) The storefront exterior entrance and doors to the Training Room corridor were in place. Now that this is in place, the surround at the north column can be installed.

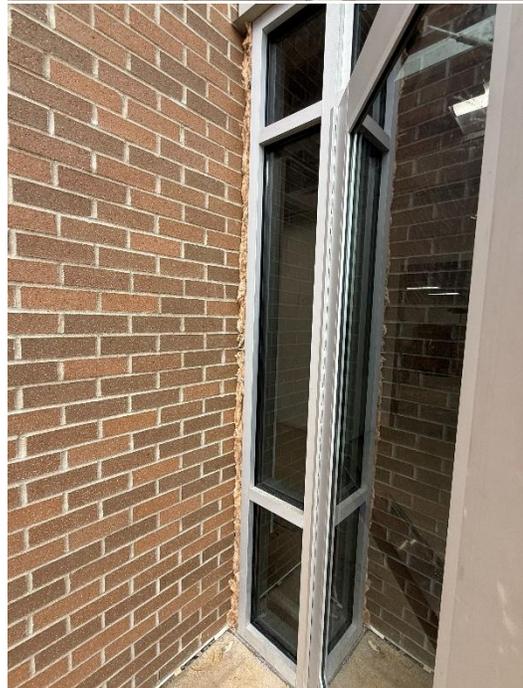
- q) On the south side of the side entrance, aluminum trim will be added and held in place with trim tape on the frame and sealant at the brick.

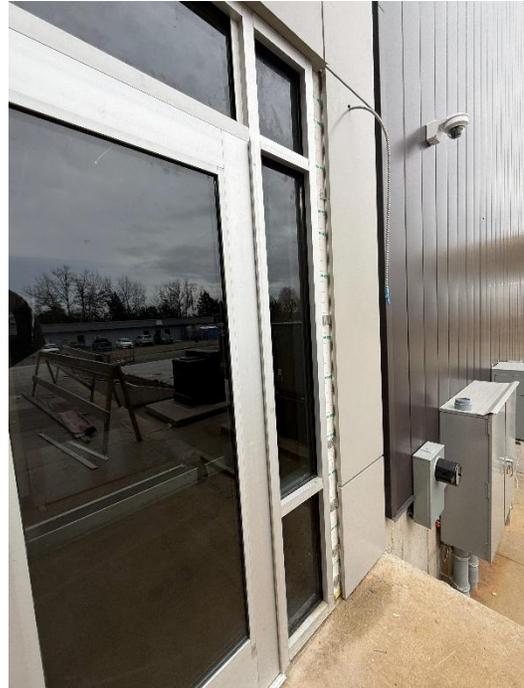
- r) On the north side of the side entrance, aluminum trim will be added and held in place with trim tape on the frame and sealant at the metal panel.

Once the trim is in place, the storefront will be the same width as the panels above.

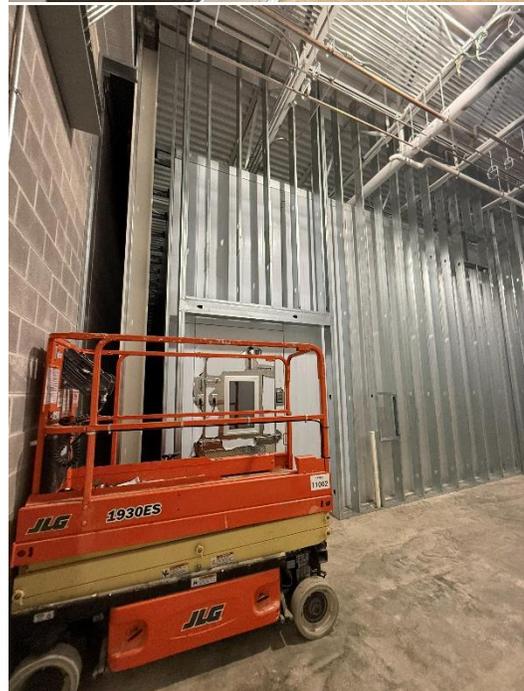
- s) Two 2'x2' access panels were indicated on the north side of the freezer box for access to the area above the box. We have discussed changing this to have one 3'x3' panel over the swinging door on the east side of the box. This will provide access where there are no items in the way and a larger opening for accessing the space.

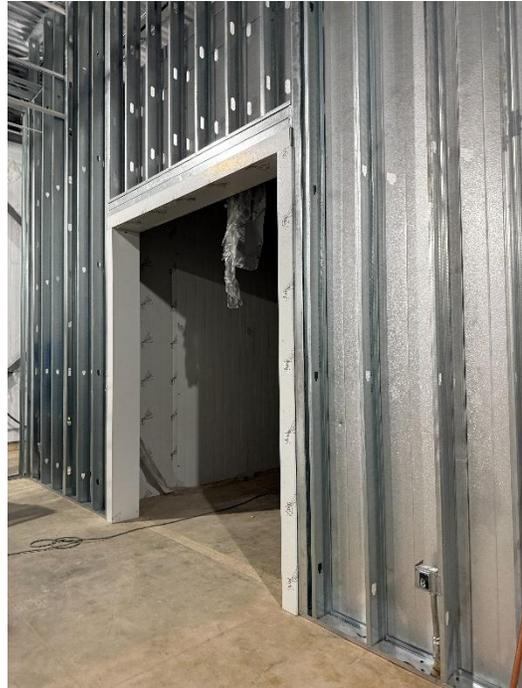
- t) The wall structure for sliding freezer door was in place. Heavy jamb studs were installed at the jambs of the opening, and a box header was installed over the opening. Since the door track will be supporting the door when it is opened, every other stud was a heavier gauge. The door weighs 800 pounds. Once the steel bridging is installed in the wall and 2x8 wood blocking is install for the track to mount to, the load will be spread over the entire area supporting the door and its track.

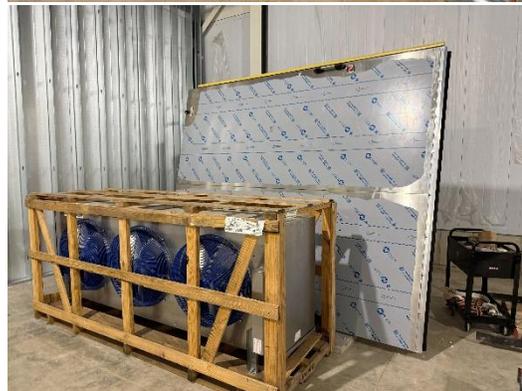
- u) The sliding door and another evaporator were stored outside the freezer box.

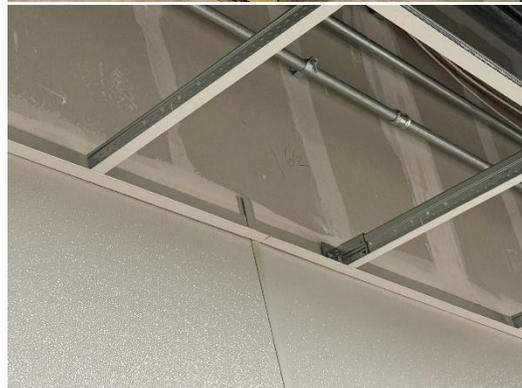
- v) During the ceiling inspection, we found that seismic clips were not consistently installed. These need to keep the grids from moving on two sides and movable on the opposite sides. They also need to be installed per the ceiling manufacturer's installation instructions.

1. The seismic end clips are not uniformly applied. The manufacturer's guide requires them at the ends of the grids as indicated. The clips anchor the grid on two walls and allow for movement on the opposite walls.
2. The hanger wires are not at 4'-0" O.C. both ways.
3. The hanger wire spacings exceed the maximum distance from the walls.
4. The hanger wires are not terminated in 3 turns in 3".
5. Some hanger wires are installed at slopes greater than 1:6. When this occurs an opposing wire is required at the same angle.
6. Some of the grids at the wall barely touch the wall molds. The maximum is 3/8" from the end to the wall mold vertical leg.
7. Some of the grids are already bent.
8. Some of the ceiling tiles with devices in them are damaged or dirty.
9. Some unused hanger wires are above ceiling.
10. The loose ends of many of the hanger wire are not close to the vertical which causes

11. Joints in main beams need seismic reinforcement clips.

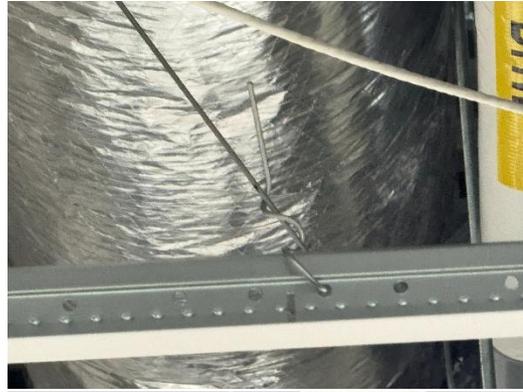
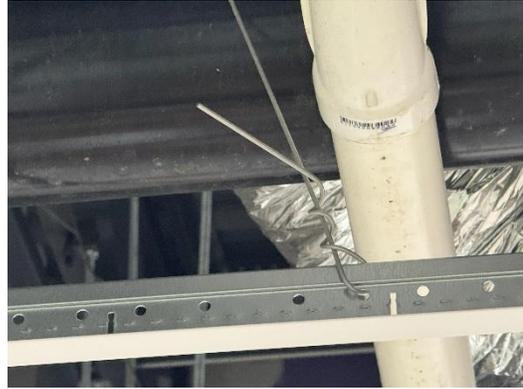
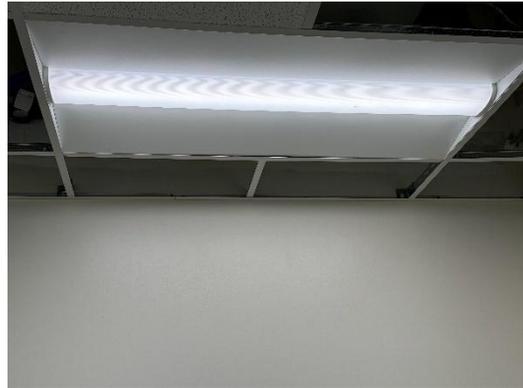
- w) Hanger wires need to be installed with three turns in 3". Maximum spacing of the hanger wires is 4'-0" on center.
- x) Terminations of hanger wire need to be cut off or bent to be parallel with the vertical to reduce danger of a sharp edge cutting a maintenance worker.
- y) In some instances, the ceiling grids were bent such as the ones at the light fixture

a hazard for maintenance workers reaching above the ceiling.

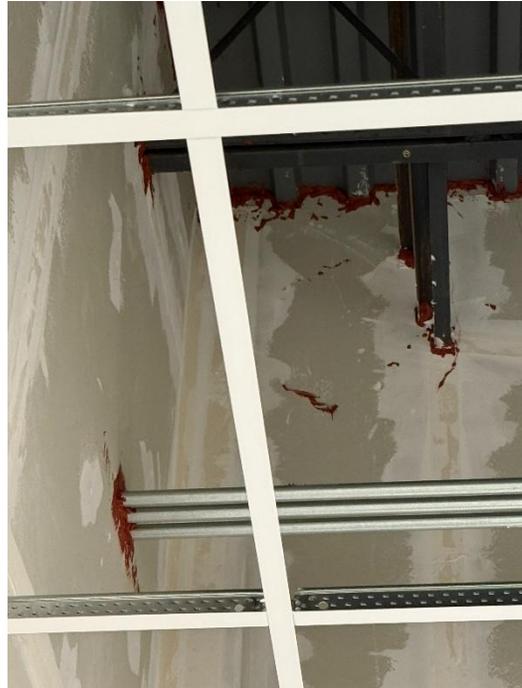
- z) The walls around the Record's Room are the only ones that are fire-resistant rated. The manufacturers of the red fire rated sealant make labels for application on the walls to alert maintenance workers that the walls must remain continuous.
