## FIELD OBSERVATION REPORT

West Hardin Middle School, 202280 -CA8

Date: 3/11/2026 Time: 12:30 PM

Report No: 31

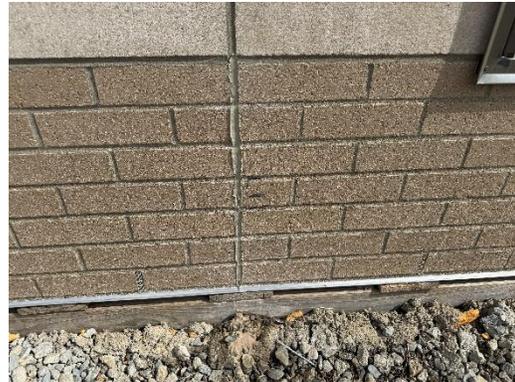
- a) The sealant in the brick crack control joint had been applied to the sample panel. The color was acceptable. The sealant joint was not tooled like a brick joint, and it protruded out past the face of the bricks. Make corrections and alert JRA when ready.

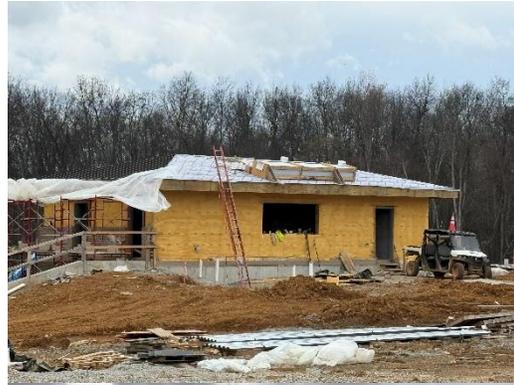
- b) Metal panels were being installed over the concessions building.

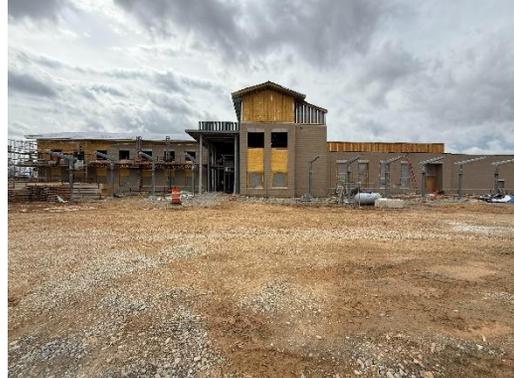
- c) Exterior finishes including bricks, fiber cement panels and sheet metal panels continued to be extended around the north side of the building.

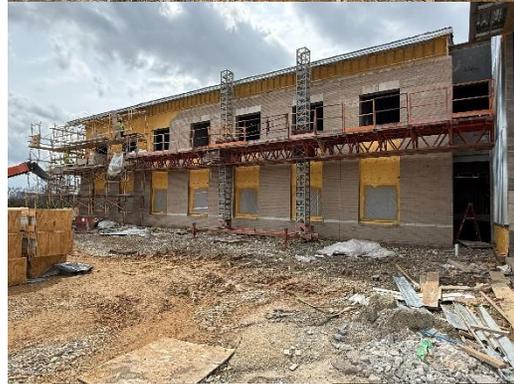
- d) Area B was being covered with bricks over the spray foam insulation.

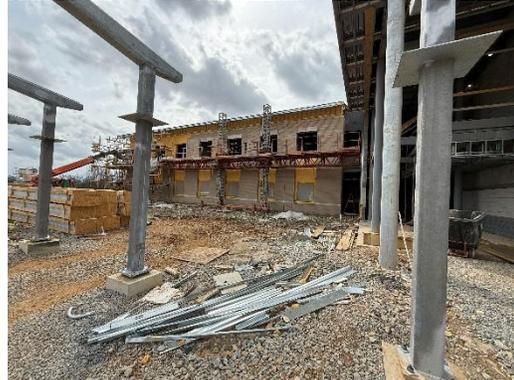
- e) It appeared that most of the steel framing for the north side of the building was in place.

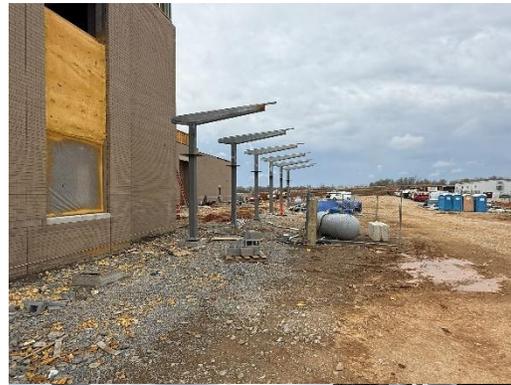
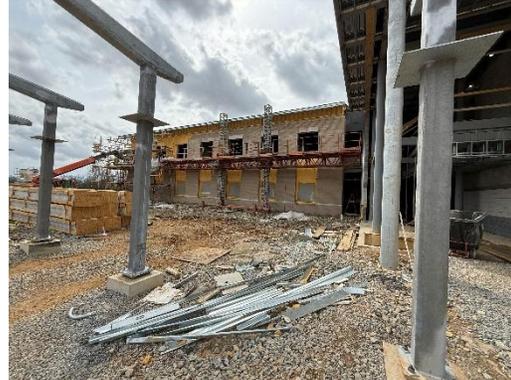
- f) Galvanized structural steel canopy frames were installed at the bus loading/unloading lane to the north of the building.

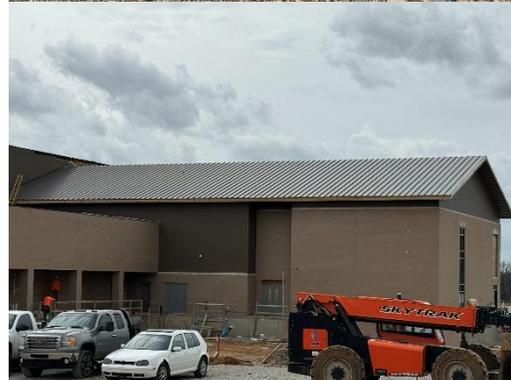
- g) Fiber cement panels were installed over the north side and gable end of Area D. They were also installed above the bricks under the gable roof eaves.

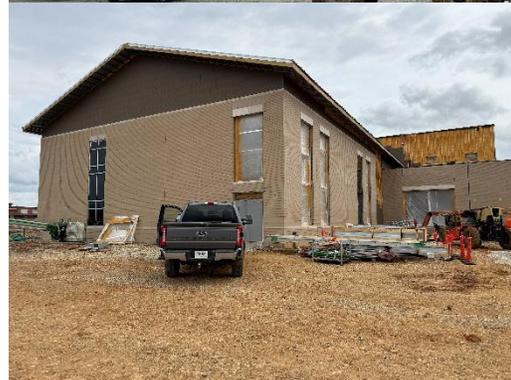
Curtainwall windows were being installed in the Band Room.

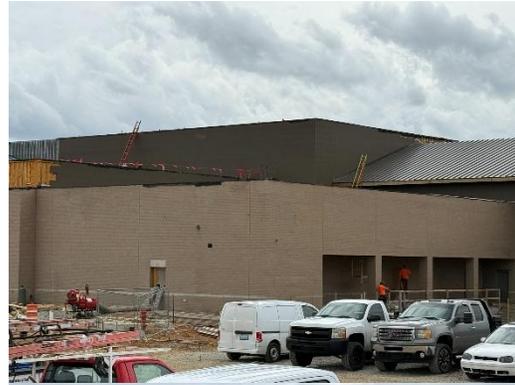
- h) Fiber cement panels were installed over the Storm Shelter/Gym above the lower roof areas.

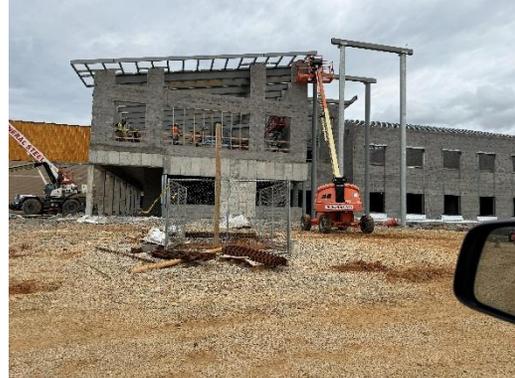
- i) Steel structural framing was being installed over the library.

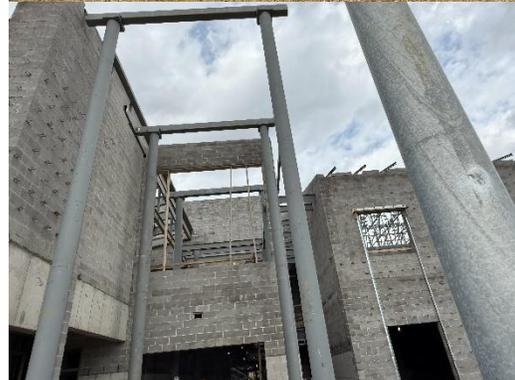
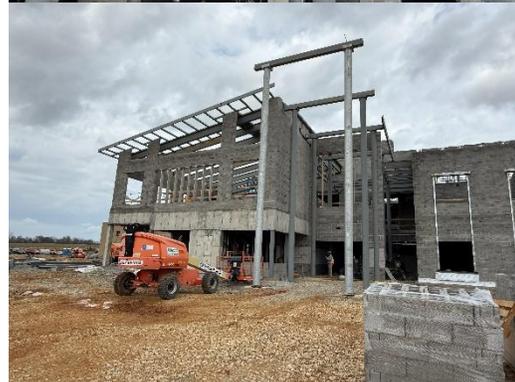
- j) The steel structure was being installed at the south entrance to the building.

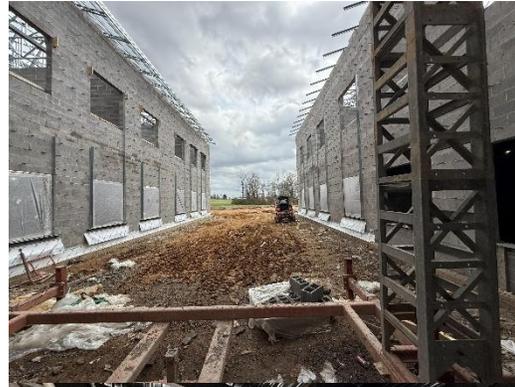
- k) Light gauge roof trusses were installed over the two southernmost wings of classrooms.

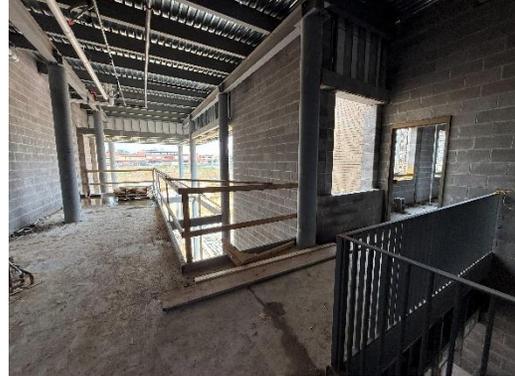
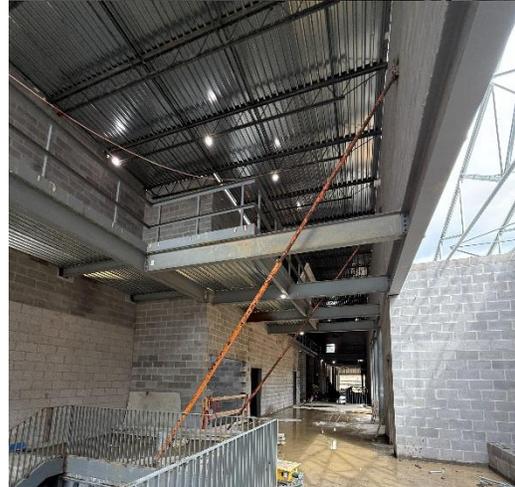
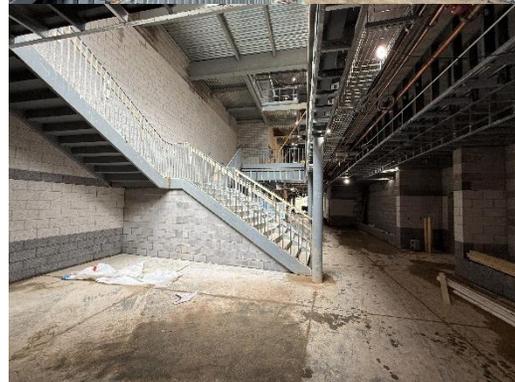
- l) Steel roof joists and metal roof deck were installed over the northern portion of the roof area above the main central corridor. The mechanical platform above the second floor could also be seen from this location.

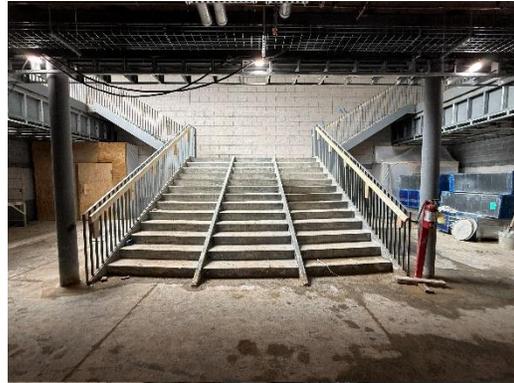
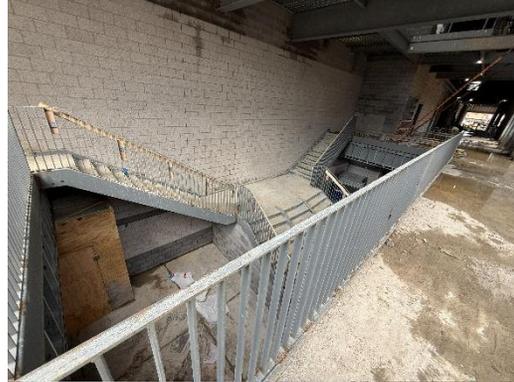
- m) Concrete had been placed in the stair pans at the central stair.

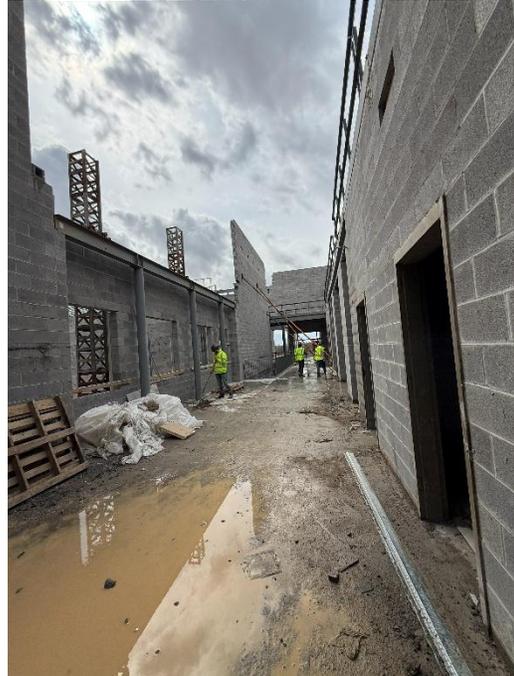
- n) The southern end of the main corridor will be one of the last areas to be covered with roof structure.

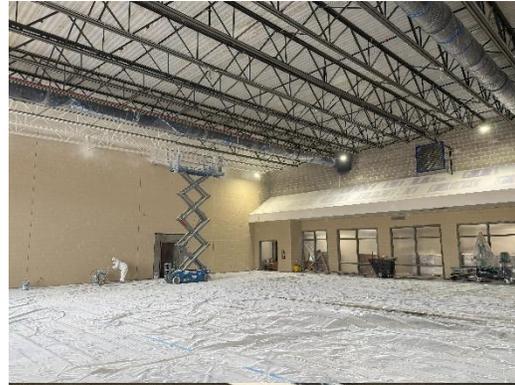
- o) Painting of the steel roof structure over the cafeteria was underway.

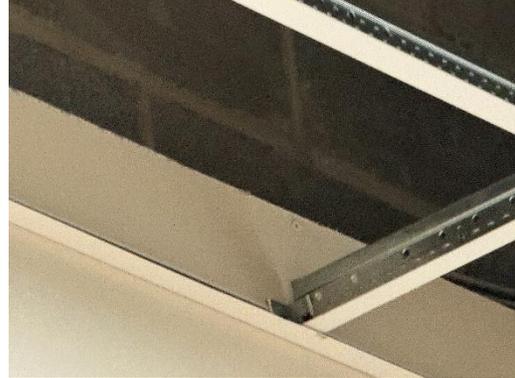
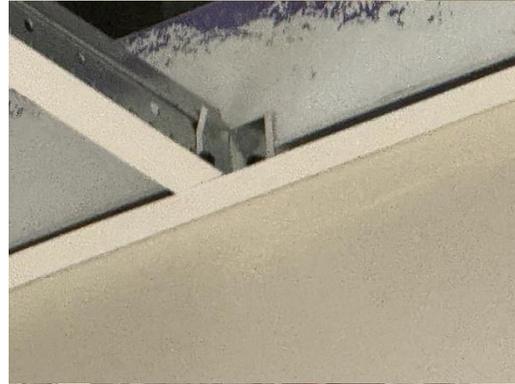
- p) Seismic clips were specified to be used at the ends of ceiling grids, instead in some cases the grid was bent up and fastened to the wall.

- t) Observations from the above ceiling inspection include the following:
1. The seismic end clips are not uniformly applied. The attached guide requires them at the ends of the grids as indicated. The clips anchor the grid on two walls and allow for movement on the opposite walls.  
In some cases, the grid is bent upward and fastened to the wall. I have not found this detail in the manufacturer's literature.
  2. The hanger wires are not at 4'-0" O.C. both ways.

Refer to the architectural above ceiling report at the end of this report.

- a) Special inspection reports with emphasis on the storm shelter area.
- b) Keep as-builts up to date.
- c) Provide punch lists for block defects in Area D.
- d) Make corrections as indicated in the above ceiling report and alert JRA when the corrections are made.

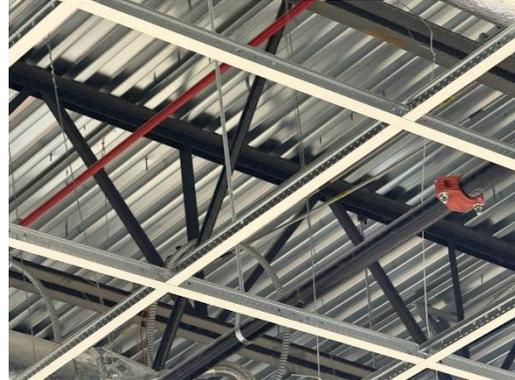
- q) Hanger wires were not at 4'-0" on center and were not at grid intersections as specified.

Hanger wires were attached to floor and roof metal deck with unknown fasteners.

3. The hanger wire spacings exceed the maximum distance from the walls.
4. The hanger wires are not terminated in 3 turns in 3".
5. Some hanger wires are installed at slopes greater than 1:6. When this occurs an opposing wire is required at the same angle.

11. Joints in main beams need seismic reinforcement clips.
12. Many of the hanger wires are attached to floor and roof deck. This might be acceptable if the hanging device is acceptable to ICON. Per the spec, the load carrying capability of the device does not degrade in load carrying capabilities over time.

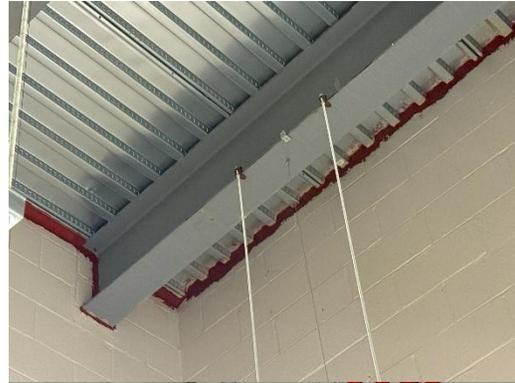
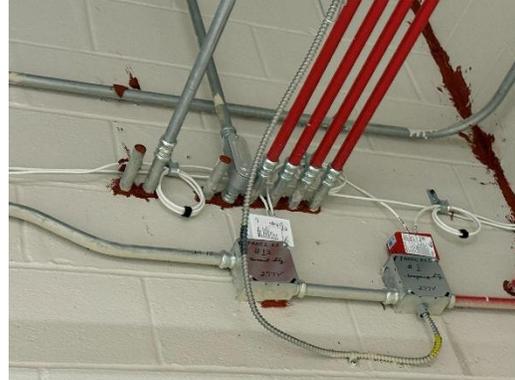
- r) Red fire-resistant sealant was used at top of wall conditions and penetrations at the two-hour fire-resistant walls around the storm shelter. Places where this material was used need to be labeled so that maintenance workers will know what materials were used.

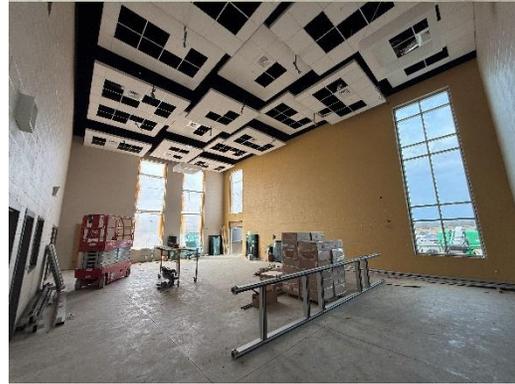
- s) The suspension system for the clouds in the band, vocal and art rooms need to be described for compliance with the specification for these ceiling types.

13. Some hanger wires were kinked to adjust height. The kinks can relax over time making the ceiling sag.
14. Armstrong has some specific requirements for hanging ceiling clouds for seismic movement. Please provide a description of exactly what was done to suspend the clouds. The clouds must be level.
