FIELD OBSERVATION REPORT

Central Hardin High School – Phase 2, 2019111 -CA8

Date: 4/7/2026 Time: 3:30 PM

Report No: 44

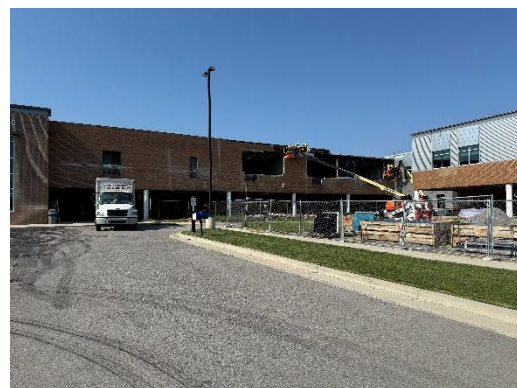
- a) Large sections of the south exterior wall of Area H were being removed for the new windows on the second floor. This is different than Area J which has load bearing exterior walls. Area H is framed with a steel structure leaving the walls to be non-structural. Since there are two windows in each room, the mason determined that it would be easier to remove the short wall between the two windows which will be laid back with new blocks.

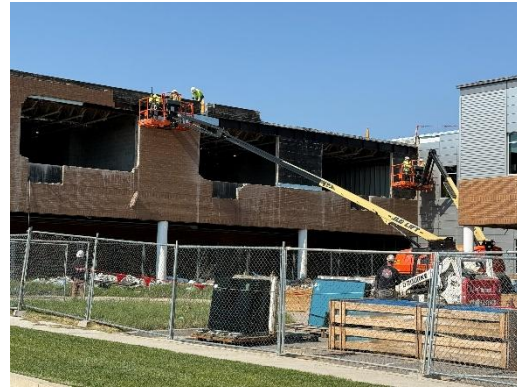
- b) The second floor is covered with sheet metal panels. The bricks are being removed on the second floor for that reason and will be removed below the second floor to repair the support framing.

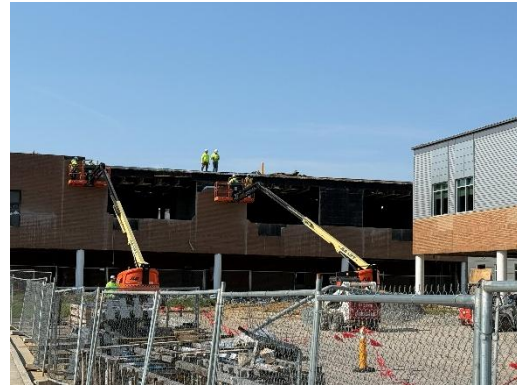
- c) The existing parapet walls at the top of the area were being removed and will be reinstated with metal framing like area J.

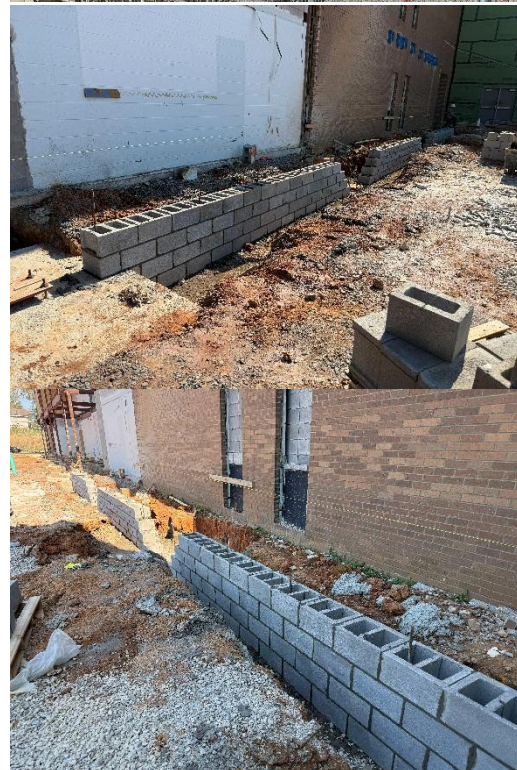
- d) Block walls were being installed in Area G for the new foundations.

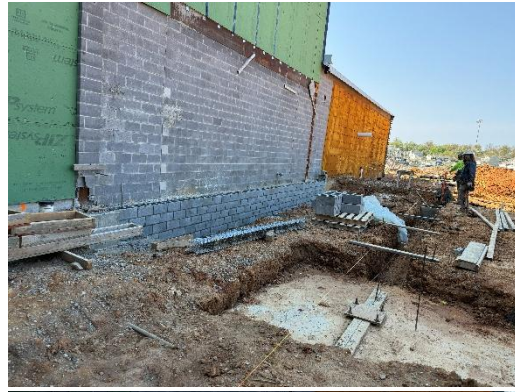
- e) Concrete footings were being installed over the entire footprint of the area.

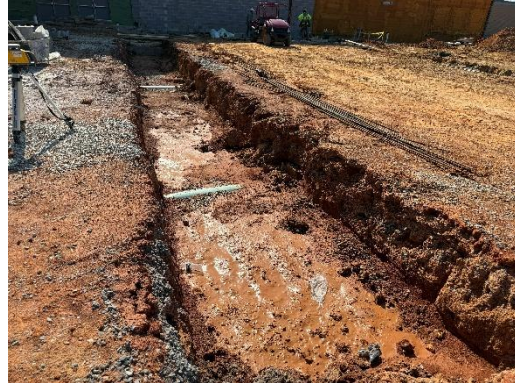
- f) A recent rains had turned the footing excavations into mud.

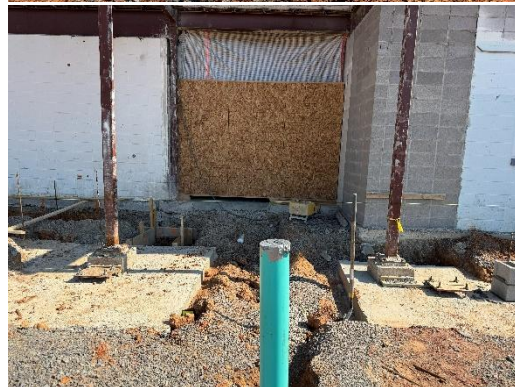
- g) The new sewer lines under Area G were backfilled with crushed stone.

- a) Note changes on the As-Built Drawings.
- b) Coordinate scoping of below slab sewer lines with Brandon.

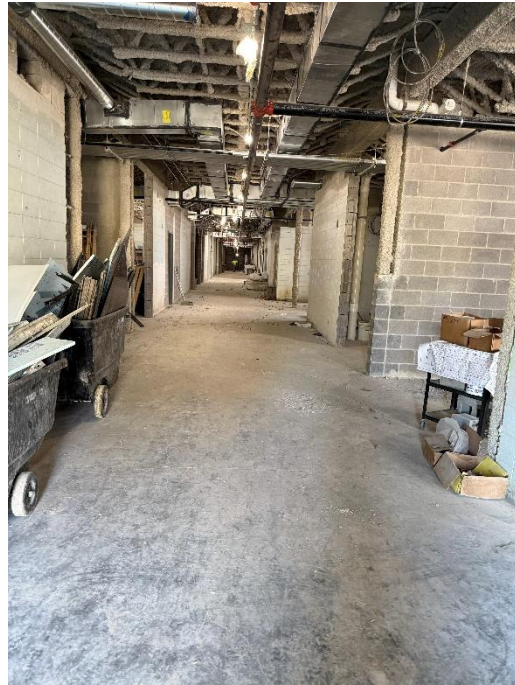
- h) The interior of Area H was relatively clean. Note the waste materials in bins along the corridor.

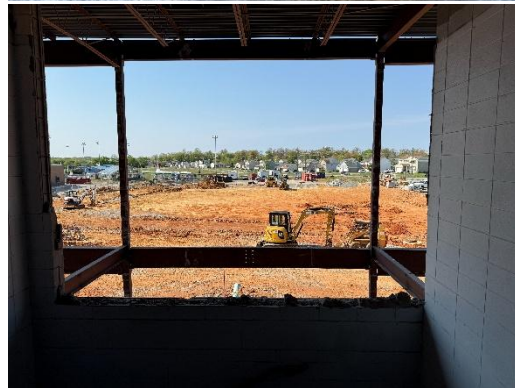
- i) Looking through the central stair, the site to the north was rough graded for the new parking lots.

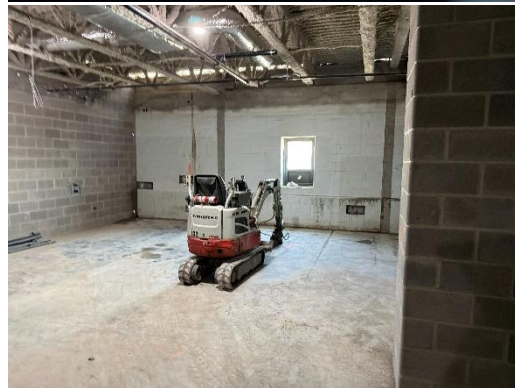
- j) The existing small window openings were being enlarged for the new windows in the classrooms.

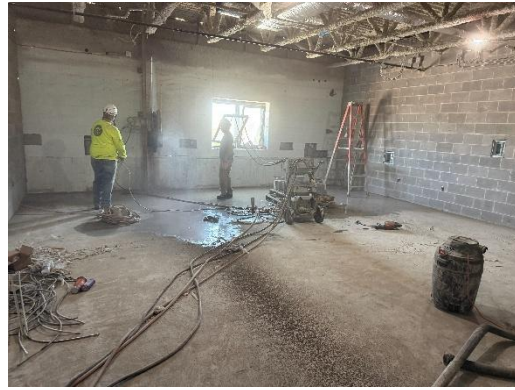
- k) The first step for the removal of the exterior wall was to saw-cut the blocks at the edges of the new window openings.

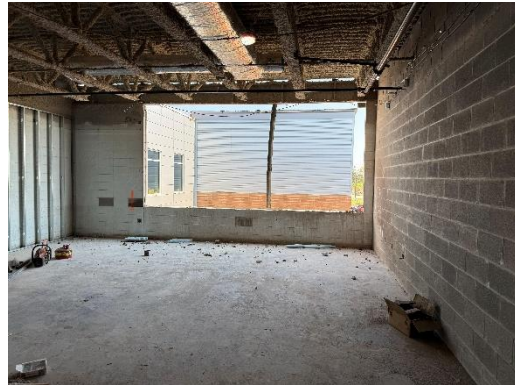
- l) Once cut free, the blocks were pushed out of the wall.

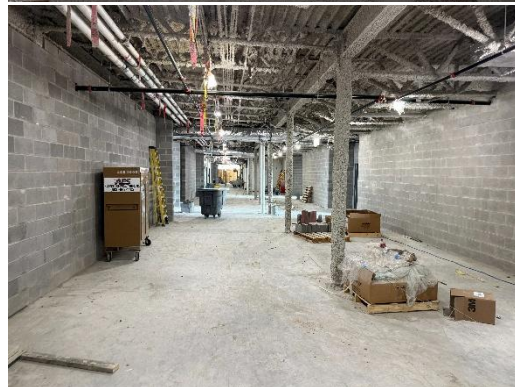
- m) With the steel structural frame, the mechanical and electrical work can continue of the second floor without having shoring like was used in Area J.

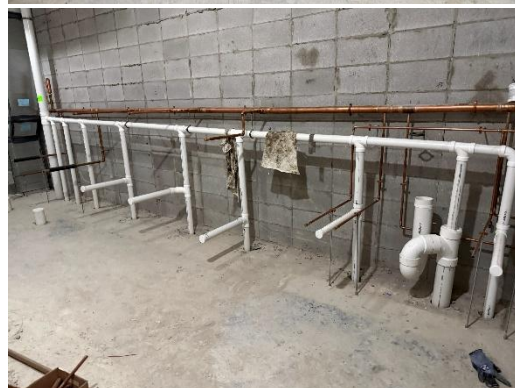
- n) The above slab plumbing tree was in place for the boy's toilet on the second floor.

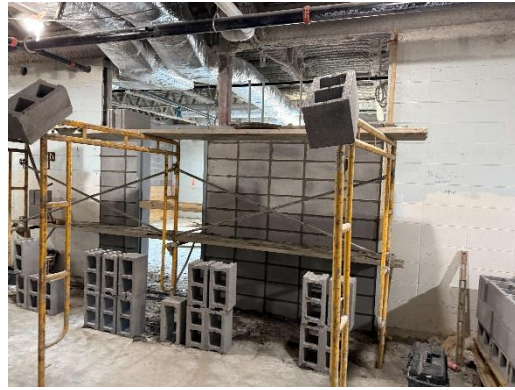
- o) New block walls were being laid for interior partitions. The masonry work appears to be better than the early work in the area.

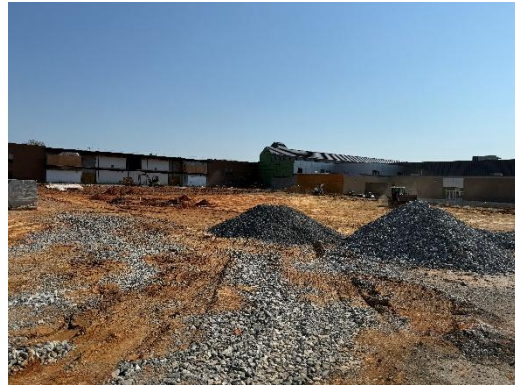
- p) Crushed stone was being stockpiled on the parking lot areas. Once the stone is down, the area can be used for construction materials and parking.

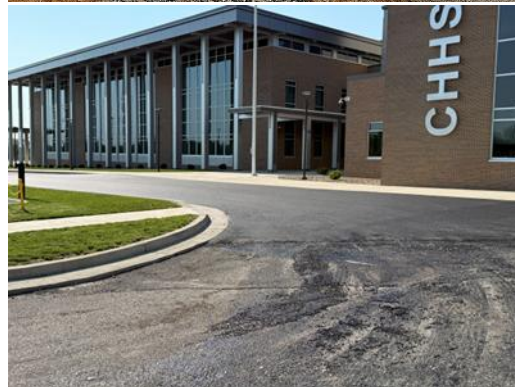
- q) Scotty's was applying a topcoat of asphalt paving in front of Phase 1.
