FIELD OBSERVATION REPORT

Child Nutrition Building (Food Service Building, 202276 -CA8)

Date: 4/7/2026 Time: 9:00 AM

Report No: 33

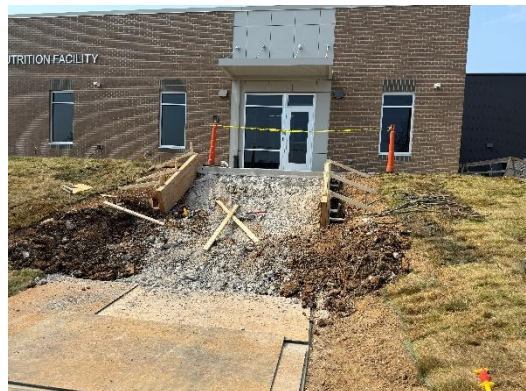
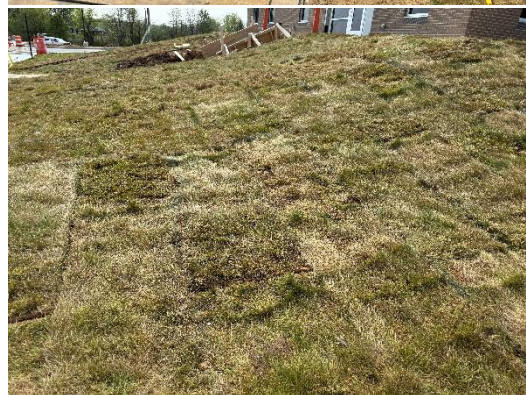
- a) Due to the finished appearance of the steps, it was determined that they could not be satisfactorily repaired. The steps will be reformed, and steel reinforcement will be used in lieu of reinforcing the concrete with fibers.
- b) The area in front of the office had been covered with sod. It appeared that it would need to be rolled to provide a uniform appearance. Irrigation will be required until the sod is established.

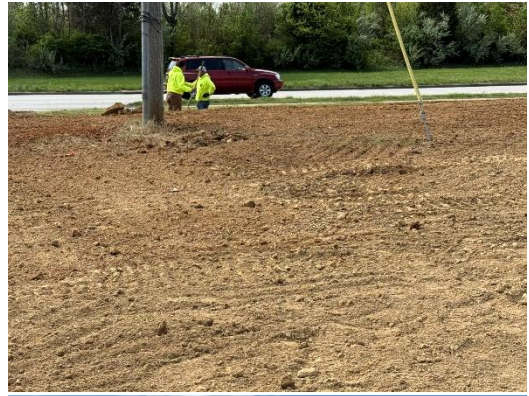
- c) The area between the south parking lot at the highway had been fine graded.

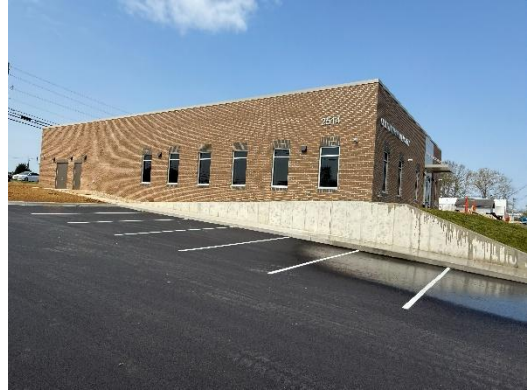
- d) The parking lots had been striped with paint. Clean up of the walks was underway.

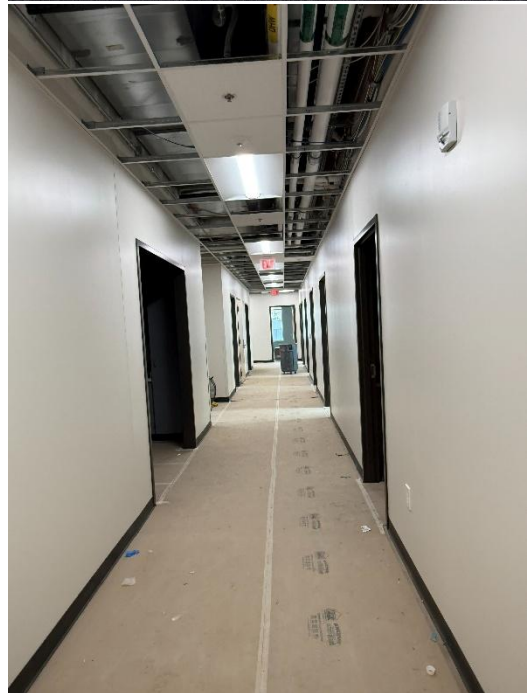
- e) Ceiling tiles will be dropped into the grids after all the mechanical/electrical above ceiling work is complete.

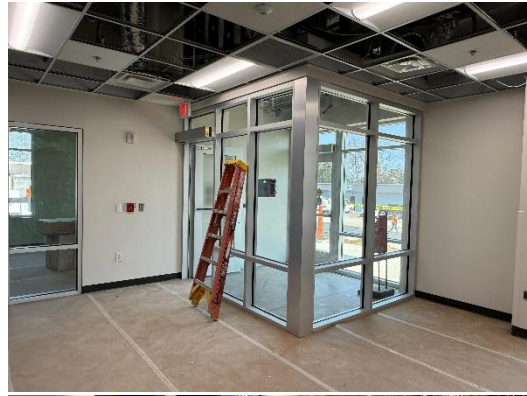
- f) The front lobby appeared to be nearing completion.

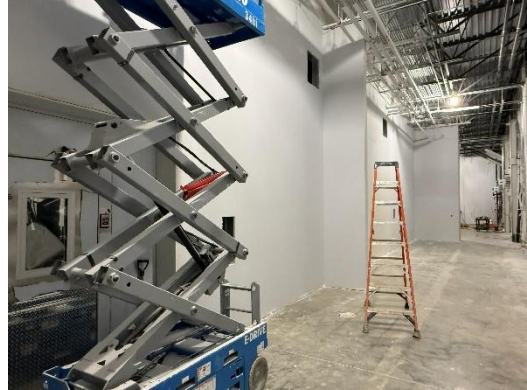
- g) The wallboard wall around the freezer was painted.

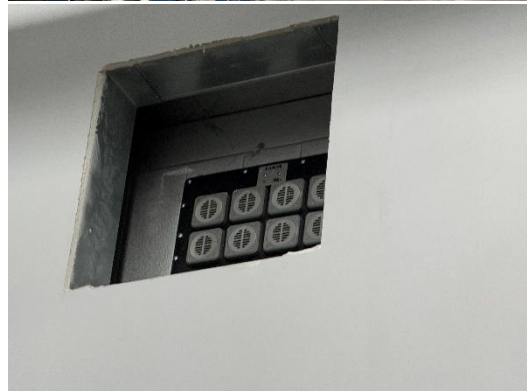
- h) An opening was left in the wallboard wall at the air circulation panel for one of the evaporators in the freezer.

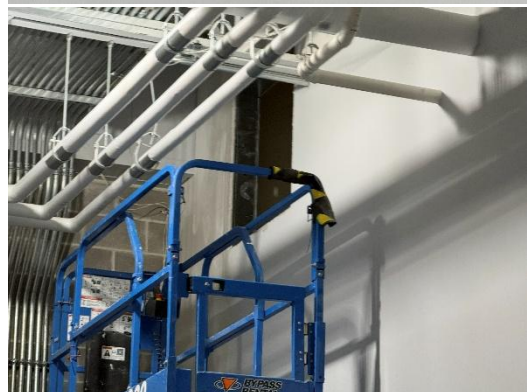
- i) The opening to the spacing above the freezer was left open. An access panel will be installed over the opening.

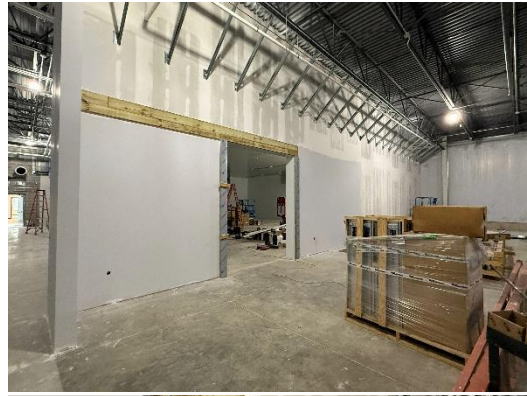
- j) On the north end of the freezer, the wall was braced to the roof structure.

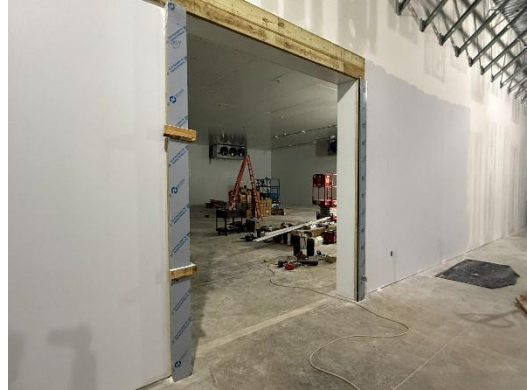
- k) Metal trim was installed over the wood blocking around the sliding freezer door opening.

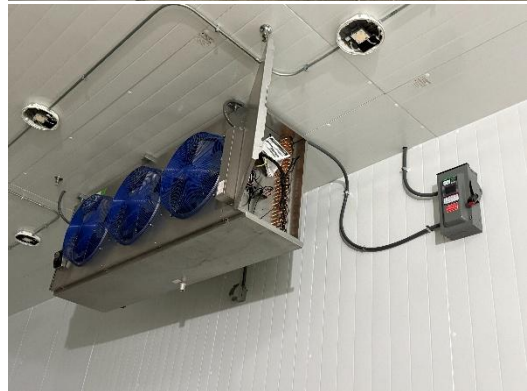
- l) The evaporators in the freezer were hung and connected to the refrigerant piping and electrical circuits

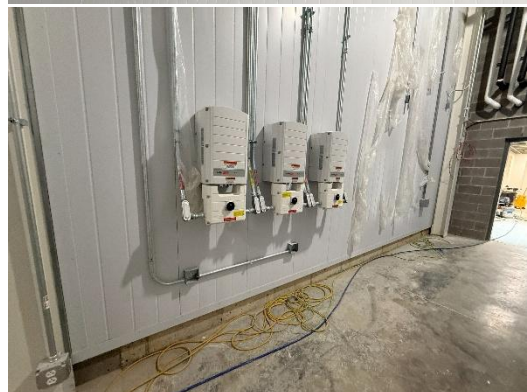
- m) The solar control panels appeared to be operating.

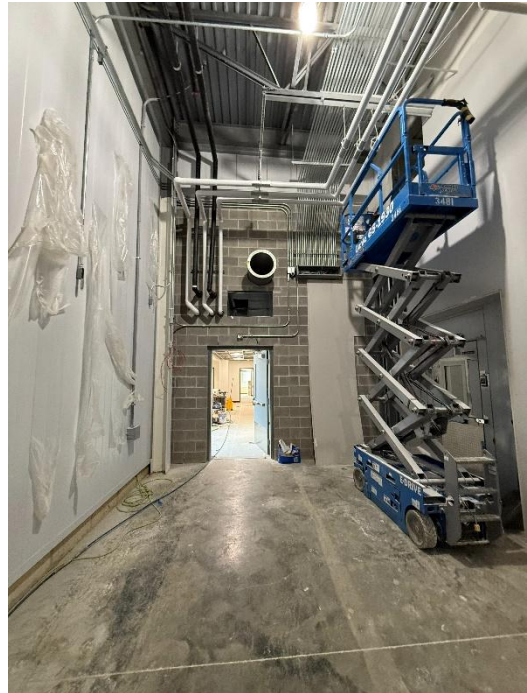
- n) Light fixtures will be suspended over the corridor in front of the freezer.

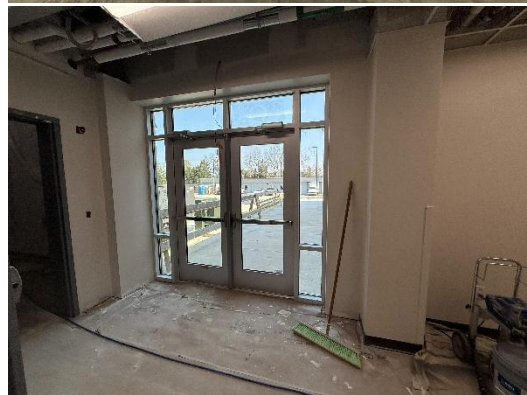
- o) Wallboard had been installed over the column at the side entrance.

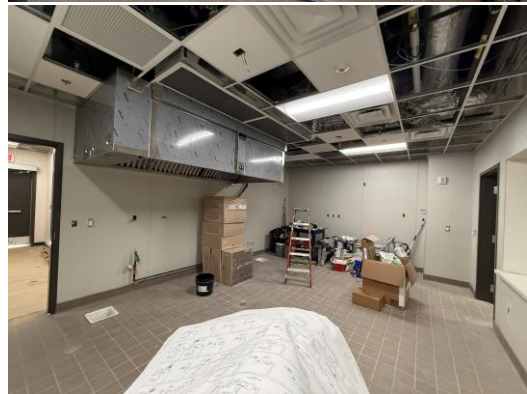
- p) The demo kitchen will initially have an oven-range installed. This will be used to test the hood for approval by the Building Inspector.

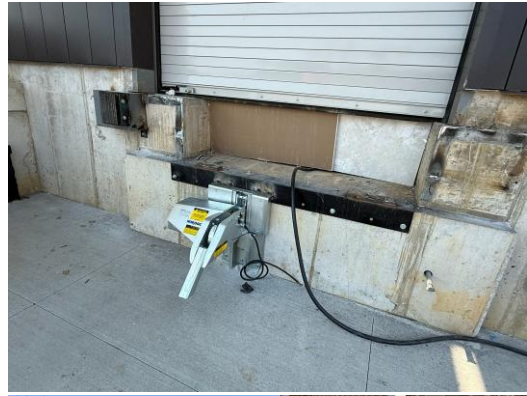
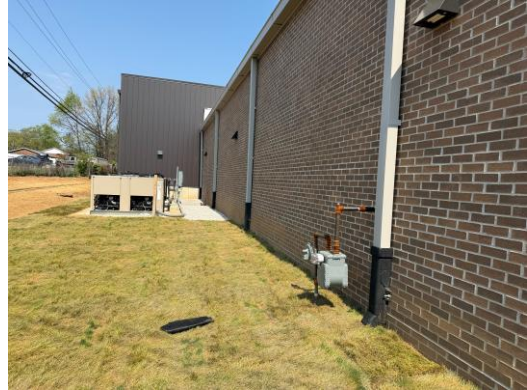
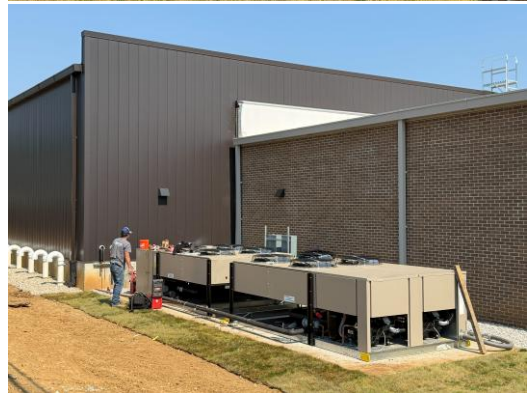
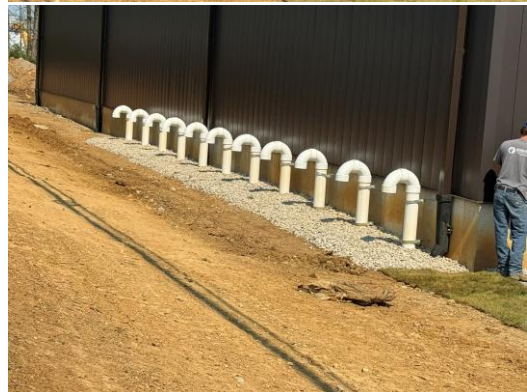
- q) The pit for the dock leveler will need to be moved to the south to be centered with the overhead door.
- r) It appeared that the flashing, trim, gutters and downspouts were complete on the west side of the building.
- s) The redundant condensing units for the freezer were in place and were being connected.
- t) Stone had been placed around the underslab vent piping for the freezer slab.

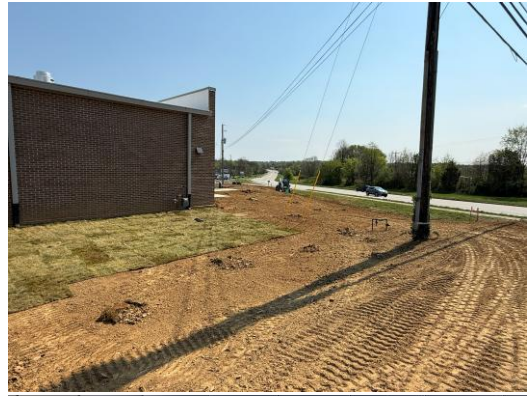
- u) The earth swale on the west side of the building was shaped to direct water to the front of the site.

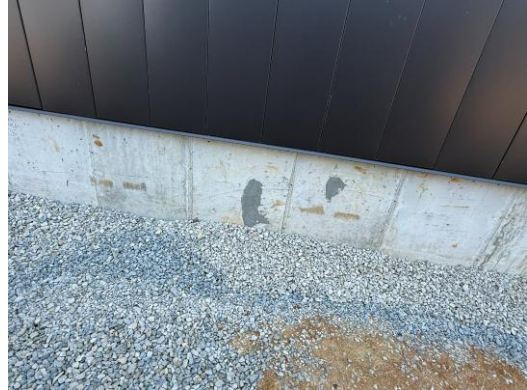
- v) Patching of voids in the exposed concrete foundations walls was in place.
