FIELD OBSERVATION REPORT

Central Hardin High School – Phase 2, 2019111 -CA8

Date: 4/29/2026 Time: 10:00 AM

Report No: 46

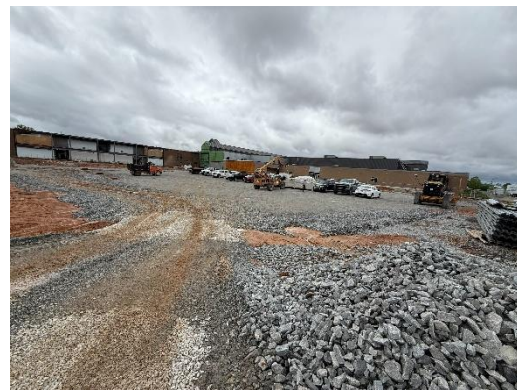
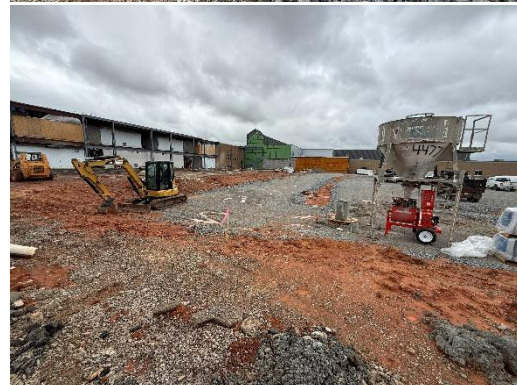
- a) The new parking area has been covered with crushed stone to provide a temporary parking lot for the workers and space for materials.
- b) Equipment that had been on the east driveway had been moved to the new parking area.

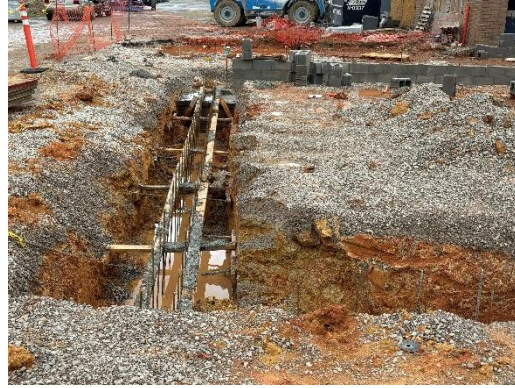
- c) Footing excavations were wet due to the recent rain. Reinforcing steel will need to be cleaned before concrete can be poured. Mud will need to be removed from footing bottoms.

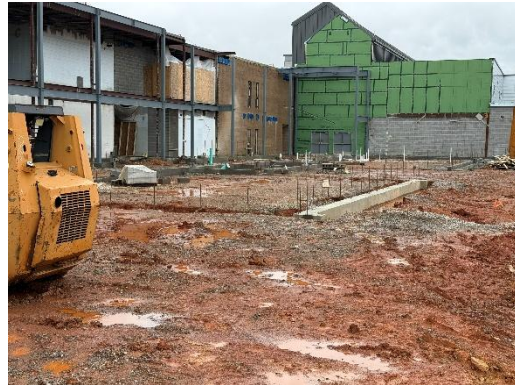
- d) A significant amount of the footings and foundations had been installed for Area G to the north of Area H.

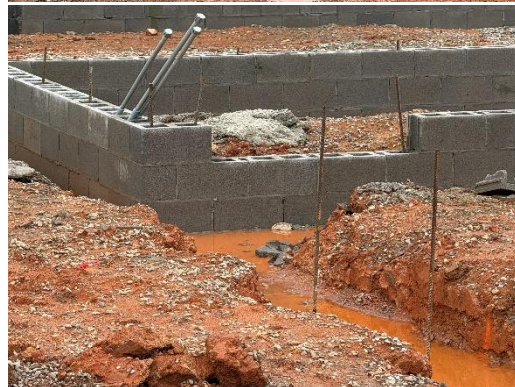
- e) Interior foundation walls were laid with CMUs.

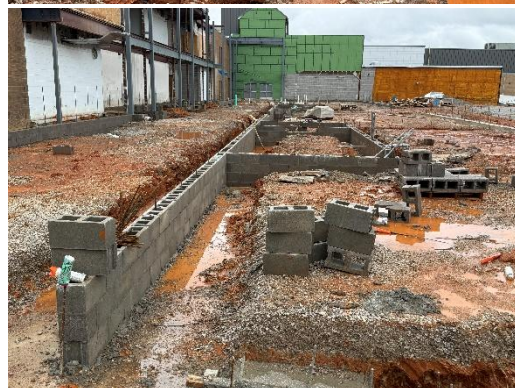
- f) Steel reinforcement was observed projecting out of the tops of the foundation walls.

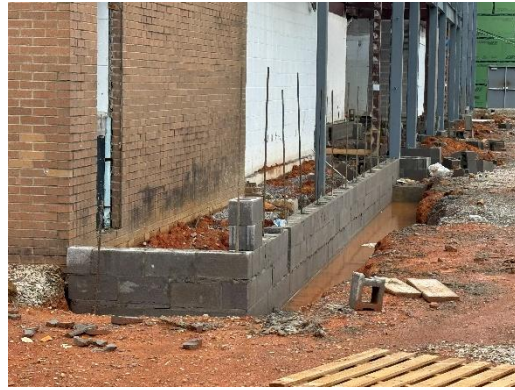
- g) The foundations were in place for the open space between Area G and H.

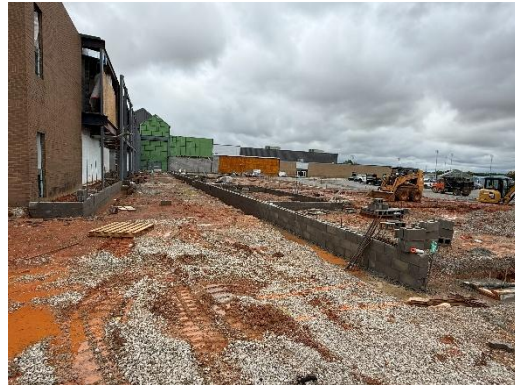
- h) The foundations were extended across the full width of Area G.

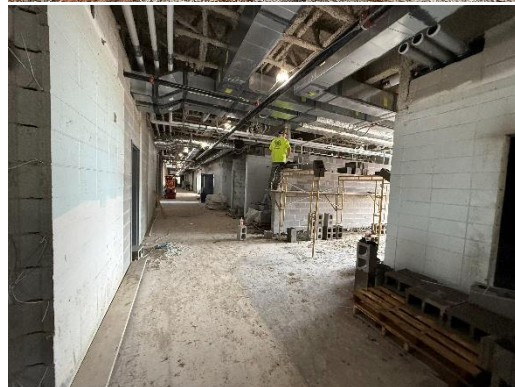
- i) Area H had been cleaned as instructed by Codell. Above ceiling work was proceeding.

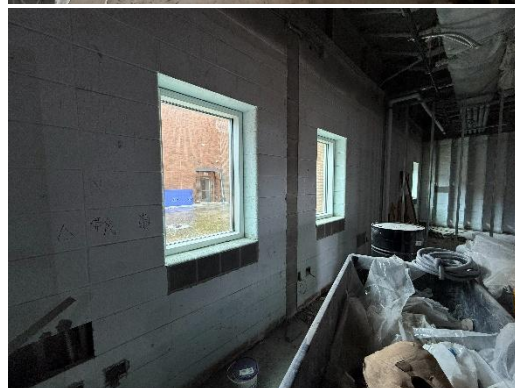
- j) Aluminum windows had been installed in the exterior wall at the courtyard between Area H and J.

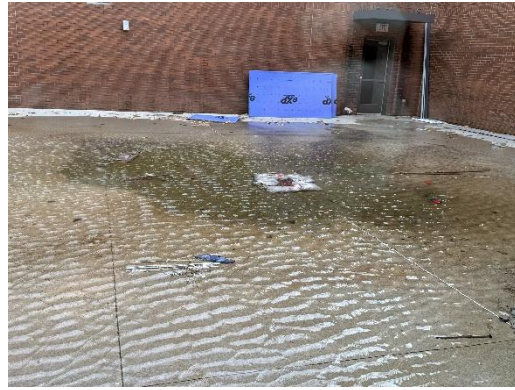
- k) The filter over the area drain for the courtyard appeared to be partially clogged and was preventing the drain from draining.

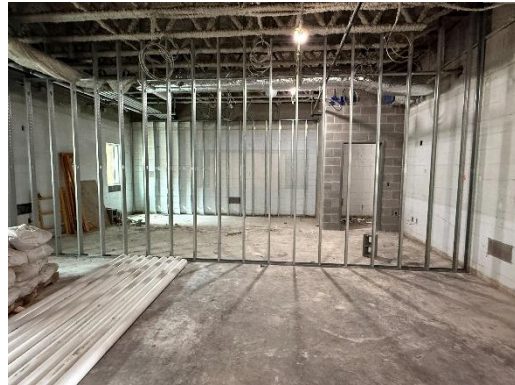
- l) Metal wall framing was being installed in the rooms in Area H.

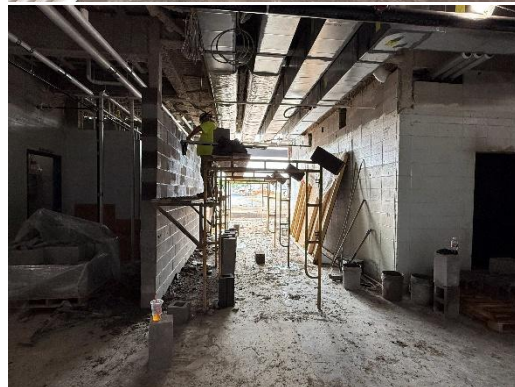
- m) CMU infills were being laid in the corridors in Area H.

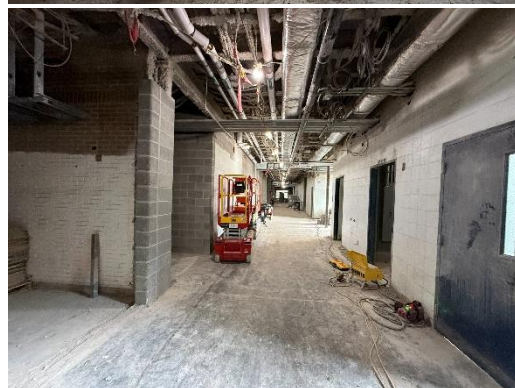
- n) It appeared that most of the above ceiling work was complete over the corridors in Area H.

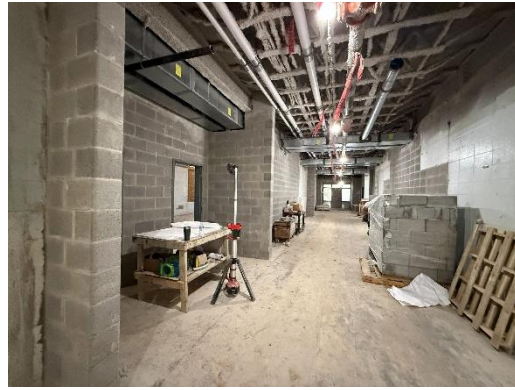
- o) It appeared that painting and other finishes can begin soon.

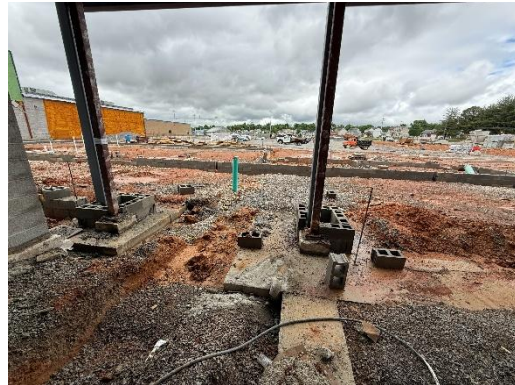
- p) From Area H looking to the north, the south to north extent of Area G was evident.

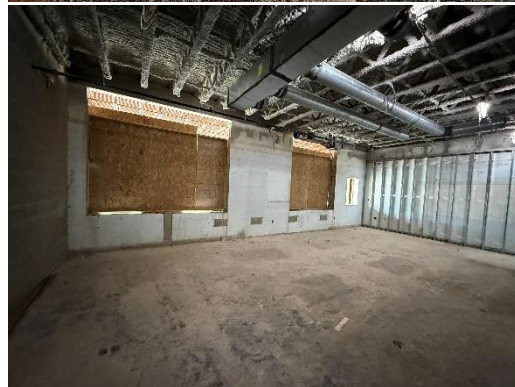
- q) Temporary closures were being maintained in the second-floor classrooms of Area H.

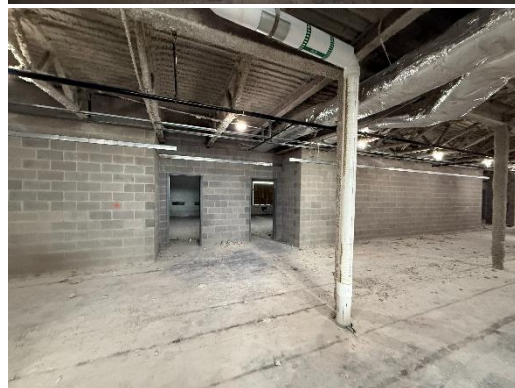
- r) The roof drainage system for Area H appears to be functioning properly.

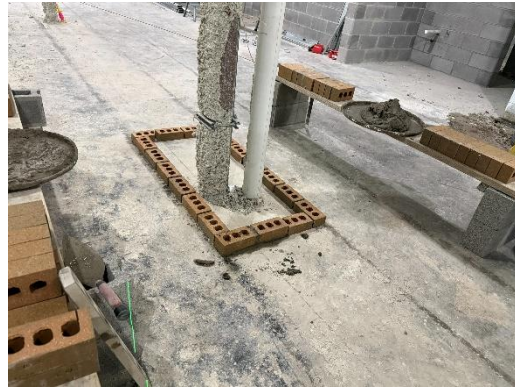
- s) Masons were laying out the piers in the open areas of the Area H corridor. These will be like similar brick piers in Phase 1.

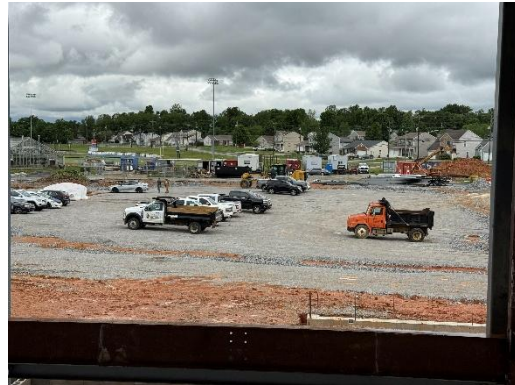
- t) From Area H, the temporary parking area could be seen.

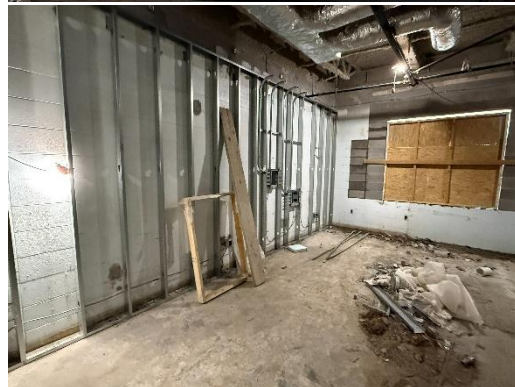
- u) Metal stud framing was installed for wallboard partitions and fur outs in Area H.

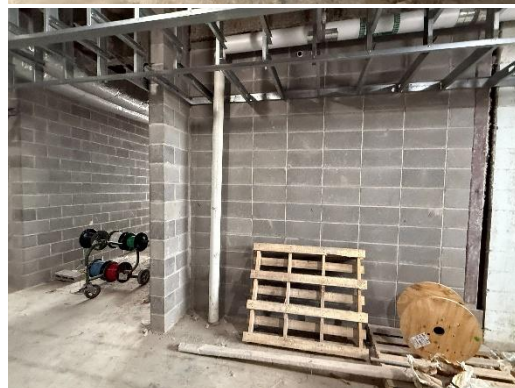
- v) Metal soffit framing was being extended along the corridors in Area H.

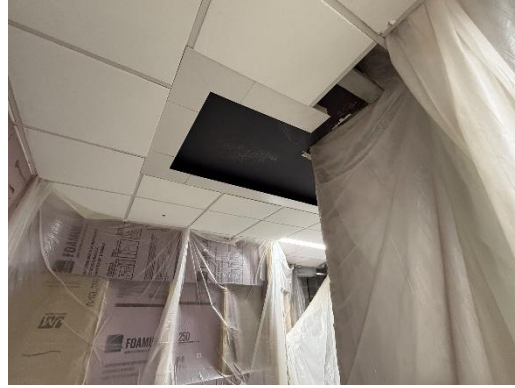
- w) It appears that the ceiling on the second floor of Phase 1 was not installed as shown on the drawings. A small portion of this will need to be removed to properly intersect with the Phase 2 ceiling.

- a) Note changes on the As-Built Drawings.
- b) Coordinate scoping of below slab sewer lines with Brandon.

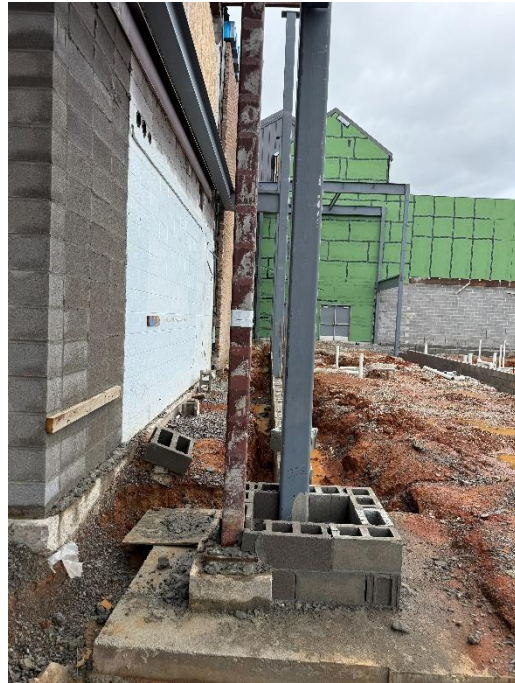
- x) New structural framing for Area G parallels the north wall of Area H. CMU foundations were being laid for the masonry piers around the columns.

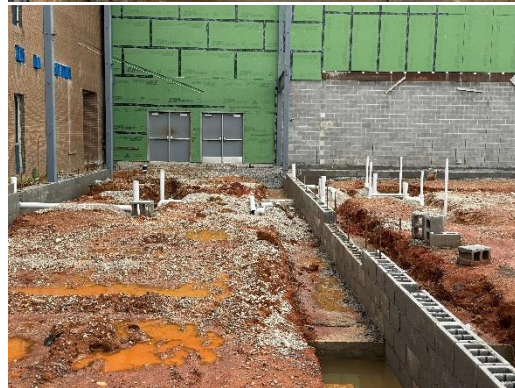
- y) Below slab plumbing runs were in place for plumbing fixtures in Area G.

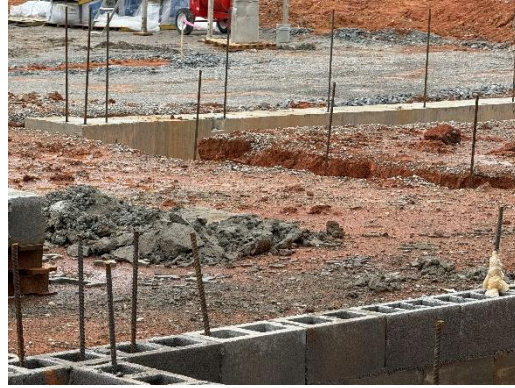
- z) The exterior concrete wall for the north side of Area G was poured.
